# ***Asbestos & Lead Paint Survey Report***

***Subject Sites:  
Three Residential Homes  
1800 8th Avenue, 1819 13th Street, 1849  
13th Street, West Linn, Oregon 97068***

***Prepared for:  
City of West Linn, Oregon***

**CEC Project No. CWL-2012.1**

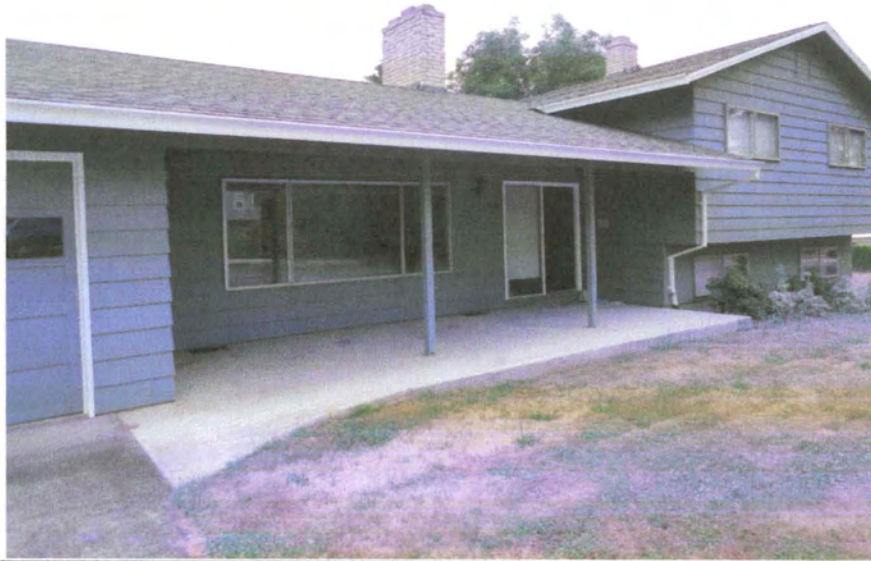
1. Front view of 1800 8<sup>th</sup> Avenue,  
West Linn, Oregon

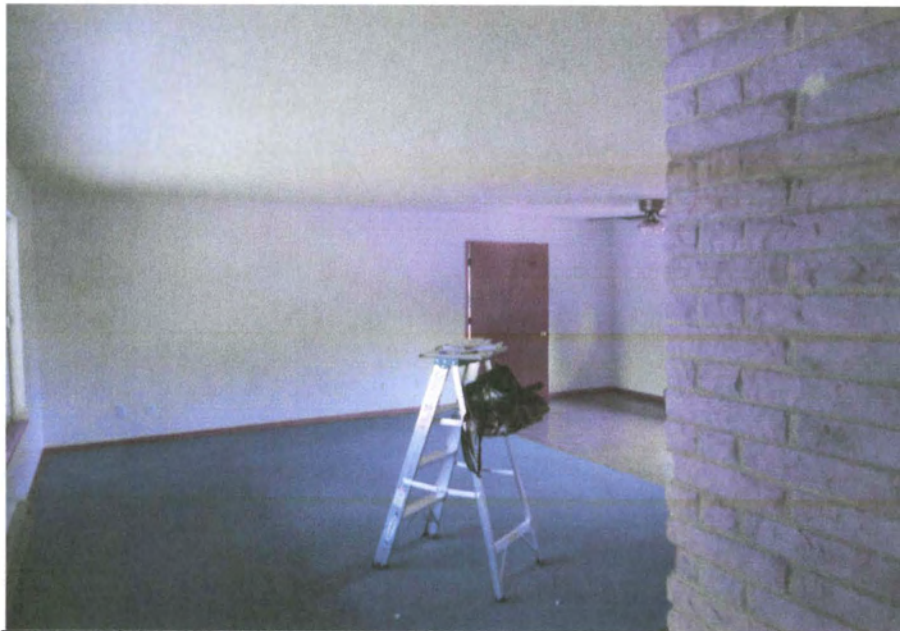
2. Main floor of house.

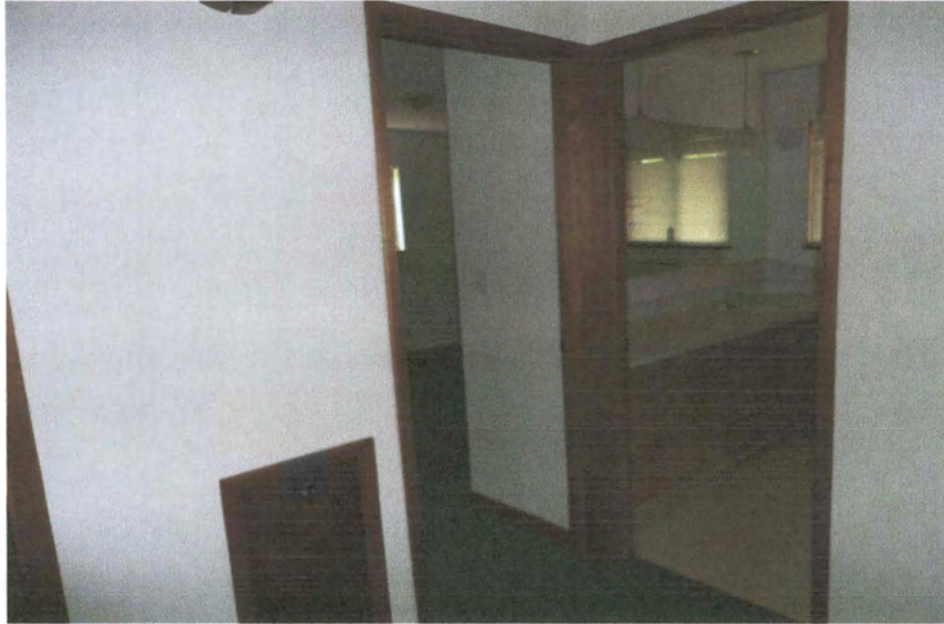
3. Bedroom/restroom area of house.

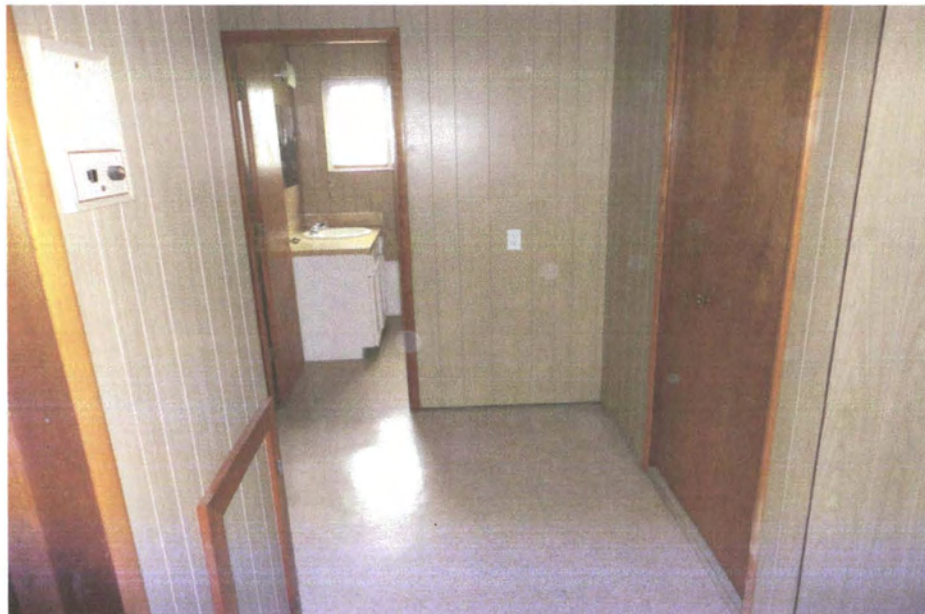
4. Basement area of house.

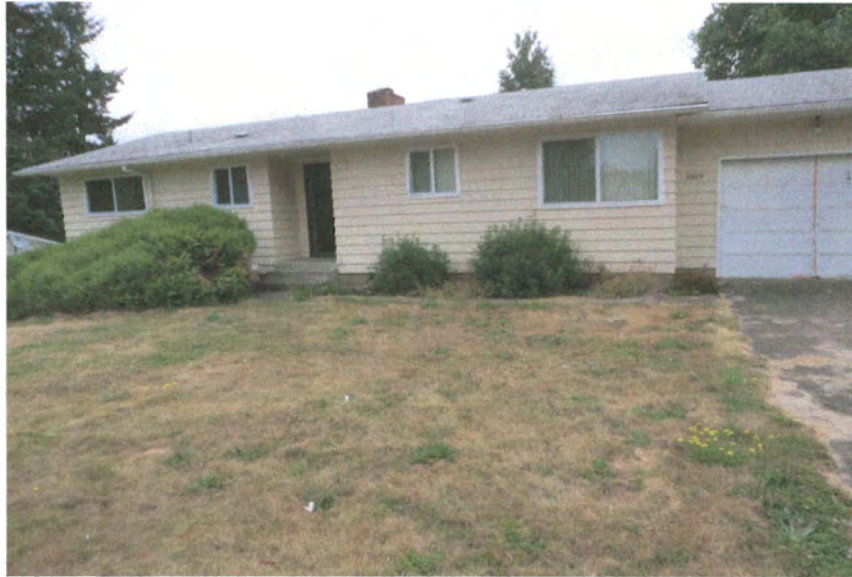
1. Front view of 1819 13<sup>th</sup> Street,  
West Linn, Oregon

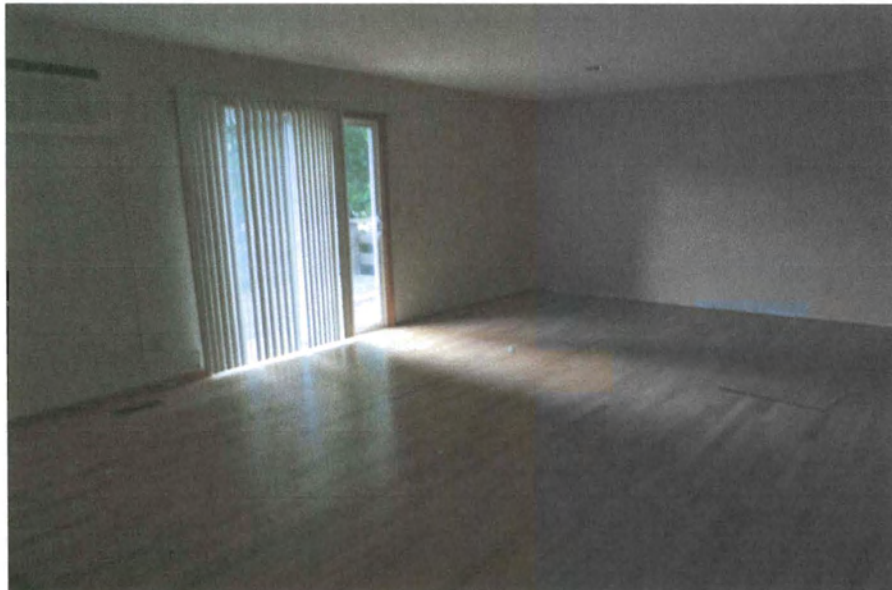
2. Main floor of house.

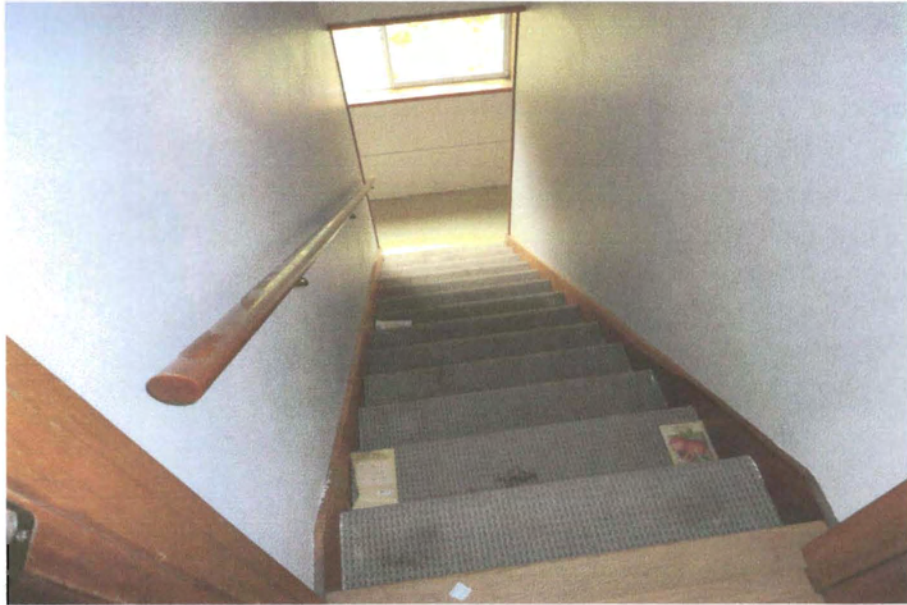
3. Stairway to basement.

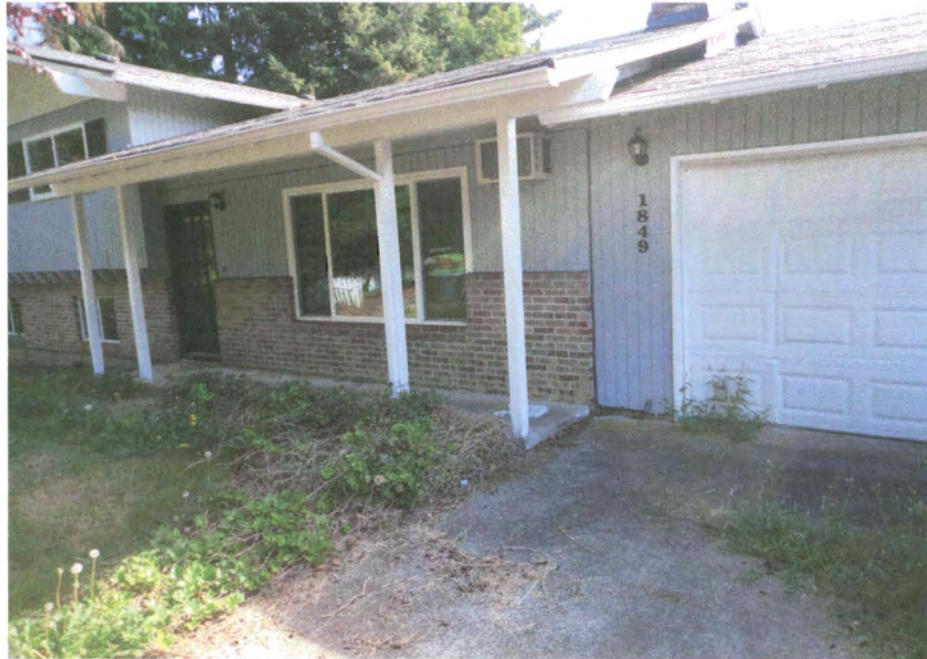
1. Front view of 1849 13<sup>th</sup> Street,  
West Linn, Oregon

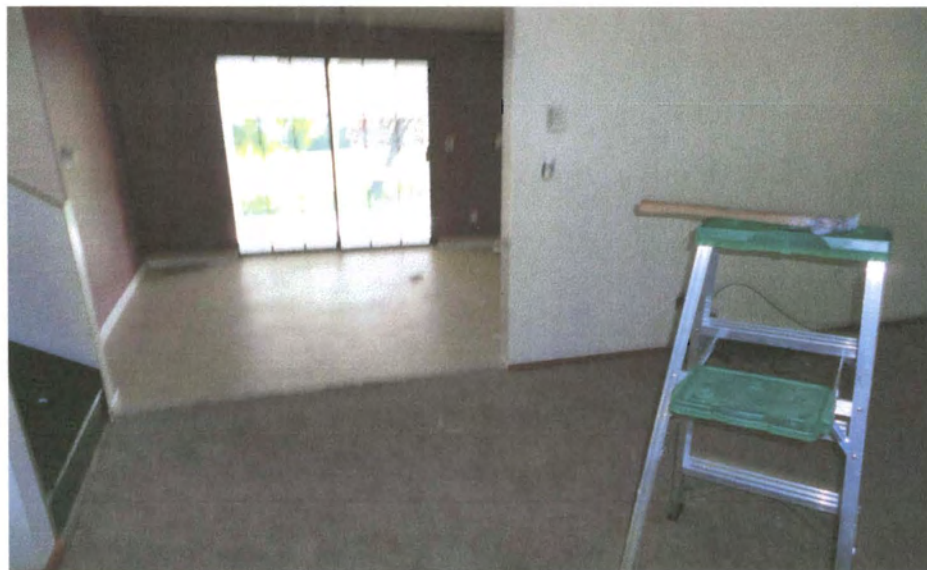
2. Main floor of house.

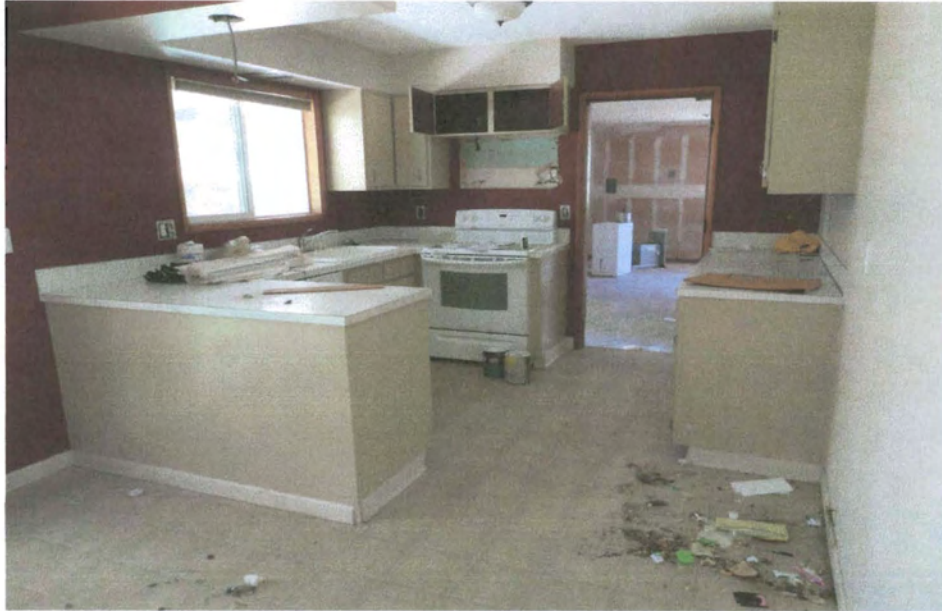
3. Kitchen area of house.

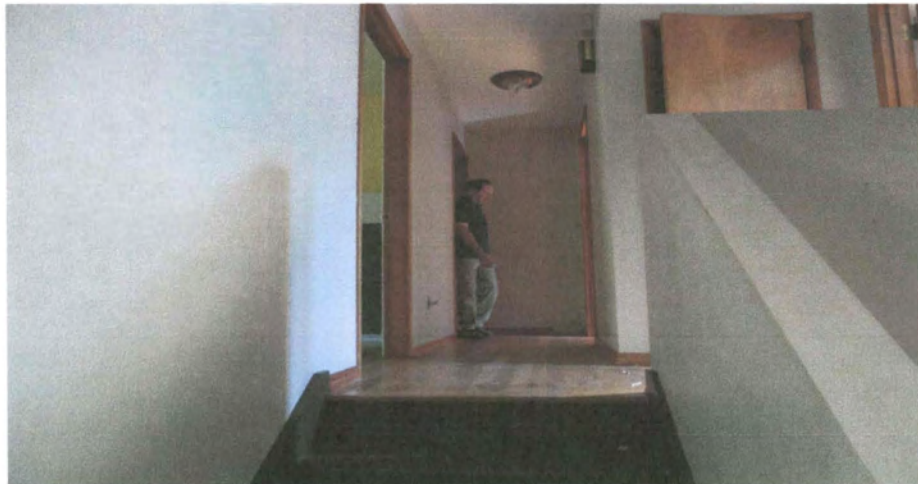
4. View of upper level.

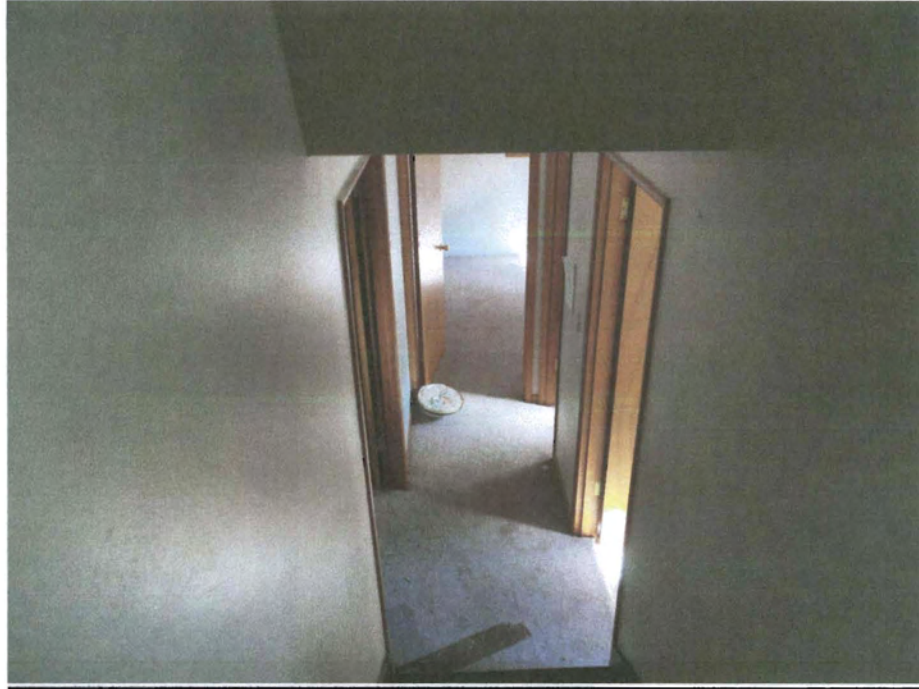
5. View of basement.
