Soils Investigation Report

6123 Skyline Drive Partition
West Linn, Oregon 97068

GeoPacific Engineering, Inc. Project No. 19-5206
April 29, 2019

**SUBJECT: GEOTECHNICAL ENGINEERING REPORT
6123 SKYLINE DRIVE PARTITION
WEST LINN, OREGON 97068**

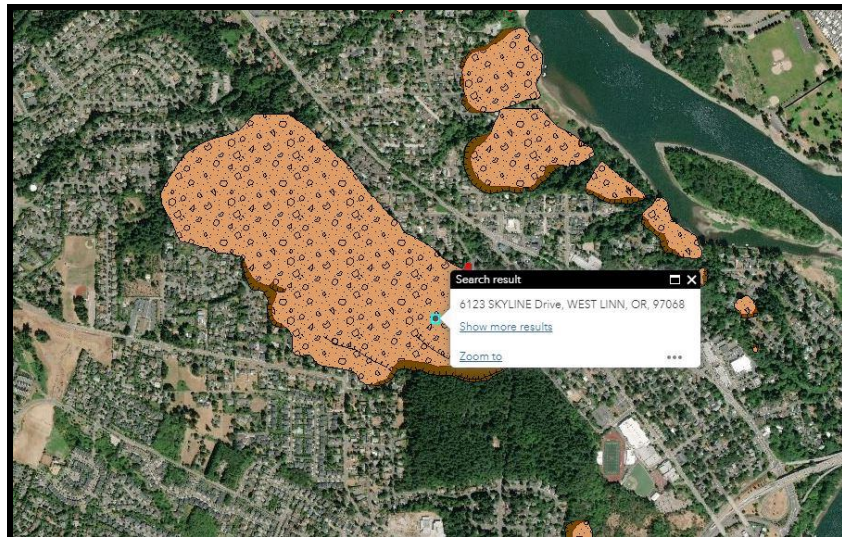
We have reviewed the State of Oregon Department of Geology and Mineral Industries (DOGAMI) landslide hazard and inventory mapping, and SLIDO LiDAR imagery which indicates that the site is located within a large ancient landslide area mapped and identified as landslide No. Canby 133. The DOGAMI mapping indicates that the landslide consists of a rock slide or translational slide with an average slope of 15 percent, and a failure depth of 38.6 feet. The direction of failure is reported to be approximately N45°E. Many homes, roads, and public infrastructure are built across the slide area including the Bolton Reservoir.

Image: SLIDO Statewide Landslide Information Layer for Oregon, DOGAMI

2. The site is located on a large ancient landslide identified by DOGAMI as Canby 133. Extensive development is present across the landslide. Detailed evaluation of the Canby 133 landslide and the affect it may have on the proposed development is beyond the scope of this study. It appears that with consideration to the degree of surrounding development, the understanding that the landside is considered to be ancient, and the long history of residential homes on the property, the overall landslide mass may be relatively stable. However, given the noted information and mapping, if additional study is determined to be needed by the client or local building official, we would recommend conducting soil borings and a quantitative slope stability of the sloping areas on the north end of the property to determine if additional stabilization measures may be desired or needed for the homesites.

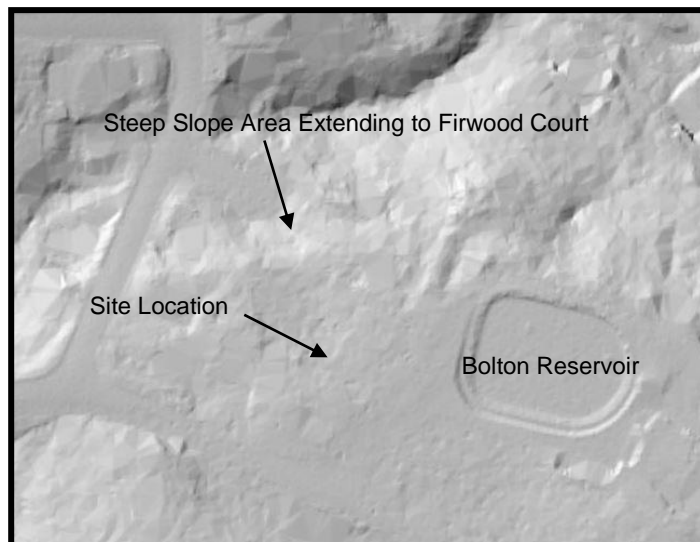
Image: LiDAR HAZVU Statewide Landslide Information Layer for Oregon, DOGAMI

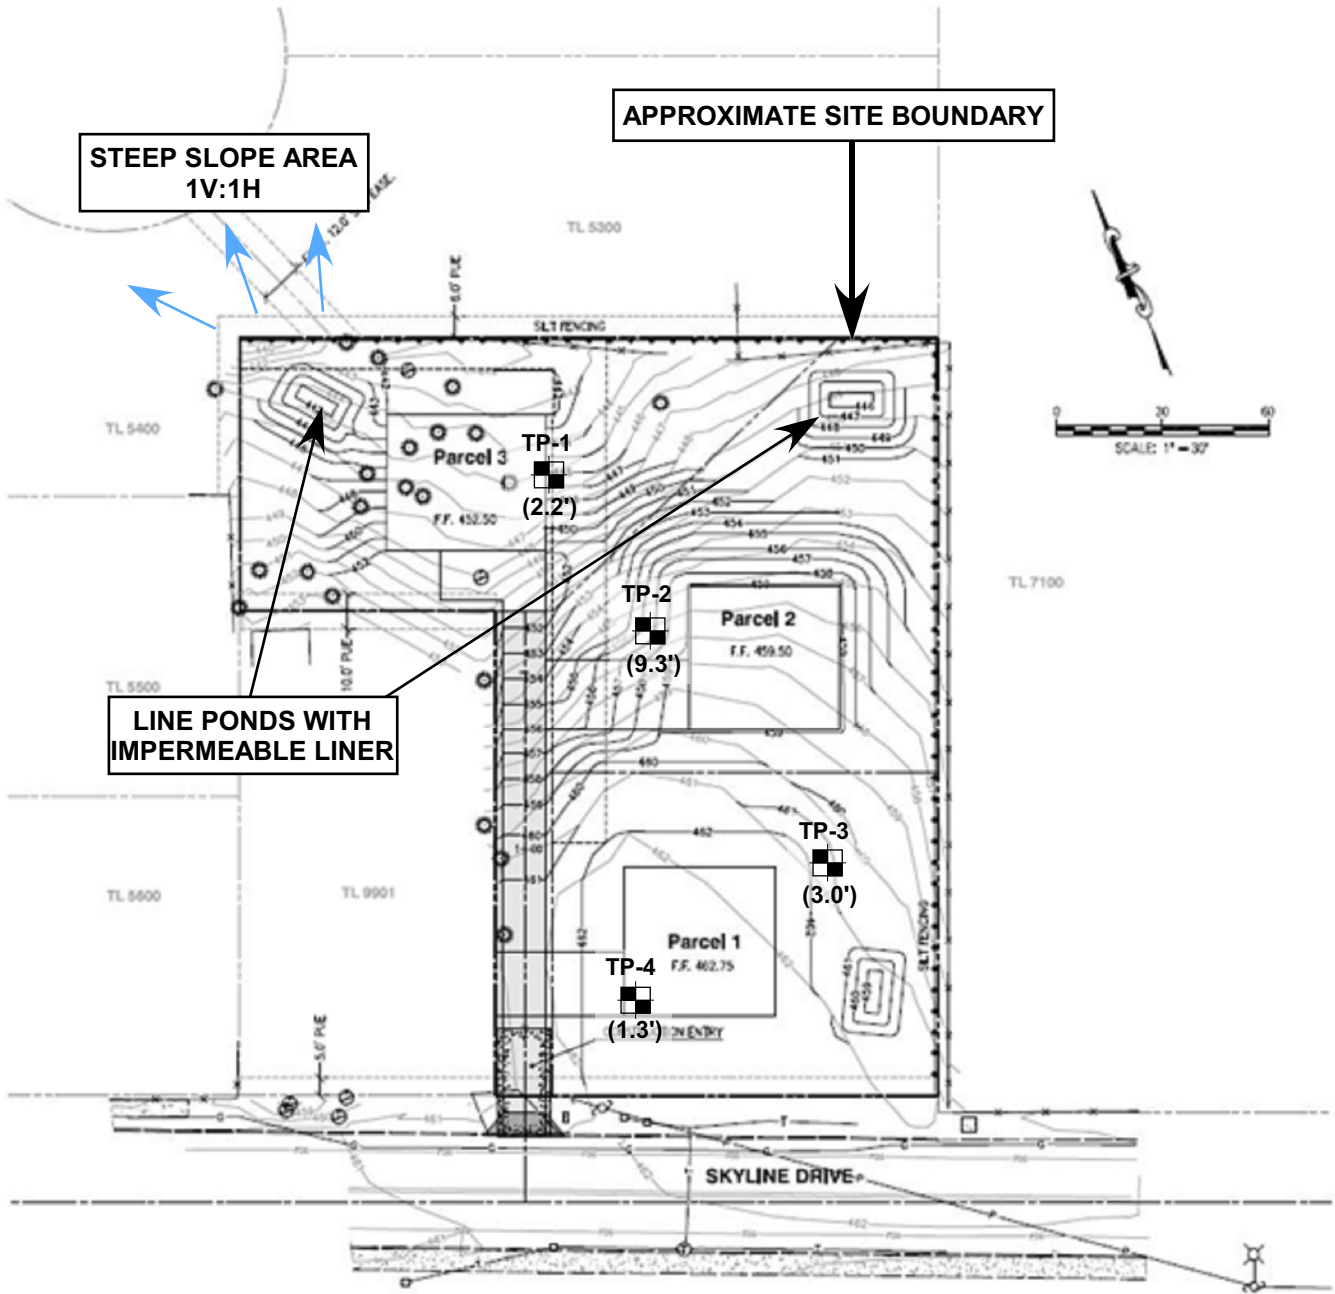
FIGURE 3

3. A moderate to steep slope is present beyond the northwestern property line that extends to Firwood Court below. Parcel 3 will be located above the slope as shown on Figure 3. The hillside is heavily vegetated and showed no signs of recent erosion or instability at the time of our study. Based on review of the site plan and the indicated building envelope for Parcel 3 it appears that 20 to 30 feet of setback is proposed from the top of the slope which is approximately 30 feet high. Recommendations regarding adequate footing-to-slope setback distances for foundations are presented below in Section 6.6, Spread Foundations.

As described above, a moderate to steep slope is present beyond the northwestern property line that extends to Firwood Court below. Parcel 3 will be located above the slope as shown on Figure 3. The overall slope height is approximately 30 feet. The hillside is heavily vegetated and showed no clear signs of recent erosion or instability at the time of our study. Based on review of the site plan and the indicated building envelope for Parcel 3 it appears that 20 to 30 feet of setback is proposed from the top of the slope to the home foundation. The noted setback distance appears to be adequate, however we recommend that a minimum footing-to-slope setback distance of at least 20 feet be maintained for foundations, engineered fill, and any structures or slabs. Reductions in setback distance should not be conducted without supporting soil boring explorations, and detailed quantitative slope stability assessment and calculations. Based on our review of the proposed locations of foundation envelopes of Parcels 1 and 2 it appears that each will be located at least 80 to 100 feet from steeply sloping areas.

SITE PLAN AND EXPLORATION LOCATIONS

4. Due to the site being located on a large ancient landslide, and the presence of a steep slope area to the north of the property, we recommend that the grading plan be adjusted to eliminate any raising of grades or additional soil surcharges on the building lots. Grade adjustments within the proposed drive and driveways appear to be feasible.

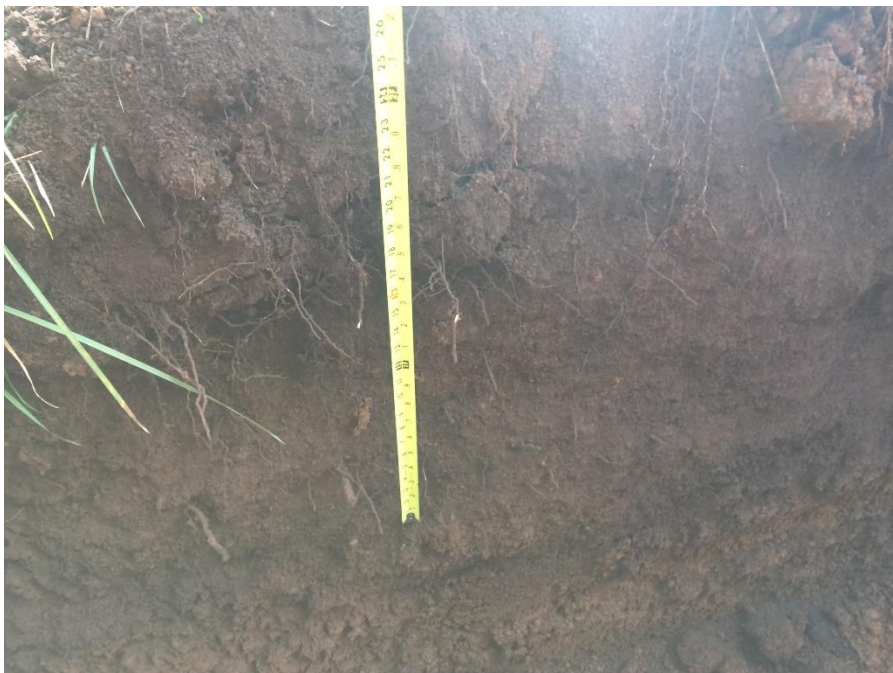
Undocumented Fill Soil Containing Organic Material

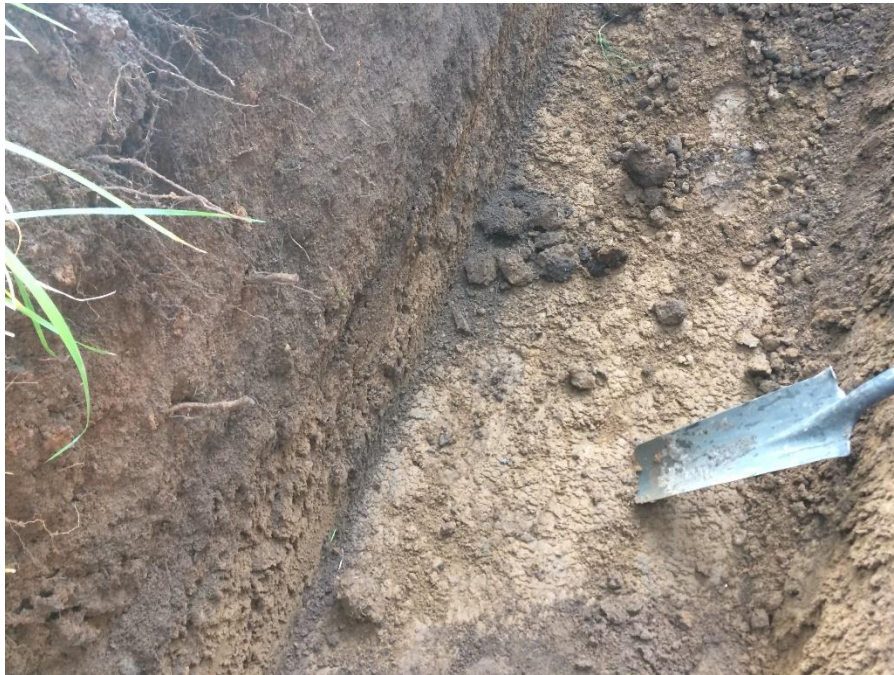
Native Soils Below the Undocumented Fill

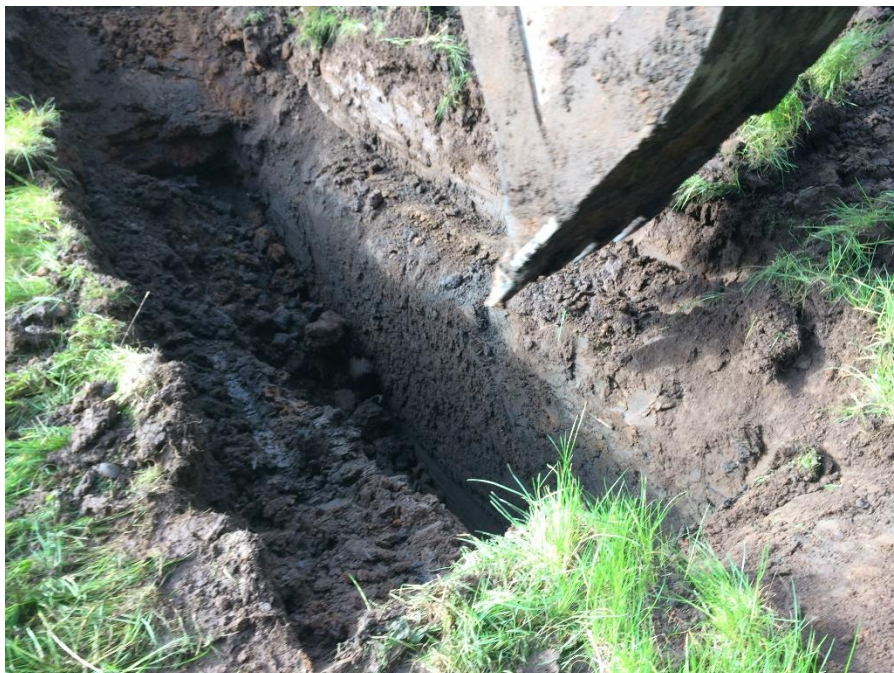
- At the location of Parcel 2, undocumented fill soils were observed to be present on the order of 9 feet thick, consisting of medium stiff, dark brown, moist, Clayey SILT (ML), containing subrounded cobble sized rock, wood debris, and a buried drain field. The fill soils are underlain by stiff native silts. We recommend either: 1) excavating and recompacting the undocumented fill soils to achieve 95 percent compaction relative to ASTM D698; or 2) leave the fill material in place and install rammed aggregate piers to support the proposed home foundation.

Undocumented Fill in Test Pit TP-2

- At the location of Parcel 2, undocumented fill soils were observed to be present on the order of 9 feet thick, consisting of medium stiff, dark brown, moist, Clayey SILT (ML), containing subrounded cobble sized rock, wood debris, and a buried drain field. The fill soils are underlain by stiff native silts. We recommend either: 1) excavating and recompacting the undocumented fill soils to achieve 95 percent compaction relative to ASTM D698; or 2) leave the fill material in place and install rammed aggregate piers to support the foundation.

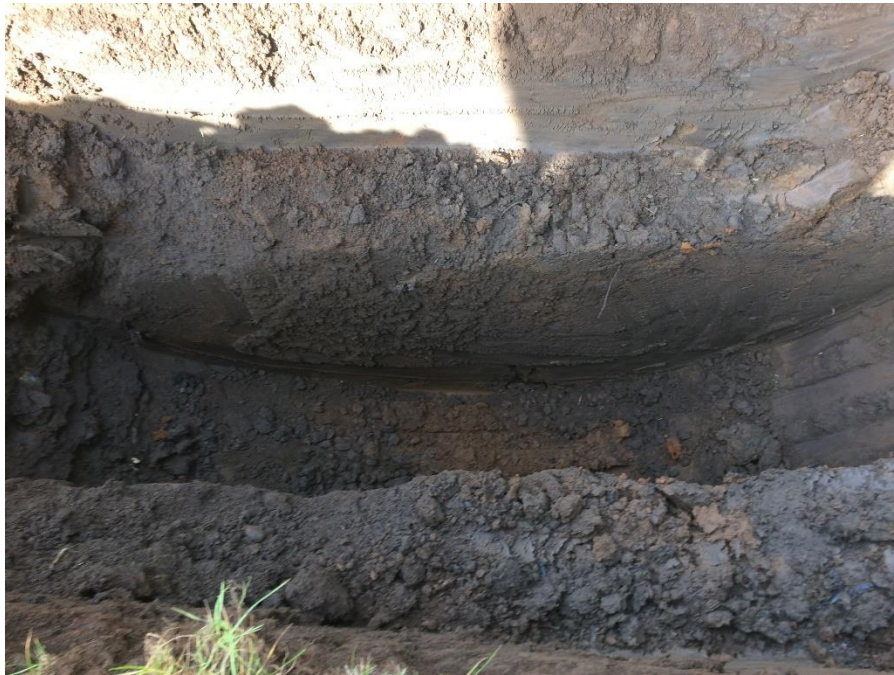
Undocumented Fill and Exposed Native Soils in Test Pit TP-2

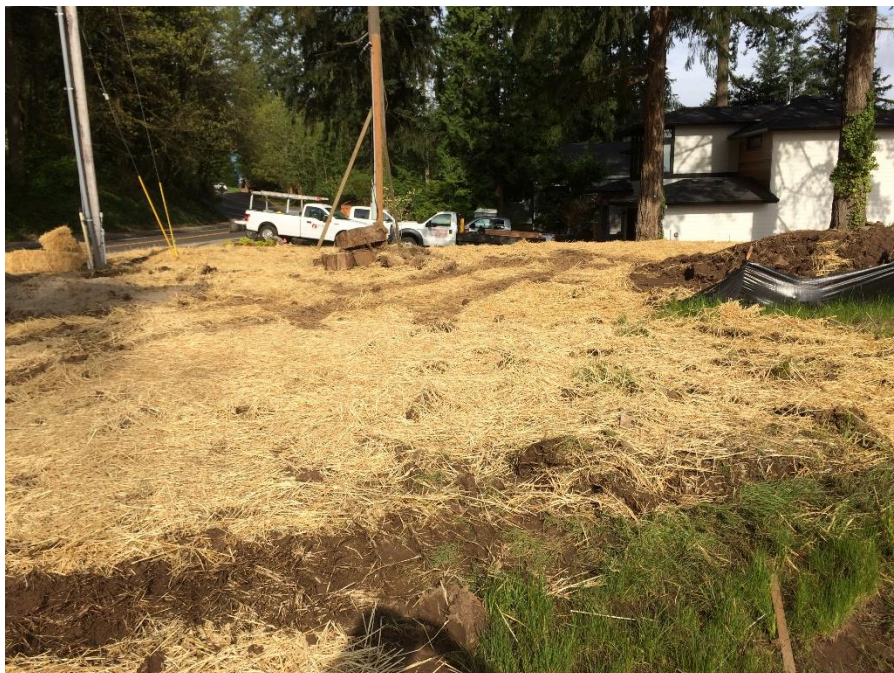
South Side of Property Where House was Demolished
