Arborist Notes

The owner of Parcels 2 and 3 is proposing to remove the stand of Douglas-fir trees there and the owner of Tax Lot 5300 questions the effect of increased exposure on the continuation of the stand on Tax Lot 5300. I went to the site on 3/22/2019 to evaluate the situation and the proposal.

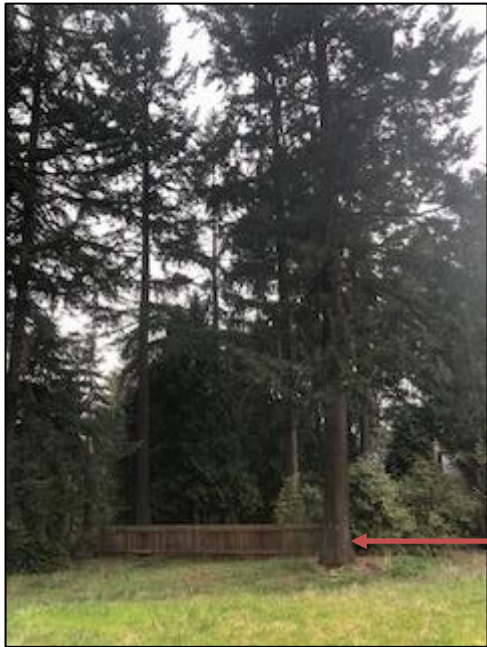
T18 on Parcel 2.

Looking north into the east portion of Tax Lot 5300 with Tree 18 (T18) on Parcel 2 in the foreground. T18 will be removed. Trees beyond the fence (Tax Lot 5300) constitute an open stand, a continuation of the subject tree on Parcel 2. Most of Parcel 2 and all of Parcel 1 are devoid of trees, providing little or no wind break for Tax Lot 5300.

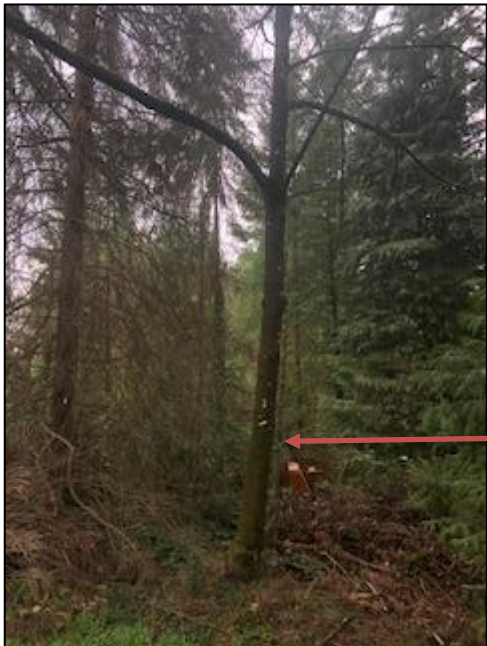
Looking north from T24 on Parcel 3 into Tax Lot 5300. Here on the west side of Tax Lot 5300 the open stand continues as mixed hardwoods and conifers. The trees on Parcel 3 do provide a wind break for Tax Lot 5300 from southerly winds. The trees on the west side of Tax Lot 5300 are fully exposed to winds from the east, north and west. The elevation is lower than Parcel 2 and this reduces wind exposure from the south.

A bigleaf maple (typical) on the west side of Tax Lot 5300. This is a very open stand of trees.

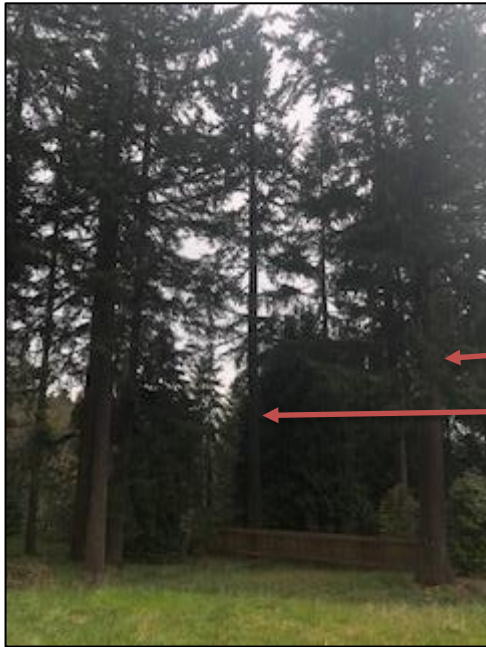
T18

This Douglas-fir tree in Tax Lot 5300 has a high LCR and strong trunk taper. It is characteristic of the conifers on Tax Lot 5300 and on Parcels 2 and 3. These traits indicate an open stand vs. a closed stand. In a closed stand, tree trunks grow with no noticeable taper and with live branches only at the top. Such trees are typical of plantations and the pole-like quality is

desirable in the logging industry. They rarely snap or blow down because they all support each other, and because there are edge trees that develop strong taper and LCR by virtue of growing at the edge of the closed stand, exposed to the elements. When edge trees are removed, the interior poles tend to snap and blow down in wind events. None of the subject trees here are interior trees.

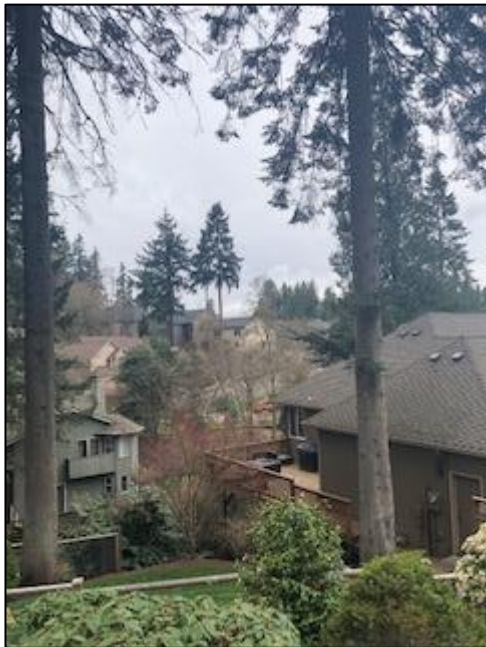
A view from Skyline Drive nearby. The mature conifers seen here are doing well as stand-alone trees. This landscape is typical of the neighborhood.

Tree removal on Parcels 2 and 3 will allow increased wind velocity from the south on the trees in Tax Lot 5300. In my opinion the adverse effect will be negligible, and I do not anticipate trunk snap or blow down to result.
