# Hydromodification Assessment

Prepared for  
The City of West Linn  
June 2015

### Hydromodification Assessment

July 1<sup>st</sup>, 2015

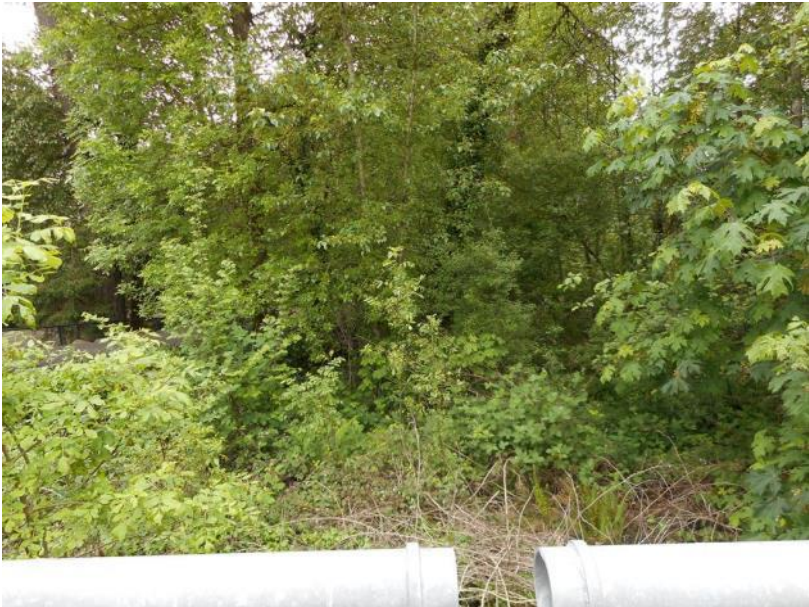
<b>Site location:</b>	001
	<b>Photo number:</b>	201
	<b>Description:</b>	Looking downstream from Landis, heavy vegetation and wide riparian buffer.

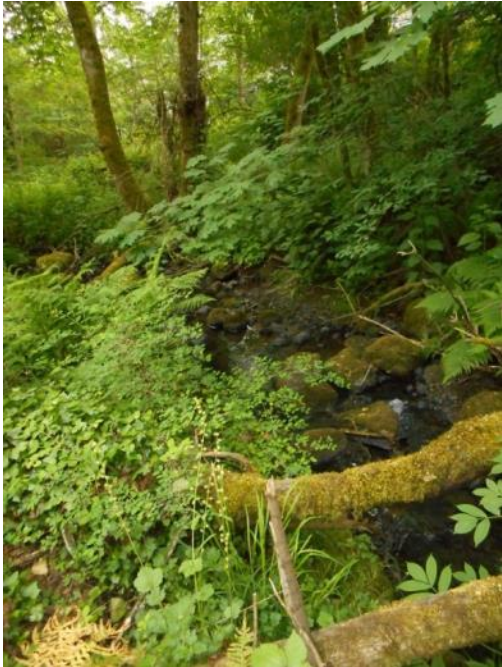
<b>Site location:</b> 001 <b>Photo number:</b> 207 <b>Description:</b> Large woody debris. No observed channel erosion.

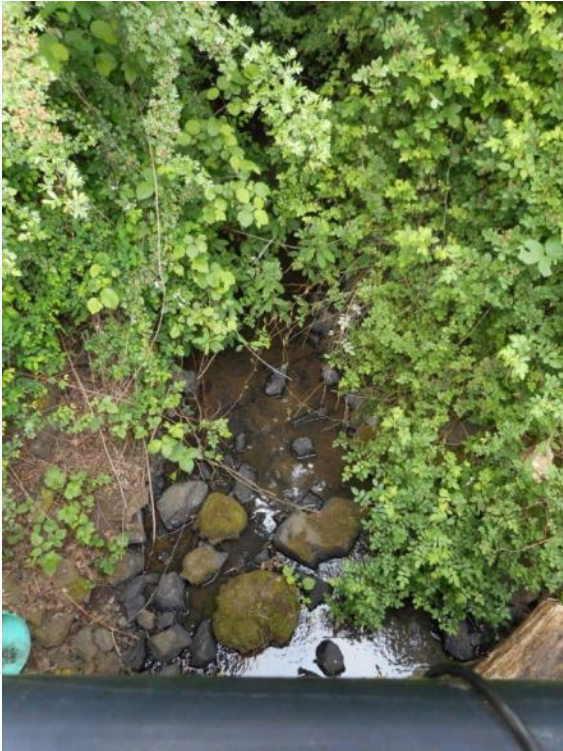
<b>Site location:</b>	002	
	<b>Photo number:</b>	220	
	<b>Description:</b>	Cobble and gravel bed material in Tanner Creek at Beacon Hill culvert.

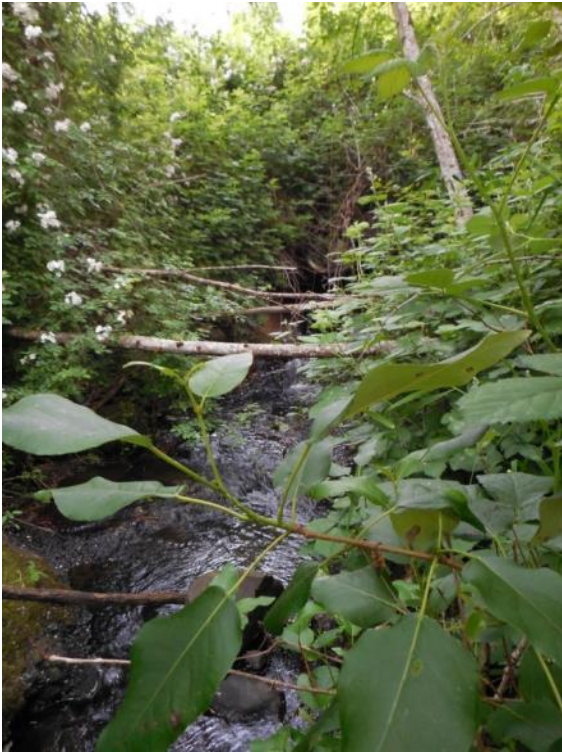
<b>Site location:</b>	005
		<b>Photo number:</b>	330
		<b>Description:</b>	Dense vegetation and LWD in channel.

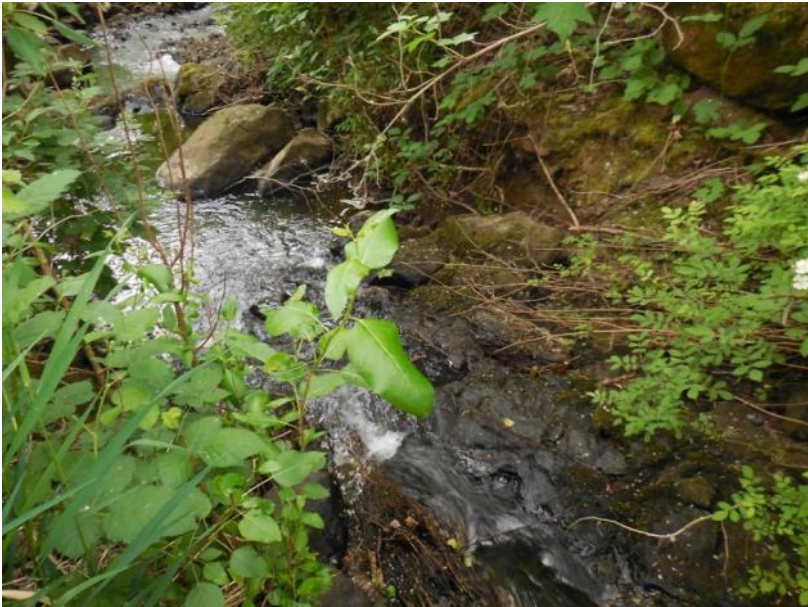
<b>Site location:</b>	005
		<b>Photo number:</b>	331
		<b>Description:</b>	Bedrock substrate with large cobbles and boulders in channel.

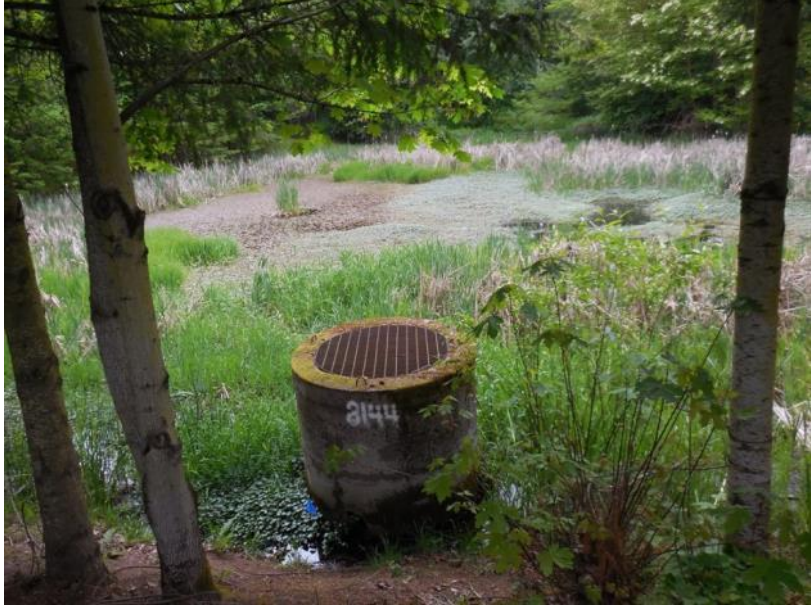
<b>Site location:</b>	006
<b>Photo number:</b>	338
<b>Description:</b>	Future detention pond retrofit with upstream development. Original design of perforated underdrain is not operational. Pond operates as a retention pond/ wetland.

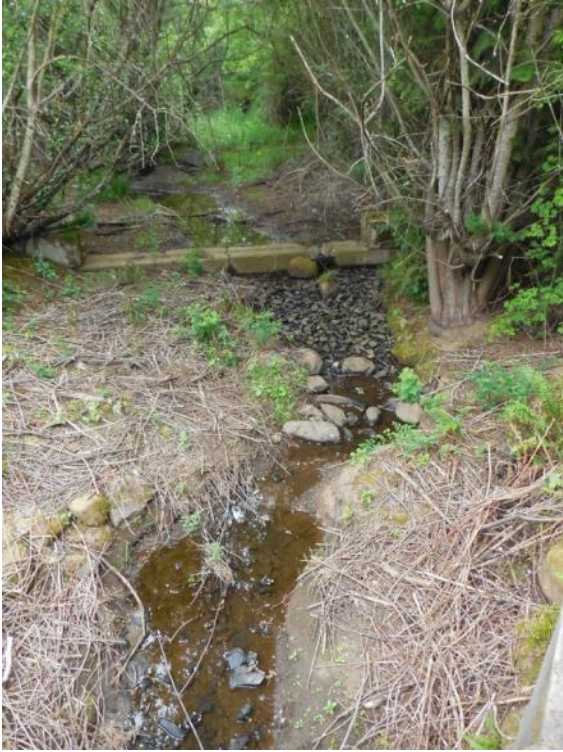
<b>Site location:</b>	007
		<b>Photo number:</b>	340
		<b>Description:</b>	Limited areas of channel incision and downcutting

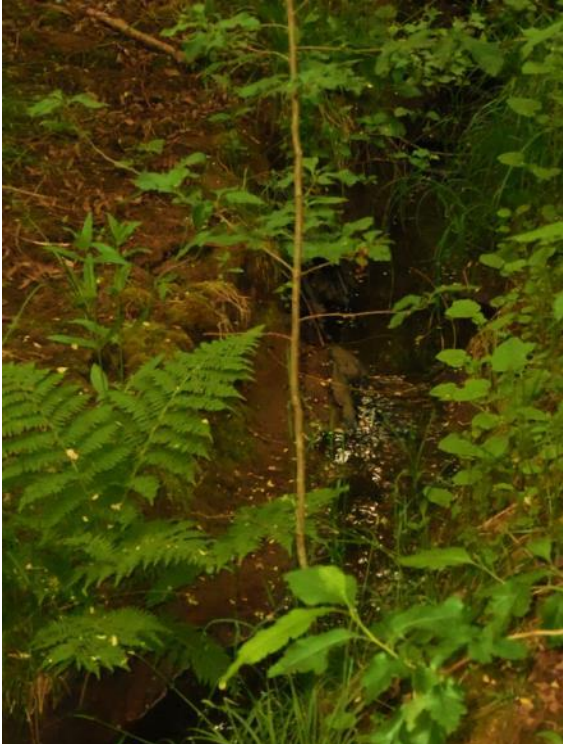
<b>Site location:</b>	007
		<b>Photo number:</b>	344
		<b>Description:</b>	Silty bank materials but bedrock substrate.

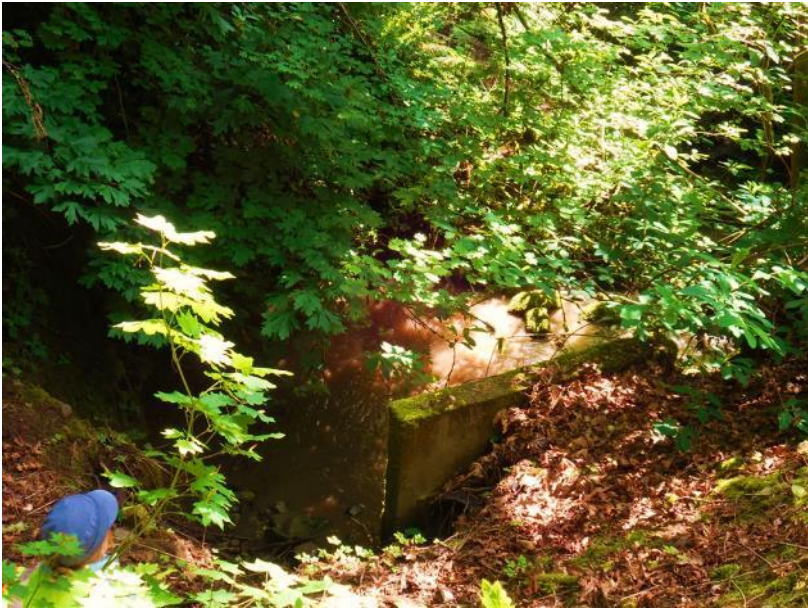
<p><b>Site location:</b> 009 <b>Photo number:</b> 002 <b>Description:</b> Outlet of culvert under Skye Parkway. Heavy vegetation and canopy. Invasive species present.</p>

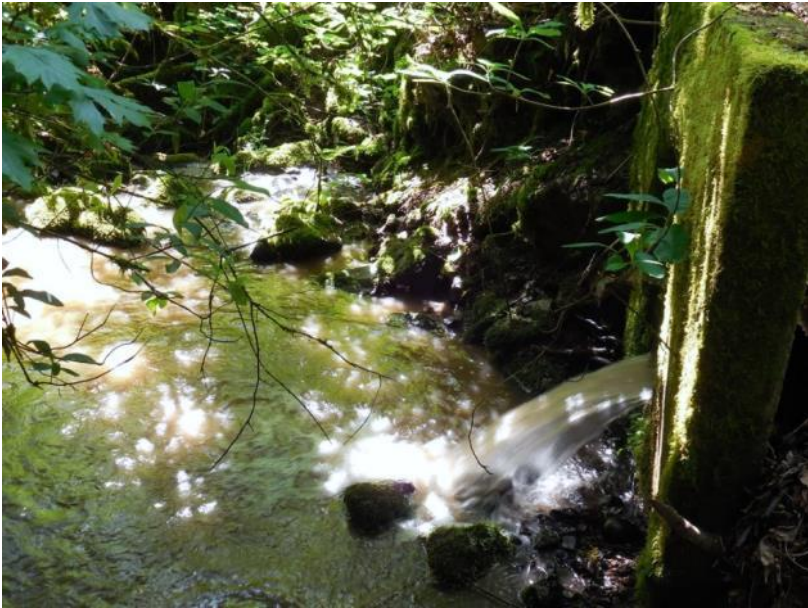
<p><b>Site location:</b> 009 <b>Photo number:</b> 004 <b>Description:</b> Scour hole at outlet of culvert. Some exposed roots along banks.</p>

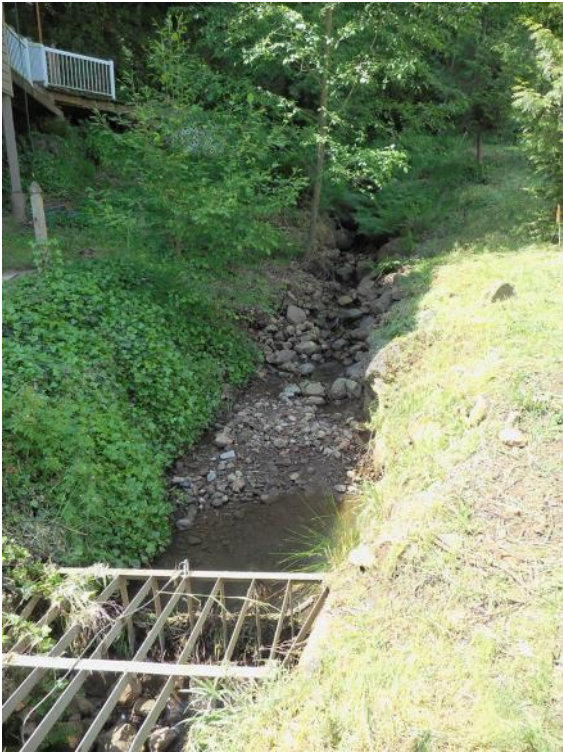
<b>Site location:</b>	010
		<b>Photo number:</b>	010
		<b>Description:</b>	Stream restoration project from 10+ years ago. Cobbles and boulders along channel alignment.

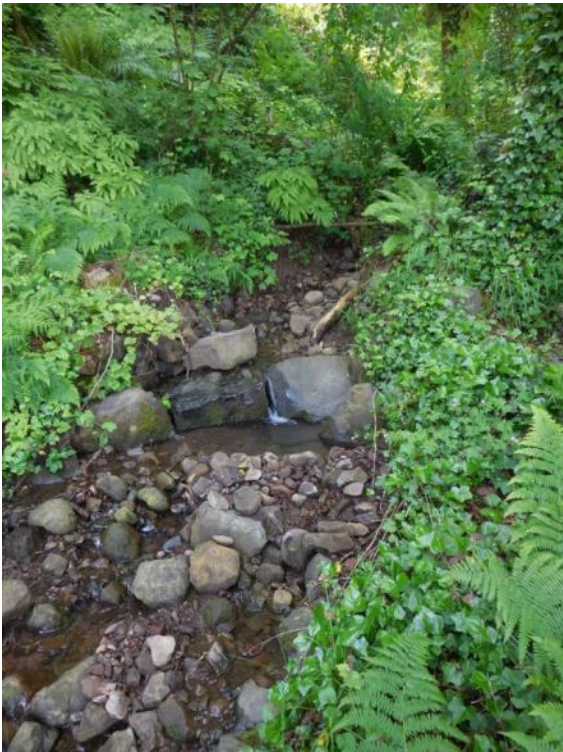
<b>Site location:</b>	010
		<b>Photo number:</b>	012
		<b>Description:</b>	Step pools with cobbles and boulders. Some invasives.

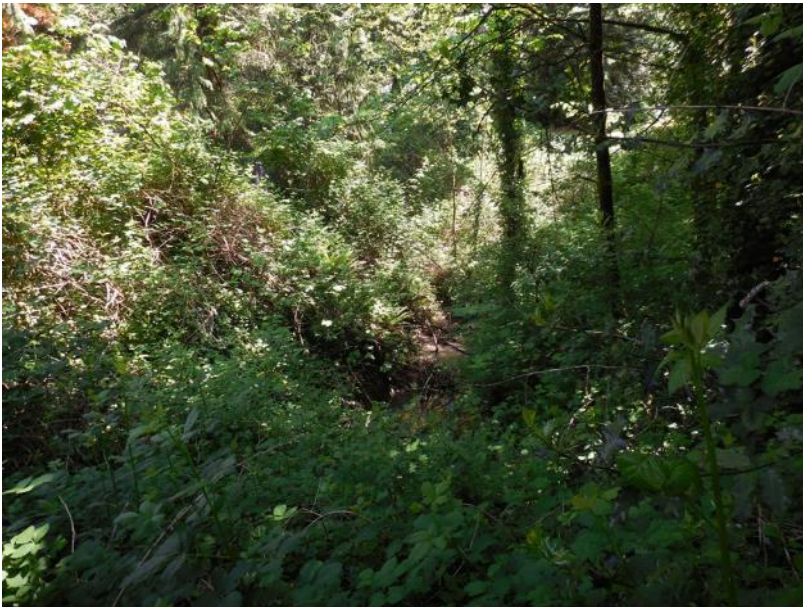
<b>Site location:</b>	011
	<b>Photo number:</b>	020
	<b>Description:</b>	Dense vegetation and wide floodplain.

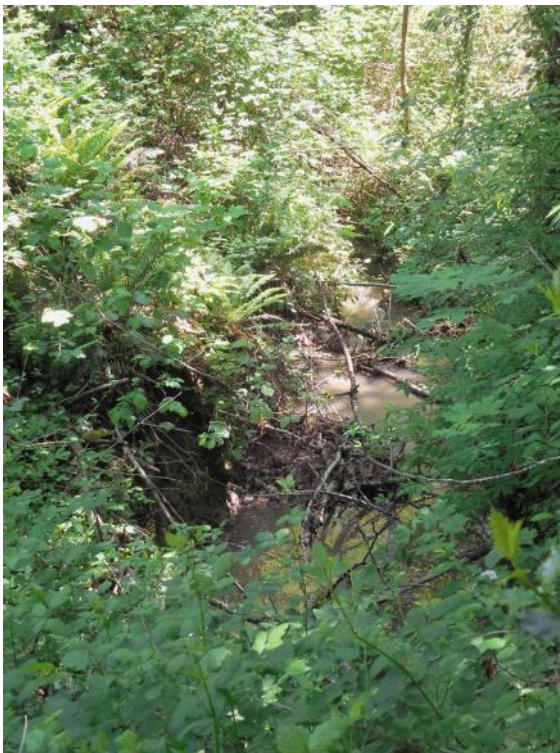
<b>Site location:</b> 011
		<b>Photo number:</b> 021
		<b>Description:</b> Observed locations of historic bank erosion. Evidence of turbid discharge continuing downstream from site location 009.

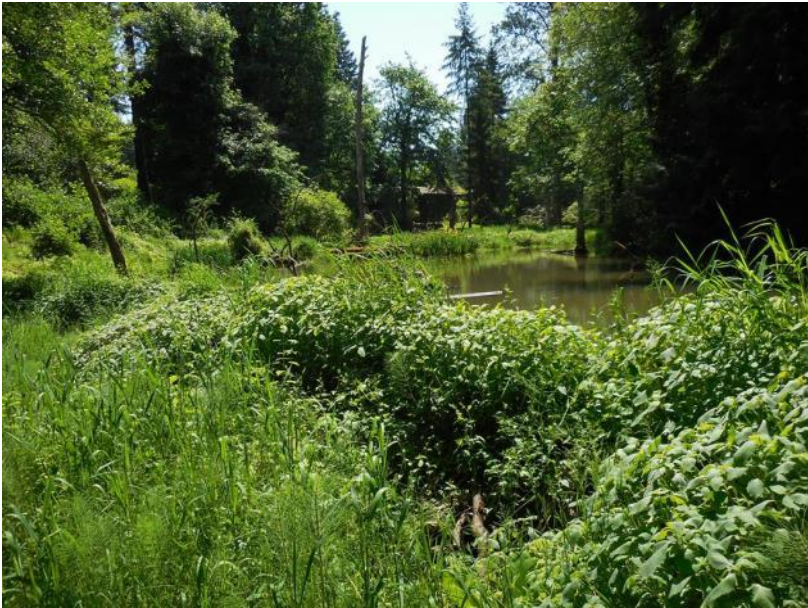
<b>Site location:</b>	012
<b>Photo number:</b>	023
<b>Description:</b>	Beaver dams created pond, which builds up and washes out with storm events. Significant vegetation including invasives, but relatively undisturbed natural habitat condition.

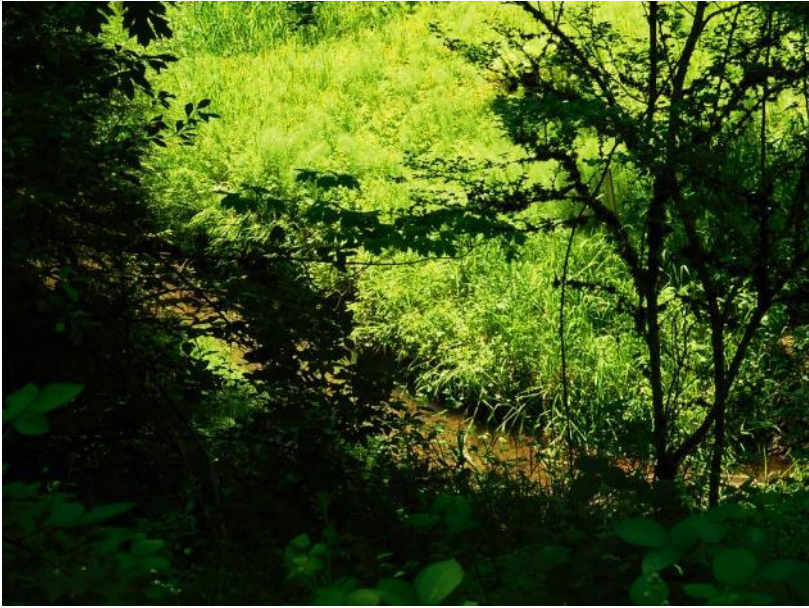
<b>Site location:</b>	015
		<b>Photo number:</b>	045
		<b>Description:</b>	Dense vegetation. Could not access stream channel to observe bed conditions.

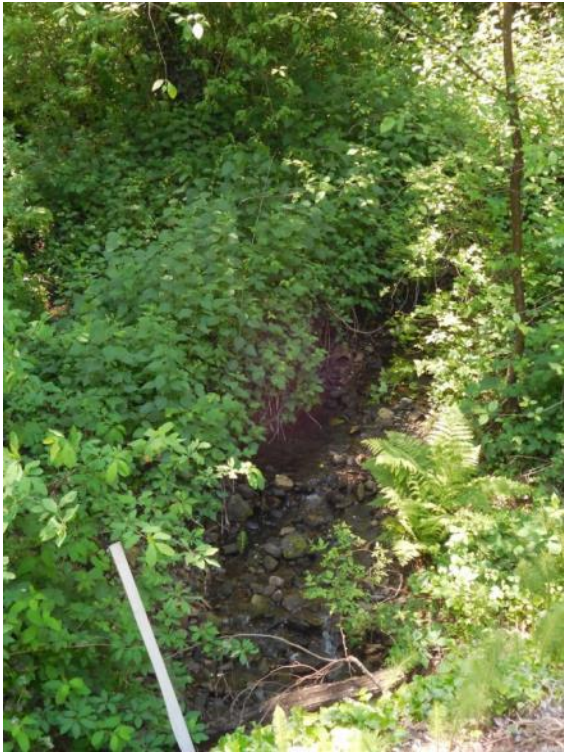
<b>Site location:</b>	018
		<b>Photo number:</b>	064
		<b>Description:</b>	Dense vegetation and cobble substrate. Potential development area to the west.
