DEVELOPMENT REVIEW APPLICATION

**Water Resource Area Protection/Single Lot Submittal
Alternative Review Process (paragraph 32.070 of WRA Protection Chapter 32)**

1822 Carriage Way, West Linn OR

Submitted by David Quinn and Laura Quinn (property owners)

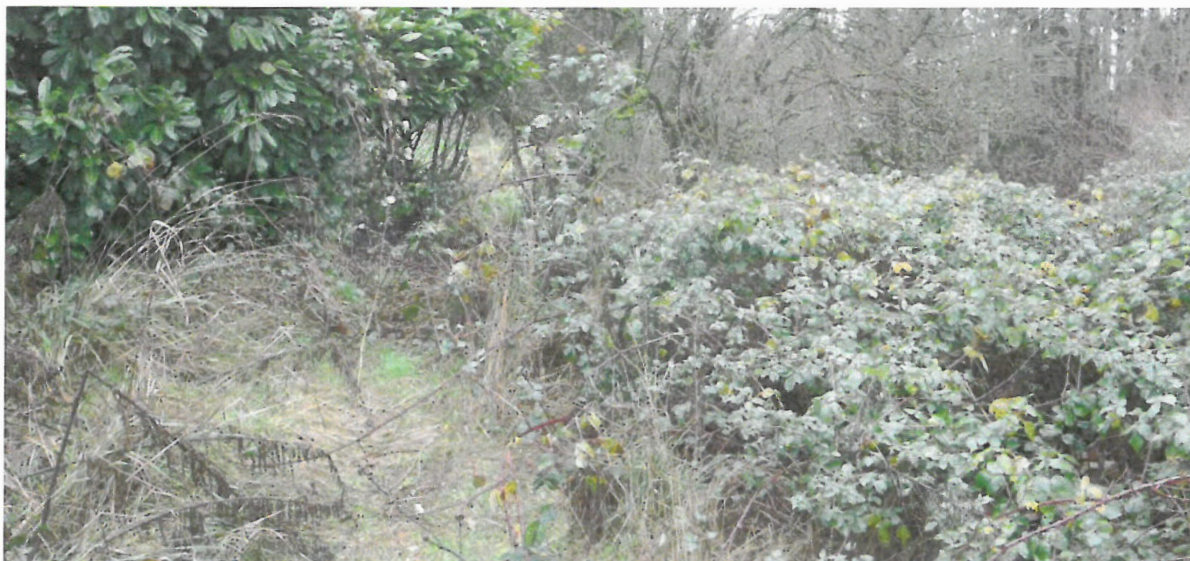
Photo Point A (above): View to northeast at vicinity of SP-1. The plot was situated mostly in Himalayan blackberry thicket, since the slope gets steeper to the right. The thicket has several willows growing up through the blackberry vines. The English laurel hedge is planted on the north property line. The grassy foreground in the left part of photo appears infrequently mowed or trimmed.

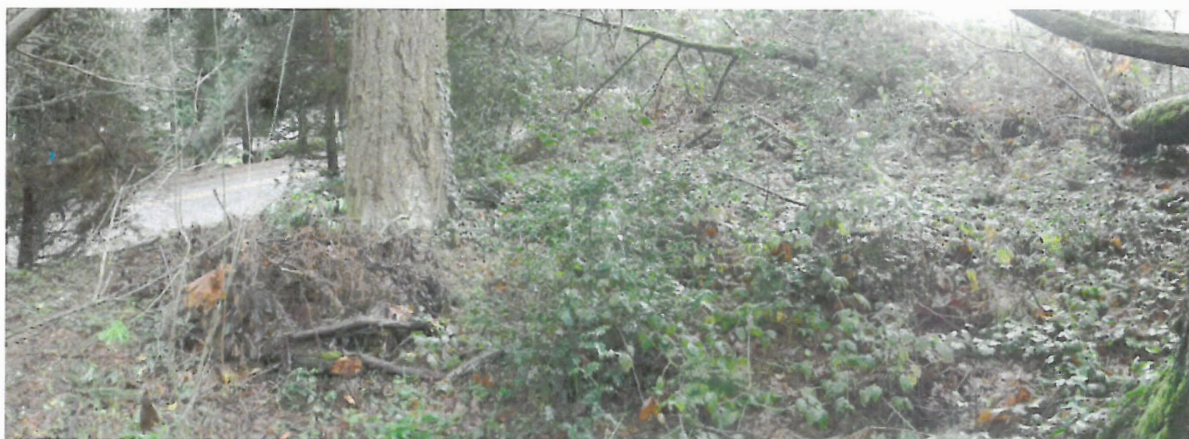
Photo Point B (above): View to southwest at vicinity of SP-2. This plot includes two large-diameter Douglas-fir trees, plus a multi-stem bigleaf maple tree. The understory is dominated by mostly non-natives, such as English ivy, holly and Himalayan blackberry. The trees are likely second- or third-growth, while the understory reflects a long history of disturbance (albeit little or not disturbance in several decades). There is an old road at the far left edge of photo that occurs on the west edge of the riparian boundary.

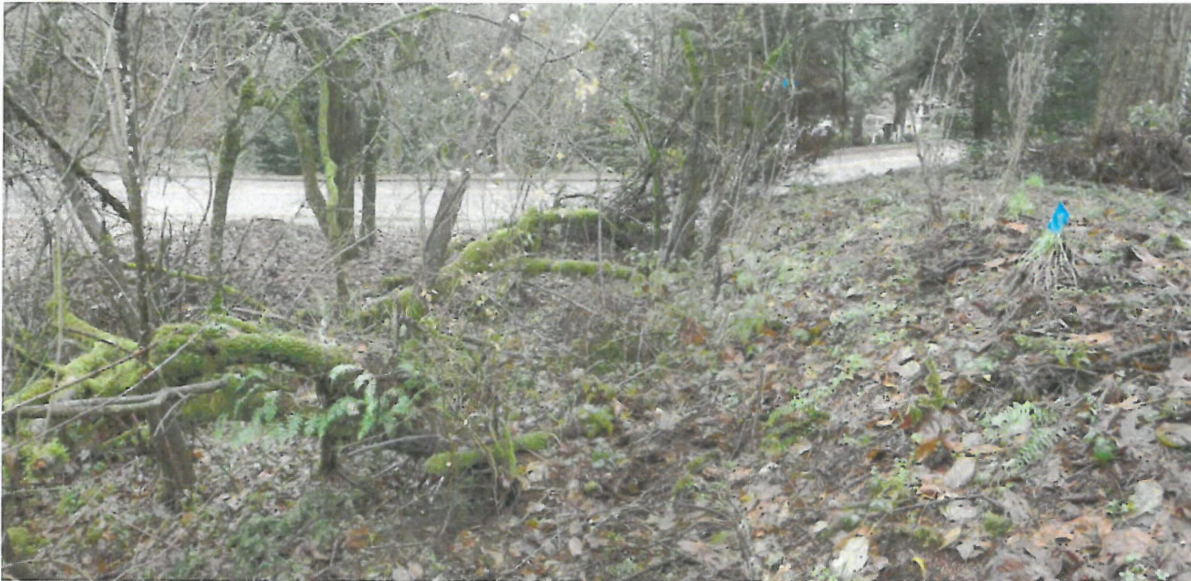
Photo Point C (above): View to south by southeast at vicinity of SP-3 (left side of photo). Blue flag near right edge of photo is riparian boundary. Area to right of blue flag is old road (possibly from past logging or clearing operations).

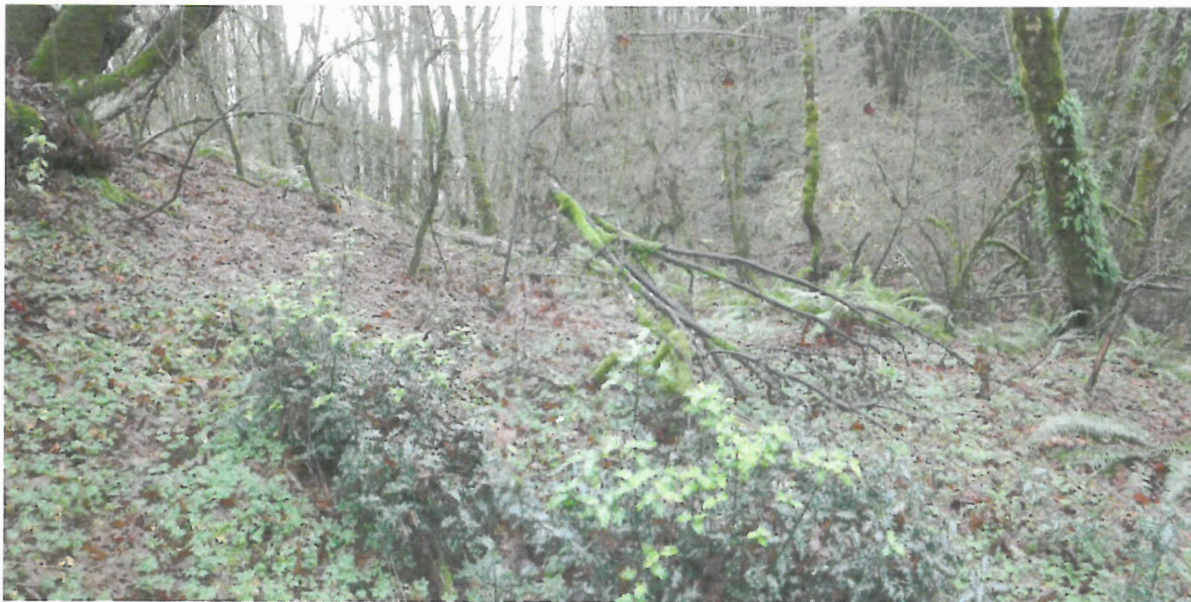
Photo Point D (above): View north at vicinity of SP-4. This location is offsite (northeast of subject lot) and it is relatively undisturbed. This vicinity is considered upland forest, rather than riparian forest, since it is dominated by bigleaf maple trees. Riparian area is the right part of photo (where red alder trees and willows become dominant).

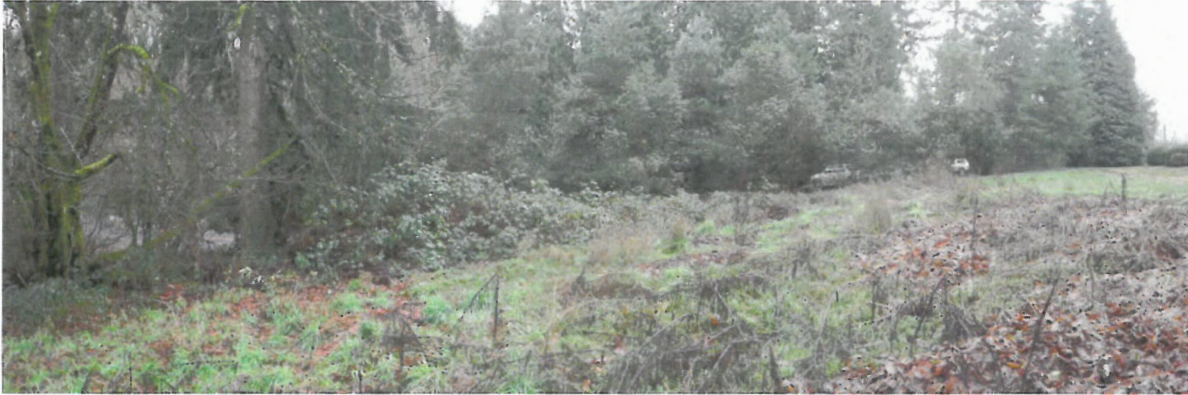
Photo Point E (above): View to southwest upslope from SP-2. The western edge of Tax lot 6801 generally lacks trees (except along Carriage Way). This part of the site has the flattest slopes, typically 5 to 15 percent. The grassy areas appear infrequently mowed or trimmed. There are also small piles of yard debris from the neighboring property to the west. The upland forest plant community begins near the left edge of photo where the Douglas-fir are growing.

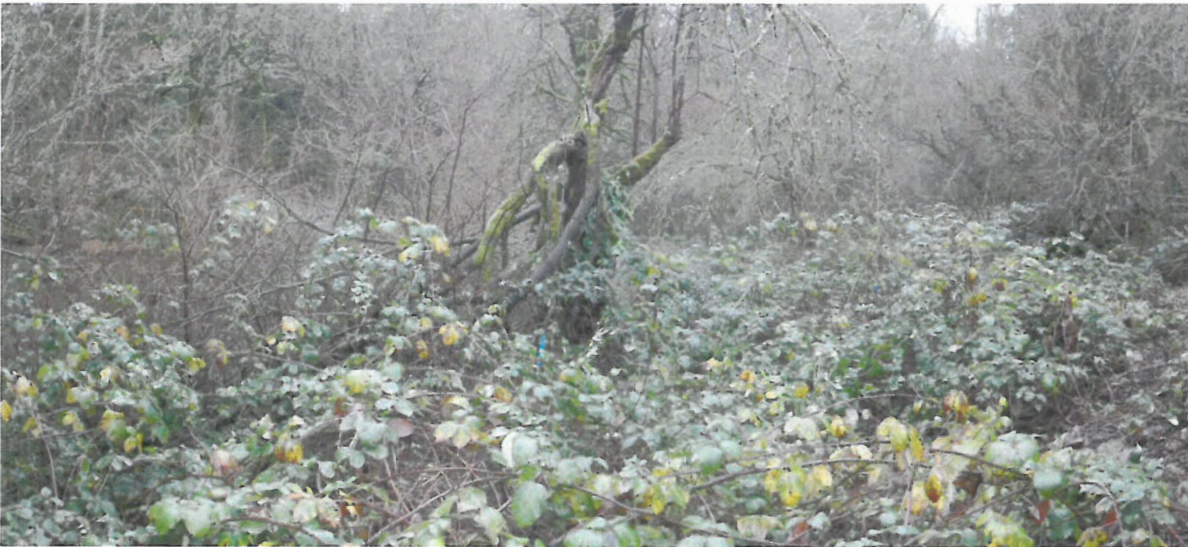
Photo Point F (above): View south at interface of riparian area and disturbed upland. Himalayan blackberries are the dominant species in the disturbed upland plant community. The riparian boundary was flagged just on the right side of the willow in the center of the photo. In general, the riparian area is defined by 1) steeper slopes; 2) native trees/shrubs that are rated FAC and FACW; 3) native understory vegetation; and 4) land that is contiguous with downslope Water Resource Area (beyond left edge of photo).

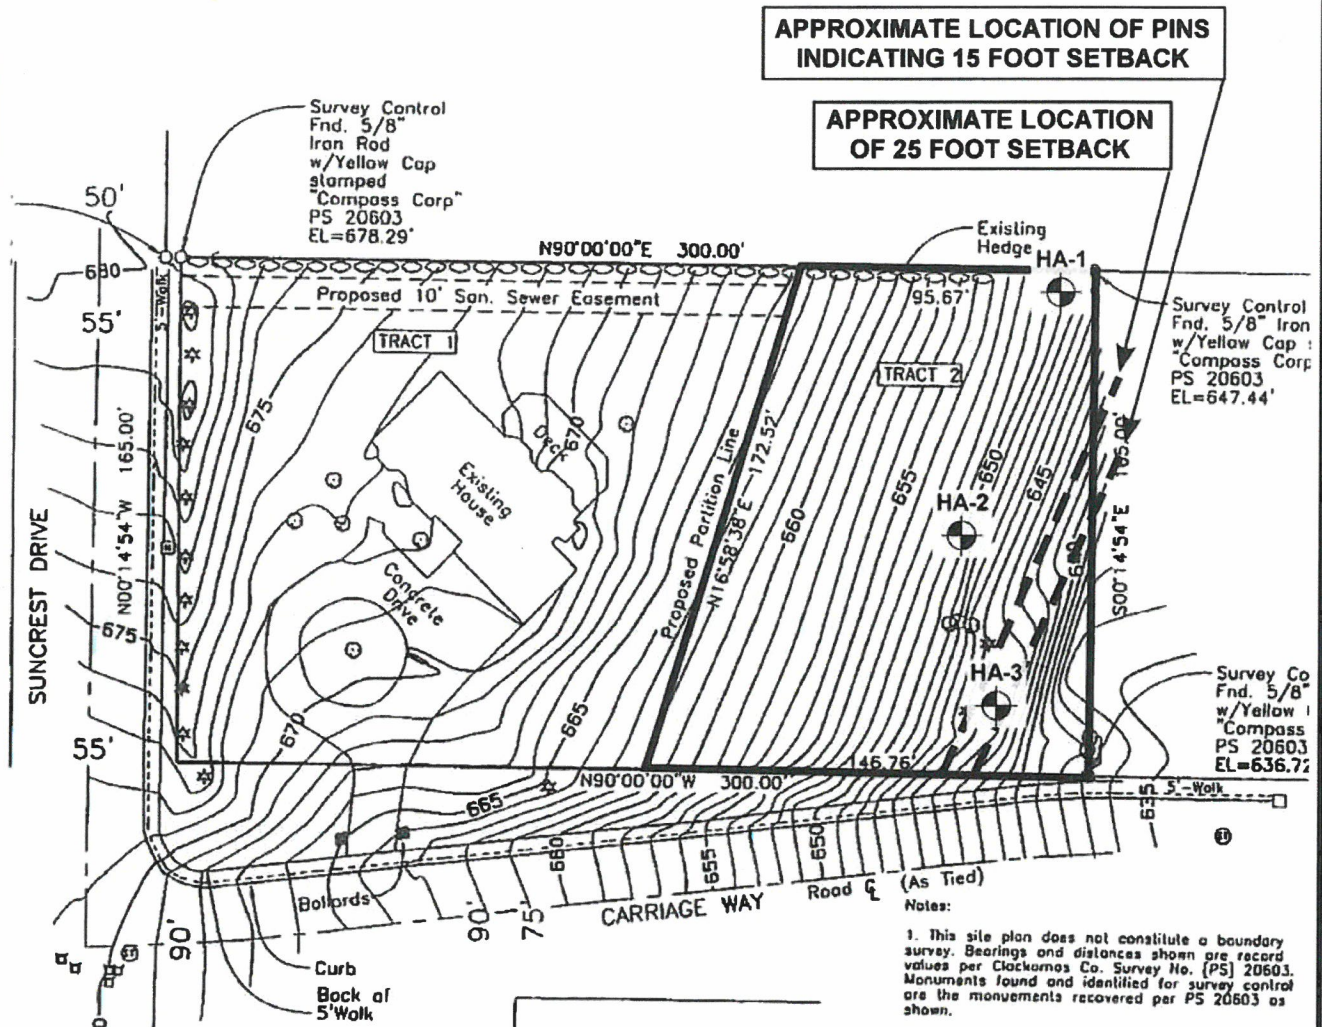
SITE PLAN AND HAND AUGER LOCATIONS

Our investigation indicates that the proposed development is geotechnically feasible and the 25 foot slope setback from the top of the slope (as indicated on Figure 2) is adequate. A geotechnical engineer should be consulted for recommendations regarding earthwork if the proposed construction will incorporate grading or placement of fill. The attached "Maintenance of Hillside Homesites" provides some guidance for employing simple precautions that may help maintain slope stability.
