#### Wildwood Drive Natural Resource Assessment

**Project:** 19738 Wildwood Drive Single Family Residence on Lot of Record

**Subject:** WRA Permit and Hardship Variance

Geologic Hazards and Geotechnical Investigation Tax Lot 9004, Map 2-1E-23AC 19738 Wildwood Drive West Linn, Oregon

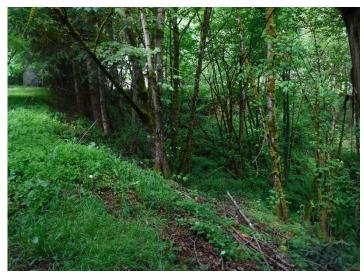
**Photo A.** View of property from Wildwood Drive.

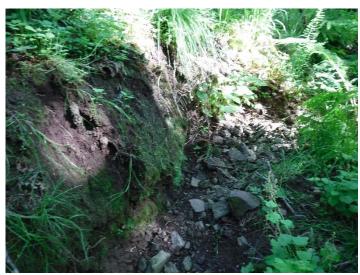
**Photo B.** View of on site portion of drainage.

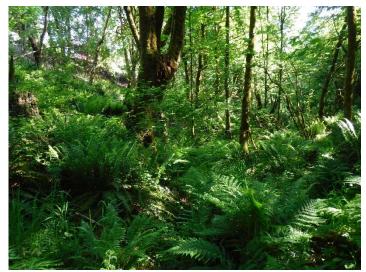
The existing condition of the on-site WRA was determined based on the presence of native vegetation, water features, and slope, consistent with CDC Section 32.050.F. The existing condition of the on-site WRA was determined to be in *good* condition due to having a dense native tree canopy and native understory. The entire site is under native tree canopy (red alder, bigleaf maple, and Douglas-fir trees). The understory was primarily dominated by pineland sword fern and vine maple, generally lacking any non-native invasive plants. Only a few Himalayan blackberry thickets were observed near the edge of the property, near Wildwood Drive.

**Photo B.** View northeast of good condition Water Resource Area (WRA).

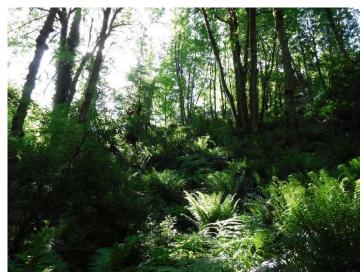
**Photo D.** View south of steep slopes adjacent to drainage.

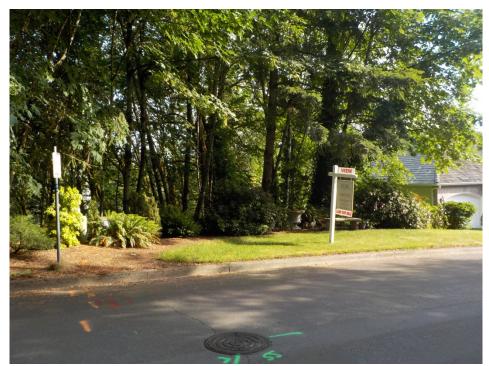
Photo 1 – Northeasterly view of the site from across Wildwood Drive.

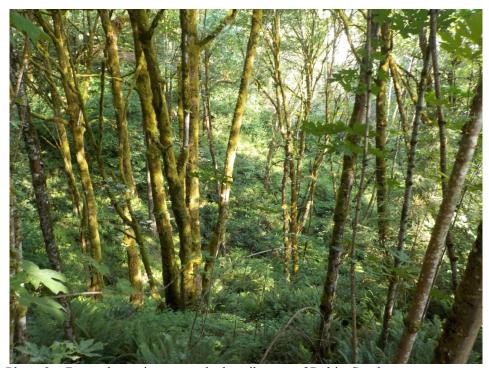
Photo 2 – Downslope view towards the tributary of Robin Creek.

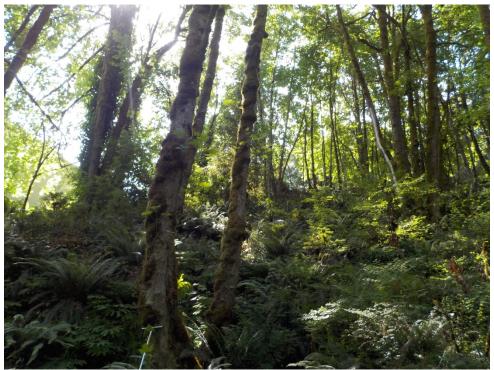
Photo 3 – Southeasterly view looking upslope from the creek bed.

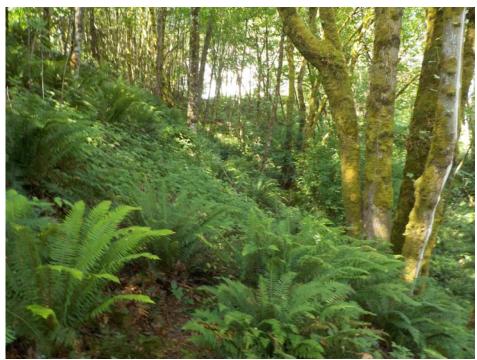
Photo 4 – Westerly view of the site taken at approximately midslope

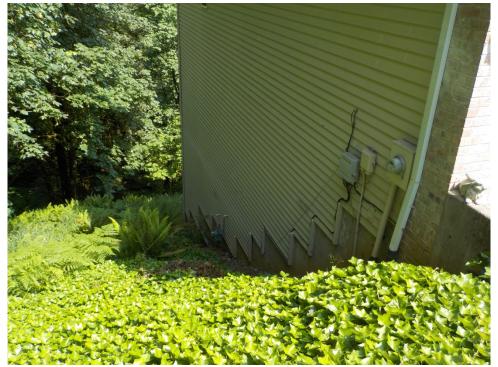
Photo 5 – Downslope view of home to the west of the site.

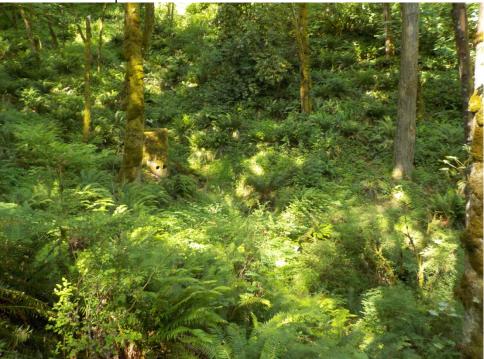
Photo 6 – View of concrete stormwater outflow structure at head of the creek near the site.

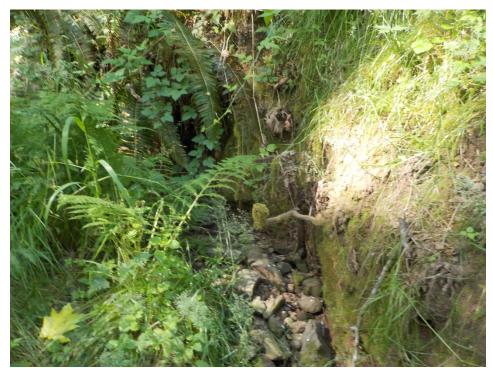
Photo 7 – View of creek bottom near the northwest portion of the site. Note that at the time of our site visit the creek had no flowing water.

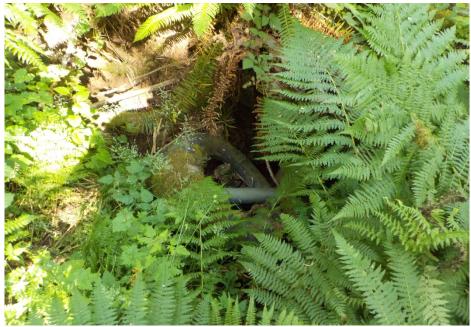
Wildwood Open Space and a tributary of Robin Creek occupy the northern portion of the site. The banks of the creek were heavily vegetated and in places overgrown to the point of obscuring the creek bed. The areas of exposed creek bed were lined with rock fragments. Debris was observed in the creek including a section of metal pipe and a tire.

Photo 8 – Close-up view of a tire and pipe observed in the creek bottom near the site.

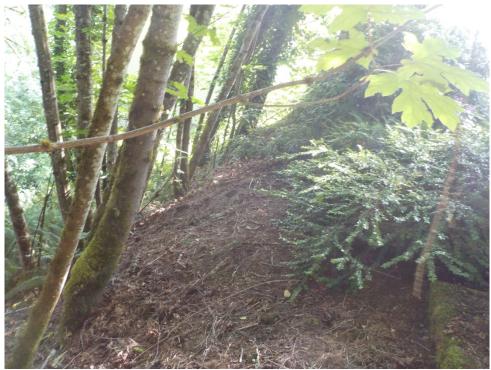
The site generally slopes down to the north from 20 to 40 degrees. Uncontrolled fill, landscape and construction-related debris, including large pieces of concrete and bricks as much as 6 feet thick were observed near the top of the slope near the southern portion of the site. Cracks on the asphalt surface of Wildwood Drive were observed near the site. The site is vegetated with evergreen and deciduous trees, ferns, ivy, and other brush.

At the time of our site visit, we observed some minor signs of shallow sloughing near the top of the slope in the uncontrolled fill. Clearing and grading activity at the site could expose surface soils to surface water erosion if not mitigated. Because of the steeply sloping nature of the site, stormwater runoff from the site could cause rill erosion in areas of exposed soil.

Photo 9 – Easterly view of the top of the slope, near the southern boundary of the site. Note that disturbed fill was observed here.

- 2. Uncontrolled fills up to several feet thick are present on the northern part of the site, along the north side of Wildwood Drive. These fills will need to be removed and replaced with properly compacted structural fill in order to construct the driveway.

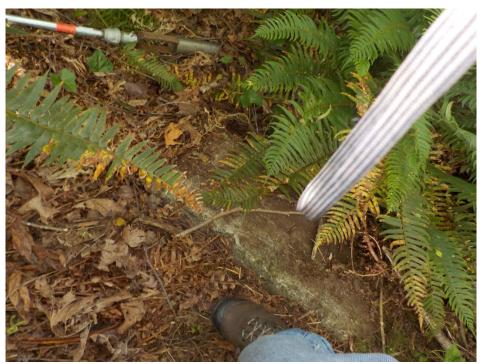
Photo 10 – Close-up view of weathered and partially buried concrete blocks observed near the southern portion of the site.

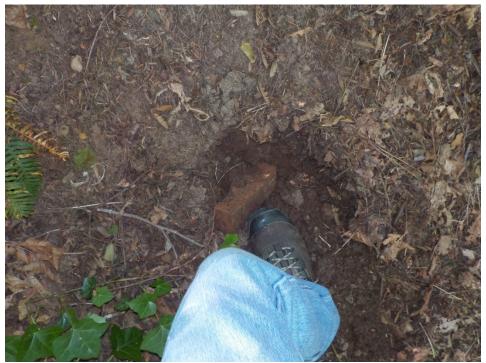
Photo 11 – Close-up view partially buried brick fragments observed near the southern portion of the site.

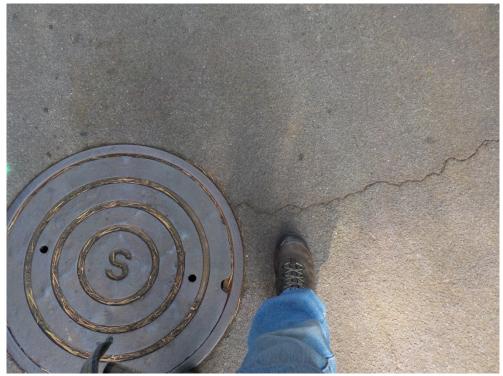
Photo 12 – View of cracking in surface of Wildwood Drive near site.
