# Historic Design Review: Supplemental Information

## Willamette Historic District—General Characteristics

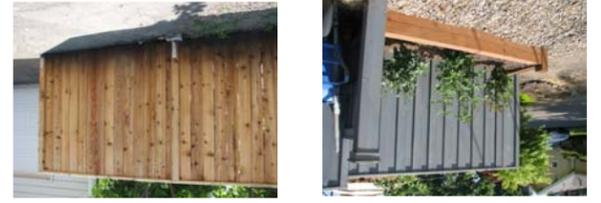
Examples of fences that meet general fence requirements.

Many fences will not need any kind of review.  
Traditional picket fences in the front yard that are 36" or less in height are typically exempt. Fences up to 72" in height, located in side or rear yards, and constructed with wood fence boards, rails and posts are typically exempt.  
Walls that are less than 36", project above the upper grade no more than 12" and are constructed of basalt are also exempt.  
The Community Development Code has more details. Fences that would not meet the requirements above or in the CDC would need to be reviewed and approved by the Historic Review Board.

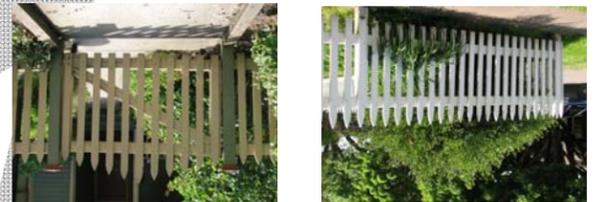
Examples of fences that meet traditional fence requirements.

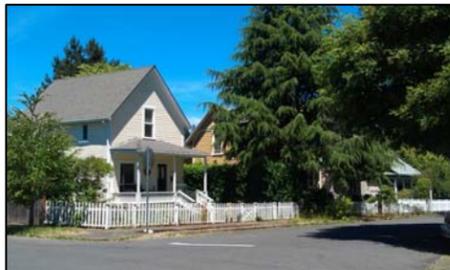
Queen Anne houses (far left) typically have a more steeply pitched roof than Craftsman or bungalow style houses (left).

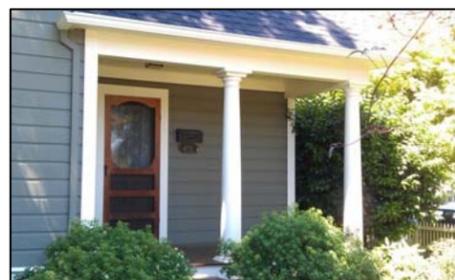
Front porches are common on houses in the district. A few have rounded columns as this example illustrates. Square posts and simple balustrades and railings are also common.

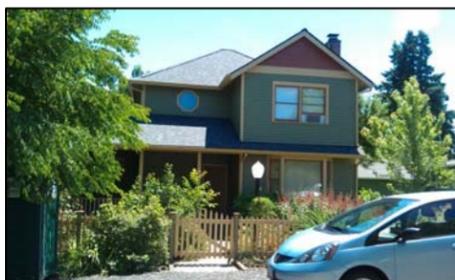
There are a number of infill residences in the district. This residence is compatible with the character of the district and is also distinct and easily identifiable as newer construction.

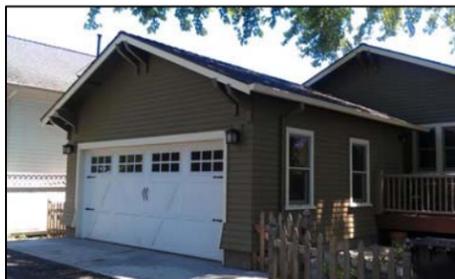
Many homes did not originally have garages and detached garages with elements of the architectural style of the residence have been constructed in the side and rear yards.

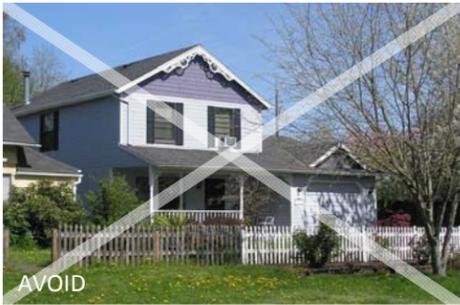
*This residence was constructed in the 1980s. The shingles and bargeboard in the gable end and the spindlework on the porch does not have a historical basis.*

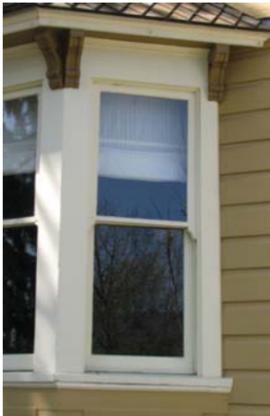
*Left: Many windows on historic houses are double-hung with 1/1 light. They often have small rail extensions on the top sash. Some Queen Anne houses have multi-light windows or windows with art glass. Craftsman and bungalow style residences often have double hung windows with 9/1 lights.*

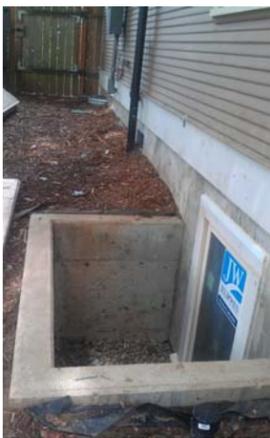
*Below: This window opening was altered to accommodate the replacement window and the window and trim do not match the visual qualities of the original window.*

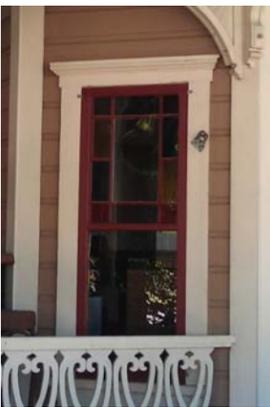
*Left: This multi-light wood sash is a replacement made from an existing sash to match a historic photograph that depicted multi-light sash windows.*

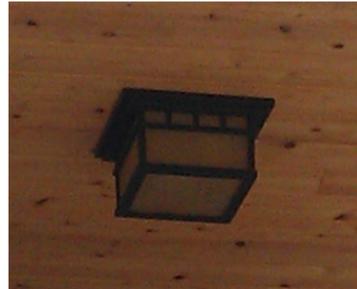
**Lighting.** Lighting on historic resources should generally be simple and small in scale. Examples below.

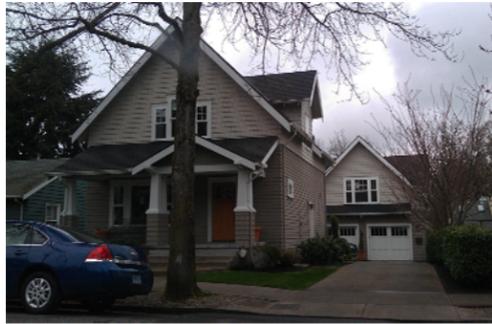
*Above: An example of recently constructed residence in a neighborhood with homes similar in age to those in Willamette. The roof shape, massing, and materials are similar to historic structures. It also has a detached, two-car garage located to the rear that has a second story that may accommodate an accessory dwelling unit.*

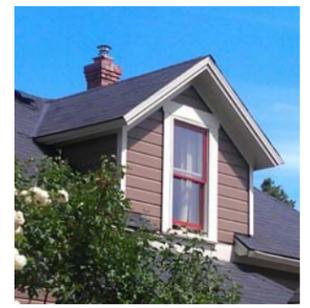
*Compatible dormer addition that is on a side elevation, does not extend above the ridge of the roof, is minimally visible from the right-of-way, and has window opening proportions that are compatible with the existing residence.*

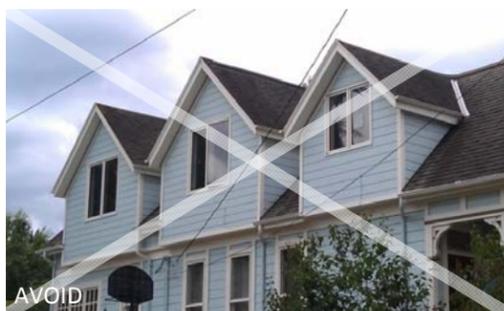
*Incompatible dormer addition that overpowers the house and is not set back from the edge of the roof. The dormer windows are a different type and light pattern (casement rather than double hung) and proportion than the windows on the original residence.*

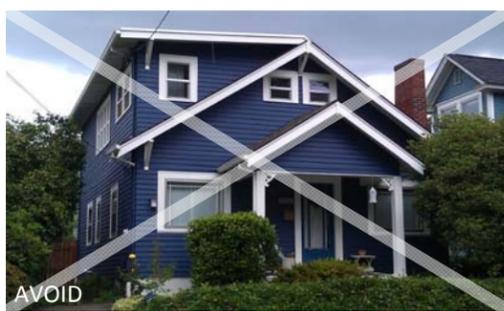
*Incompatible addition that alters the roof pitch, is flush with the side elevation, and overpowers the original residence.*
