This report evaluates the transportation impacts of the proposed New West Linn Elementary School located in West Linn, Oregon. The purpose of this report is to identify mitigation measures required to accommodate potential traffic impacts from the proposed project. This chapter provides a summary of the study area, existing transportation conditions, project trip generation and distribution, future transportation conditions, and impacts identified for the proposed project.

The proposed project would construct an elementary school (pre-kindergarten to fifth grade) with a maximum capacity for 500 students. The project site has recently been annexed within the City limits. The site will be zoned R-10 (Single-Family Residential Detached) which allows for educational land uses. The proposed school is assumed to be constructed and occupied by the beginning of the 2012 school year (September).

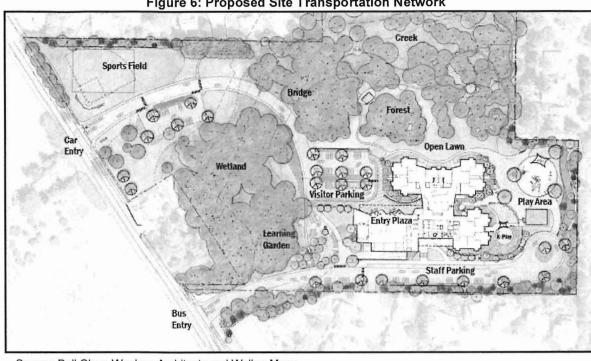
Figure 6: Proposed Site Transportation Network

- The layout of the north site access roadway network would provide adequate circulation to the visitor parking area and the parent drop off/pick up area. The parent drop off/pick up area would provide curb storage for 13 parents which should alleviate potential impacts to vehicle circulation.

- A gated emergency vehicle connection would be provided between the south access roadway and Bay Meadows Drive.
- A gated on-site motor vehicle connection would be provided between the north and south internal roadways for use during events to alleviate imbalanced exiting traffic demands at the site access points.

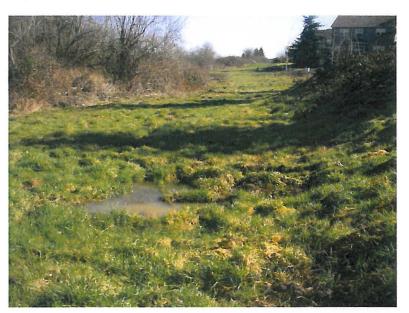
Photo 1. Assessment Area D looking east - Hydrology, soil and vegetation alterations from seasonal mowing and discharges from stormwater outfall pipes.

Soils were found to be fairly undisturbed and true to the soil survey map units characteristics. There may be some compaction of soils by vehicles that traverse both assessment areas, as well as possible cut/fill in the vicinity of the existing buildings (Photos 1 and 2).

The hydrology has been altered by residential and public storm drains daylighting directly into Assessment Area D (Photo 1) and immediately above and below Assessment Area E. Surface water ponding occurs in wheel ruts left by vehicular traffic that do not readily drain (Photos 1 and 2).

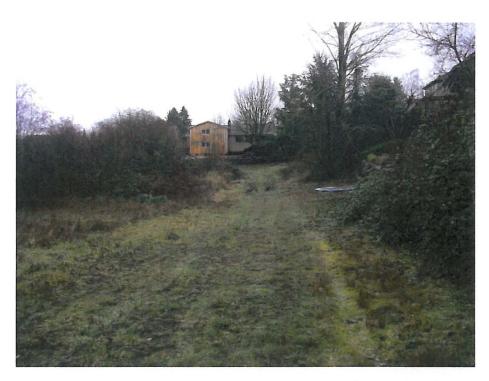
Photo 2. Assessment Area E looking east - Hydrology, soil and vegetation alterations on the edges from seasonal mowing.

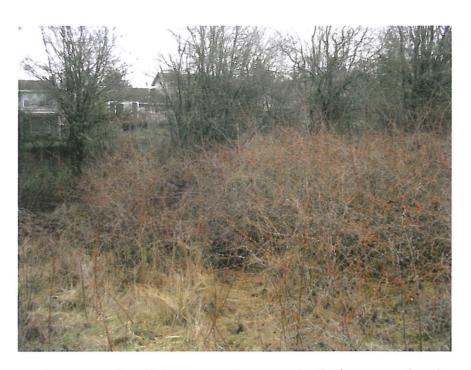
Photo 3. Assessment Area E - Representative vegetation in the center of study area.

The main observed factor that altered the plant community types is the seasonal practice of mowing the edge of the forest to attempt to minimize invasive blackberry proliferation, which has resulted in quackgrass (*Agropyron repens*) dominating Assessment Area D (Photo 1). There is a relatively less disturbed deciduous plant community in the central core of Assessment Area E dominated by Western crabapple (*Malus fusca*), Nootka rose (*Rosa nutkana*) and trailing blackberry (*Rubus ursinus*) (Photo 3).

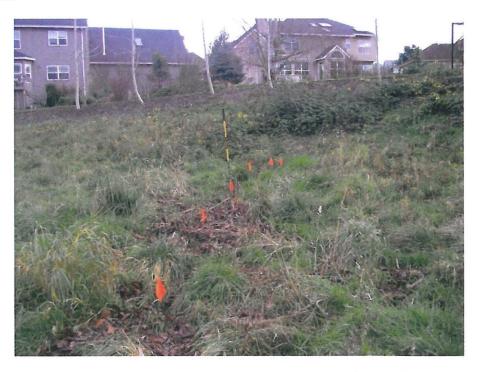
Photo 4. Flow path of surface water in Assessment Area D (Water 4) from the 12" storm outfall pipe.

Two small portions of Assessment Area D (Water 4 at D2 (Photo 4) and closed depressional area at D3 (Photo 5)) were determined to be extensions of the Wetland "A" headwaters of Trillium Creek (Wetland "A" is identified in the Wetlands/Waters Delineation Report for West Linn Wilsonville School District Erickson School Site). Hydrology mainly enters the area via stormwater outfall pipes at two separate points. One discharge area includes two 4" PVC outfall pipes, discharging stormwater from the adjacent residential subdivision. The second outfall is a 12" cement pipe, discharging stormwater, which creates a 6" – 1' wide channel.

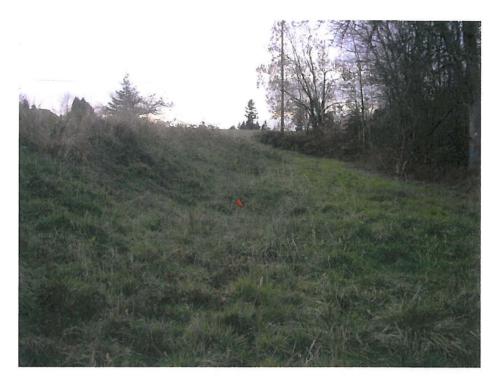
Photo 5. Assessment Area D - Closed depressional area at D3 (orange flag).

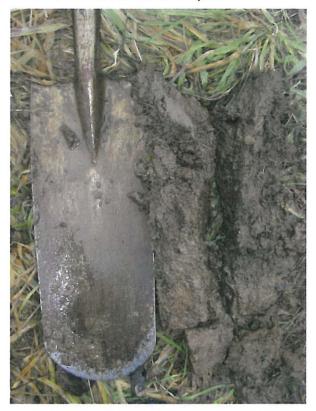
Photo D1 - Soil Profile at Sample Plot D1D

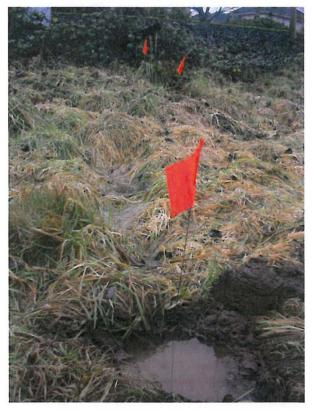
Photo D2 - Sample Plot D1D

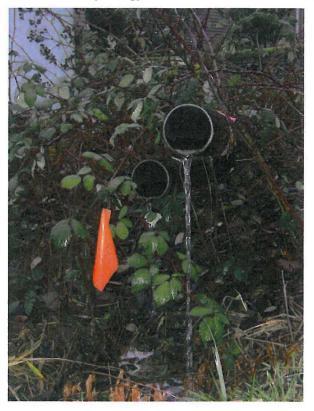
Photo D3 - Source of Hydrology for D1 Plots - Storm Water Outfall Pipes

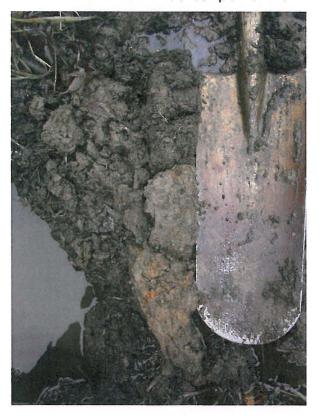
Photo D4 - Soil Profile at Sample Plot D2E

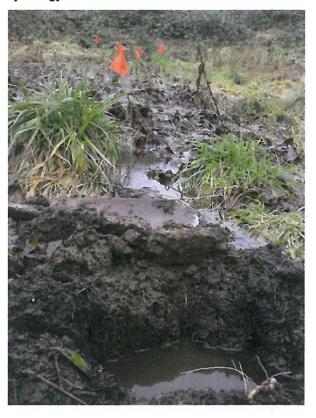
Photo D5 - Hydrology at Plot D2E - Source is a Cement Stormwater Outfall Pipe

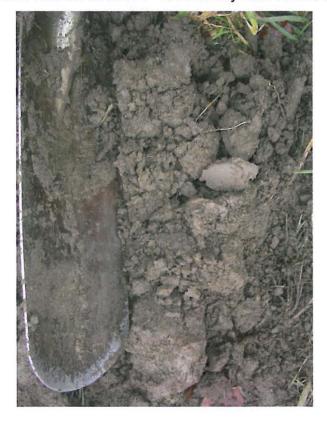
Photo D6 - Soil Profile at Plot D2UP1 - 10 Feet Away From Surface Hydrology of D2

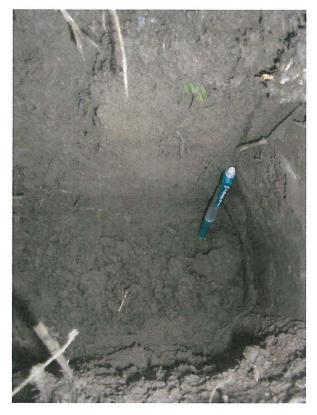
Photo D7 - Soil Pit at D2UP1

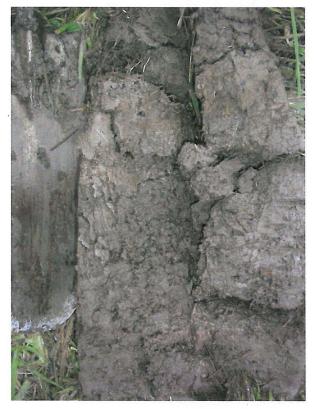
Photo D8 - Soil Profile at Plot D3A

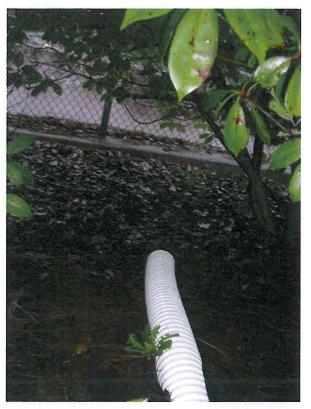
Photo D9 - Stormwater Outfall Pipe Above Tennis Court From Tax Lot 3400

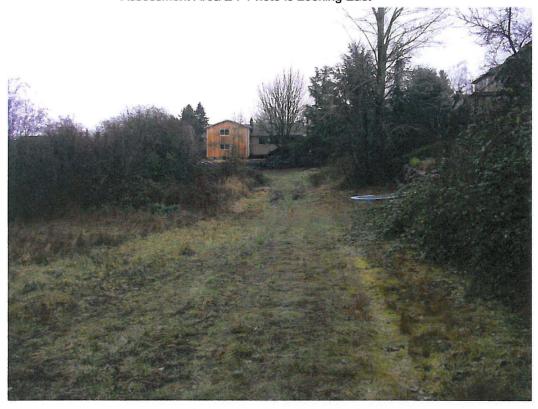
Photo E1 - Slight Concave Topography at the Upper (Southern) End of Assessment Area E . Photo is Looking East

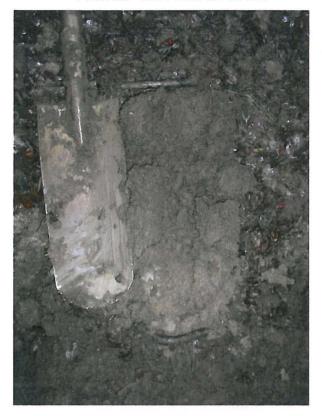
Photo E2 - Soil Profile at Plot E1J

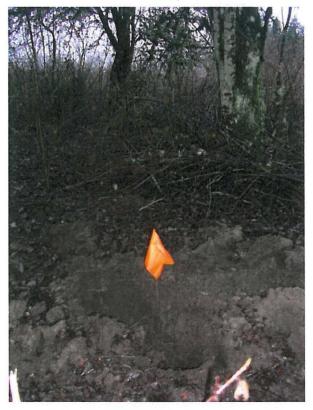
Photo E3 - Sample Plot E1J

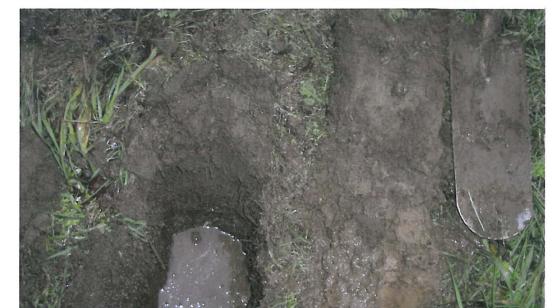
Photo E4 - Soil Pit and Profile at Plot E1K - Initial Groundwater Level

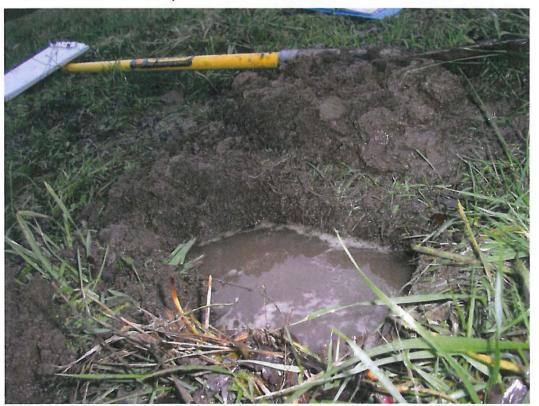
Photo E6 - Sample Plot E1K - Final Groundwater Level
