RE: DR-12-09/WAP 12-01 Bolton Primary School

BOLTON PRIMARY SCHOOL
Class I Design Review and Water Resources Area Permit
April 20, 2012

Class I Design Review and Water Resources Area Permit for bank and slope stabilization and erosion prevention project at Bolton Primary School.

**Wetland Delineation
for the Bolton Primary School
Streambank Stabilization Project
in West Linn, Oregon**

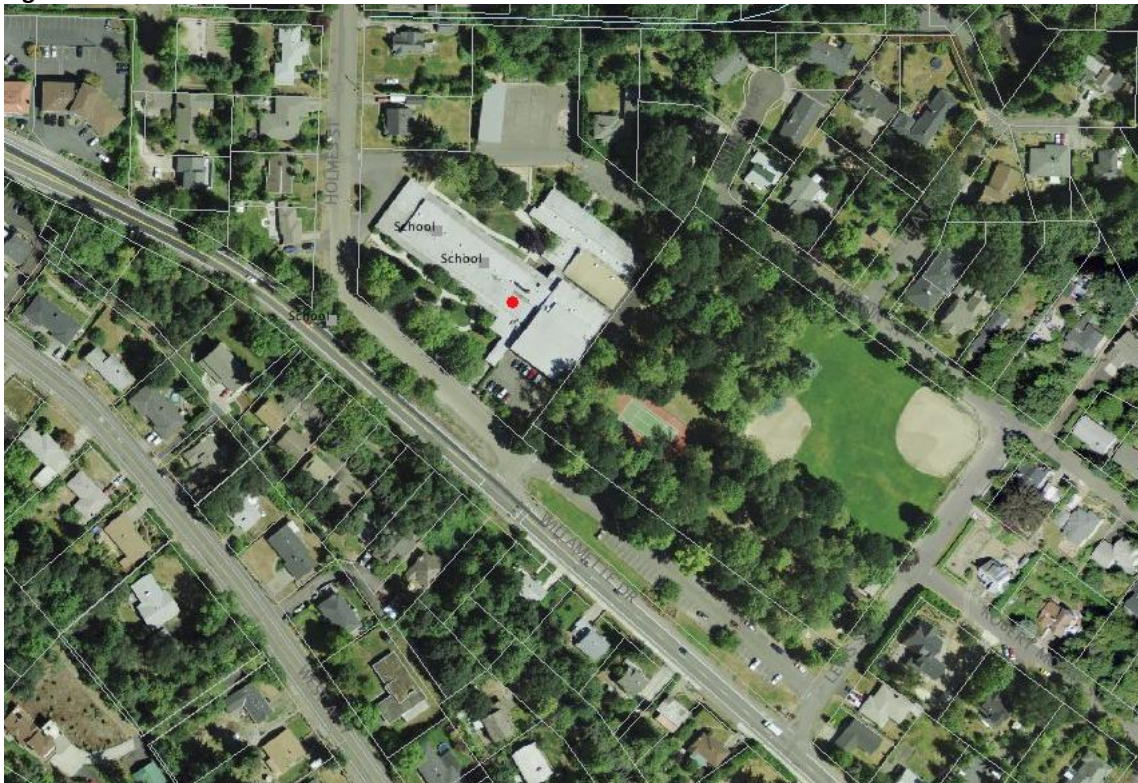
Figure 1: Aerial Photo

5933 Holmes St. (2S 2E Section 30 BC, Tax Lot 2300). Its location is shown in Figure 1.

The site is developed with a primary school, driveway, parking, and play fields as shown in Figure 1 and Sheet A2.00. The entire site is approximately 3.3 acres. In addition to the school building, a play area is located on the north side of the school. Parking is located on the north and south sides of the building.

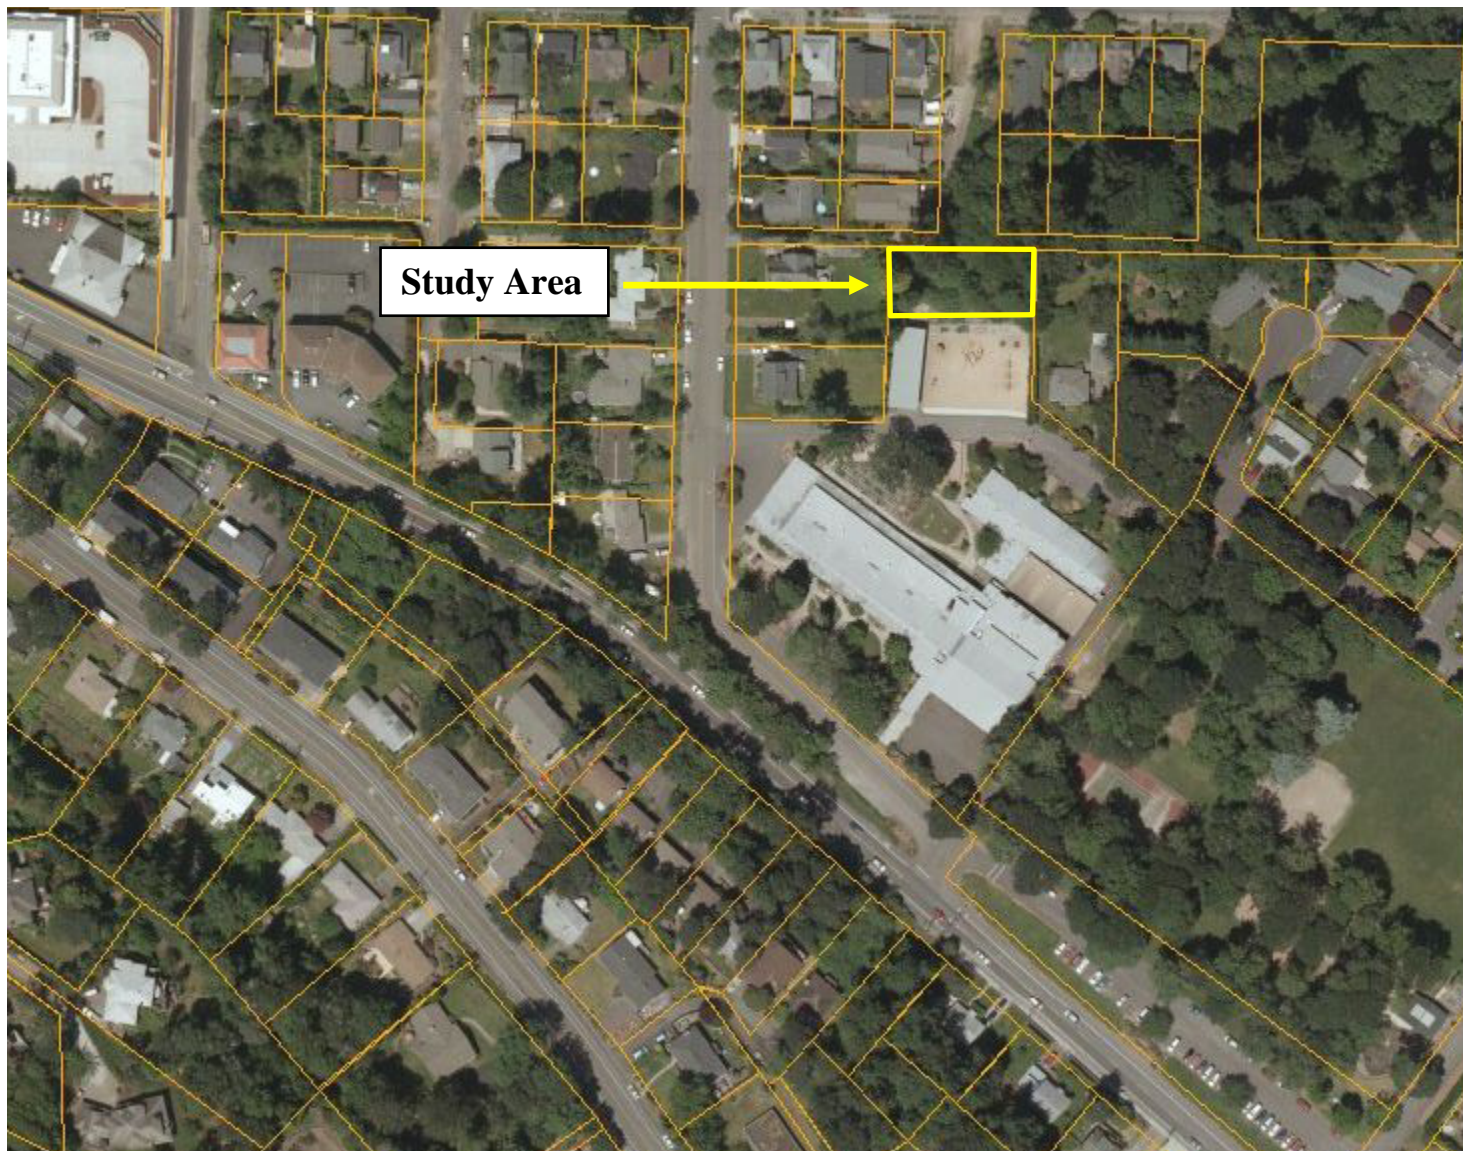
FIGURE
4

Soil series map for the Bolton Primary School streambank stabilization project in West Linn, Oregon (USDA Web Soil Survey, 2012).

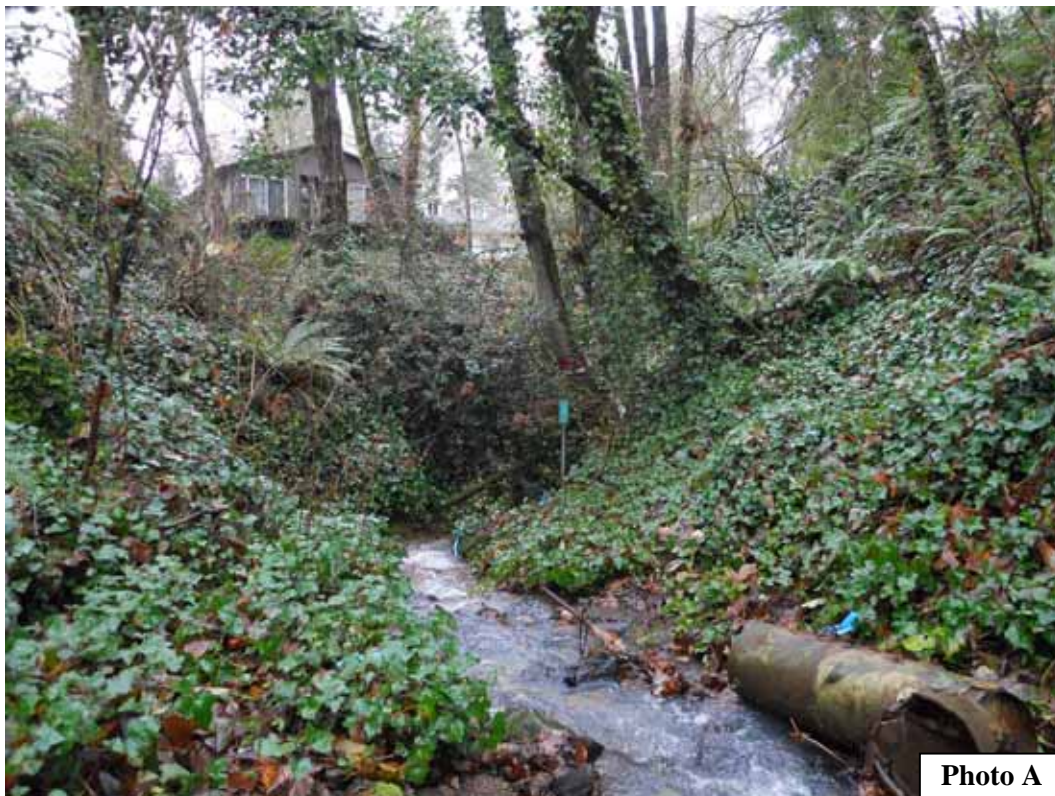
Photo A

Photo A:
Bolton Creek. View to
NE / downstream.

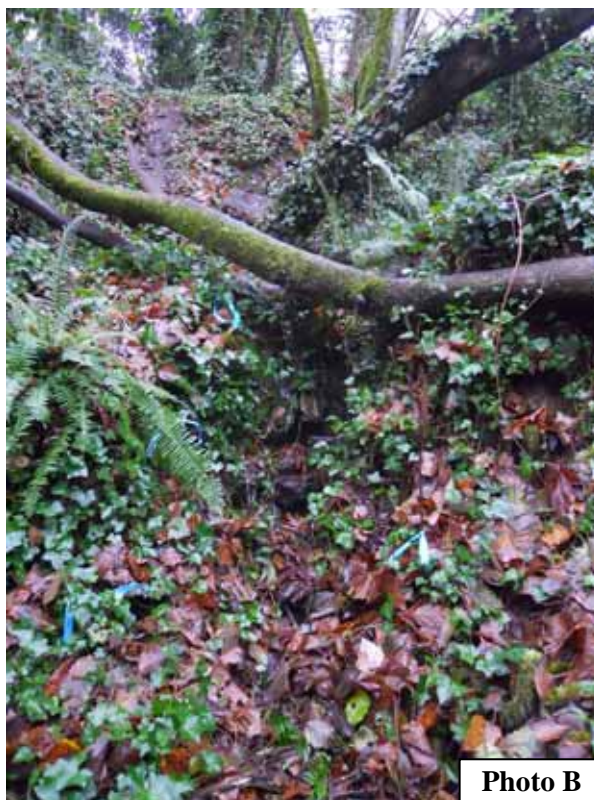
Photo B

Photo B:
View to SE, hillside seep
on south slope.

The seep is relatively narrow, approximately 3 to 4 feet wide, and has a defined bed and bank. It extends upslope along the south side of the creek. A 15-inch concrete stormwater outfall pipe is located at the upper end of the seep. A 6-inch concrete stormwater outfall pipe is located further upslope but not connected to the seep. No water was observed flowing out of either pipe during the site visit. Situated into the slope at the upper end of the seep is a small hollow, approximately 3 feet high, 4 feet long, and 3 to 4 feet deep. Subsurface flow was visibly entering the hollow and flowing into the seep. The Cowardin class for the seep is Riverine Intermittent Unconsolidated Bottom Saturated/Semipermanent/Seasonal (R4UBY), and the HGM class is Headwater Slope (SH).

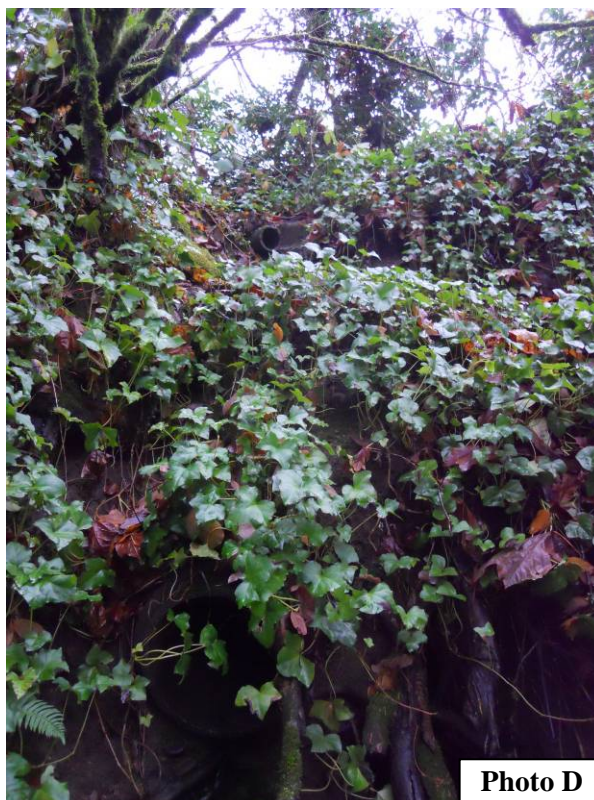
Photo D

6-inch CCP upslope of the hillside seep.

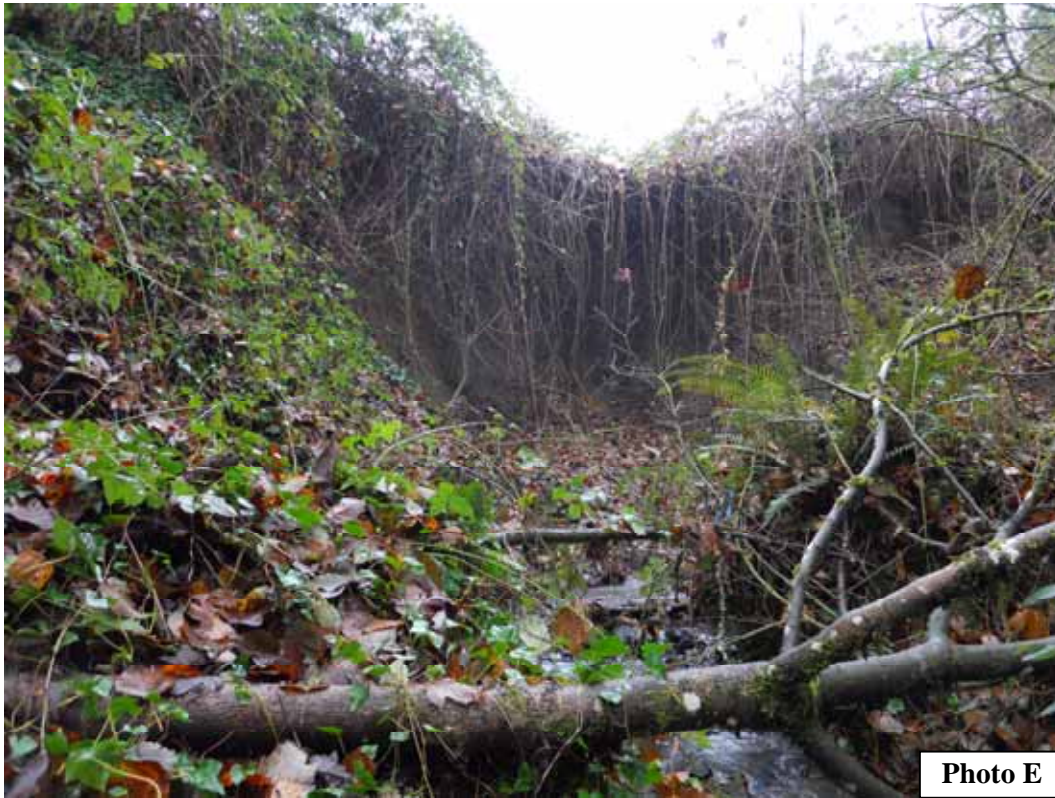
Photo E

Photo E:
Landslide along south
slope. View to
southwest.

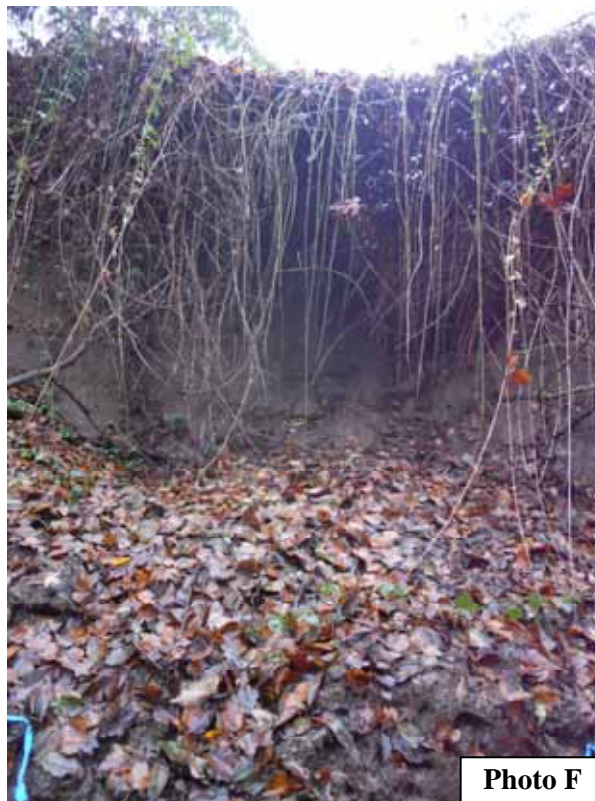
Photo F

Photo F:
Landslide along south
slope. View to south.

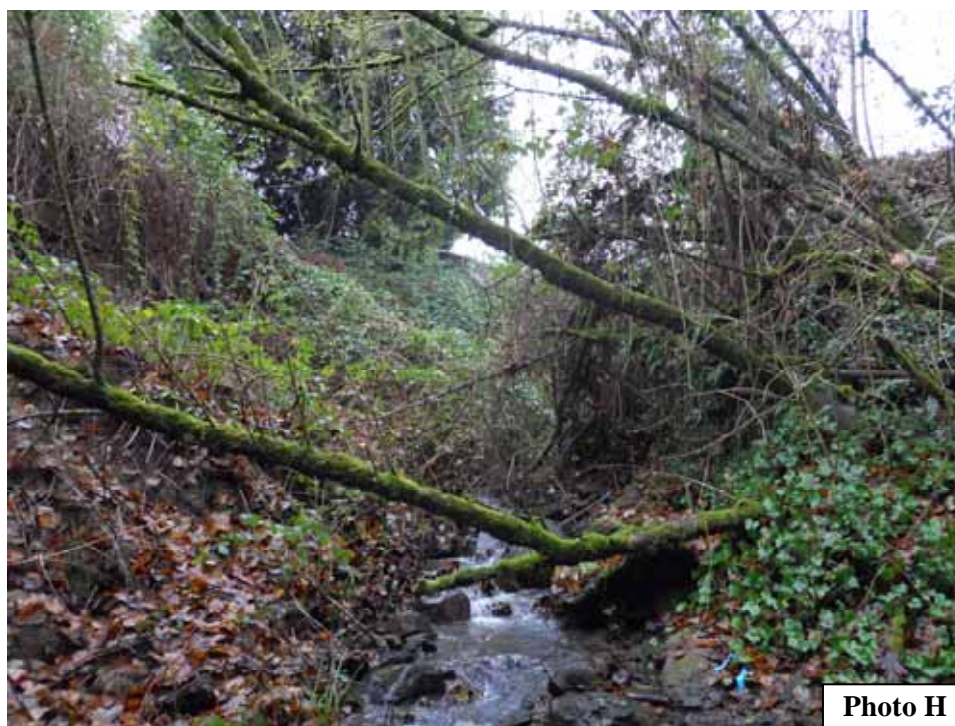
Photo H

Bolton Creek. View to NW / upstream.

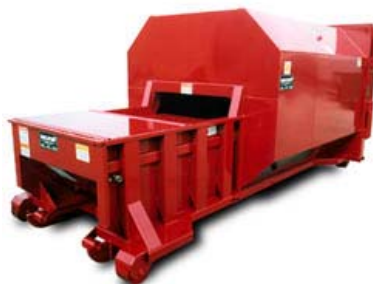
RJ-88SC Self Contained Compactor

Marathon's **RJ-88SC Self-Contained Compactor/ Containers** are ideal for waste with high liquid content and for applications where space is limited. Each RJ-88 series compactors store liquid and controls insect and odor problems.

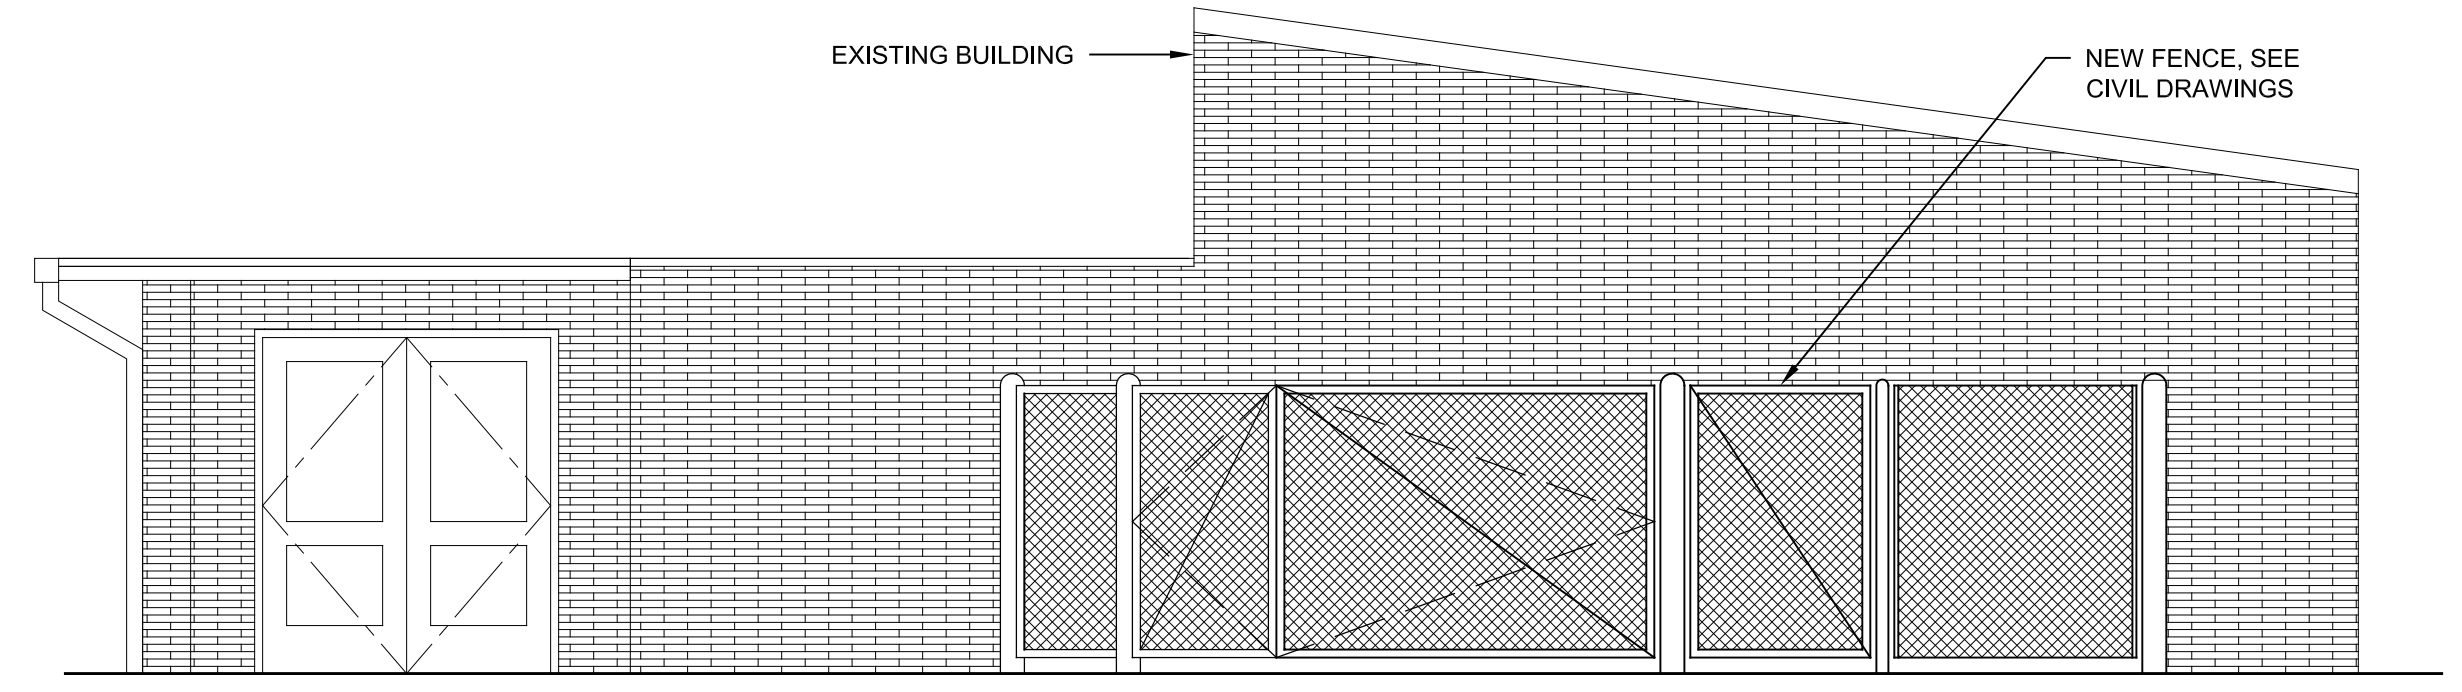
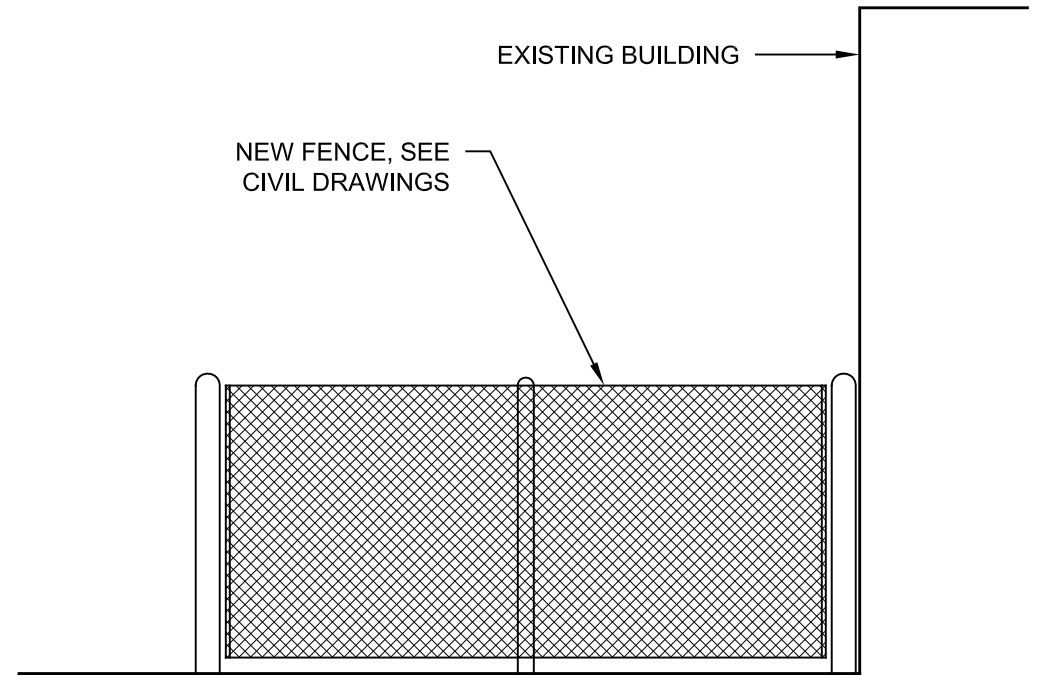
TRASH AREA ELEVATION 3
SCALE: 1/4" = 1'-0"

TRASH AREA ELEVATION 2
SCALE: 1/4" = 1'-0"

TRASH AREA ELEVATION 1
SCALE: 1/4" = 1'-0"

As noted above, the proposed fence surrounding the trash and recycling area shall be 6-feet high, meeting the maximum height standards of 8 feet.
