STAFF REPORT

PLANNING DIRECTOR DECISION

FILE NO.: WAP-13-04

REQUEST: Water Resource Area (WRA) permit for extension of a private sanitary sewer line from an existing line to serve a house at 20800 Hidden Springs Road

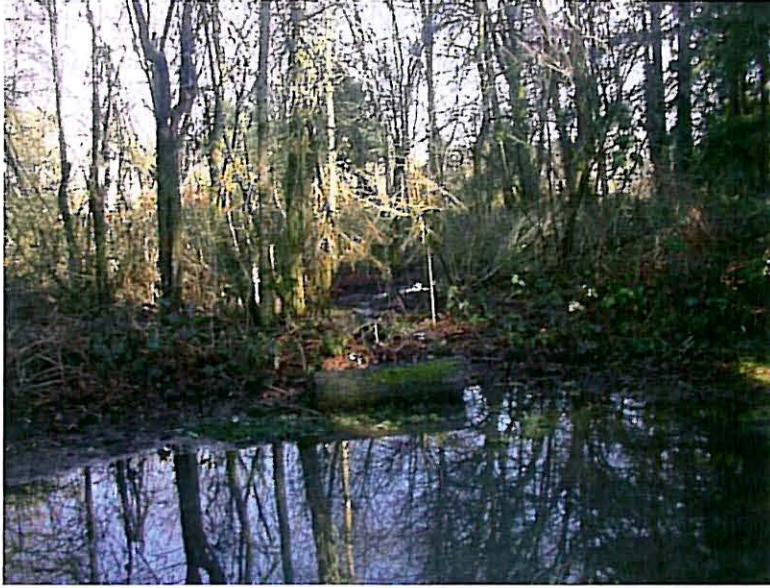
Photo 1 Hydrology alteration – open water pond formed by log across creek channel

The hydrology of the site has been altered in a number of locations, and for an indeterminate period of time. On-site alterations have occurred on the main channel by placing a log to dam up the middle of the creek (Photo 1). The wetland headwaters has been driven through by vehicles enough that there is no distinct appearance of a wetland; rather it looks like pockets of surface water that refuse to drain.

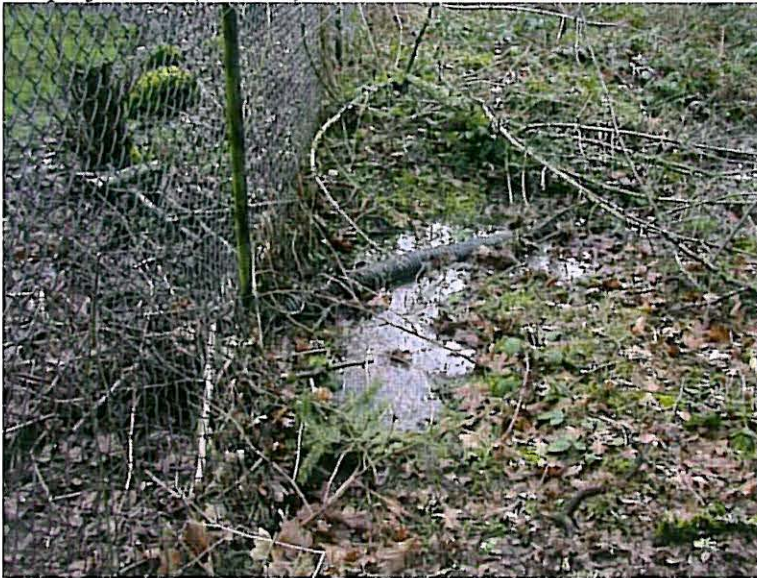
Photo 2 Hydrology alteration – Trillium Creek diversion by resident north of study area

Trillium Creek channel has been diverted into a pipe by the adjacent property owner north of the project site (Photo 2).

This effectively drains the main channel and discharges the creek outside of the private resident's property line on the central portion of the Erickson School site.

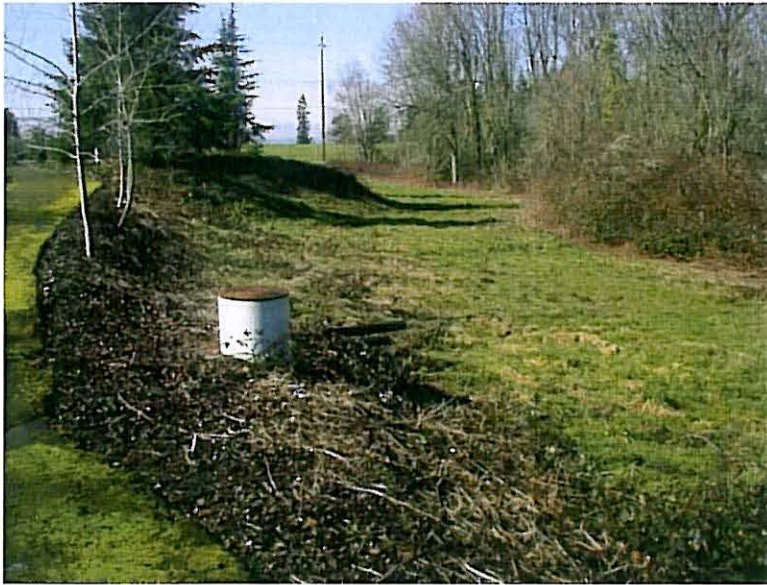
Photo 3 Hydrology alteration – Storm water drain pipe from Bay Meadows Drive subdivision

At the southwestern side of the study area, impervious surfaces, streets, and rooftops directly discharge runoff through a series of pipes and culverts to the grassy area of the study area (Photo 3).

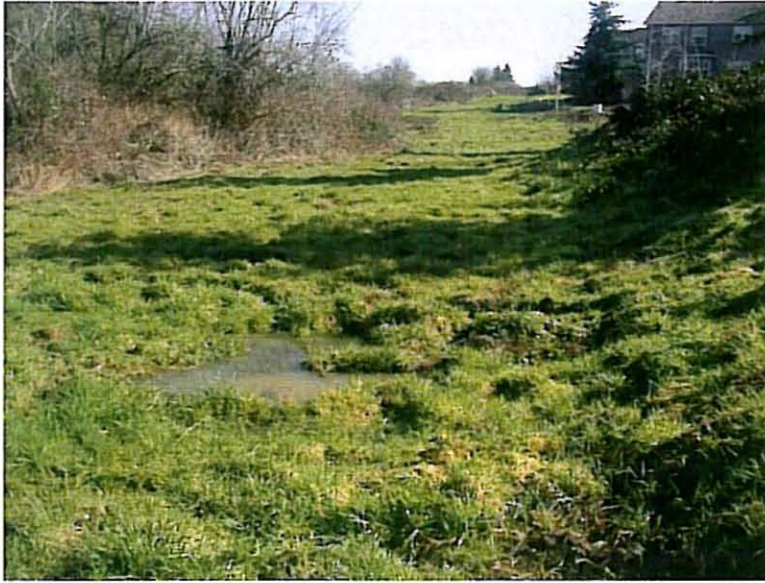
Photo 4 Hydrology alteration – Wet area formed by storm drainage discharging directly to project study area

This creates an artificially ponded area that does not infiltrate quickly in the grassy swale, and it raises the water table in some of the upland areas surrounding the discharge point (Photo 4).

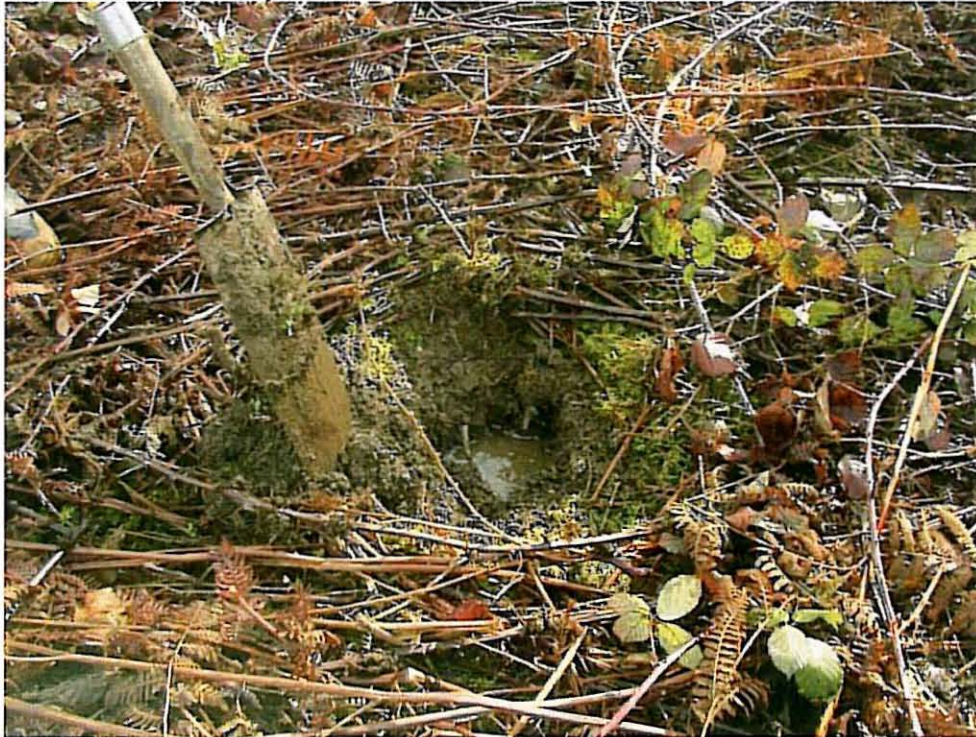
Photo B3a Sample Plot SP B-3 Inundation Within 5 Inches of Surface

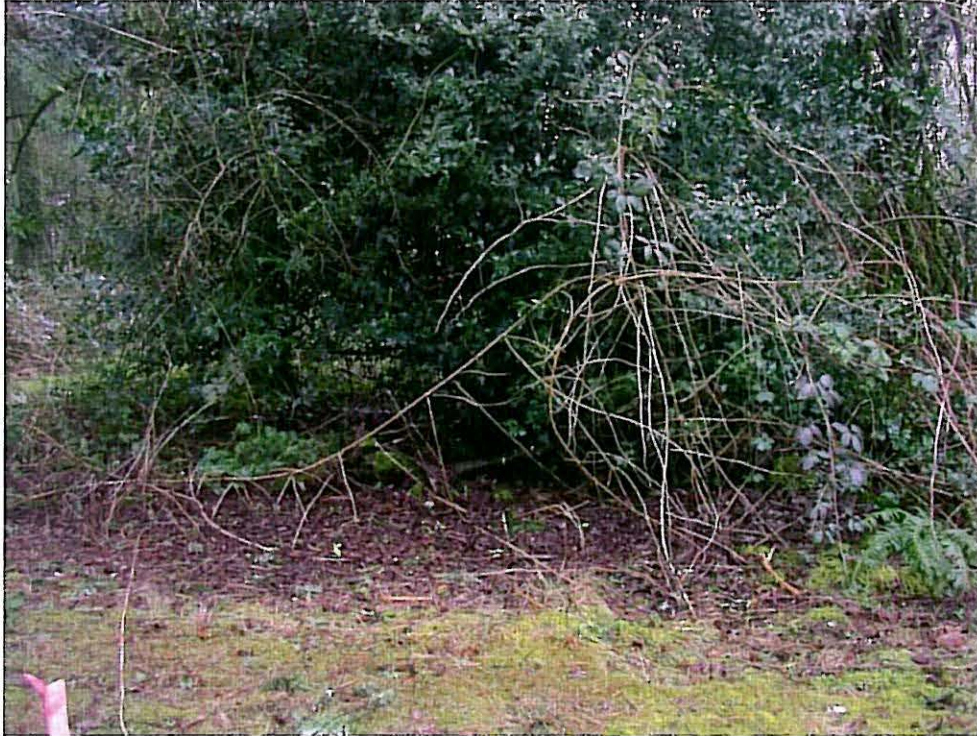
Photo C3 Gleyed Soils at SP C-1

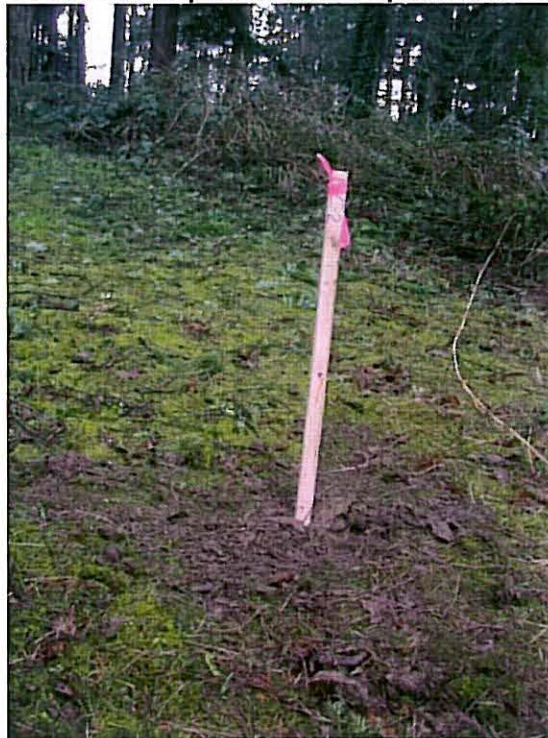
Erickson Wetlands
Photo C6 Sample plot SP C-2 Non-Hydric Soils

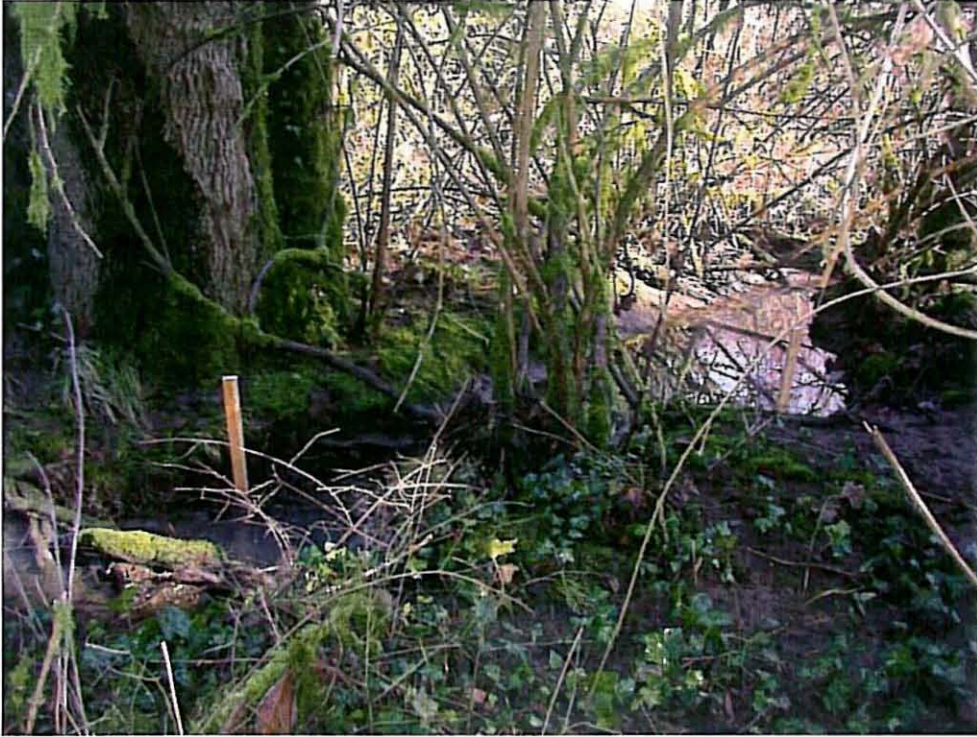
Photo W1 Water 1 - Ordinary High Water Elevation Trilium Creek February 2009

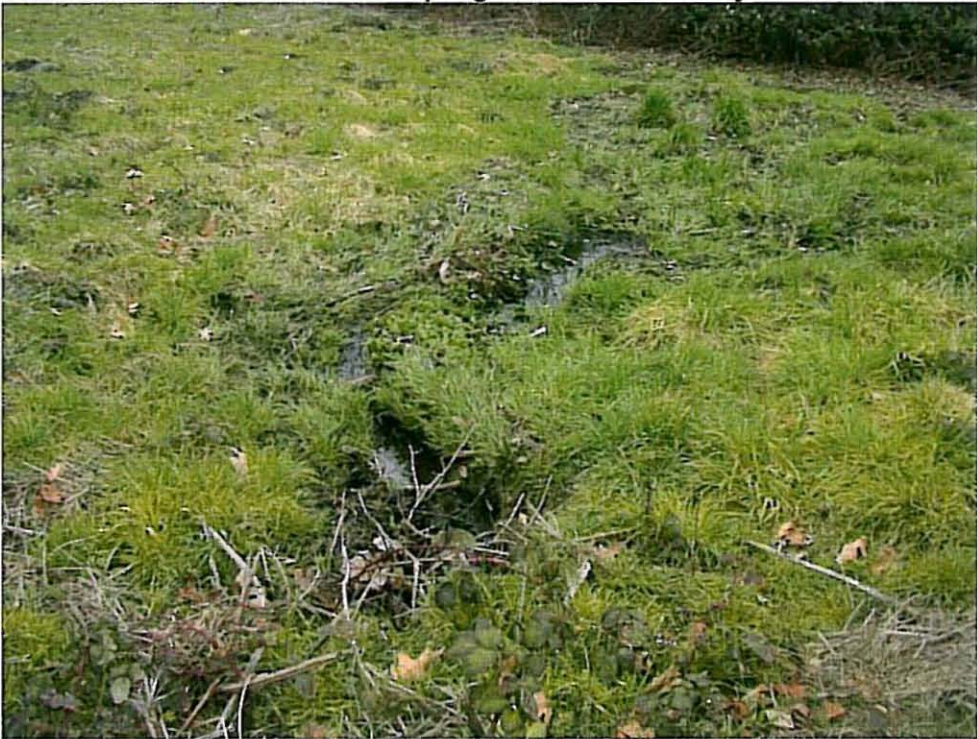
Photo W2 - Hidden Springs Stormwater Conveyance

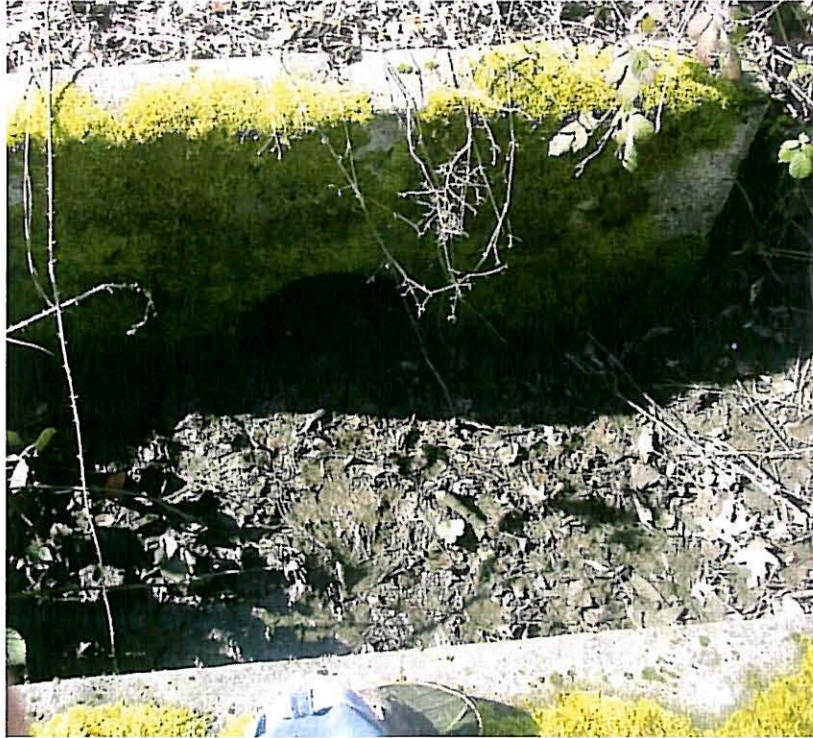
Photo W3 Culvert Under Rosemont Rd Feeds Stormwater Ditch Water 3
