**CITY OF WEST LINN
PLANNING AND
DEVELOPMENT**

**APPLICANT'S ORIGINAL SUBMITTAL (MINUS
ITEMS RESUBMITTED LATER)**

FILE NO.: DR-08-01/VAR-08-01/WAP-08-01

REQUEST: CLASS II DESIGN REVIEW FOR NEW 70-UNIT HOTEL AT 2400-2450 WILLAMETTE FALLS DRIVE REQUIRING WATER RESOURCE AREA PERMIT DUE TO THE PRESENCE OF BERNERT CREEK AND WETLANDS ON SITE AND INCLUDING A CLASS II VARIANCE FOR THE DEVELOPMENT OF MORE THAN 5,000 SQUARE FEET OF WATER RESOURCE TRANSITION AREA ON A SITE PARTIALLY WITHIN THE WATER RESOURCE AREA AND A CLASS II VARIANCE TO REMOVE THE ONLY SIGNIFICANT TREE WITH DRIPLINE + 10 AREA ON THE PROPERTY

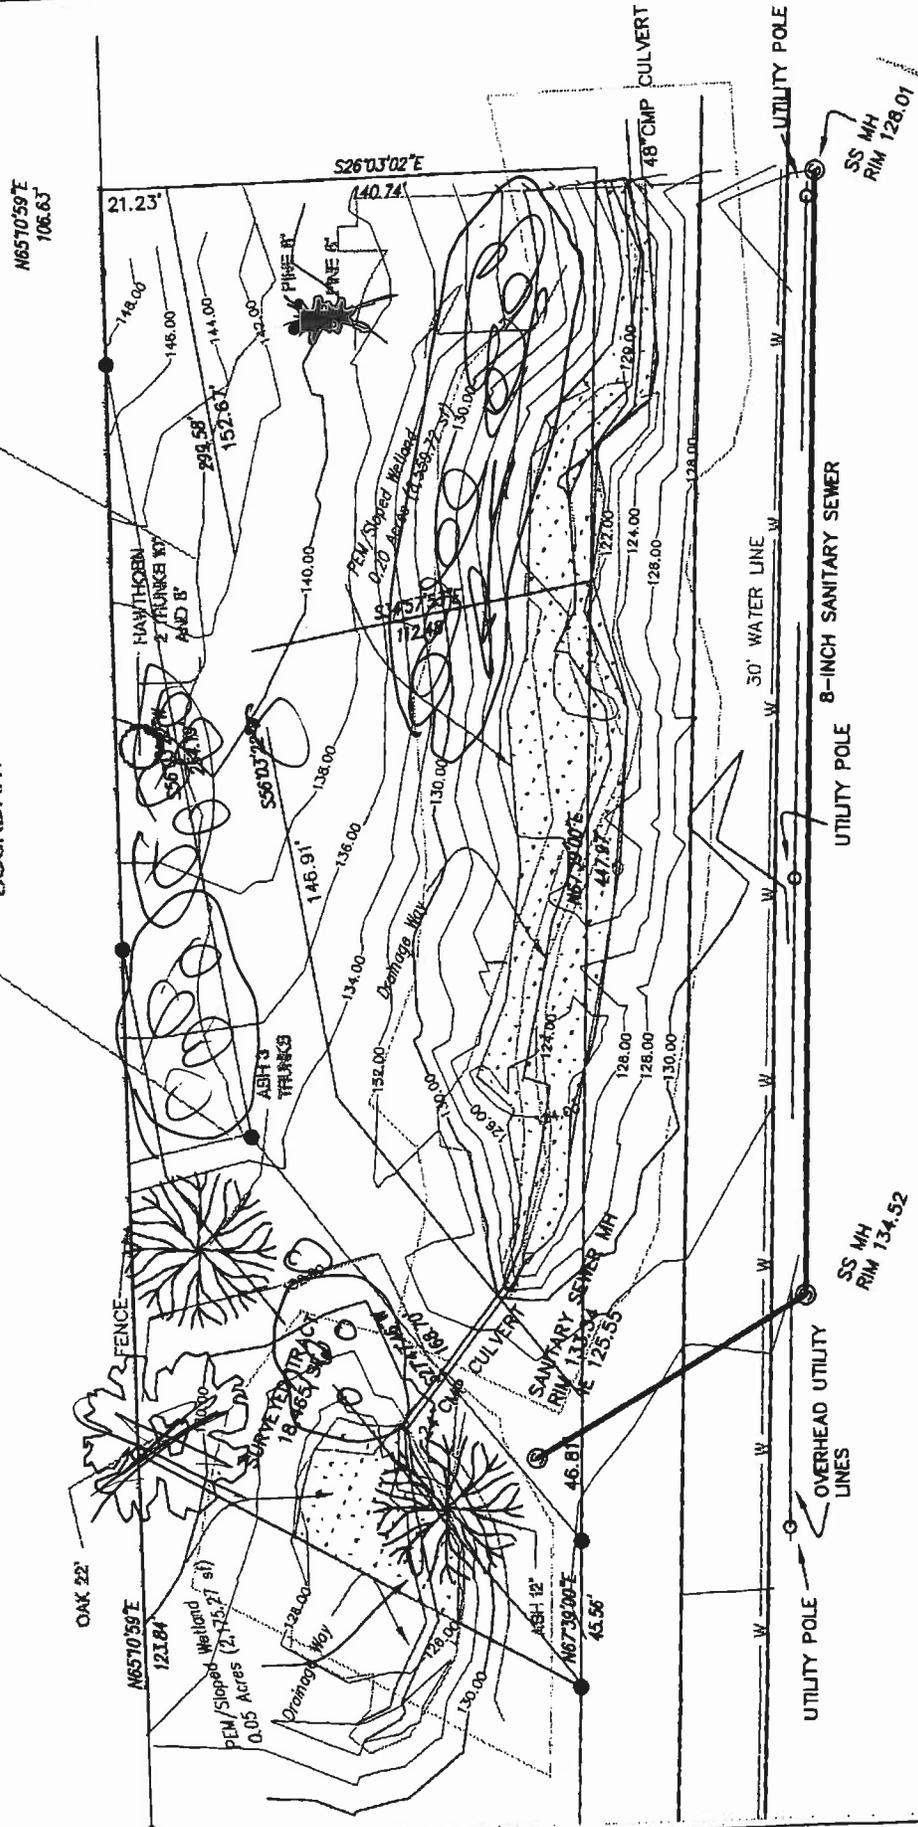
A3

Wetland map and survey provided by Burton Engineering (PLS).
 EXISTING CONDITION MAP - HOLIDAY INN EXPRESS
 WEST LINN, OREGON - PROJECT# 1920

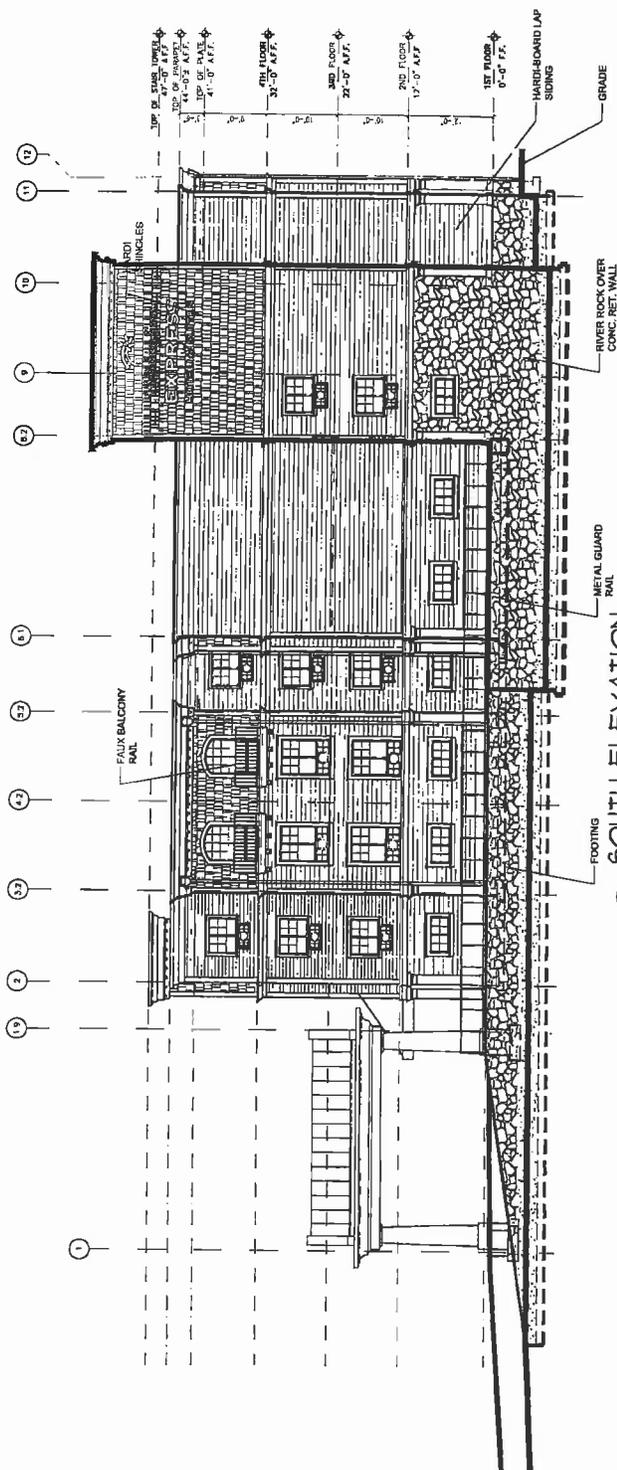
1 SOUTH ELEVATION
SCALE : 1/8" = 1'-0"

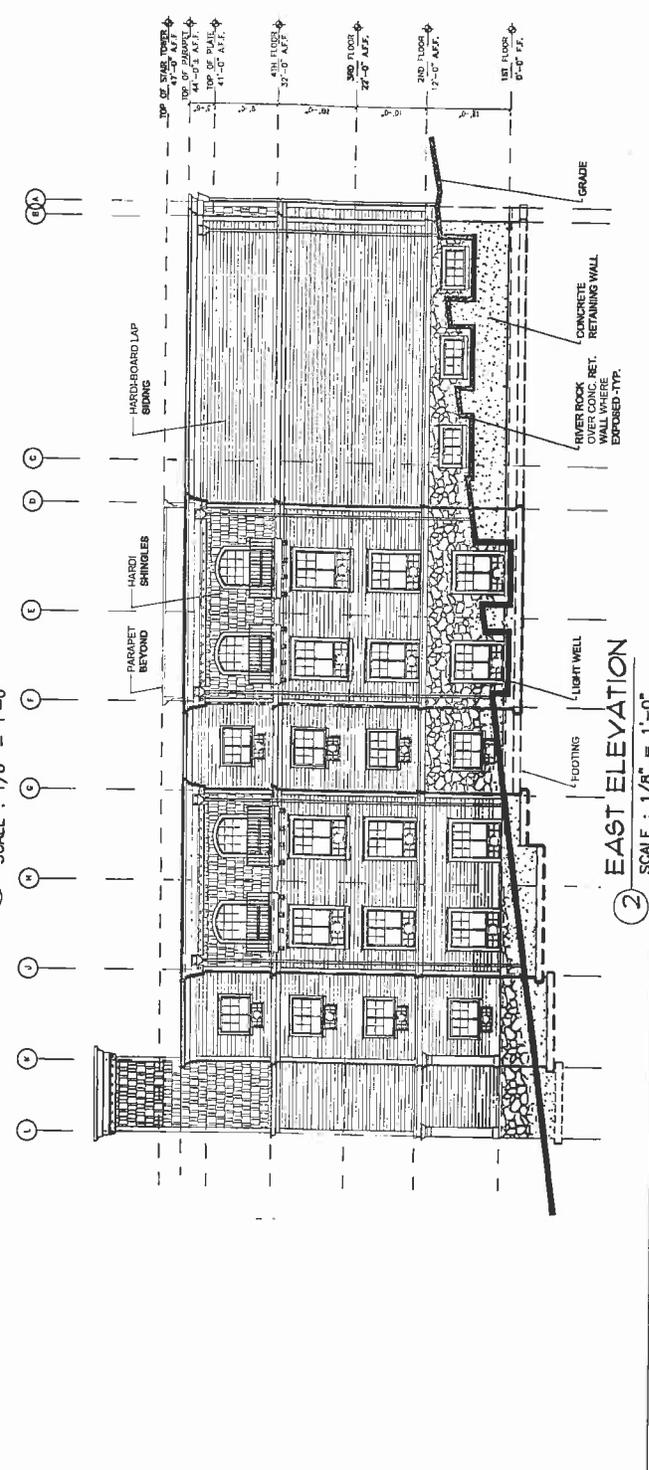
2 EAST ELEVATION
SCALE : 1/8" = 1'-0"

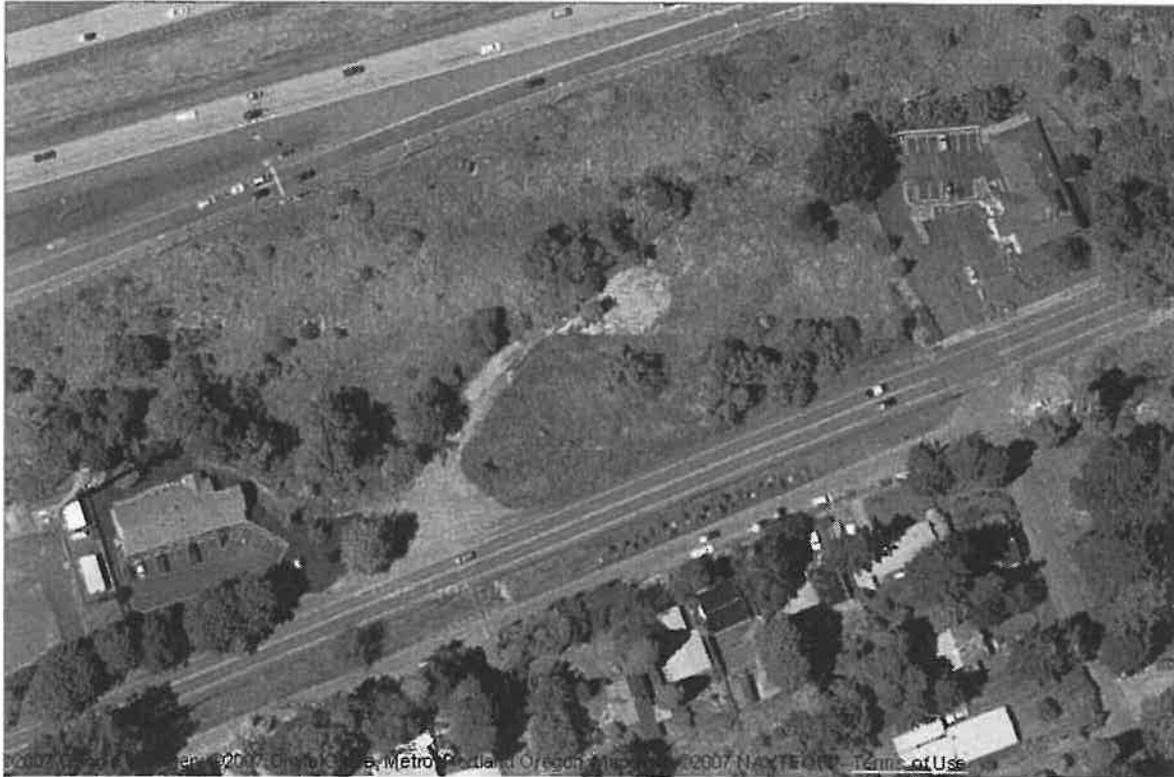
MAP I Aerial Photo with Sound Recording Location

A precision sound pressure level meter (Type I) was placed at the recording location, at the corner of 7th and Willamette Falls Drive. (see Map I). Sound data together with a calibration signal were recorded on to an acoustical computer. Observations of ambient and other noise sources such as wind, traffic and other pertinent factors were noted during the data collection intervals. Data was computer time-stamped at one-second intervals.

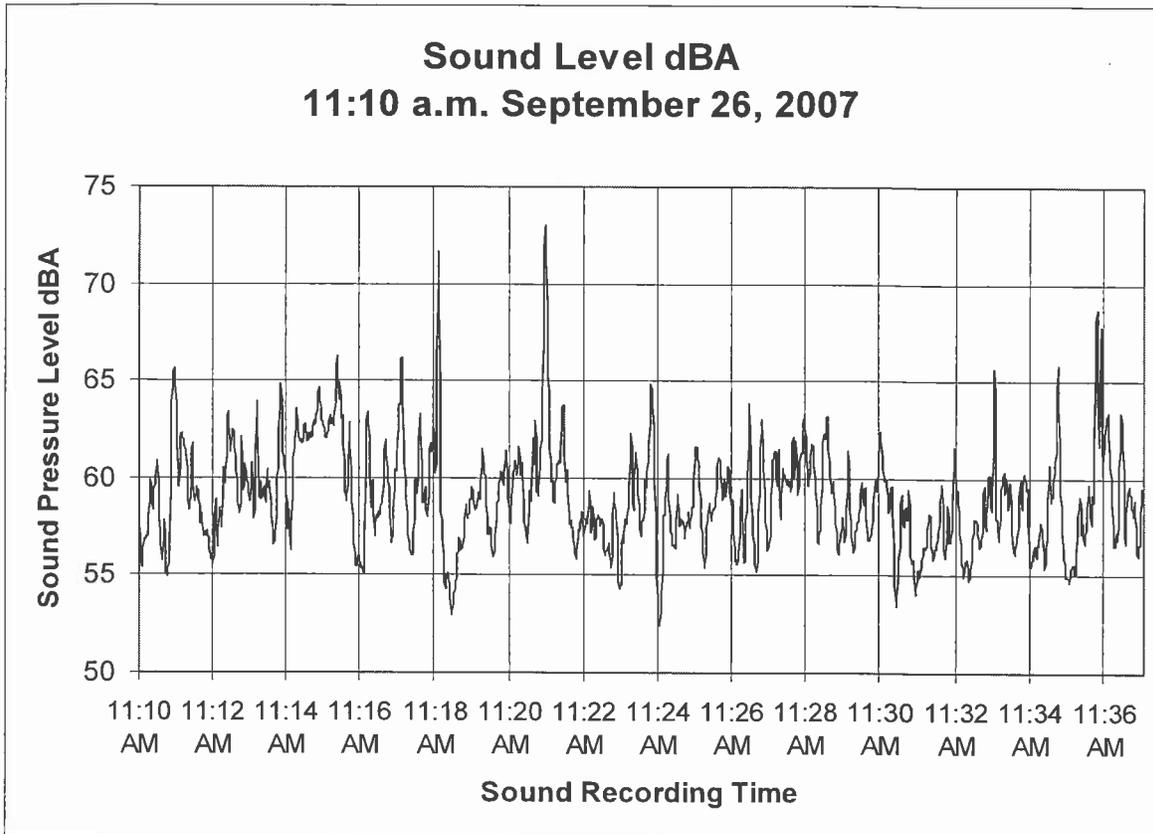
Graph 1
Sound Recording

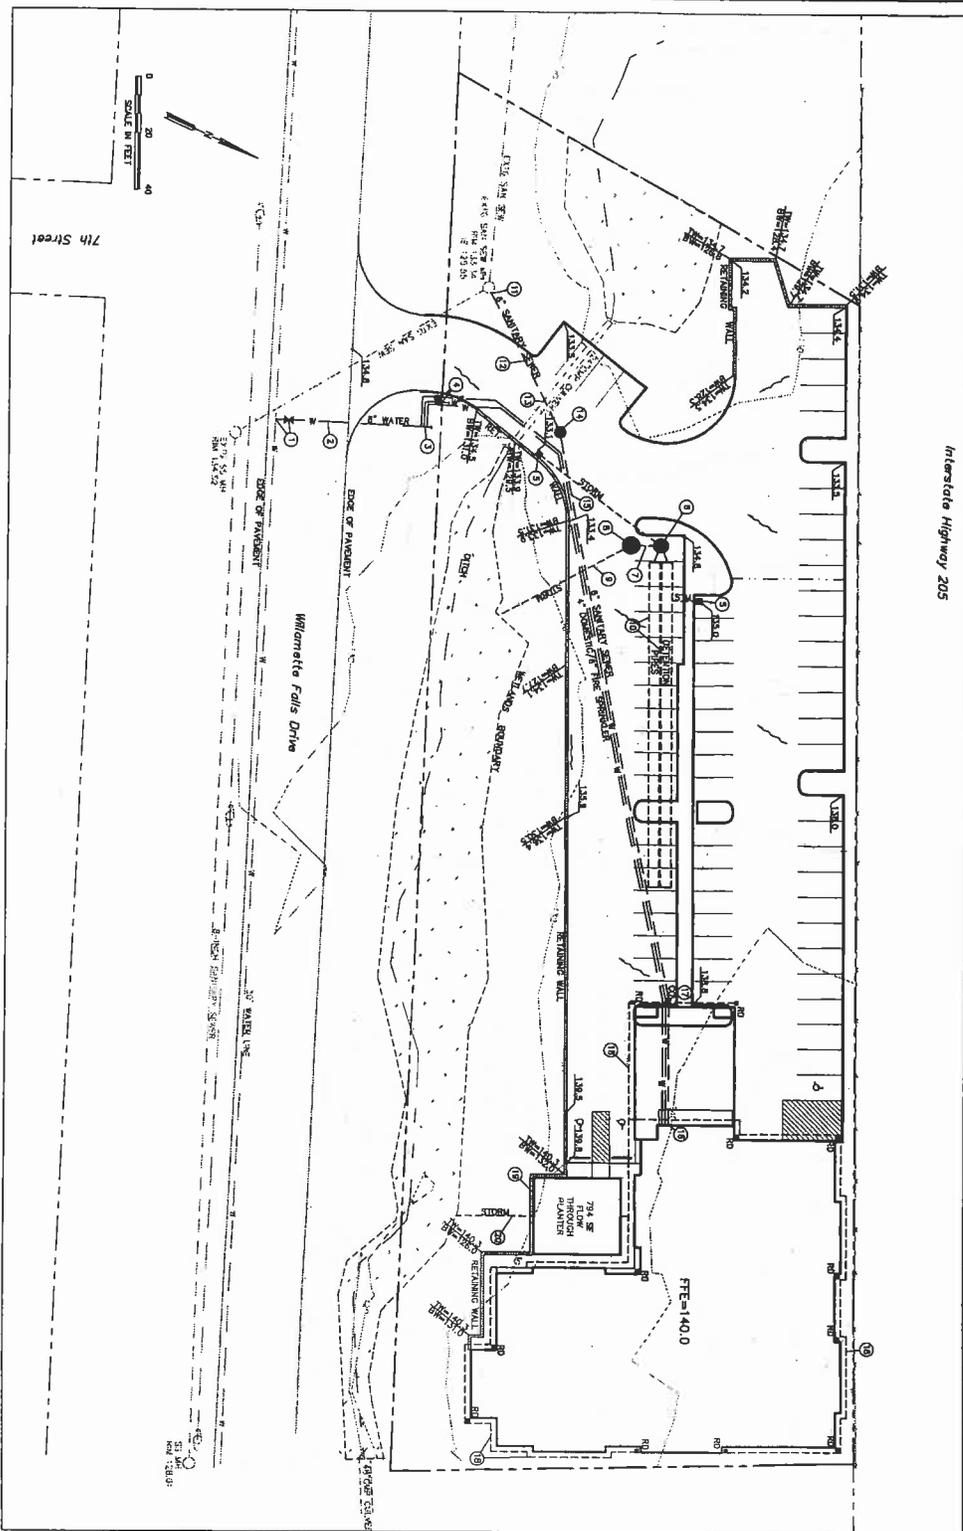
GRADING AND UTILITY PLAN
 DRAWING NO. C-1
 PROJECT NO. 07-0001
 SHEET 01

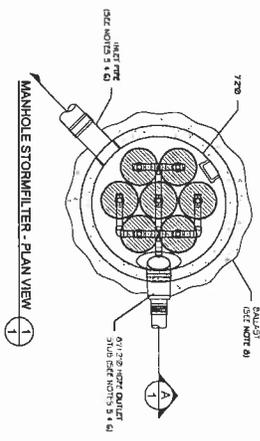
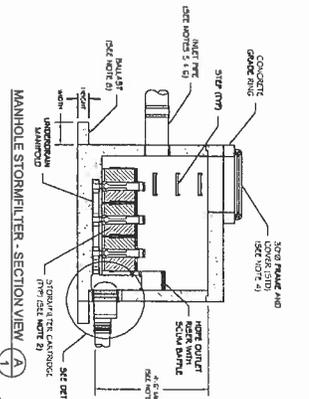
FLOW CONTROL STRUCTURE
DETAIL 1

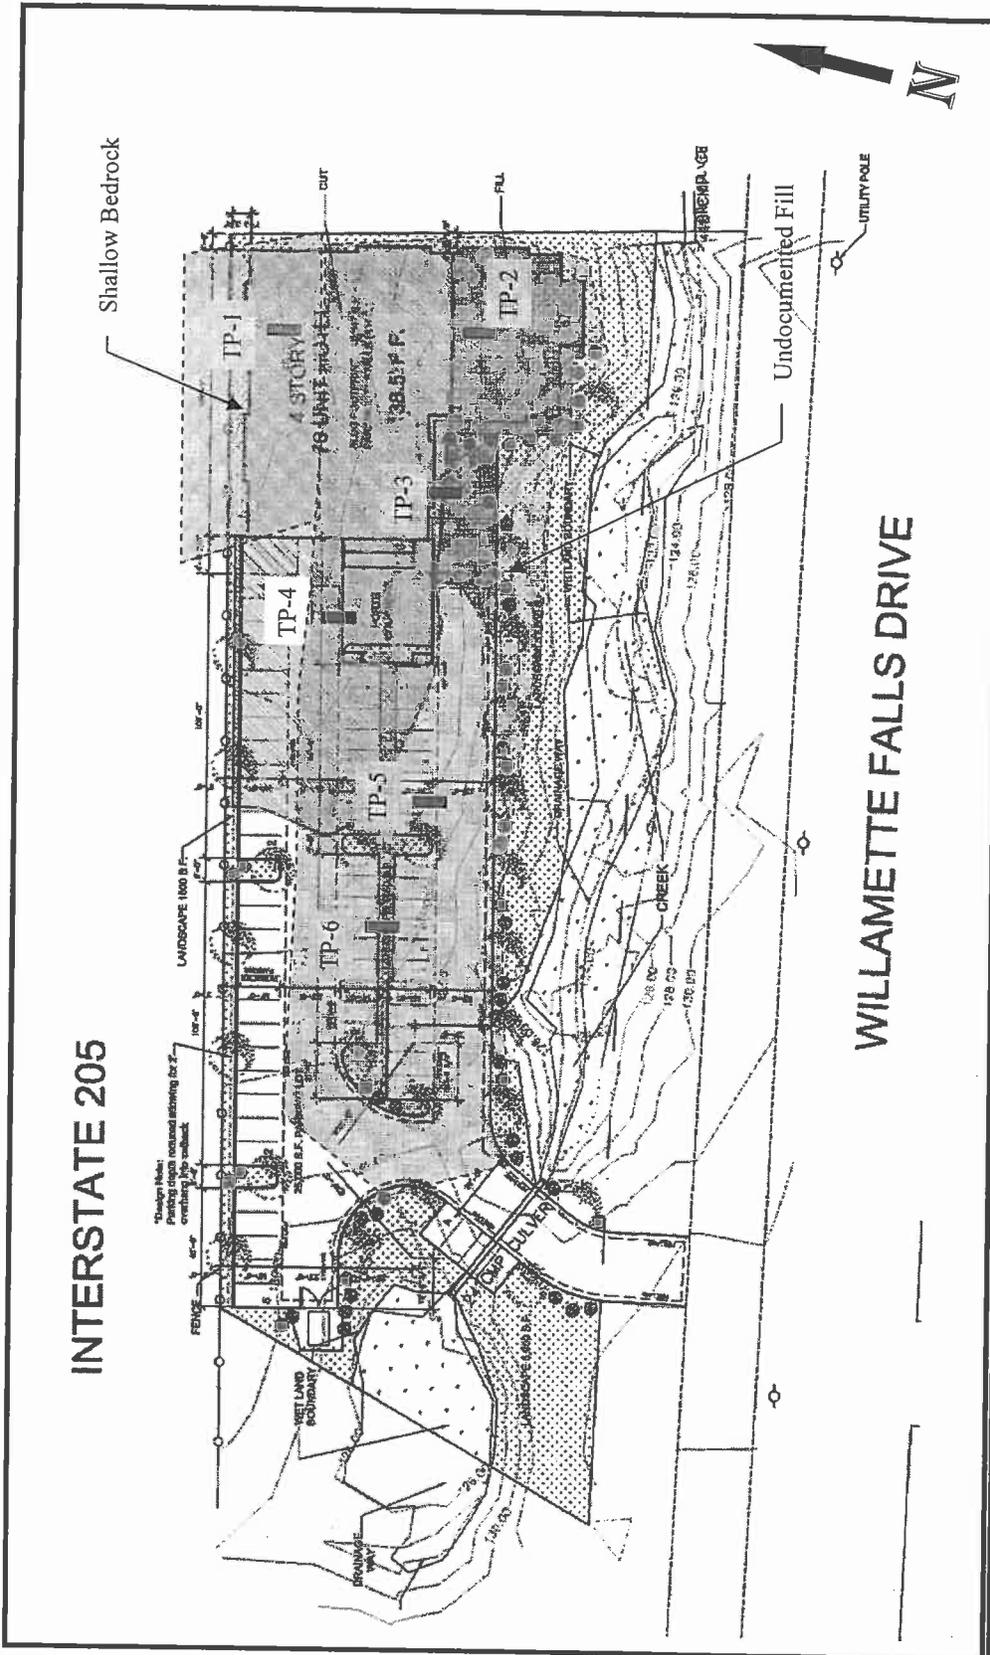
<p>Terra Dolce Consultants, Inc. 485 Collins Crest Gladstone, Oregon 97027</p>	<p>Vic Patel Proposed Holiday Inn Express 2400 Block Willamette Falls Drive West Linn, Oregon</p>		
<p>Project No. 291-001</p>	<p>September 7, 2007</p>	<p>Site Plan</p>	<p>Figure 2</p>

On August 22, 2007 TDC conducted a site visit to evaluate the surface and subsurface conditions of the site. TDC advanced six test pits up to 9 feet below the ground surface (bgs) (designated TP-1 through TP-6, Figure 2). TDC observed the following subsurface conditions.

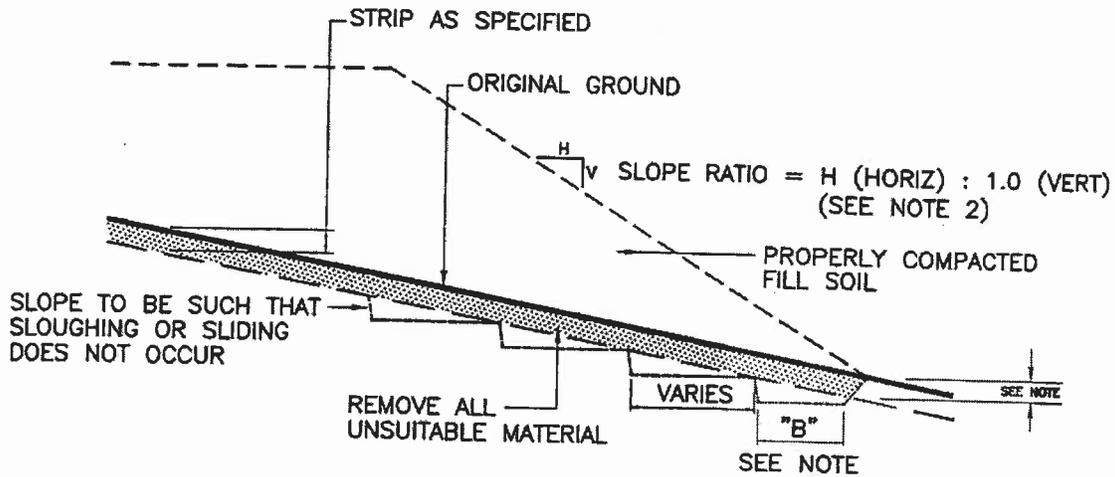
1. BENCHES ARE REQUIRED WHERE THE NATURAL SLOPES ARE STEEPER THAN 5:1 (HORIZONTAL TO VERTICAL), OR WHERE SPECIFIED BY THE SOILS ENGINEER. WHERE FILLS ARE TO BE PLACED ON EXISTING SURFACES HAVING SLOPES STEEPER THAN 3:1, INDIVIDUAL GEOTECHNICAL ANALYSES AND RECOMMENDATIONS ARE REQUIRED FOR DEVELOPMENT OF BENCHING DETAILS.

When fills are placed on existing slopes steeper than 5(H):1(V), the fills should be keyed into the existing hillside (see Figure 6). The keys should be at least two feet wider than the compaction equipment. Provisions for subsurface drains may be required in places where there are groundwater seeps or, springs, or wet conditions. These provisions should be made on a case-by-case measure.

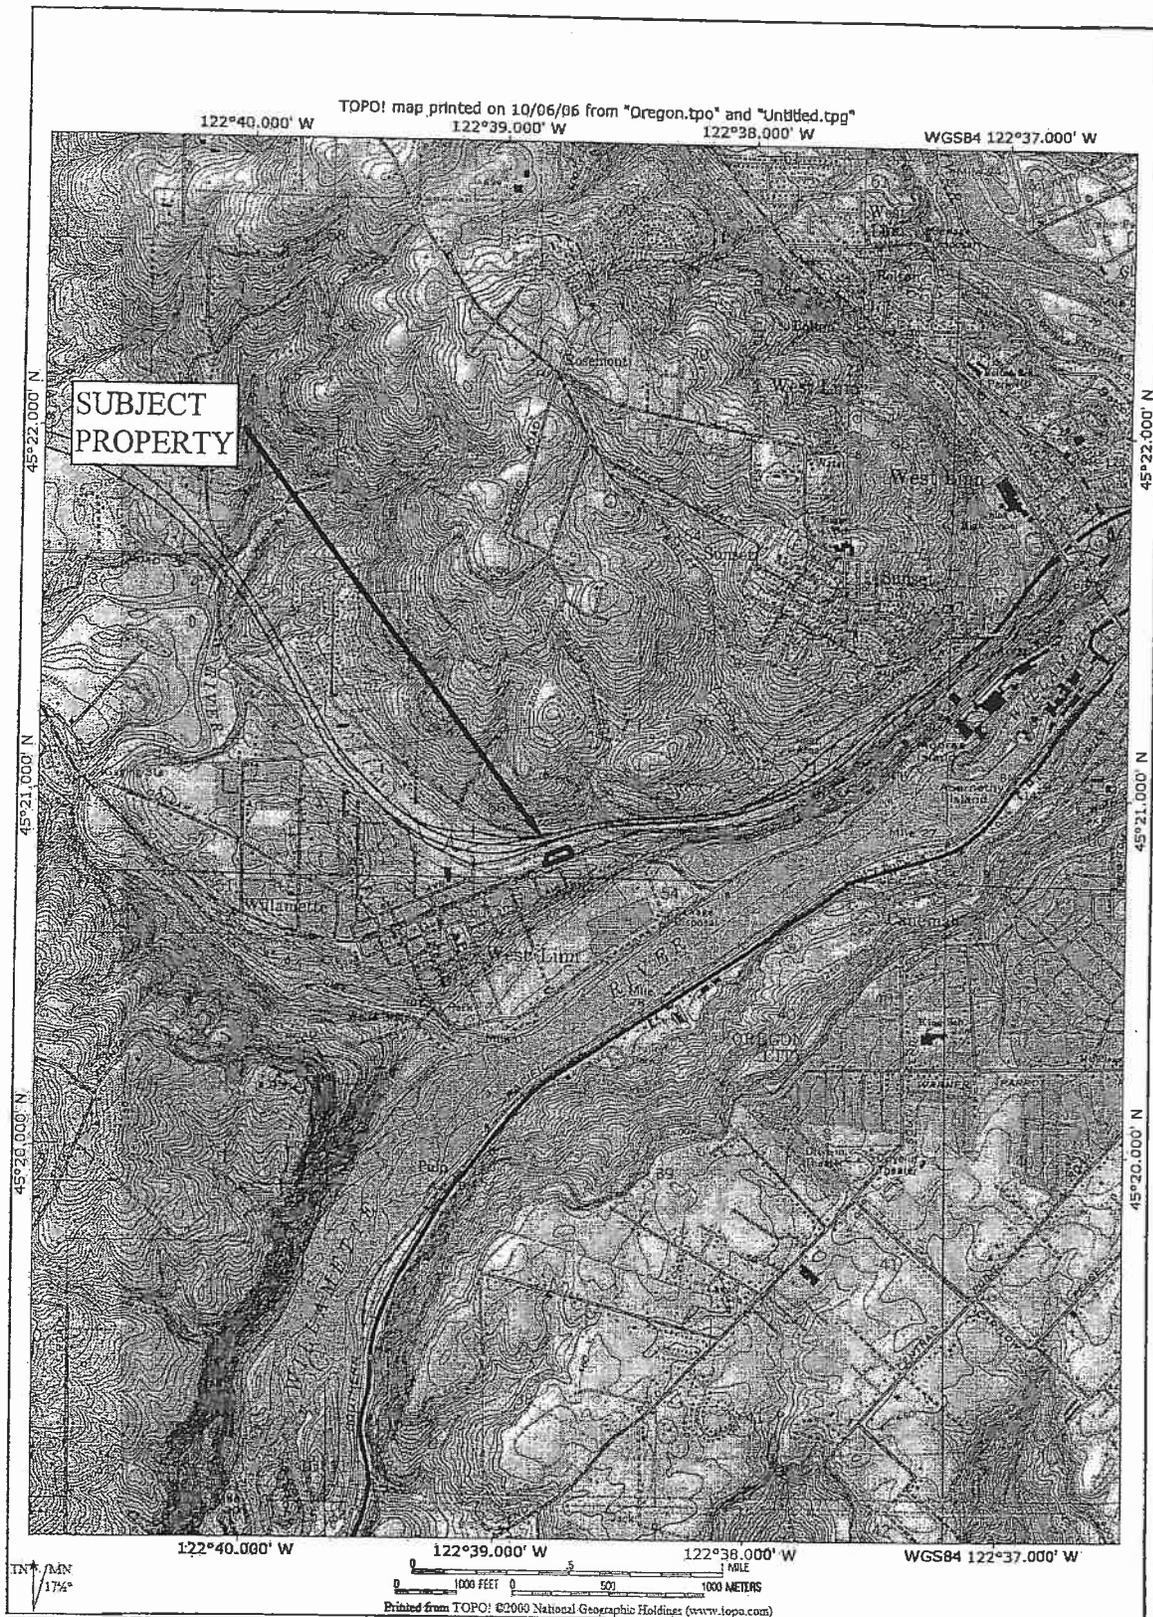
Figure 1: Topographic Map
 Holiday Inn Property – West Linn, OR

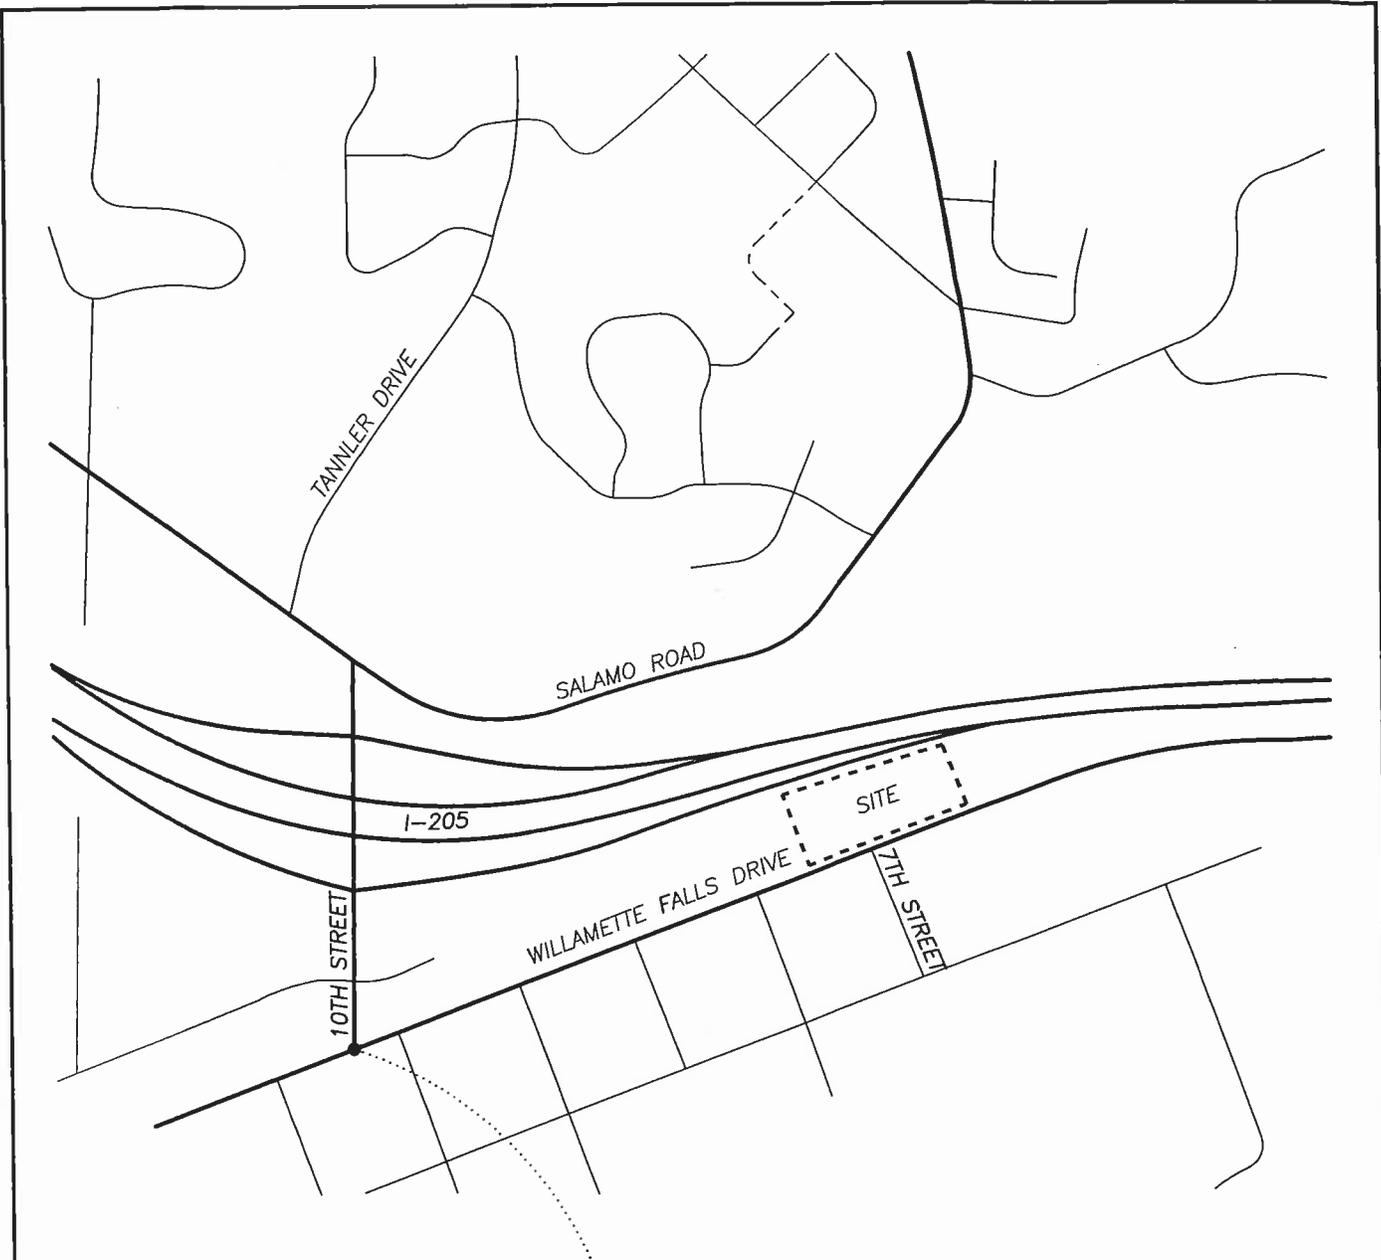
VICINITY MAP
Existing Intersection Configurations
& Traffic Control Devices

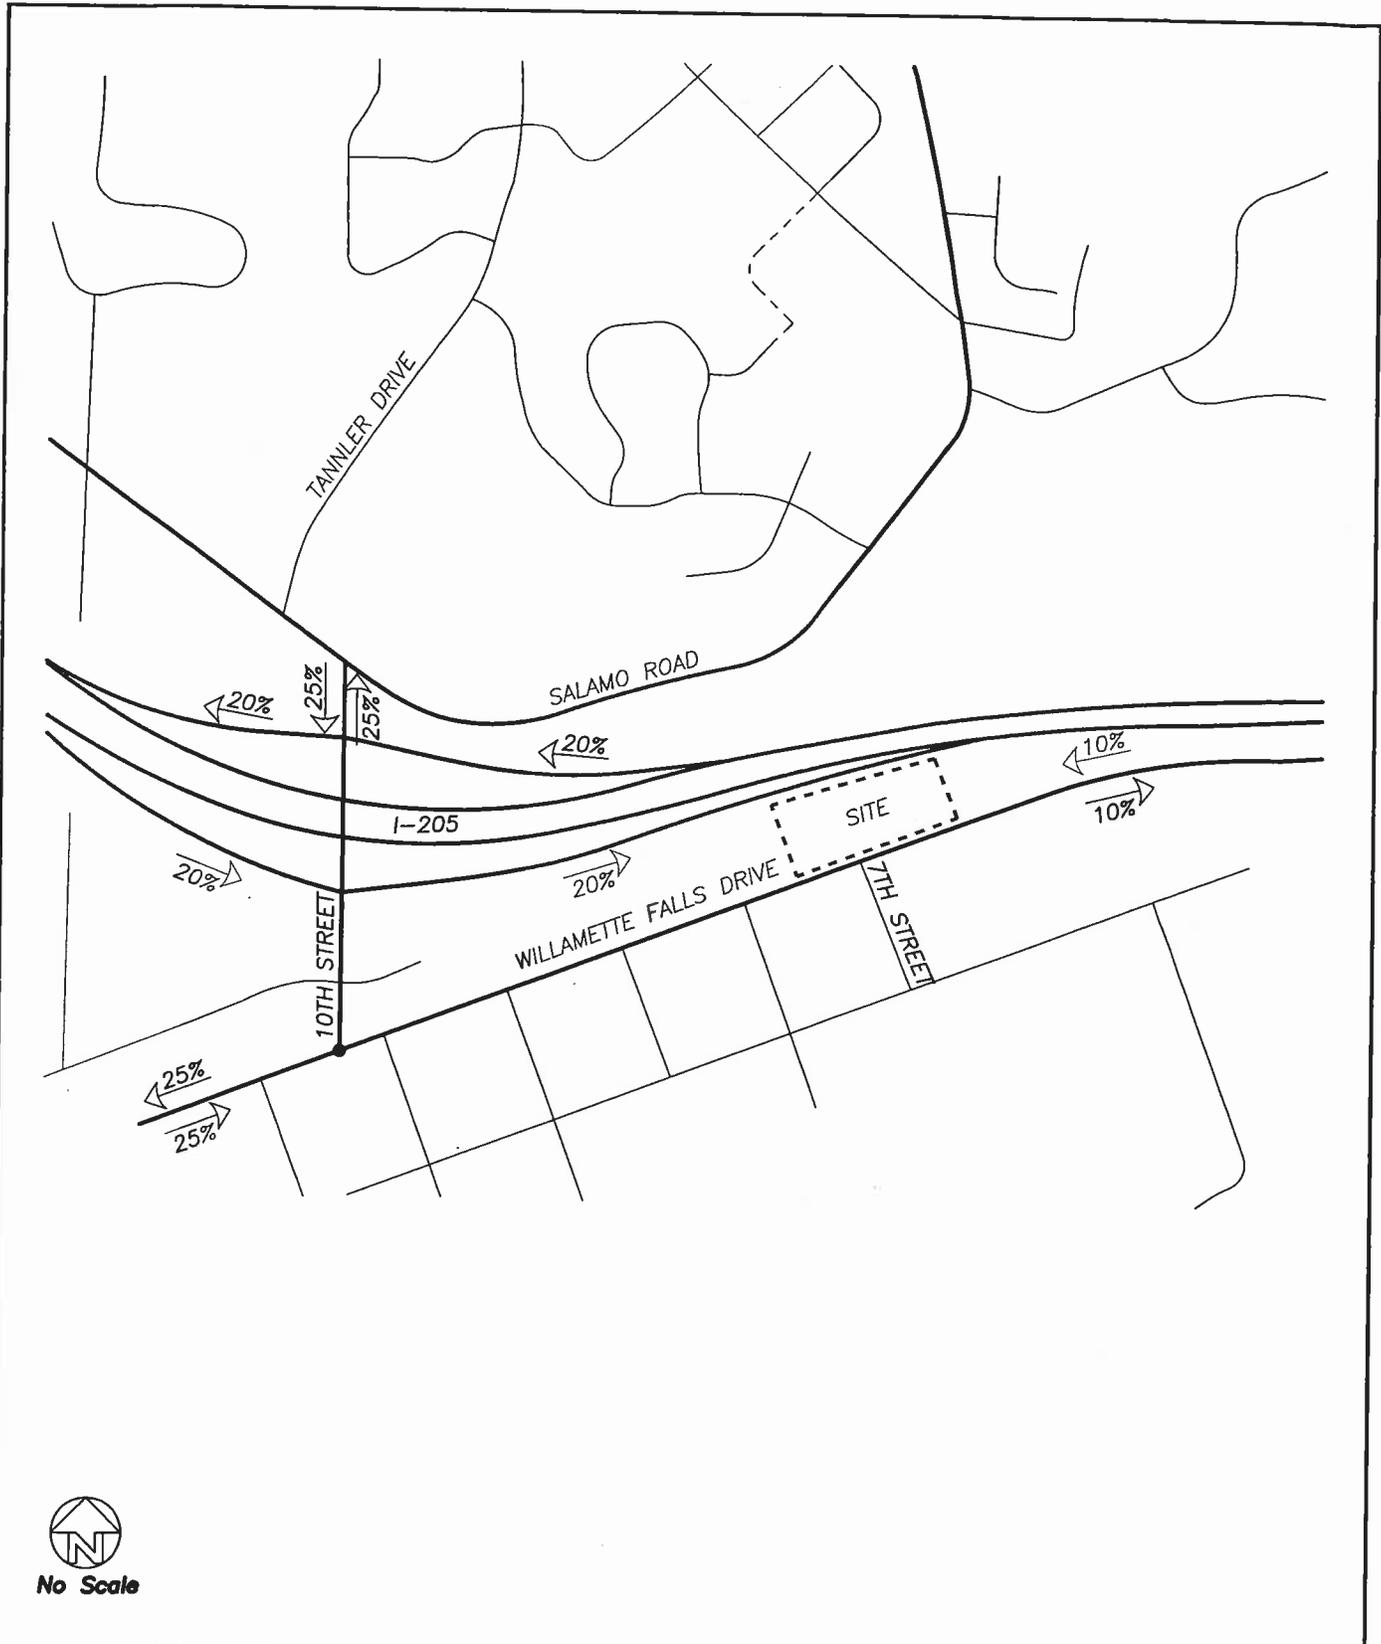
SITE TRIP DISTRIBUTION
 Inbound & Outbound Percentages
 AM & PM Peak Hours

The traffic flow diagram on page 10 shows the distribution of the site trips from the proposed development. The traffic flow diagram on page 11 shows the assignment of the site trips to the roadway network during the morning and evening peak hours.

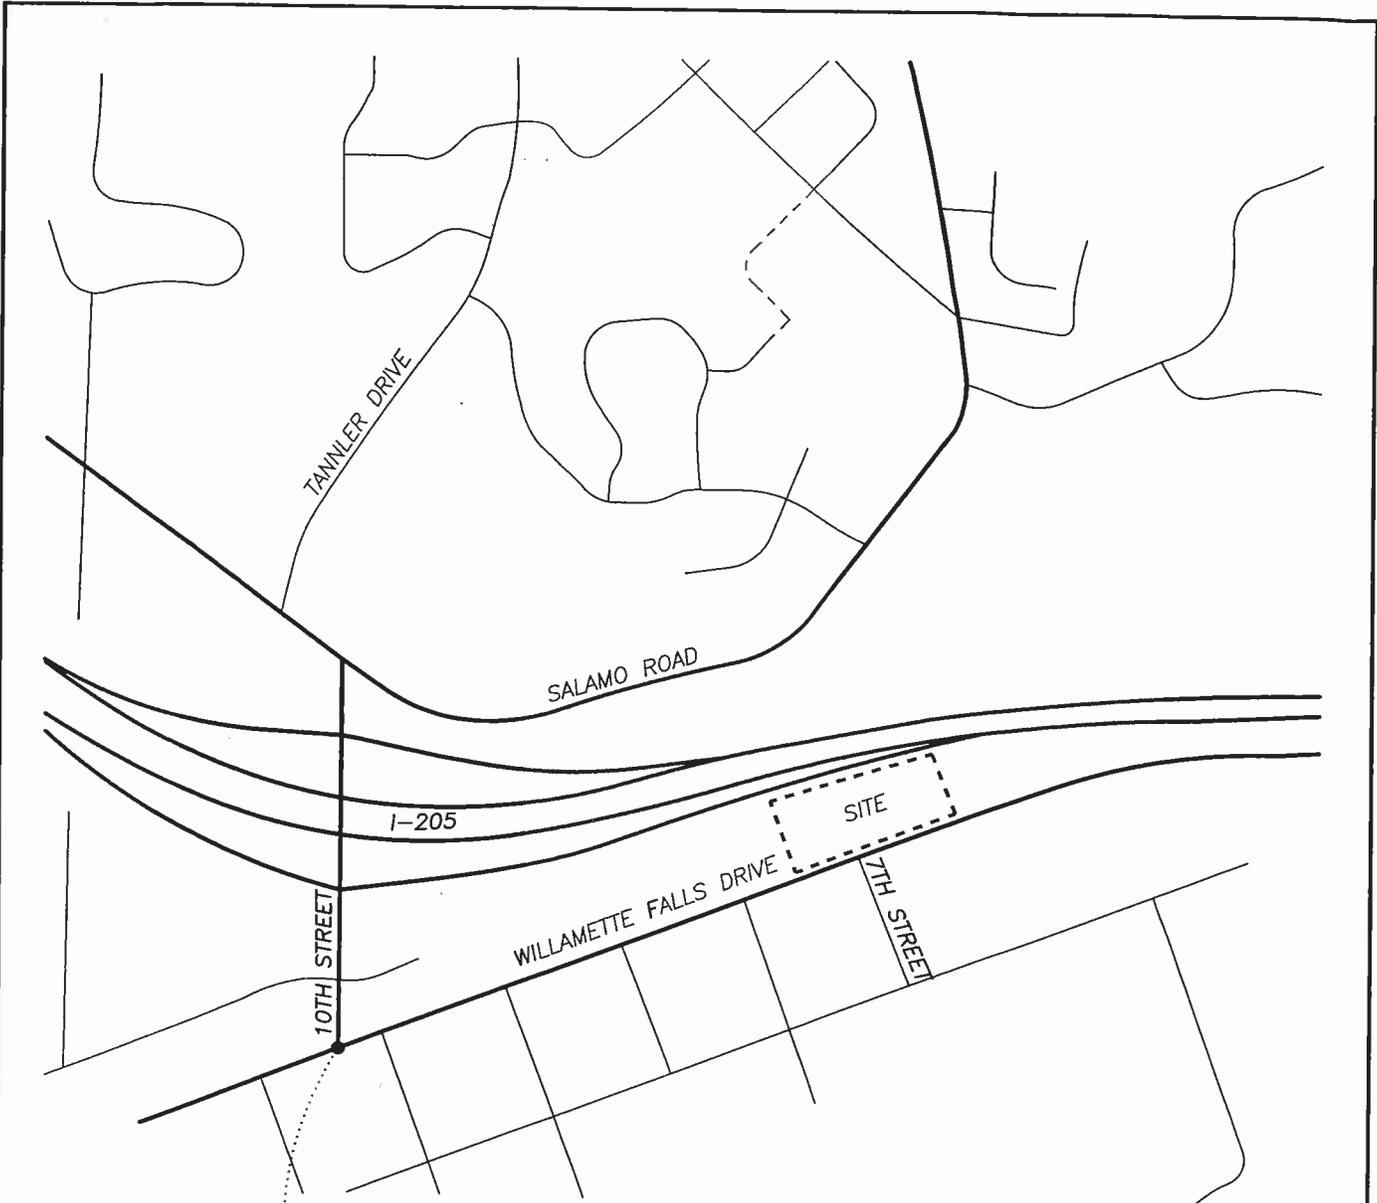
TRAFFIC VOLUMES
 2009 Background Traffic
 AM & PM Peak Hours

The background traffic volumes comprise the existing traffic volumes with the growth rate applied and in-process traffic volumes added. A traffic flow diagram showing the background traffic volumes during the morning and evening peak hours is given on page 13. A traffic flow diagram showing the background traffic with the site trips added is given on page 14.

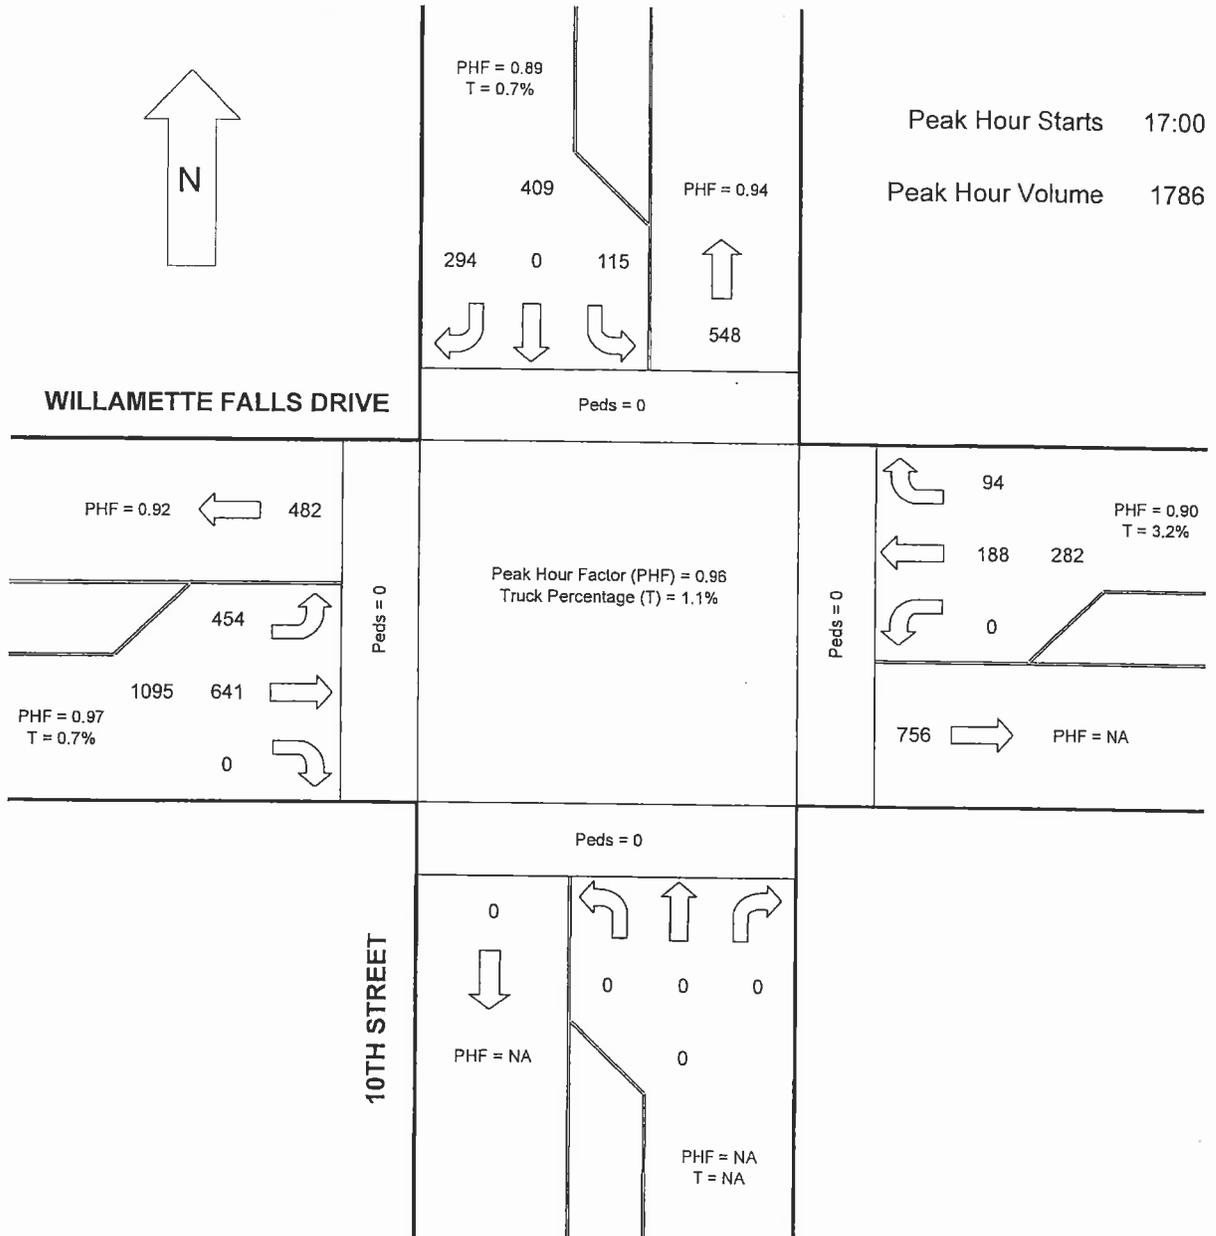
Intersection Turning Movement Peak Hour Diagram

Location WILLAMETTE FALLS DRIVE AT 10TH STREET
Date 7/24/2007
Day of Week Tuesday
Time Begin 16:00
Reviewed By: DE

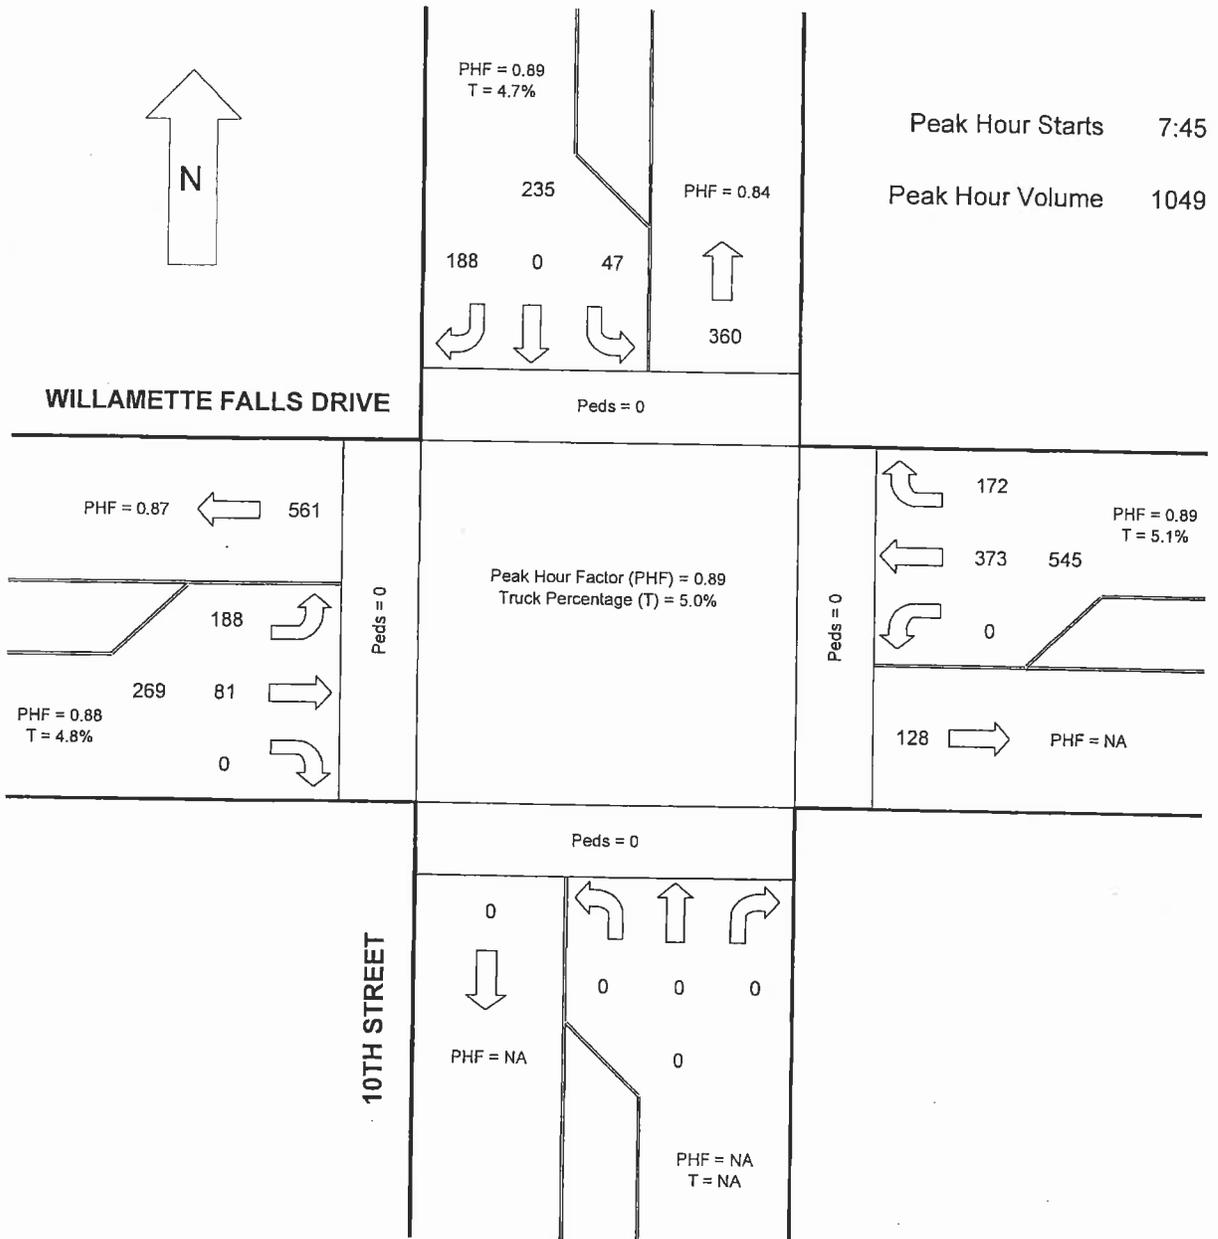
Intersection Turning Movement Peak Hour Diagram

Location WILLAMETTE FALLS DRIVE AT 10TH STREET
 Date 7/24/2007
 Day of Week Tuesday
 Time Begin 7:00
 Reviewed By: DE
