CITY OF WEST LINN
PRE-APPLICATION CONFERENCE MEETING
SUMMARY NOTES
May 2, 2024

SUBJECT: Proposed Planned Unit development to create 26 lots.

FILE: PA-24-07

SITE PLAN - 50' LOT ALTERNATE
RIVANNA BEACH
WEST LINN WATERFRONT DEVELOPMENT
FORWARD VISION DEVELOPMENT
WEST LINN, OR

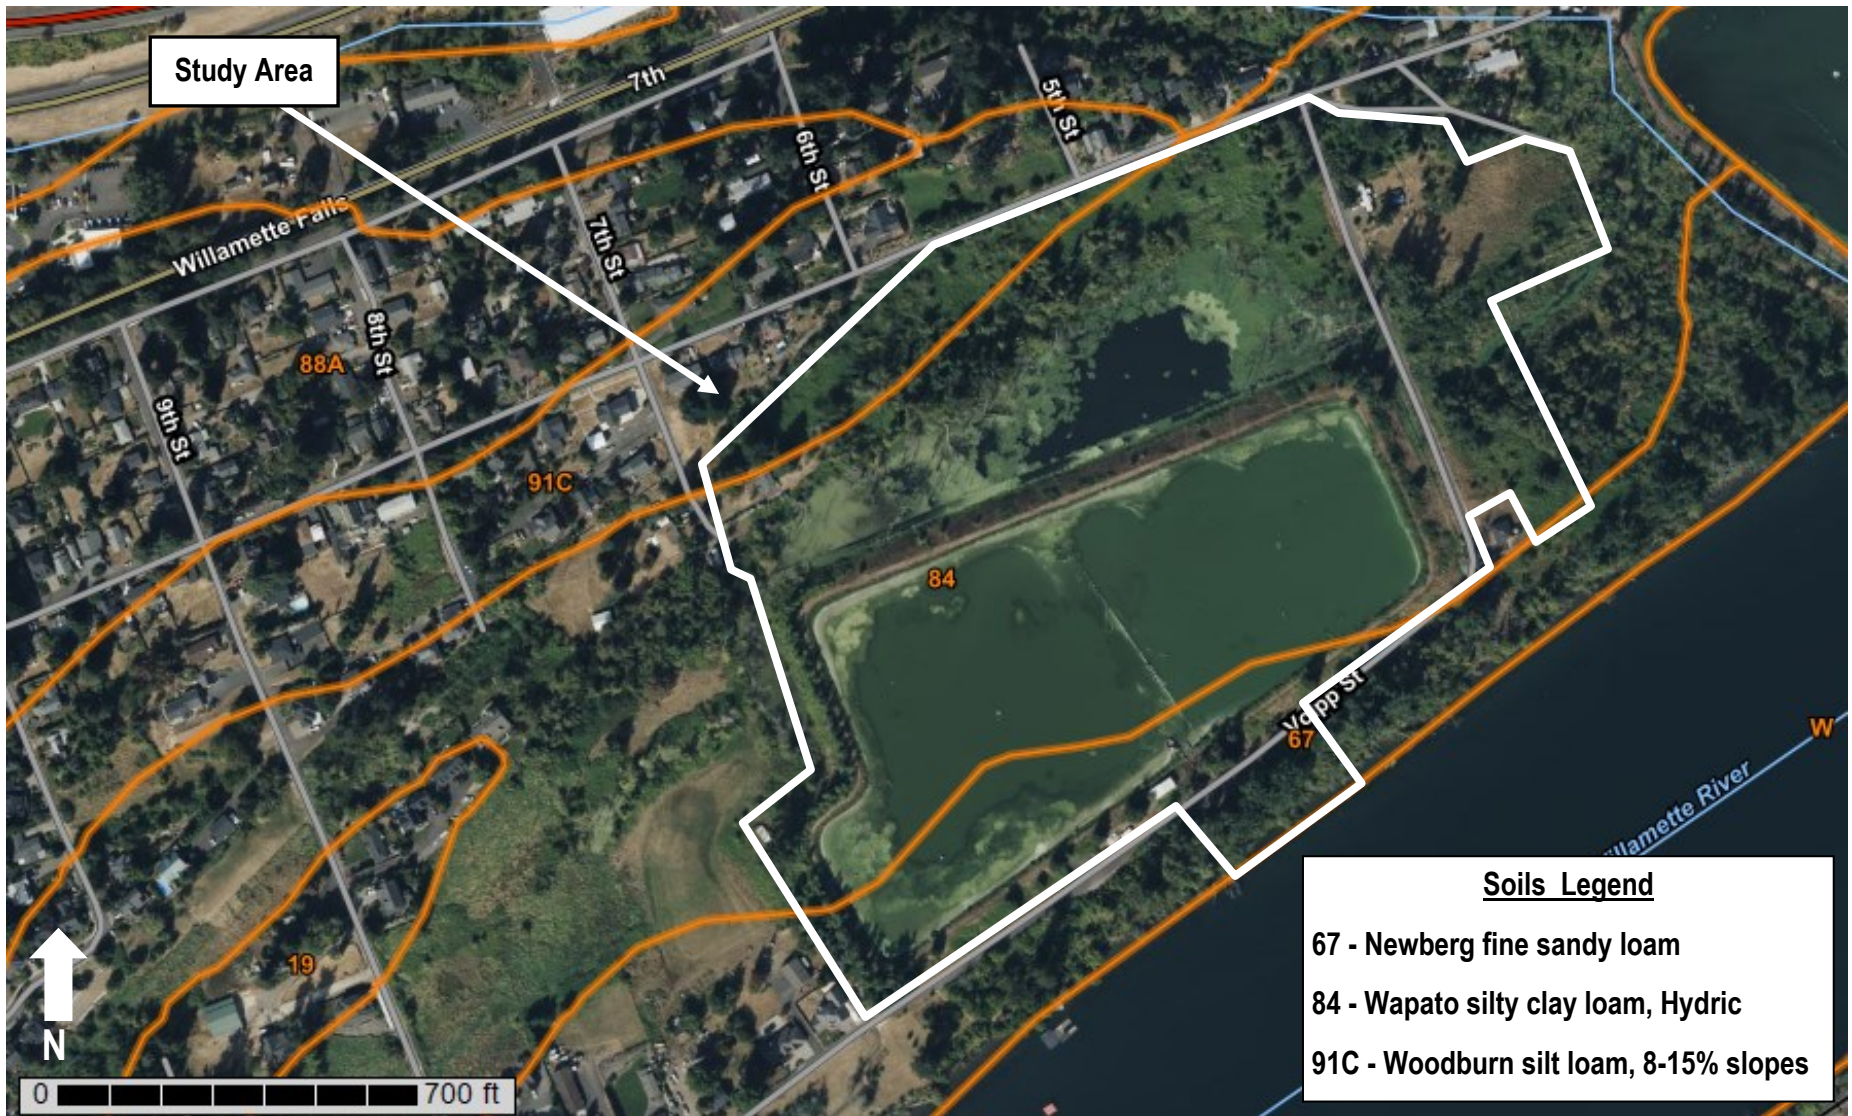
FIGURE
4

Soils Legend

67 - Newberg fine sandy loam

Soils
Rivianna Beach Development - West Linn, Oregon
Natural Resources Conservation Services, Web Soil Survey, 2023
(websoilsurvey.sc.egov.usda.gov)

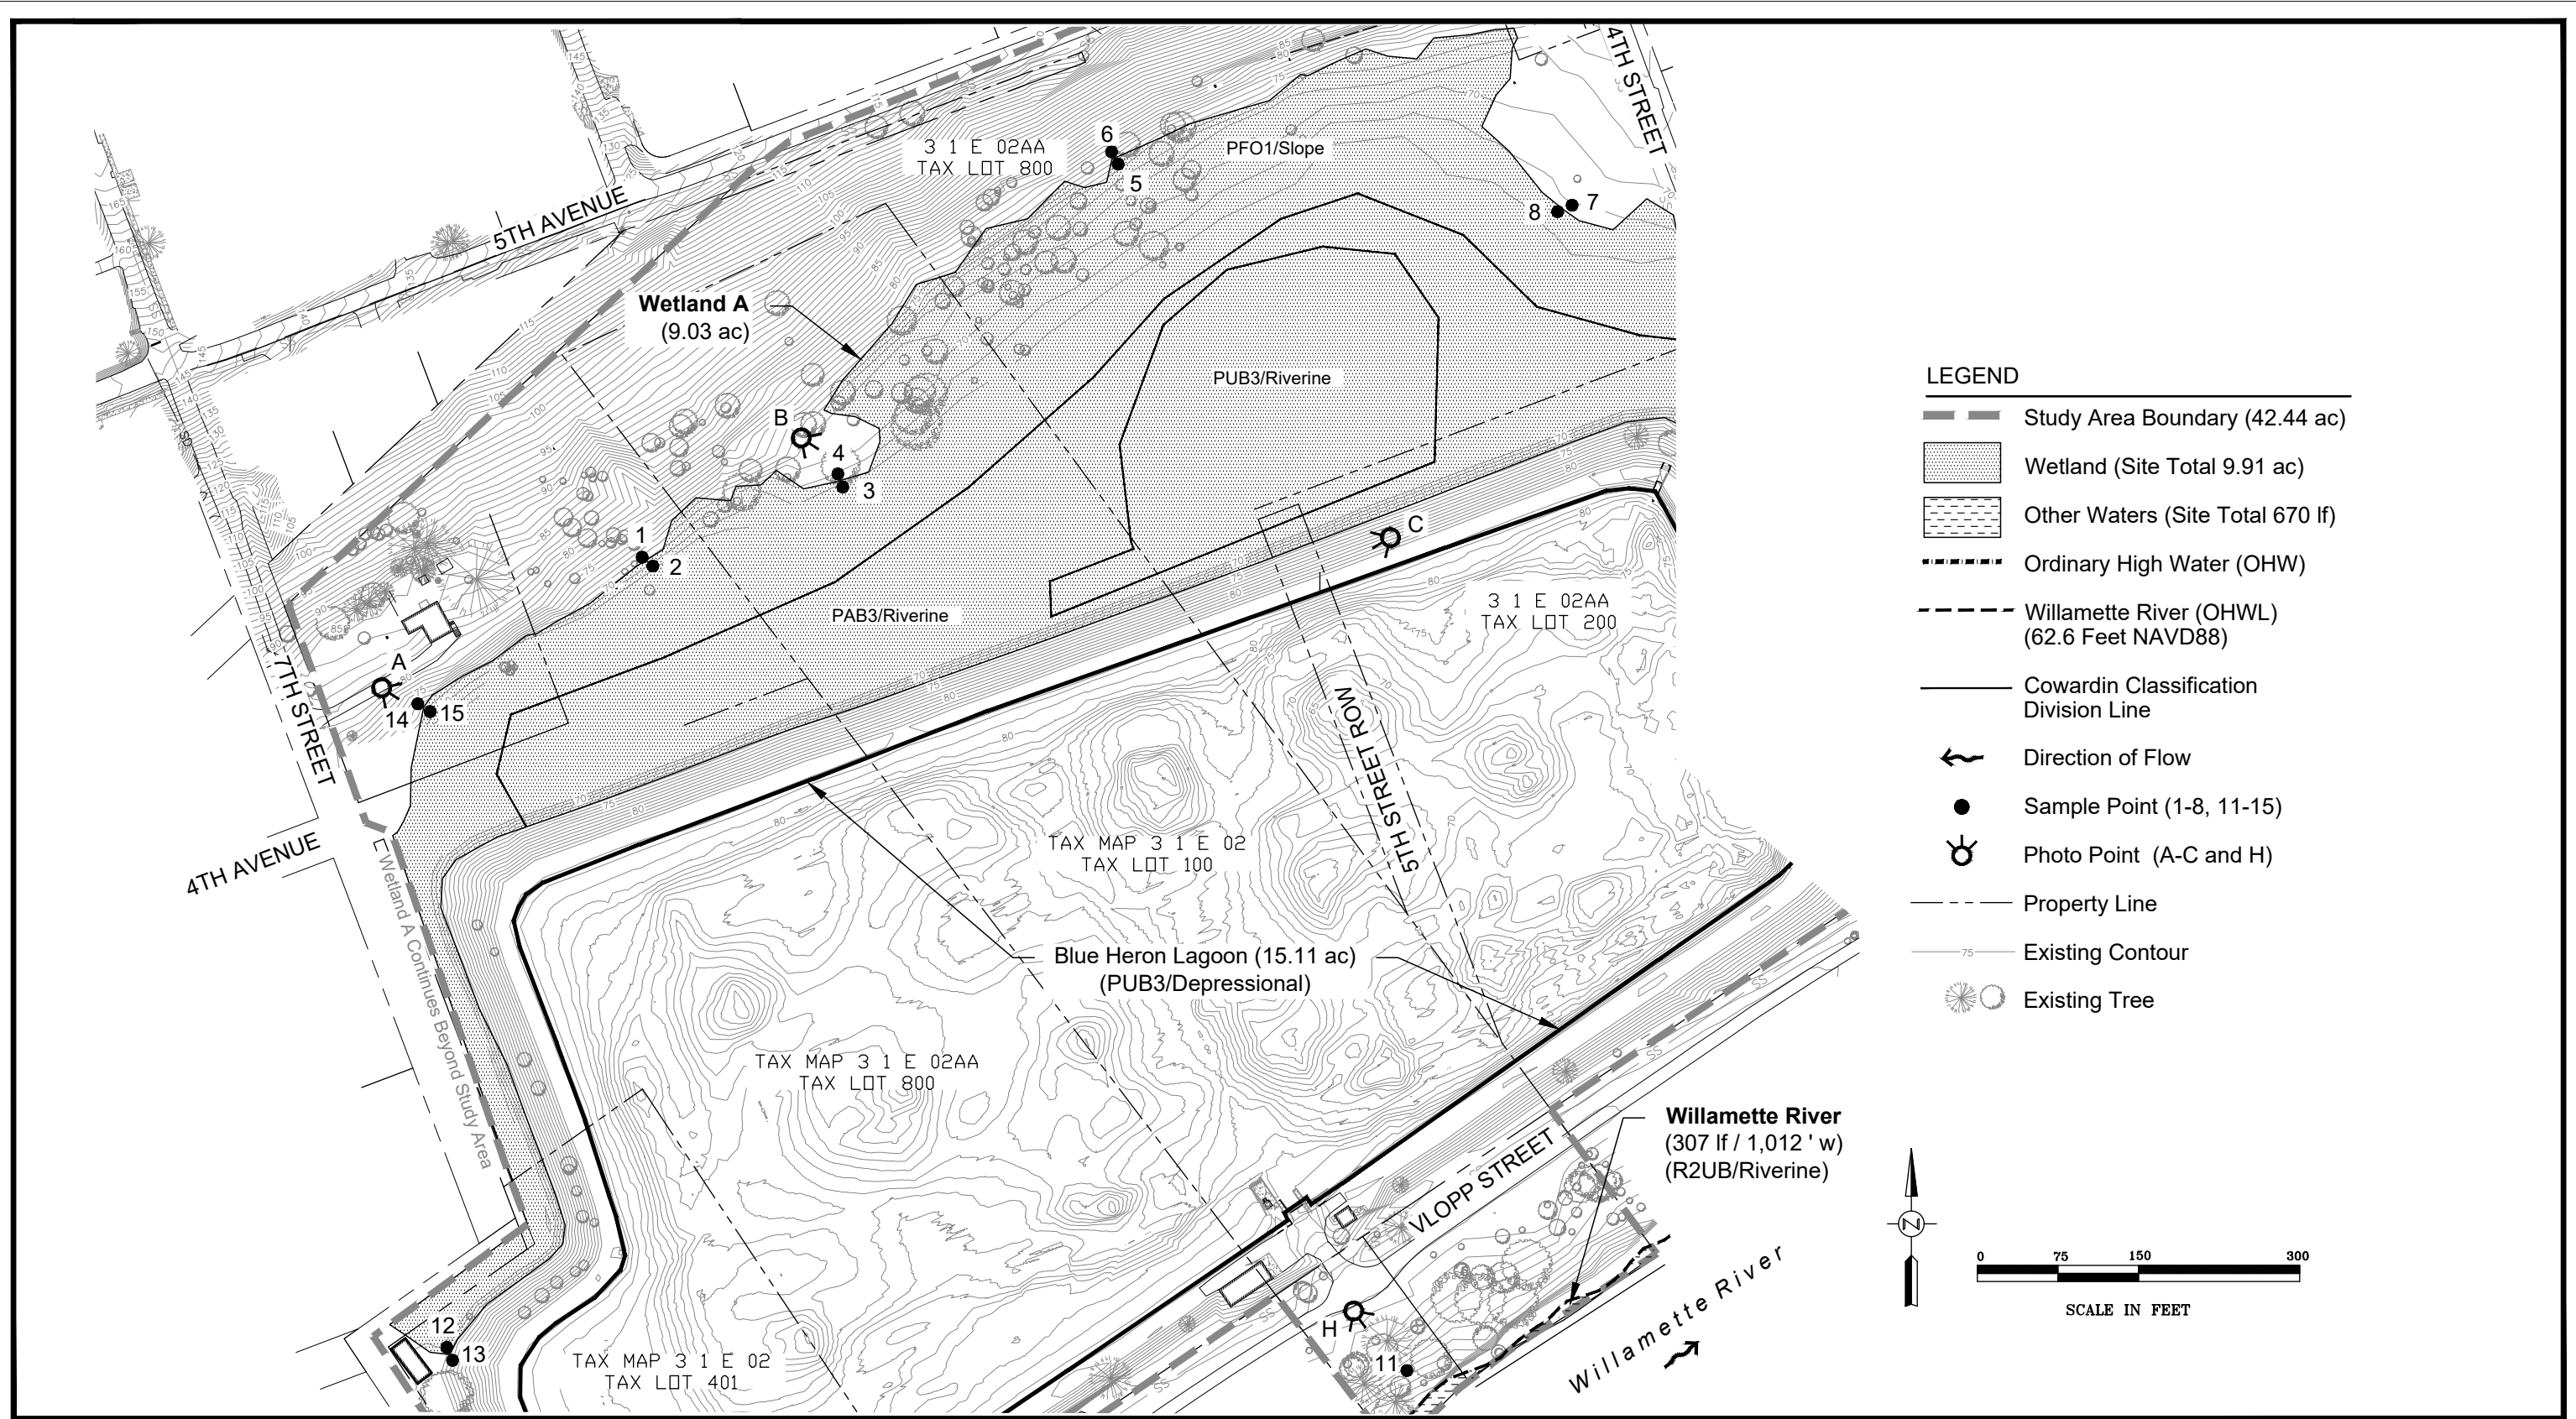
- LEGEND**
- Study Area Boundary (42.44 ac)
 - Wetland (Site Total 9.91 ac)
 - Other Waters (Site Total 670 lf)
 - Ordinary High Water (OHW)
 - Willamette River (OHWL) (62.6 Feet NAVD88)
 - Cowardin Classification Division Line
 - Direction of Flow
 - Sample Point (1-8, 11-15)
 - Photo Point (A-C and H)
 - Property Line
 - Existing Contour
 - Existing Tree

Survey provided by 3J Consulting
 Survey accuracy is sub-centimeter.
 Sample points, wetland flags collected by PHS with
 submeter accuracy using Trimble GPS (Geo7x)
 Ordinary High Water of Willamette River determined by
 Public Lands Map, DSL 1975

Wetland Delineation
 Rivianna Beach Development - West Linn, Oregon

The study area is located adjacent to the north bank of the Willamette River in West Linn, Clackamas County, Oregon. Figures, including a map depicting the location of the wetlands and other waters are in Appendix A. Data sheets documenting onsite conditions are provided in Appendix B. Photos of the onsite existing conditions are included in Appendix C.

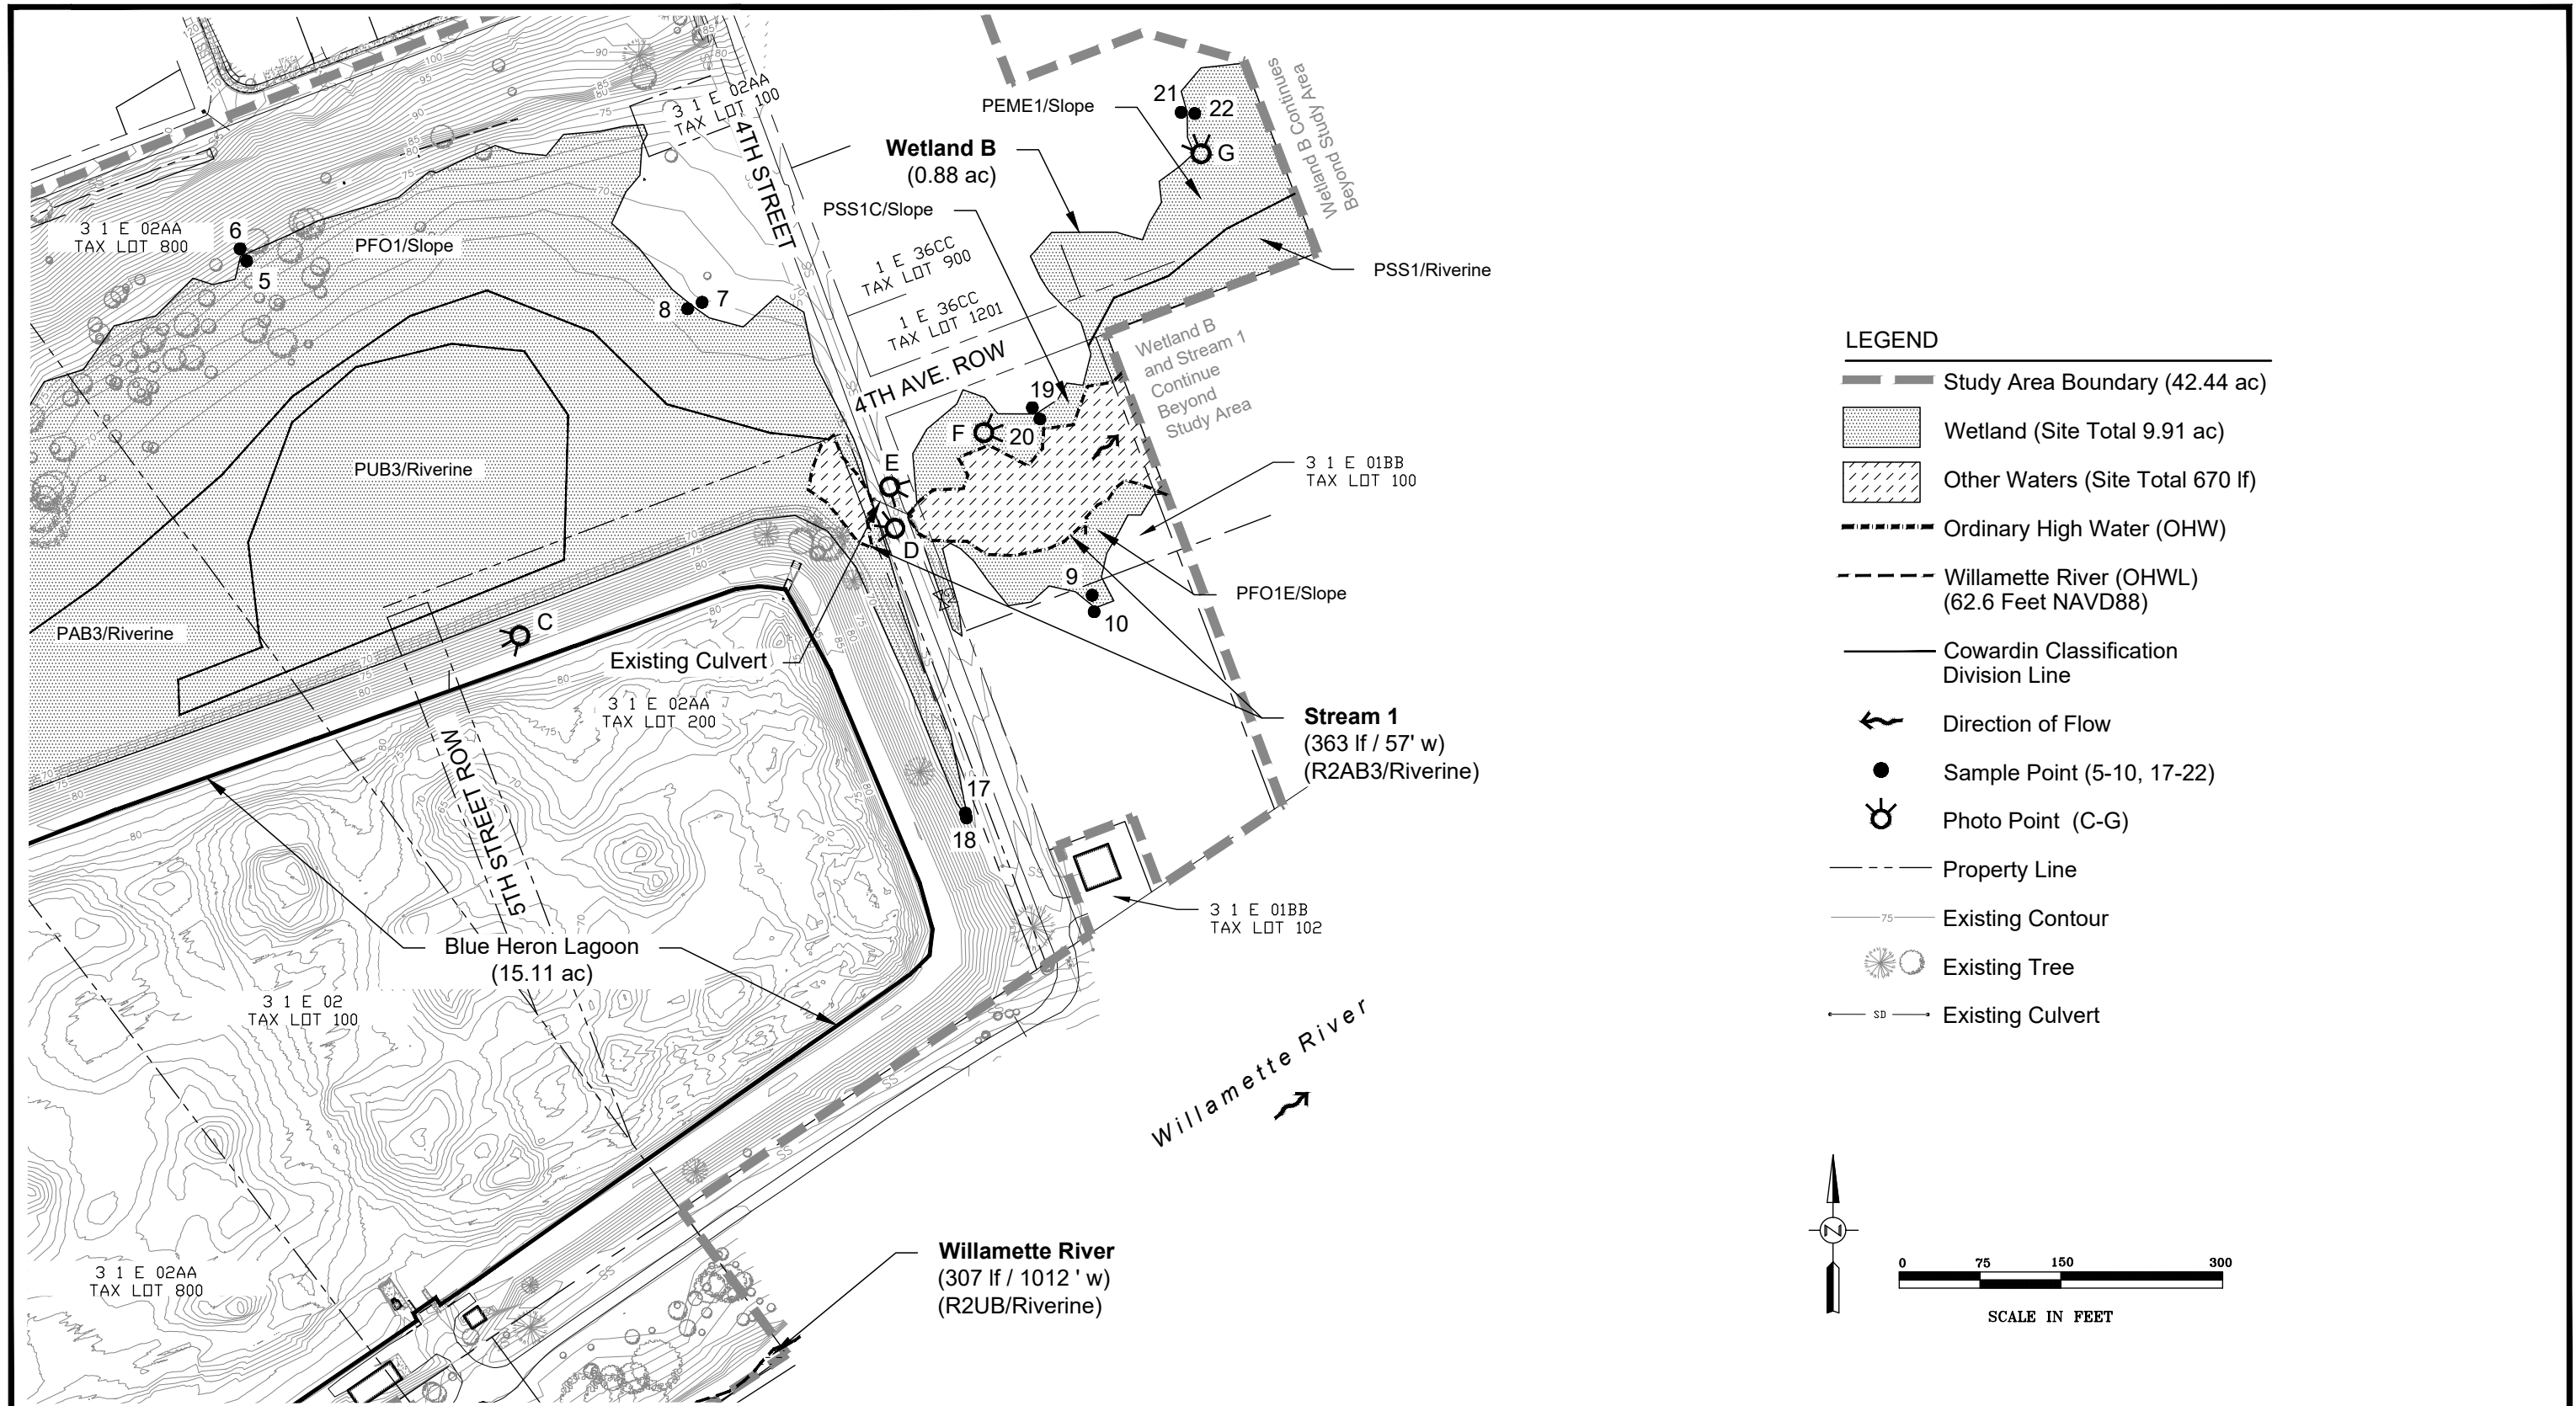
FIGURE 6A

Survey provided by 3J Consulting
 Survey accuracy is sub-centimeter.
 Sample points, wetland flags collected by PHS with
 submeter accuracy using Trimble GPS (Geo7x)
 Ordinary High Water of Willamette River determined by
 Public Lands Map, DSL 1975

Wetland Delineation
 Rivianna Beach Development - West Linn, Oregon

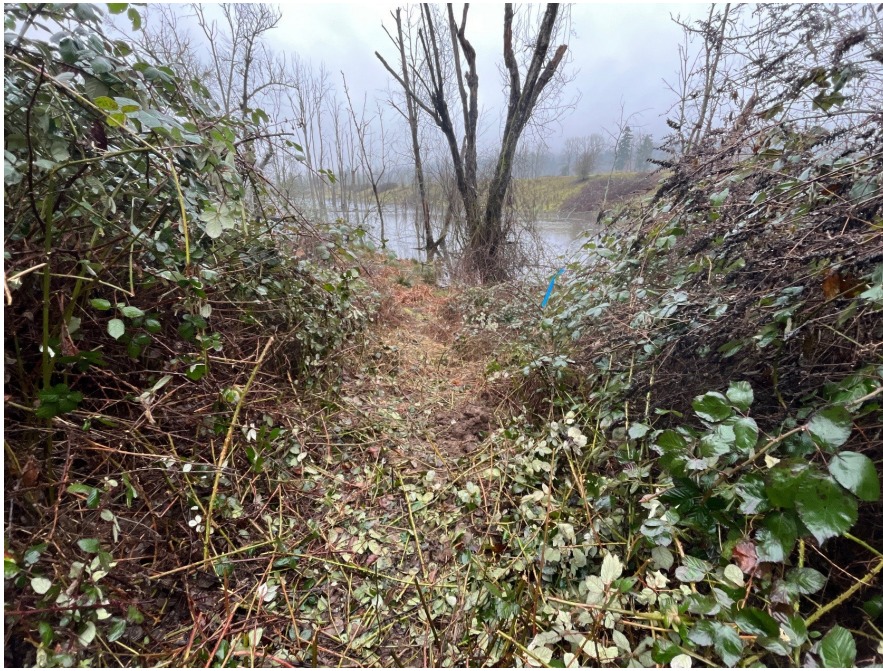
Photo A:

Looking southeast towards Sample Points 14 & 15 along Wetland A's northwest boundary. The Blue Heron Lagoon is in the background.

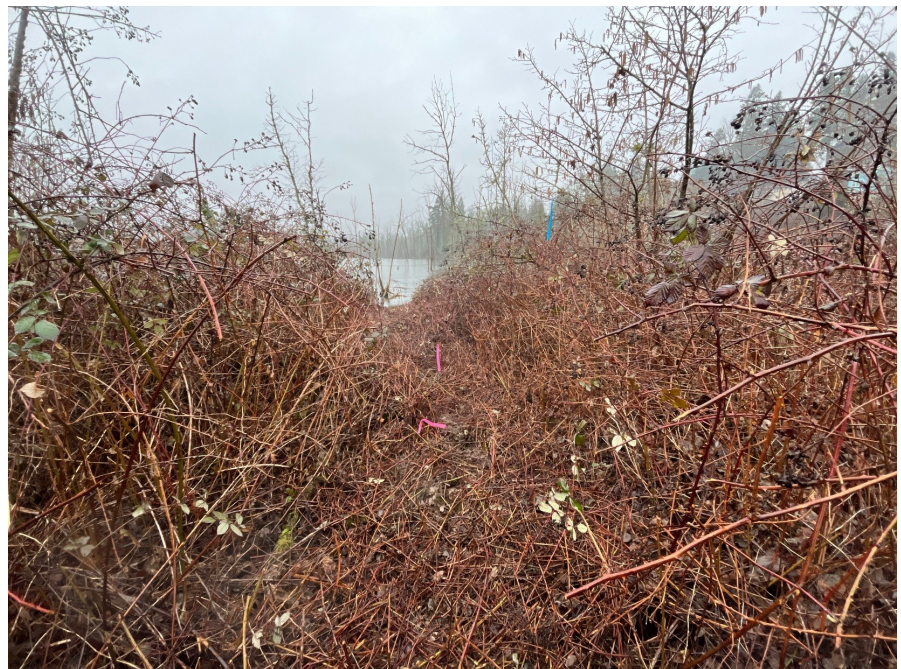
Photo B:

Looking southeast towards Sample Points 3 and 4 along the Wetland A's boundary. The Blue Heron Lagoon is in the background.

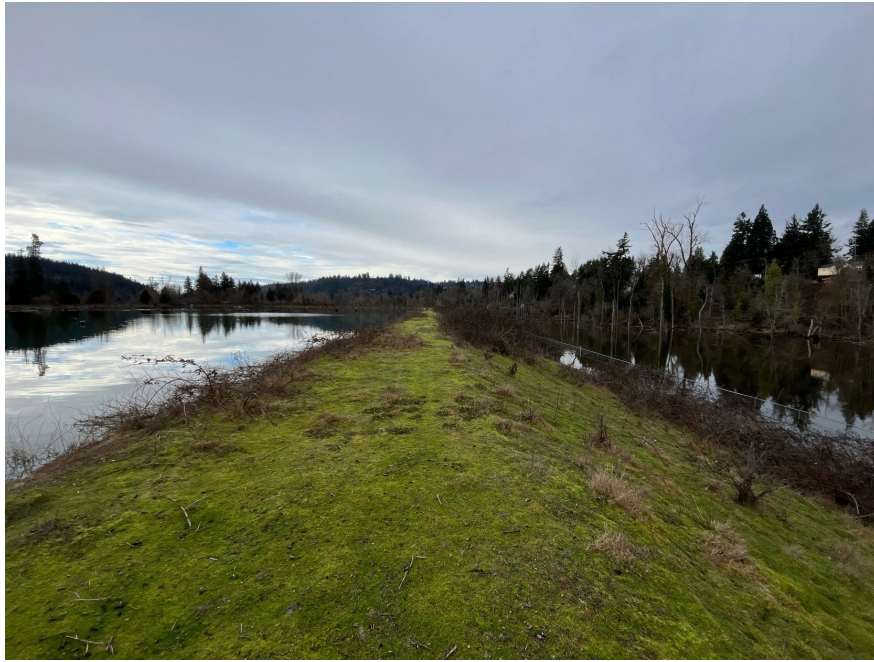
Photo C:

Looking southwest along the northern berm of the onsite settling pond (Blue Heron Lagoon). Wetland A is on right side of photo.

Several snags are present along the periphery of Wetland A, indicating more intense flooding and a fluctuating water table, likely caused through impoundment. Construction of the northern berm and the steep topography of north of the settling pond has created conditions for upslope runoff from 5th Avenue to become impounded. Ponding is further intensified by onsite beaver activity. Current onsite conditions include a beaver dam west and near 4th Street. Peak flooding engulfs the settling pond's west, north and east sides at the bottom of the outer side of the berms.

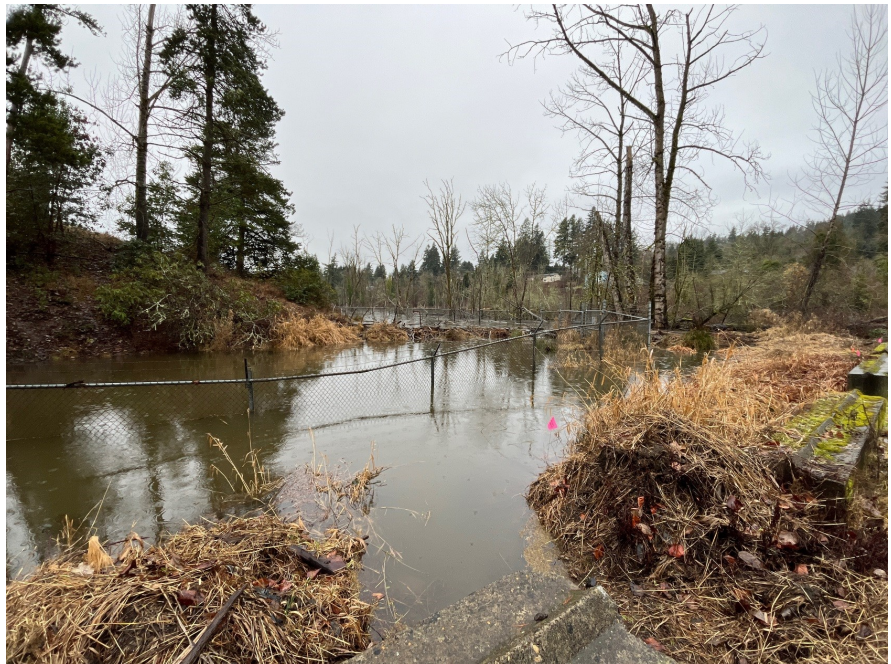
Photo D:

Facing northwest towards the beaver dam west of 4th Street.

No recent alterations or disturbances were observed onsite at the time of the site visit in January 2024, but as stated above, the presence of beaver was observed including a dam west of 4th Street. Water seasonally flows over 4th Street during the wet season, which was observed during the delineation.

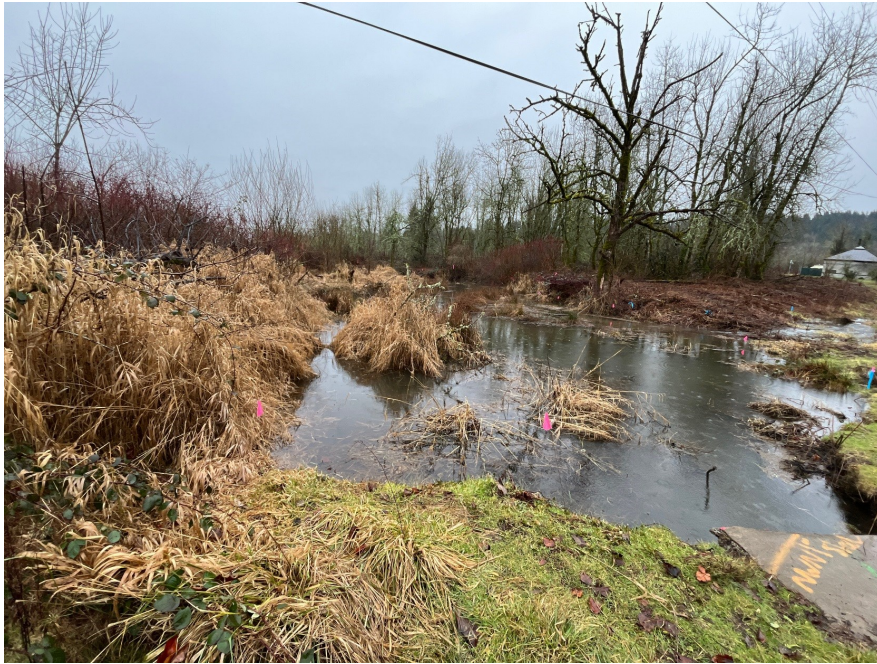
Photo E:

Looking southeast in the downstream direction of Stream 1, east of 4th Street.

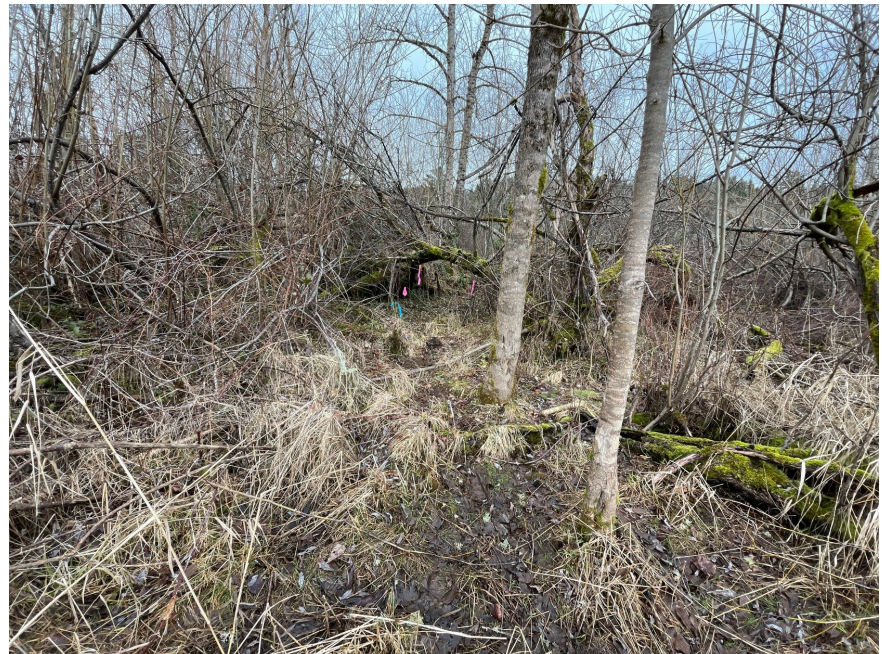
Photo F:

Looking east at Sample Points 19 & 20 on Wetland B's northern boundary.

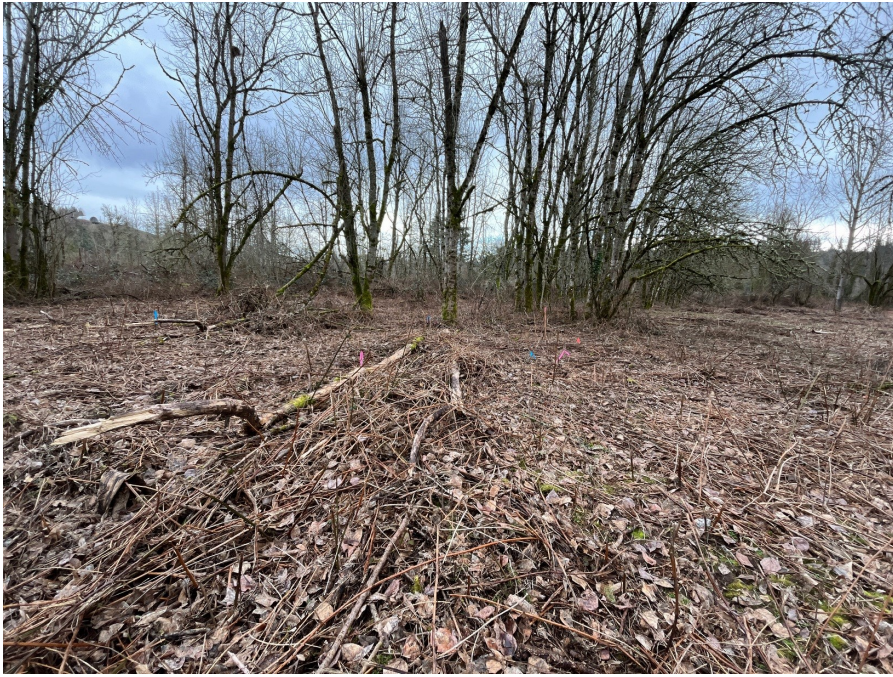
Photo G:

Looking north at Sample Points 21 & 22 at northeast end of Wetland B.

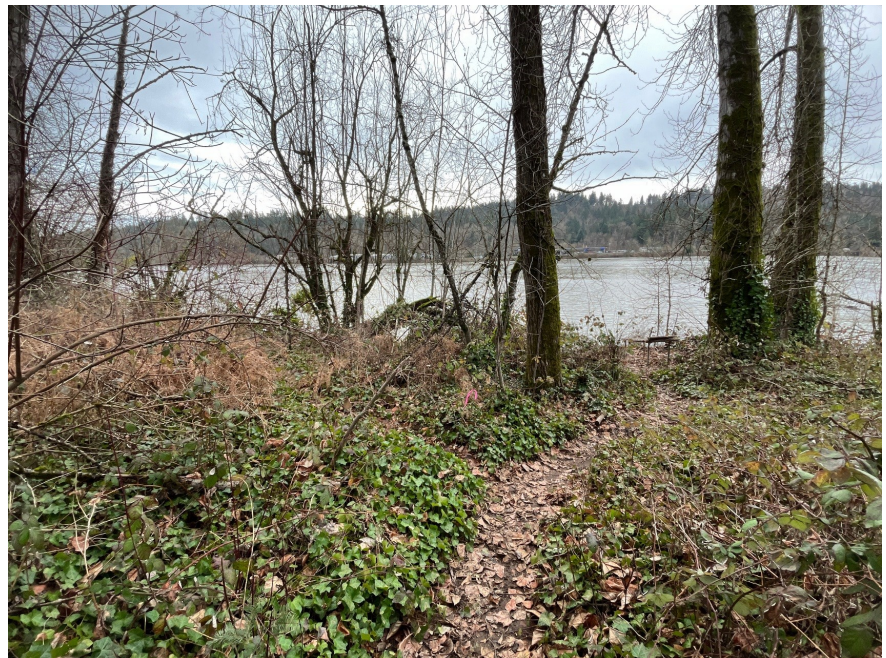
Photo H:

Looking south towards the Willamette River and Sample Point 11.
