Wetland Delineation for Rivianna Beach Development in West Linn, Clackamas County, Oregon

PHS Project Number: 7298

April 10, 2024

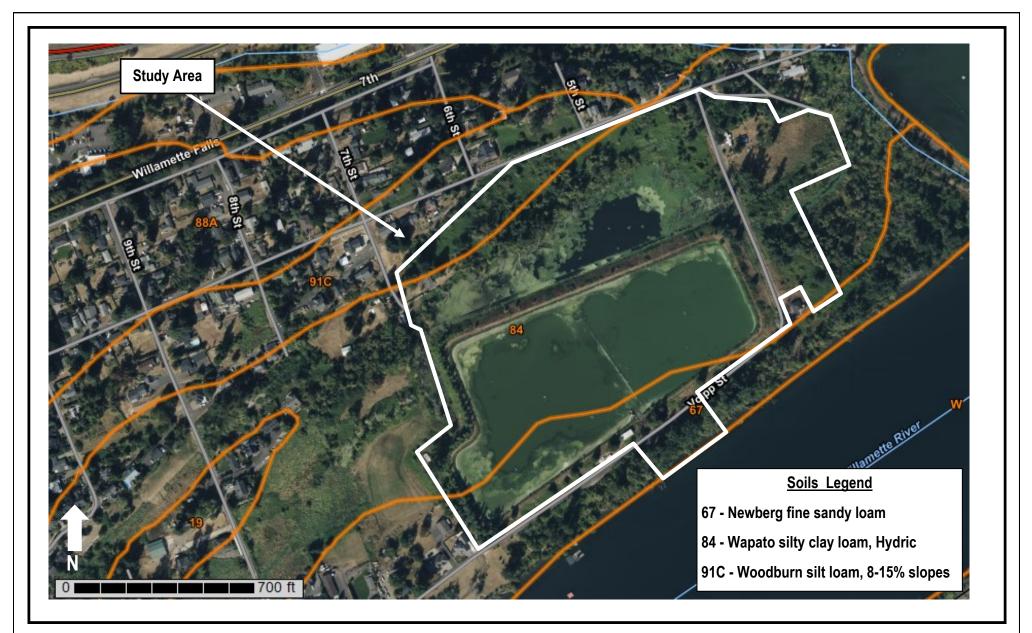
4

Pacific Habitat Services, Inc. 9450 SW Commerce Circle, Suite 180 Wilsonville, OR 97070 Soils Rivianna Beach Development - West Linn, Oregon Natural Resources Conservation Services, Web Soil Survey, 2023 (websoilsurvey.sc.egov.usda.gov) FIGURE

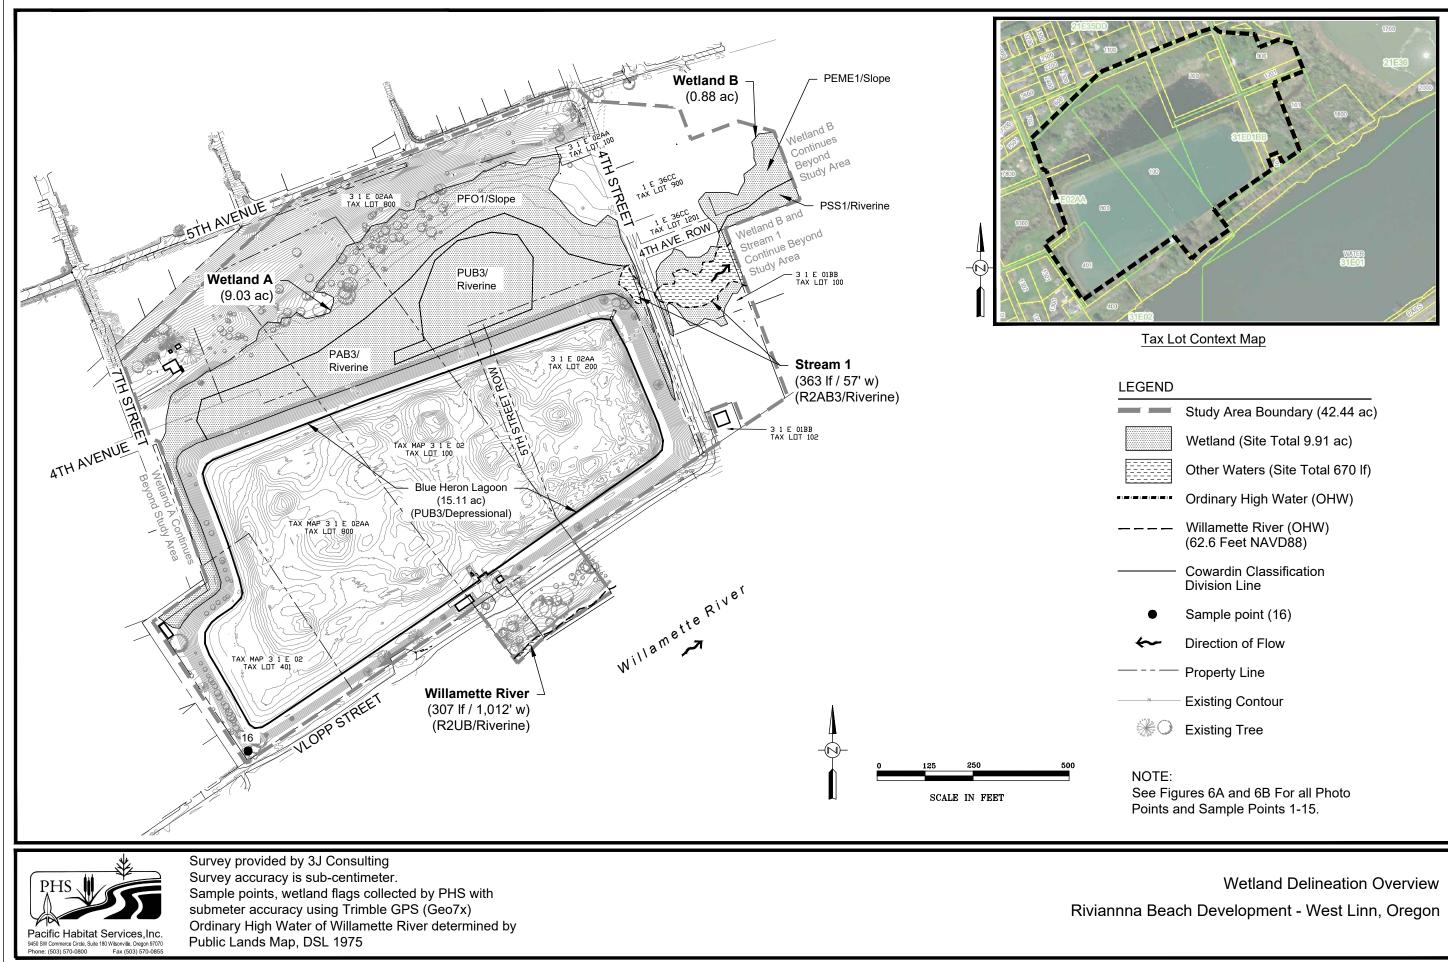
Study Area Boundary (42.44 ac)
	Wetland (Site Total 9.91 ac)
	Other Waters (Site Total 670 lf)
	Ordinary High Water (OHW)
	Willamette River (OHW) (62.6 Feet NAVD88)
	Cowardin Classification Division Line
D	Sample point (16)
-	Direction of Flow
	Property Line
	Existing Contour
	Existing Tree
-	ures 6A and 6B For all Photo nd Sample Points 1-15.

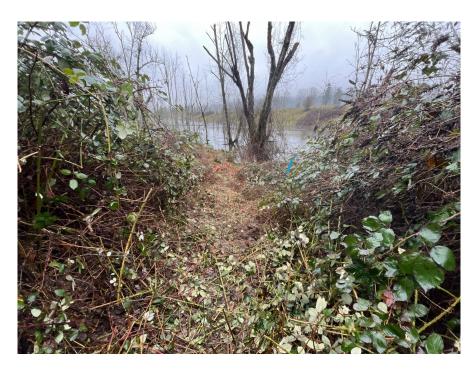
Photo A:

Looking southeast towards Sample Points 14 & 15 along Wetland A's northwest boundary. The Blue Heron Lagoon is in the background.

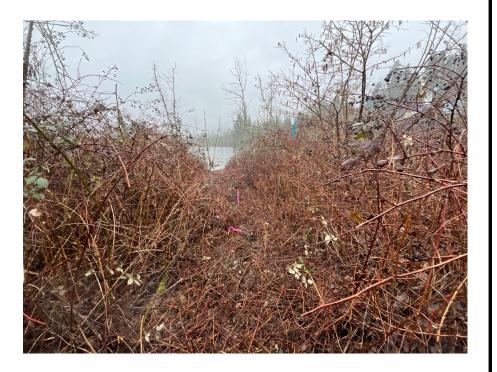
Photo B:

Looking southeast towards Sample Points 3 and 4 along the Wetland A's boundary. The Blue Heron Lagoon is in the background.

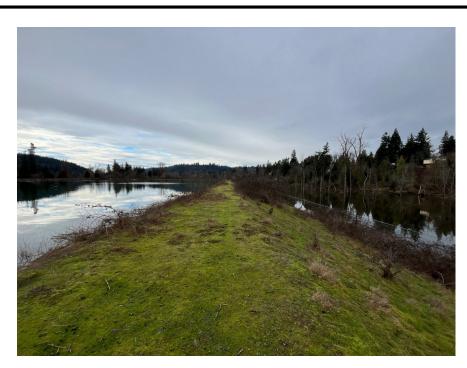
Photo C:

Looking southwest along the northern berm of the onsite settling pond (Blue Heron Lagoon). Wetland A is on right side of photo.

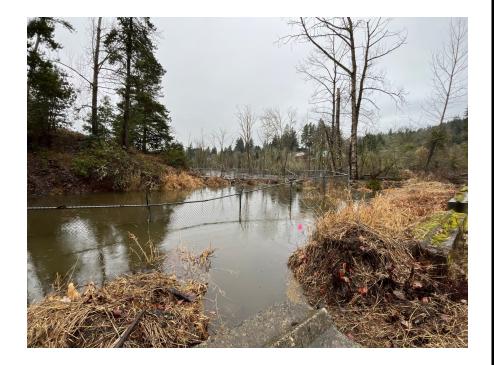
Photo D:

No recent alterations or disturbances were observed onsite at the time of the site visit in January 2024, but as stated above, the presence of beaver was observed including a dam west of 4th Street. Water seasonally flows over 4th Street during the wet season, which was observed during the delineation.

Facing northwest towards the beaver dam west of 4th Street.

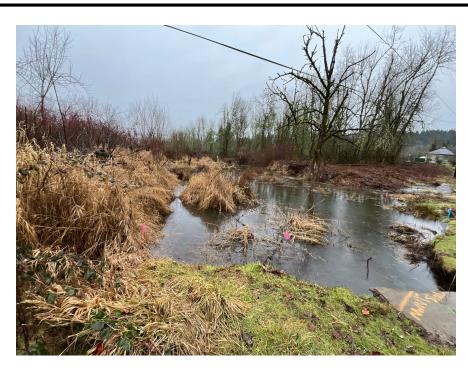
Photo E:

Looking southeast in the downstream direction of Stream 1, east of 4th Street.

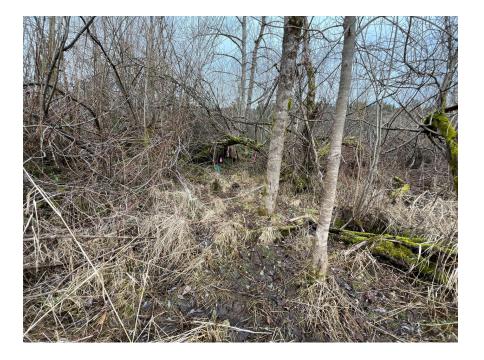
Photo F:

Looking east at Sample Points 19 & 20 on Wetland B's northern boundary.

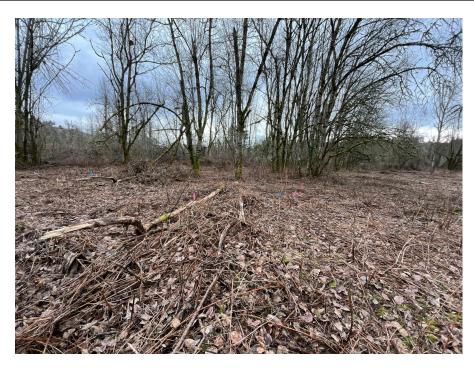
Photo G:

Looking north at Sample Points 21 & 22 at northeast end of Wetland B.

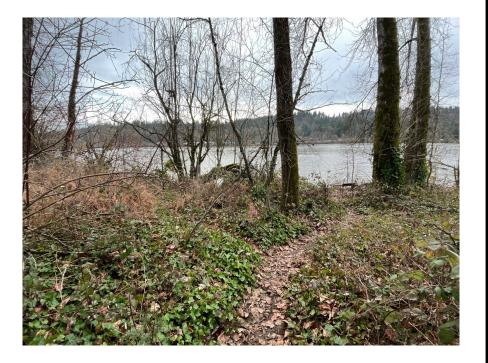
Photo H:

Looking south towards the Willamette River and Sample Point 11.
