# Historic Design Review: Supplemental Information

## Willamette Historic District—General Characteristics

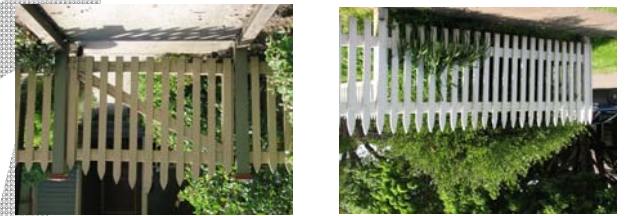
Examples of fences that meet traditional fence requirements.

Many fences will not need any kind of historic review. Traditional picket fences in the front yard that are 36" or less in height are typically exempt. Fences up to 72" in height, located in side or rear yards, and constructed with wood fence boards, rails and posts are typically exempt. Walls that are less than 36", project above the upper grade no more than 12", are also exempt. The Community Development Code has more details. Fences that would not meet the requirements above or in the CDC would need to be reviewed and approved by the Historic Review Board.

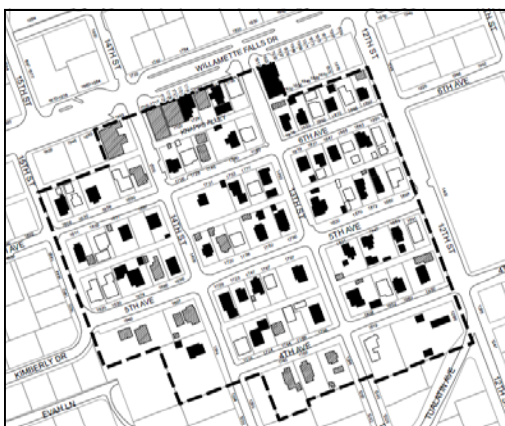
The following describes and illustrates many of the defining characteristics of the City's Willamette Historic District. Changes to properties in the local historic district may require review and approval by City Staff or the Historic Review Board. Most of the local district is also listed on the National Register of Historic Places and this designation provides additional opportunities and incentives. More information is available on the City's website and in the National Register form at <http://westlinnoregon.gov/planning/willamette-historic-district>.

Houses in the Willamette Historic District are generally 1 ½ stories, with a few having a full two stories. They have generally consistent front and side setbacks. There are a mix of architectural styles, but it is dominated by Queen Anne, Craftsman, and bungalow residences. There are a number of infill residences, many of which were constructed using elements of the architectural styles represented in the district.

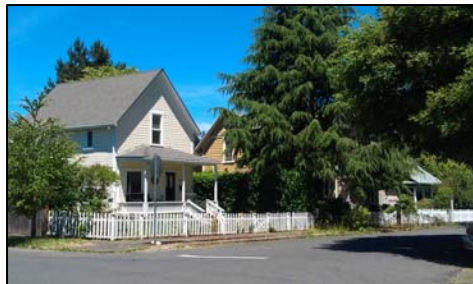
Queen Anne houses (far left) typically have a more steeply pitched roof than Craftsman or bungalow style houses (left).

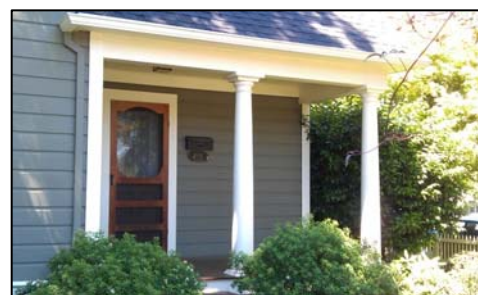
Front porches are common on houses in the district. A few have rounded columns as this example illustrates. Square posts and simple balustrades and railings are also common.

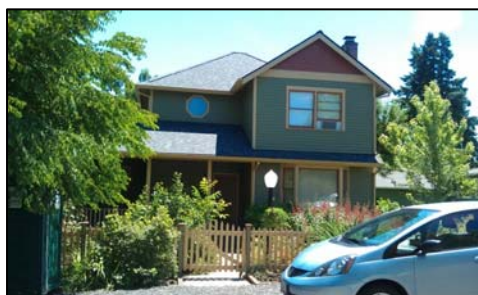
There are a number of infill residences in the district. The size, form, and massing of this residence is compatible with the character of the district and it is also distinct and easily identifiable as newer construction.

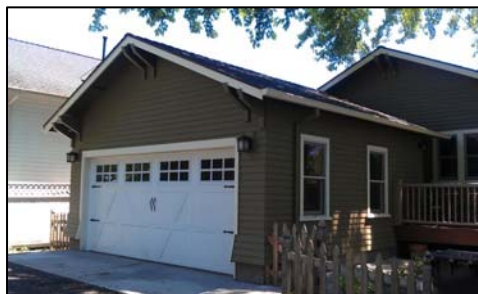
Many homes did not originally have garages. Detached garages with elements of the architectural style of the residence have been constructed in the side and rear yards.

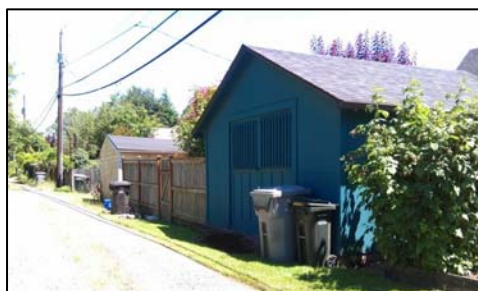
Most of the lots have a rear alley. Most garages are detached and accessed from the alley, although homes without an alley have driveways, and some garages on corner lots are accessed from the side streets. Small outbuildings and taller fences are also common in rear yards.

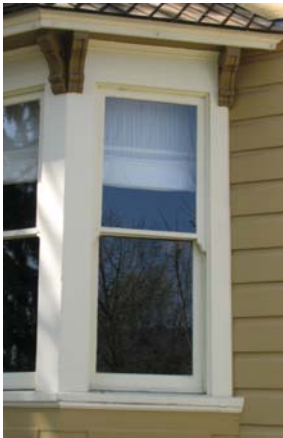
*Left: Many windows on historic houses are double-hung with 1/1 light. They often have small rail extensions on the top sash. Some Queen Anne houses have multi-light windows or windows with art glass. Craftsman and bungalow style residences often have double hung windows with 9/1 lights.*

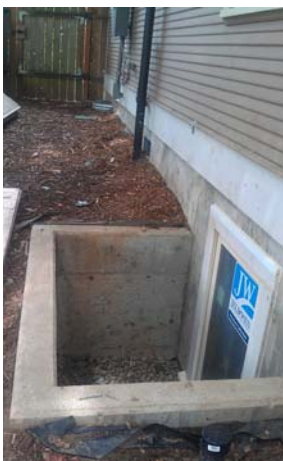
*Below: This window opening was altered to accommodate the replacement window and the window and trim do not match the visual qualities of the original window.*

*Above left: The addition of egress windows are exempt from HRB review if the windows installed are wood windows or another material that is consistent with the original historic appearance.*

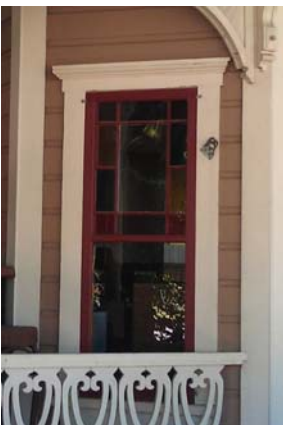
*Left: This multi-light wood sash is a replacement made from an existing sash to match a historic photograph that depicted multi-light sash windows.*

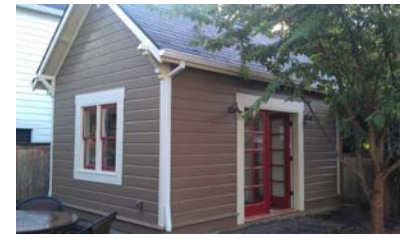
*This accessory structure is an example of a compatible, not in period building. Its massing and height are similar to historic structures in the neighborhood. It has double hung wood windows and brackets in the gable ends, which are both common in the district.*

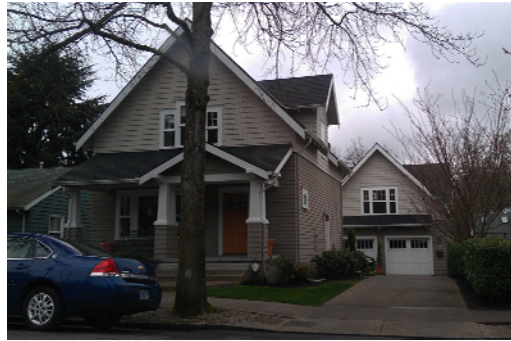
*Above: An example of recently constructed residence in a neighborhood with homes similar in age to those in Willamette. The roof shape, massing, and materials are similar to historic structures. It also has a detached, two-car garage located to the rear that has a second story that may accommodate an accessory dwelling unit.*

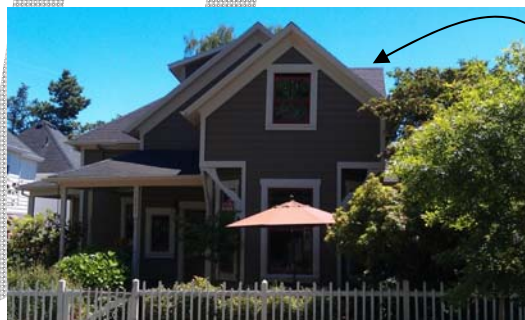
*Compatible dormer addition that is on a side elevation, does not extend above the ridge of the roof, is minimally visible from the right-of-way, and has window opening proportions that are compatible with the existing residence.*

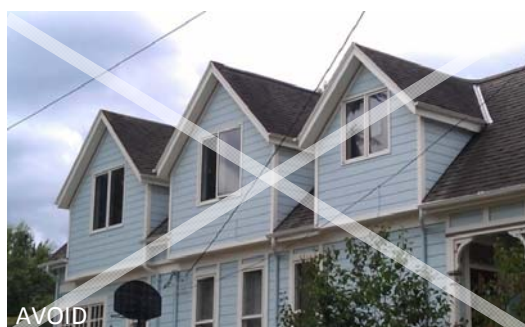
*Incompatible dormer addition that overwhelms the house and is not set back from the edge of the roof. The dormer windows are a different type and light pattern (casement rather than double hung) and proportion than the windows on the original residence.*

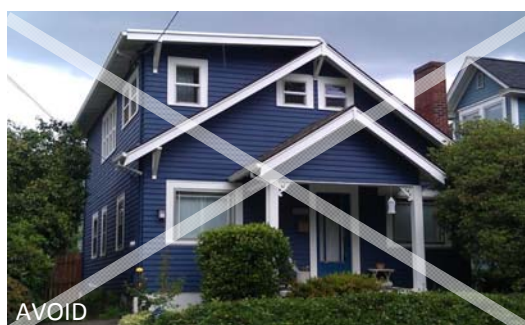
*Incompatible addition that alters the roof pitch, is flush with the side elevation, and overwhelms the original residence.*

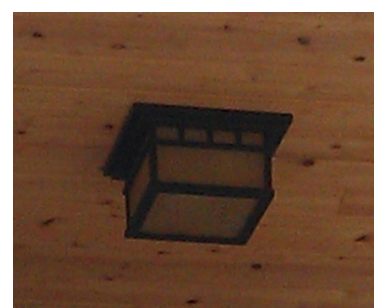
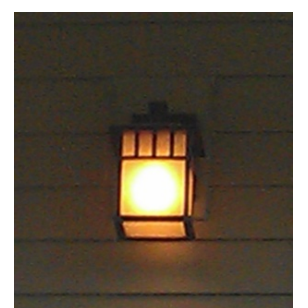
**Lighting.** Lighting on historic resources should generally be simple and small in scale. Examples below.
