**DEVELOPMENT REVIEW APPLICATION**

<b>Site Location/Address:</b>  18000 Upper Midhill Drive	Assessor's Map No.: 21E14CA
	Tax Lot(s): 200
	Total Land Area:

The Applicant is proposing a 34 lot single family subdivision consistent with the standards of the R-4.5 zone.

This memorandum summarizes the results of a transportation impact analysis prepared for the proposed Upper Midhill Estates residential development located at the northern terminus of Upper Midhill Road in West Linn, Oregon. Figure 1 illustrates the site vicinity map. The proposed development plan includes 34 single-family residential homes located along an extension of Upper Midhill Drive that connects to Hillside Drive to the west. Figure 2 illustrates the conceptual site plan. Construction of the proposed development is expected to occur in 2015 with full build-out and occupancy in 2016.

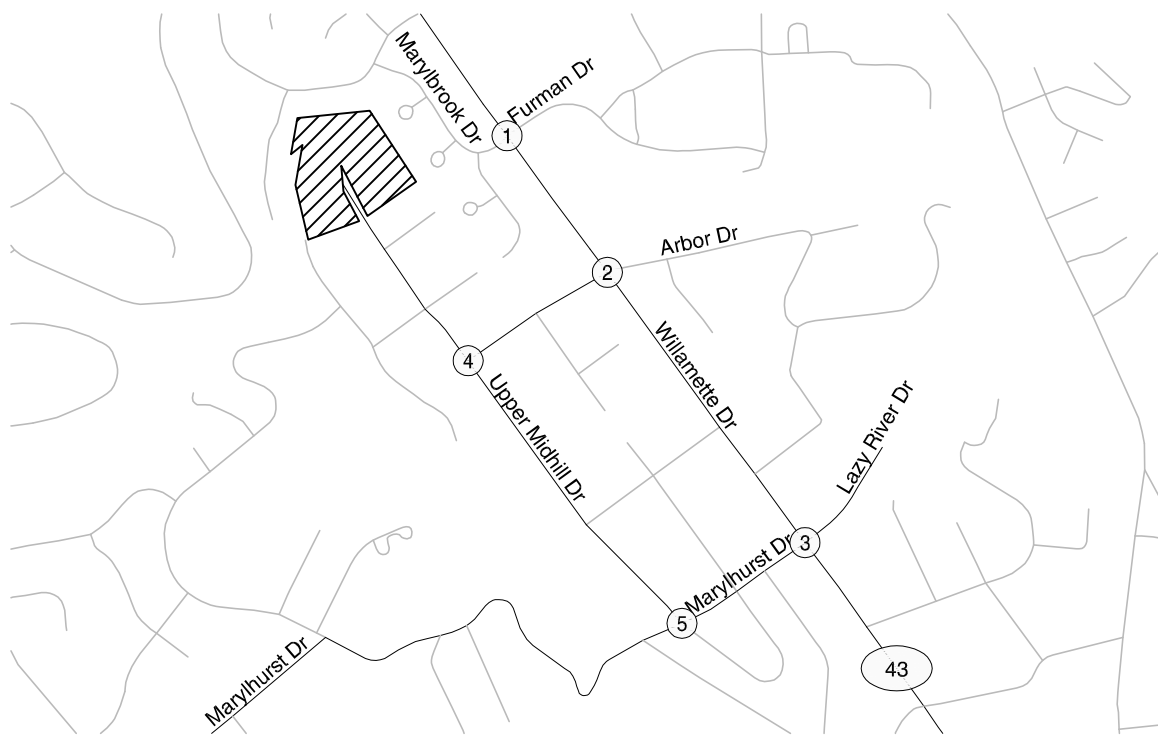
Figure 3

Existing Lane Configurations & Traffic Control Devices  
West Linn, OR

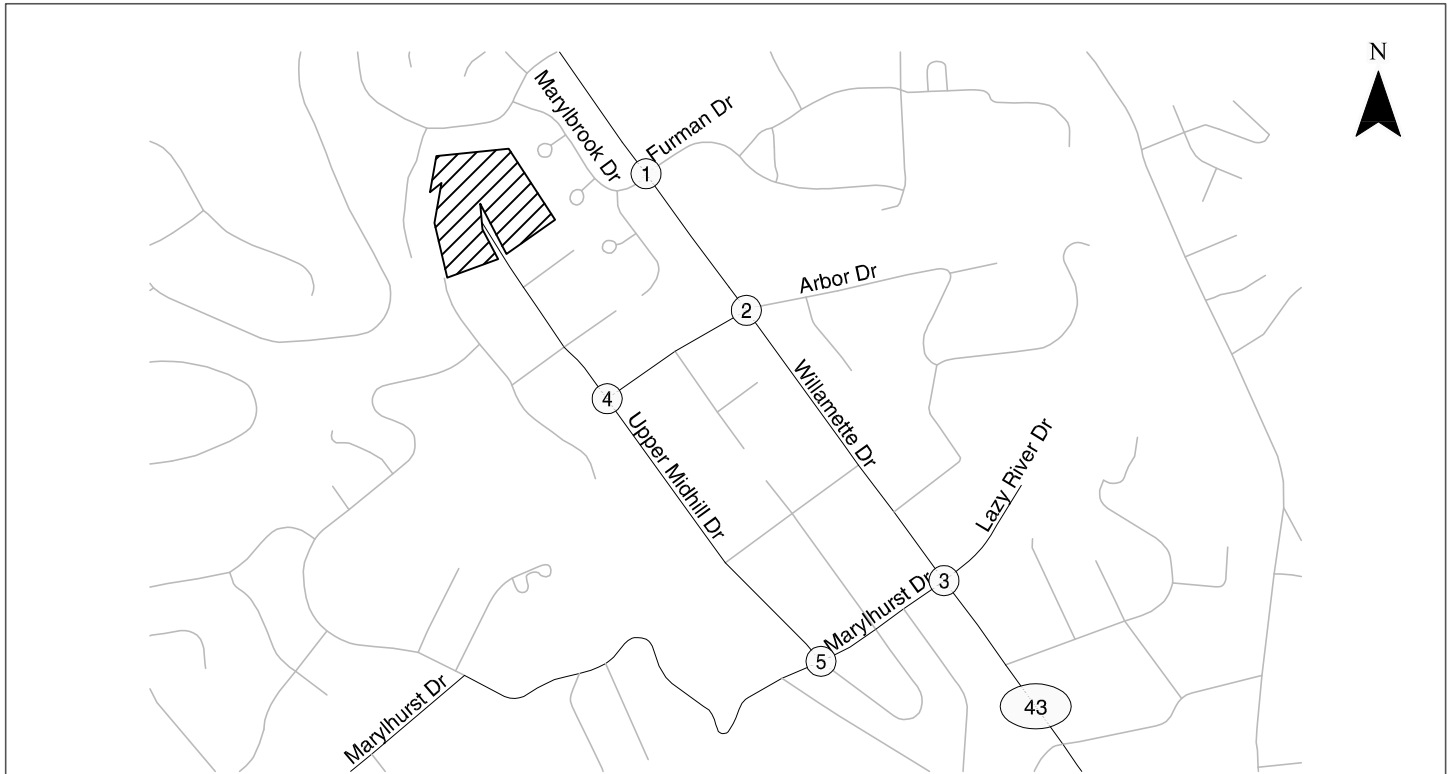
Existing Traffic Conditions  
 Weekday AM & PM Peak Hour  
 West Linn, OR

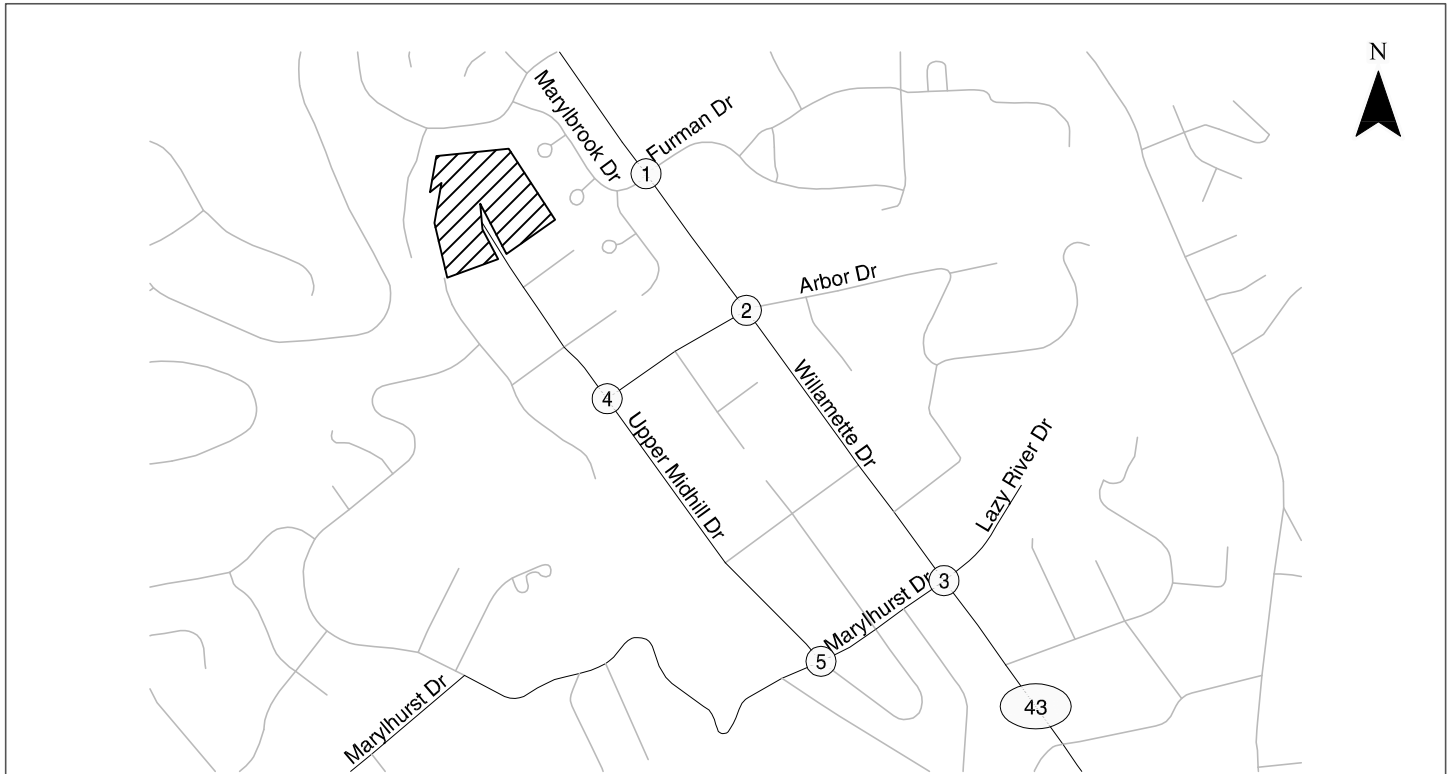
The eastbound approach to the Willamette Drive/Arbor Drive intersection is expected to continue to operate at LOS F and above capacity during the weekday p.m. peak hour. Potential mitigation measures are identified later in this report.

Year 2016 Background Traffic Conditions  
 Weekday AM & PM Peak Hour  
 West Linn, OR

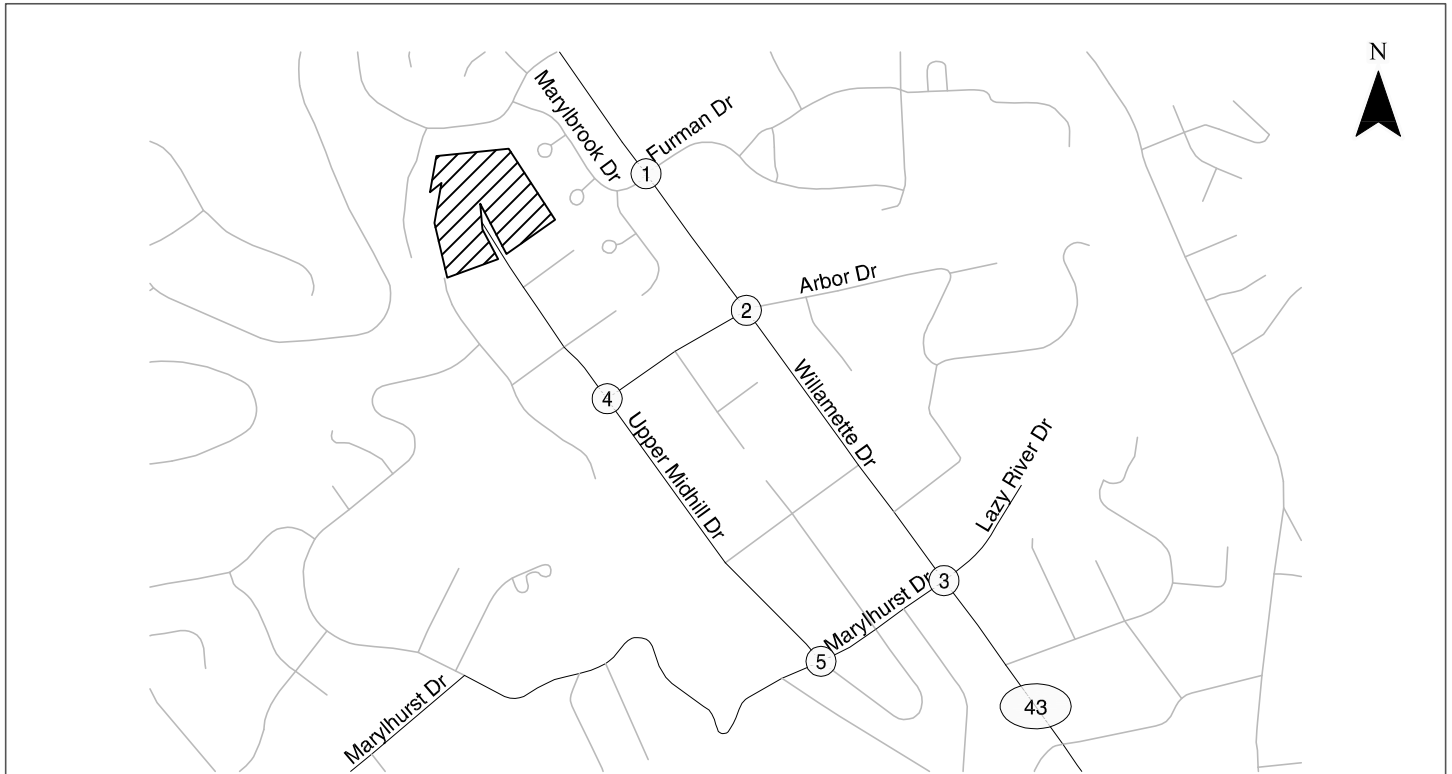
Year 2016 Total Traffic Conditions  
 Weekday AM & PM Peak Hour  
 West Linn, OR

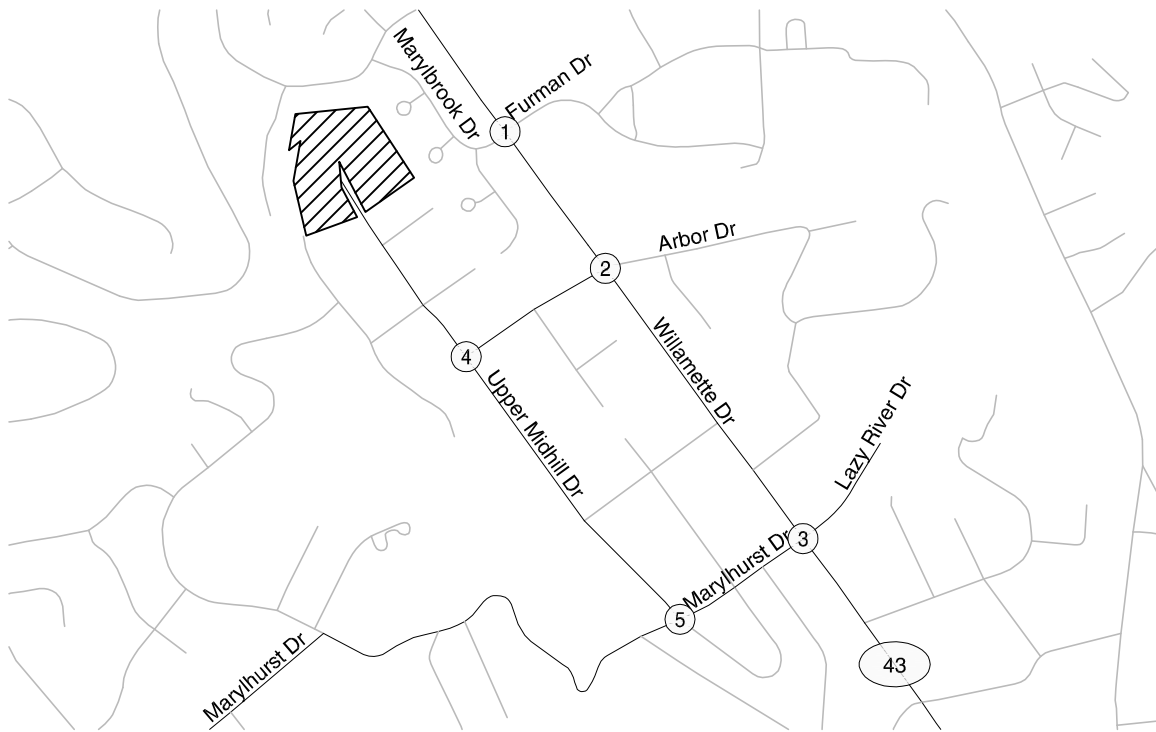
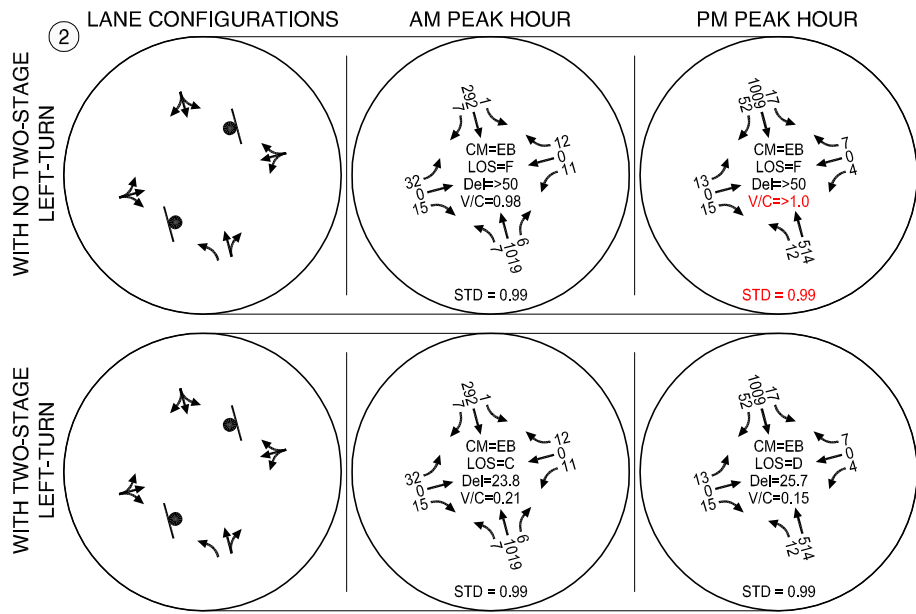
Figure 8 summarizes the results of the traffic operations analysis at the study intersection under year 2016 total traffic conditions with the proposed mitigation (with and without the two-stage left-turn capability). *Appendix "G" includes the worksheets used to evaluate year 2016 total traffic conditions at the Willamette Drive/Arbor Drive intersection with the proposed mitigation.*

Year 2016 Total Traffic Conditions - Mitigated  
 Weekday AM & PM Peak Hour  
 West Linn, OR

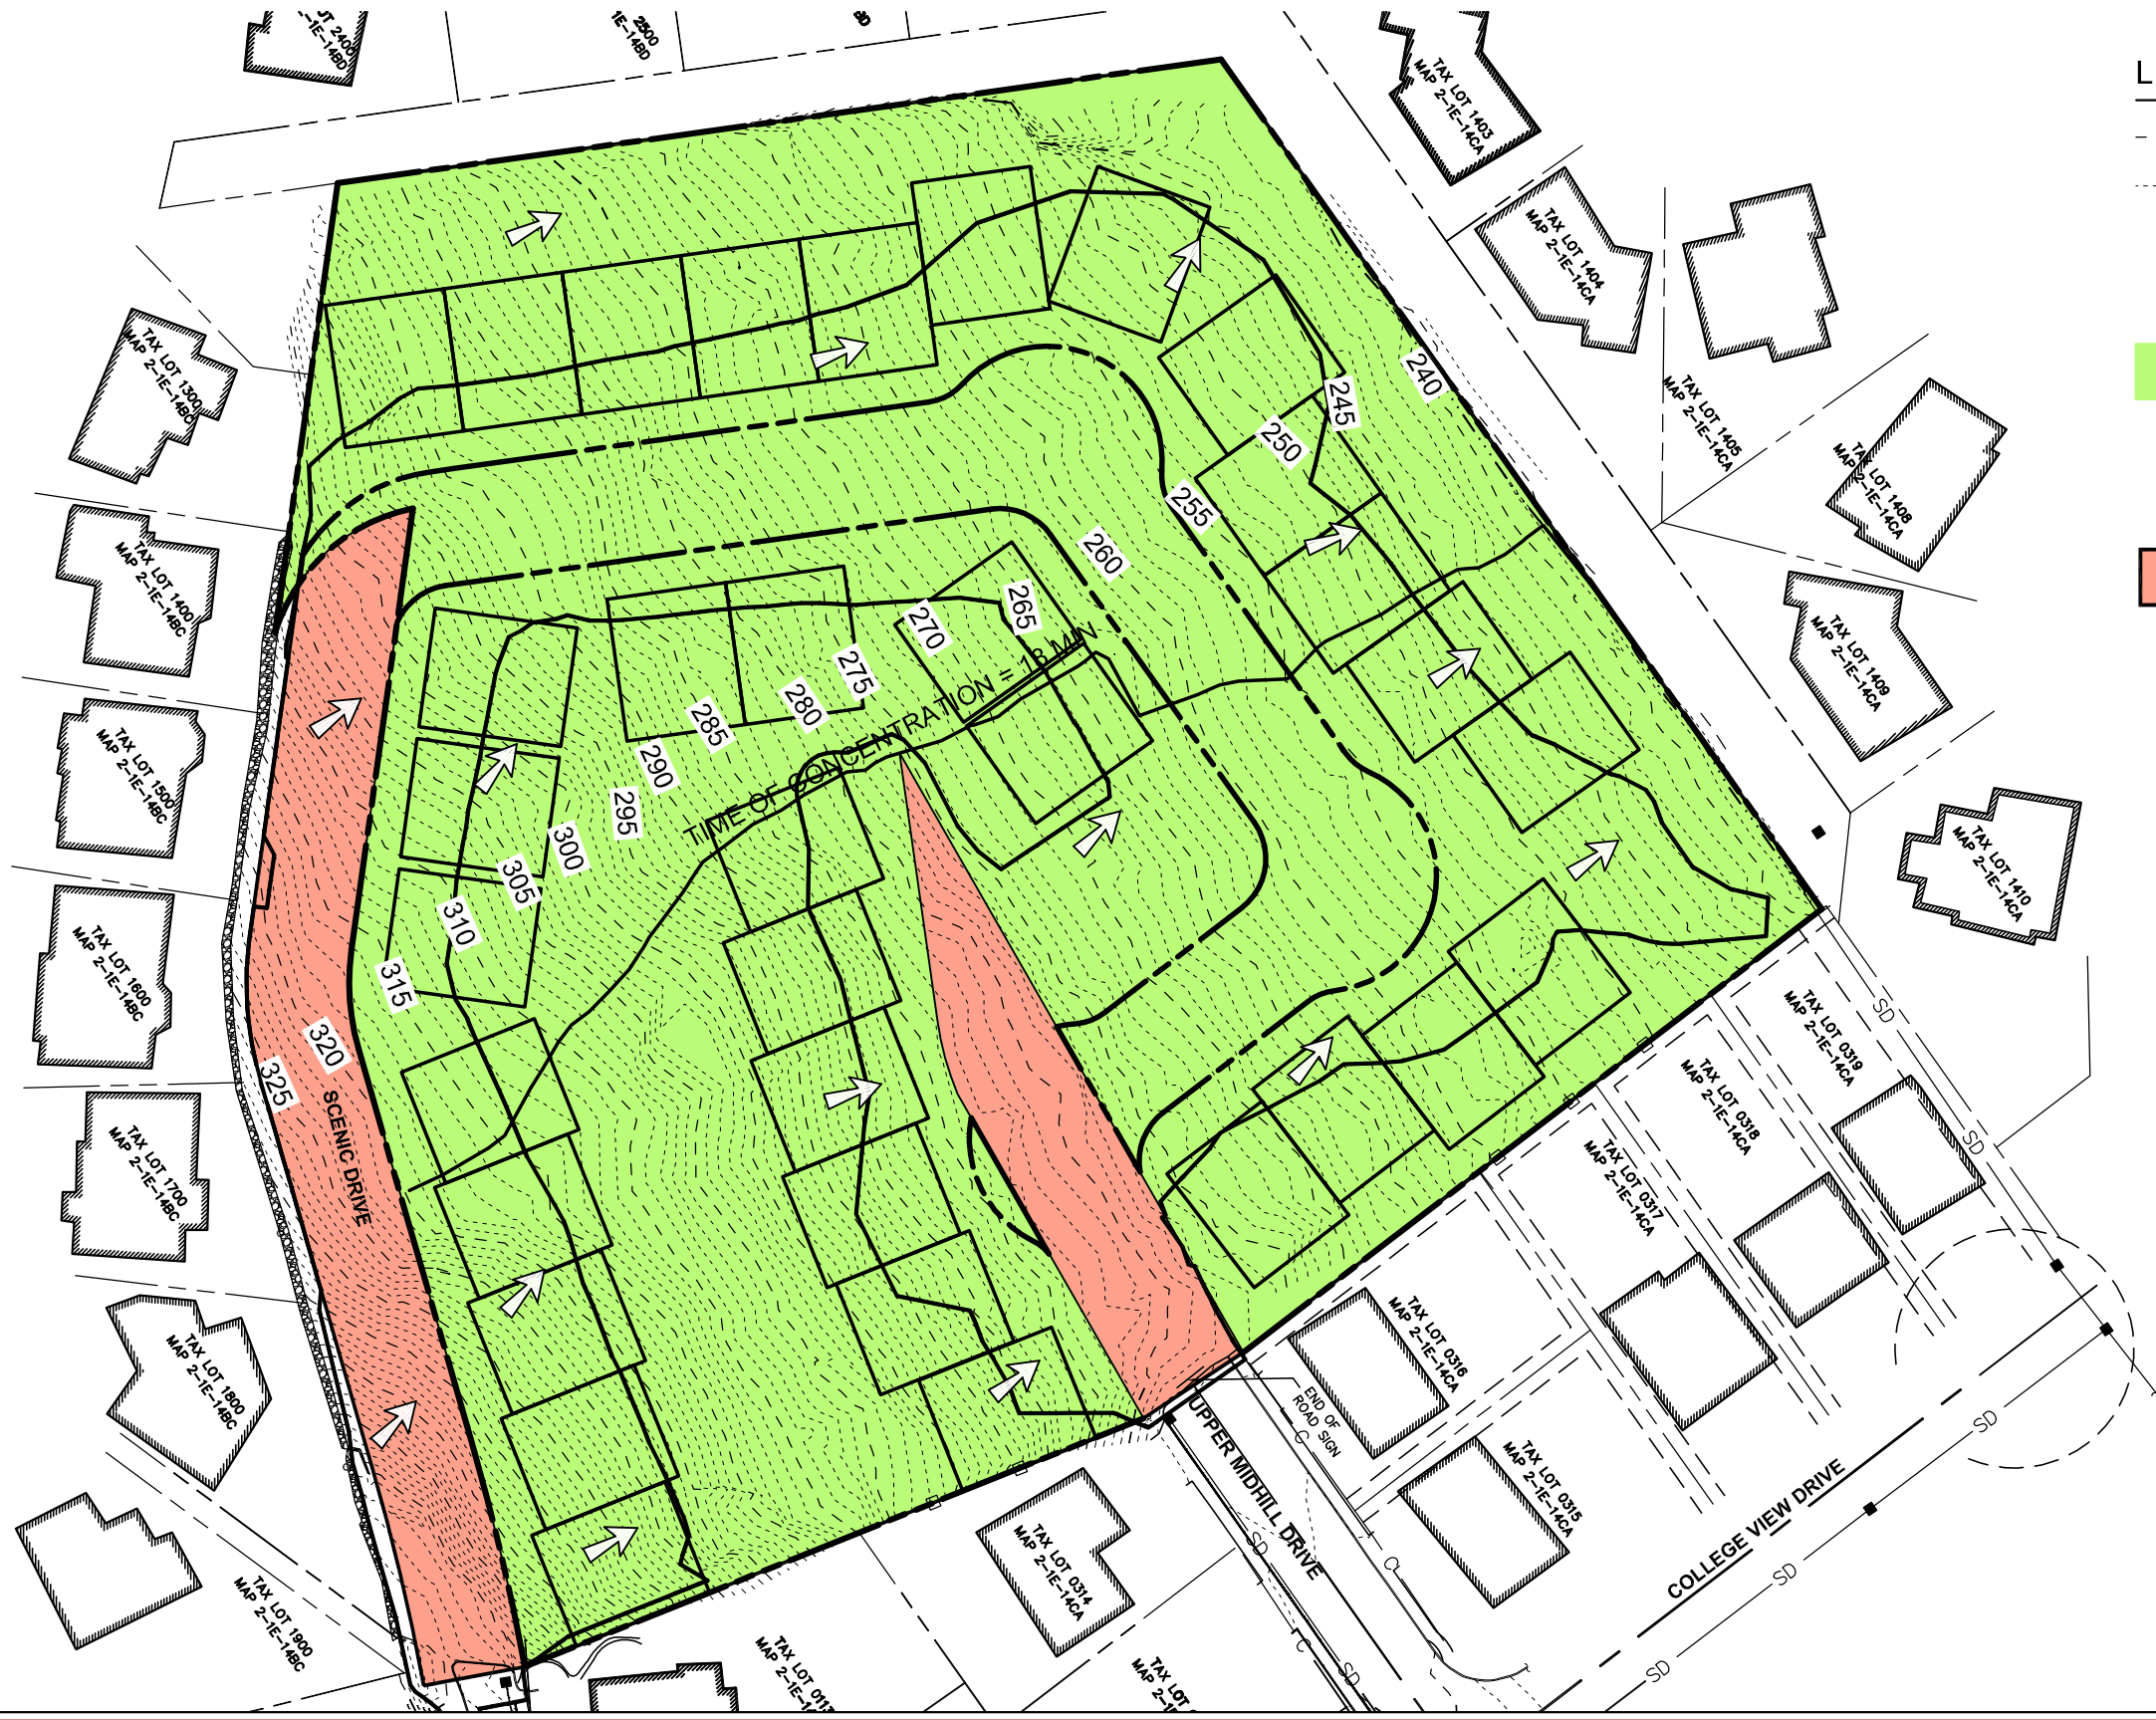
EXISTING OFFSITE AREA = 0.74 AC  
 IMPERVIOUS AREA = 0.00 AC  
 PERVIOUS AREA = 0.74 AC  
 PERVIOUS CURVE NUMBER = 77  
 TIME OF CONCENTRATION = 18 MIN

# EXISTING SITE CONDITIONS CHÊNE BLANC ESTATES

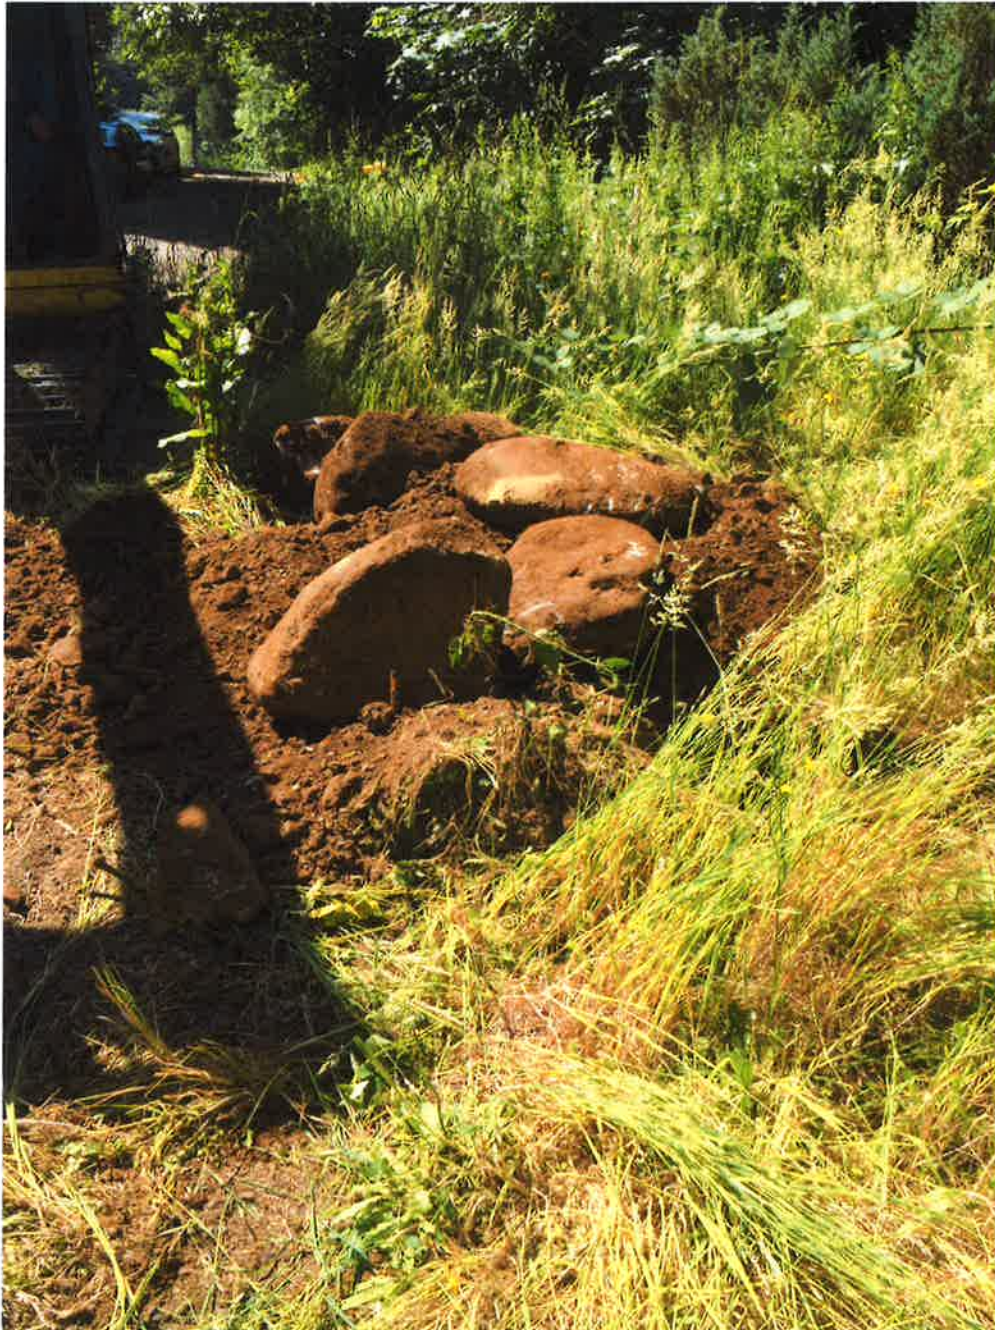
**Fill Material Consisting of Boulders in Test Pit TP-4**

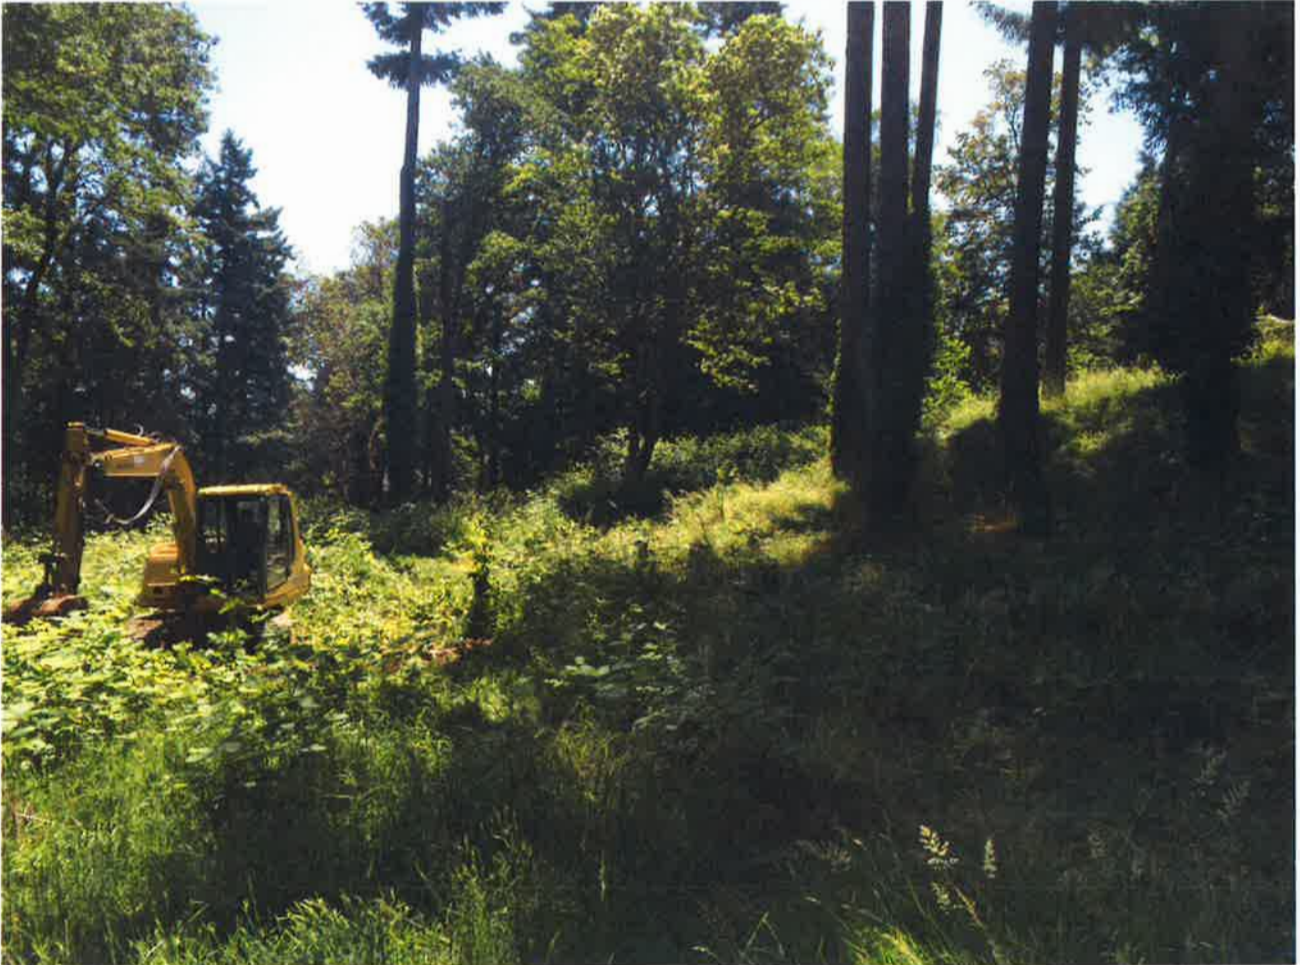
**Subcontractor Excavating Test Pit TP-5, View to the South**
