**STAFF REPORT
PLANNING MANAGER DECISION**

FILE NO.: WAP-16-02

REQUEST: Establish the Water Resource Area (WRA) boundary at 1822 Carriage Way using the "Alternate Review Process". (CDC 32.070-080)

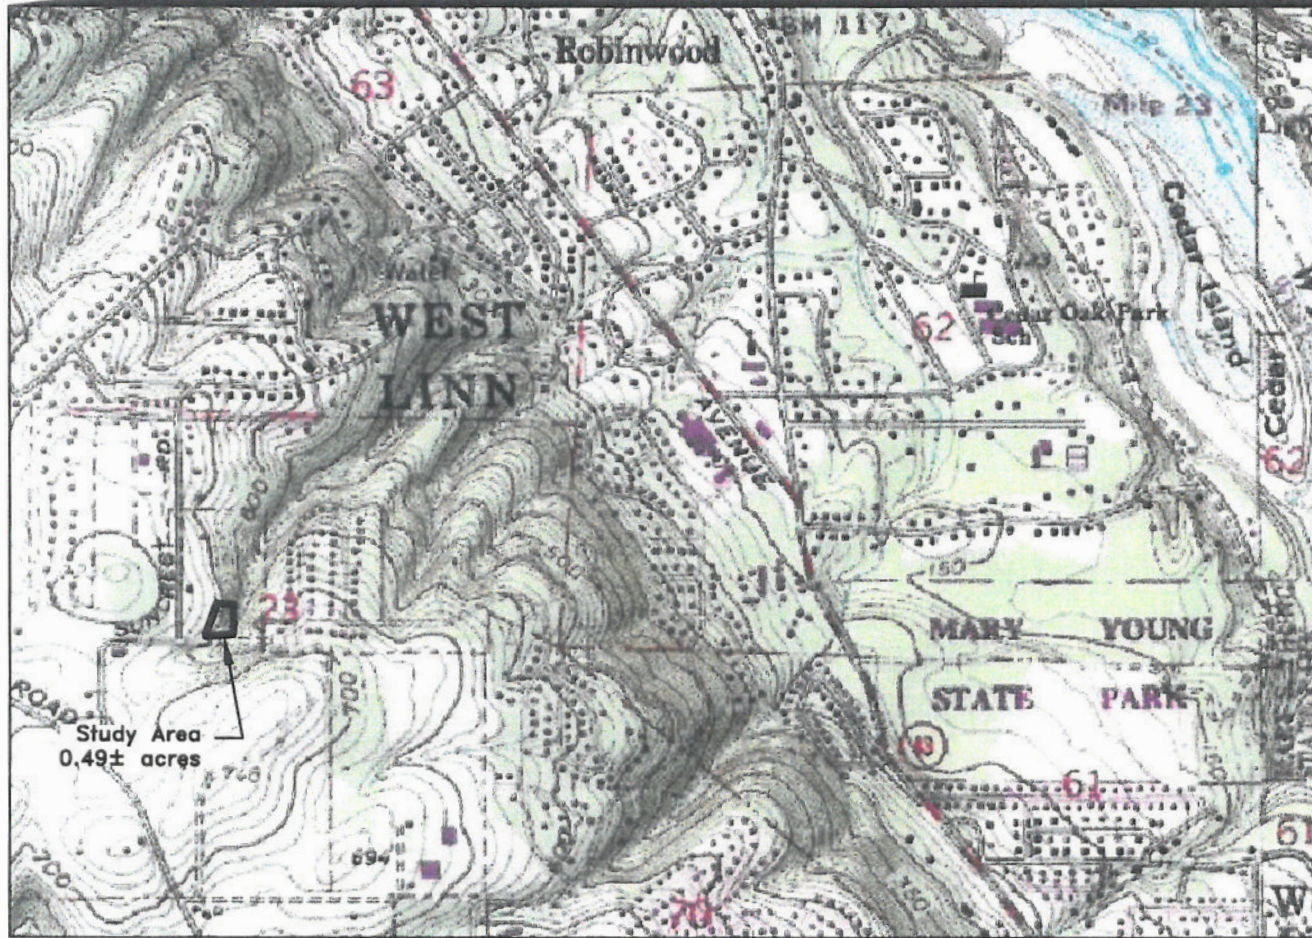
NOTE: The 0.49± acre study area is located at 1822 Carriage Way. The centroid of the study area is approximated at 45.382643° North and -122.655586° West.

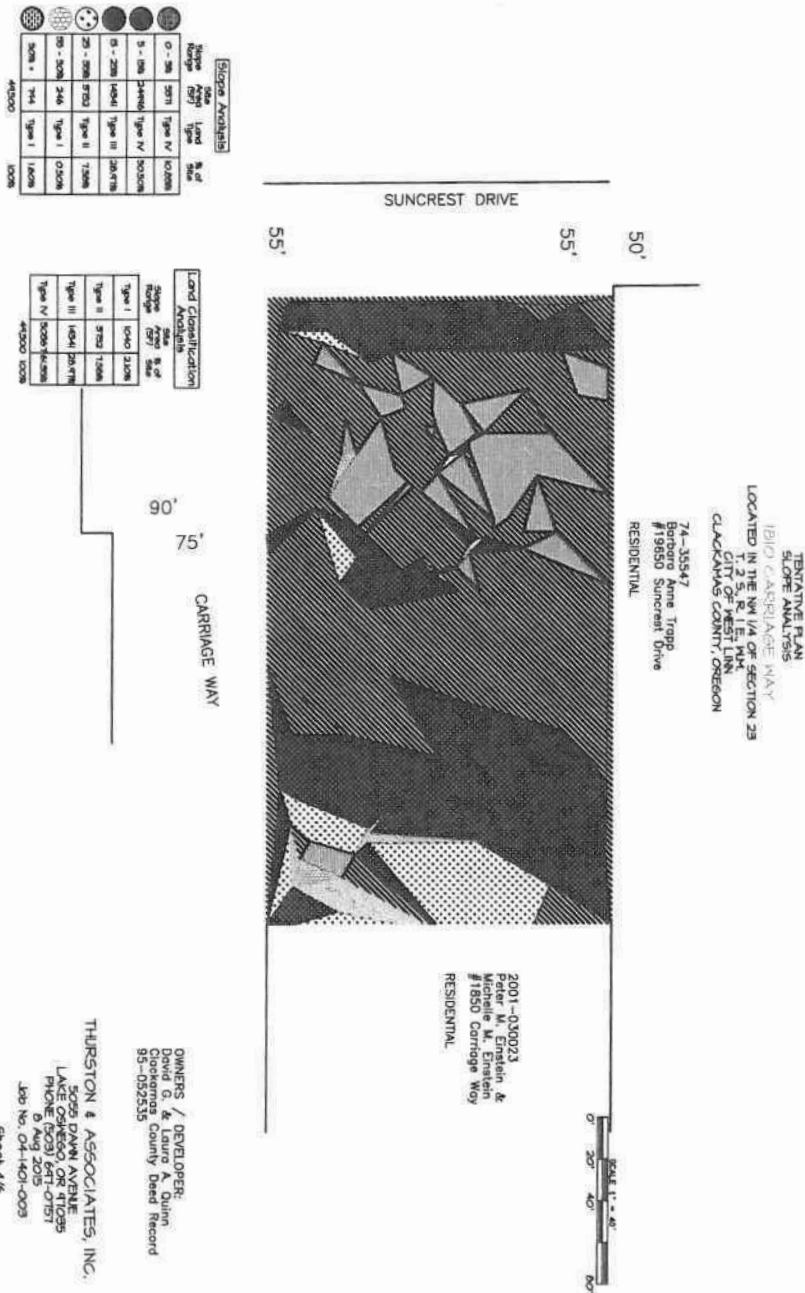
Attachment C. Slope Analysis Map

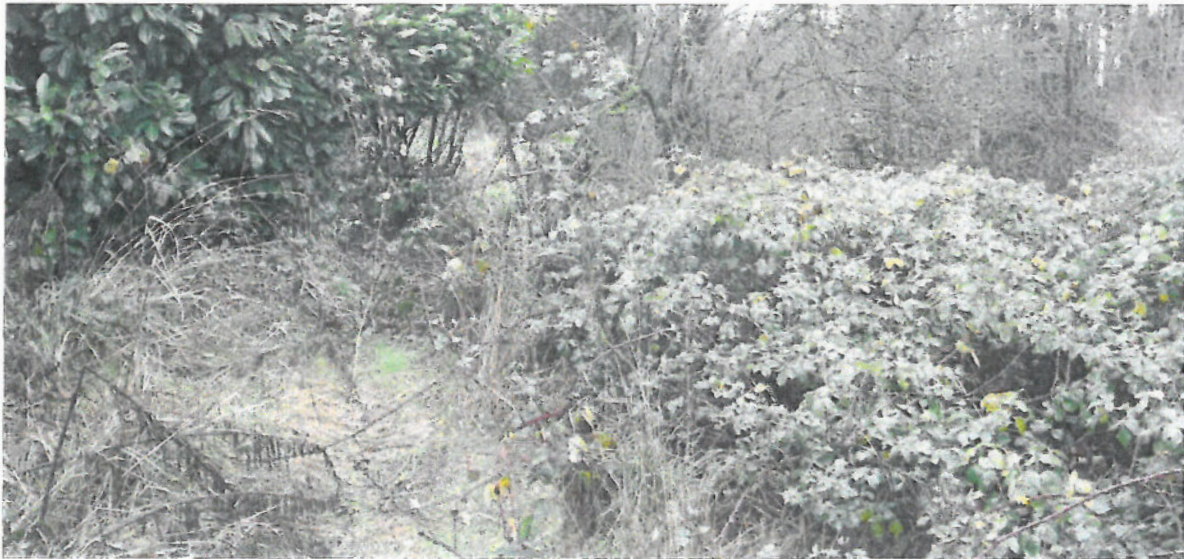
Photo Point A (above): View to northeast at vicinity of SP-1. The plot was situated mostly in Himalayan blackberry thicket, since the slope gets steeper to the right. The thicket has several willows growing up through the blackberry vines. The English laurel hedge is planted on the north property line. The grassy foreground in the left part of photo appears infrequently mowed or trimmed.

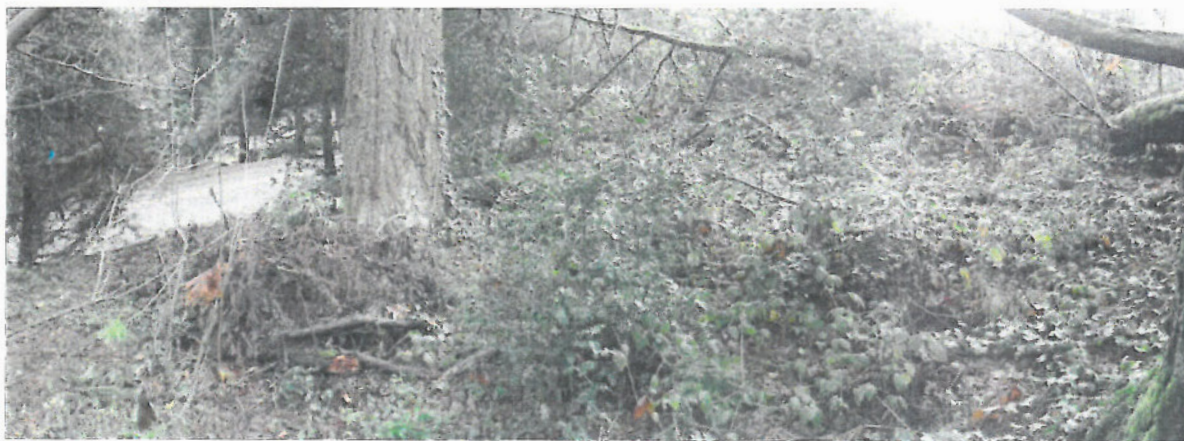
Photo Point B (above): View to southwest at vicinity of SP-2. This plot includes two large-diameter Douglas-fir trees, plus a multi-stem bigleaf maple tree. The understory is dominated by mostly non-natives, such as English ivy, holly and Himalayan blackberry. The trees are likely second- or third-growth, while the understory reflects a long history of disturbance (albeit little or not disturbance in several decades). There is an old road at the far left edge of photo that occurs on the west edge of the riparian boundary.

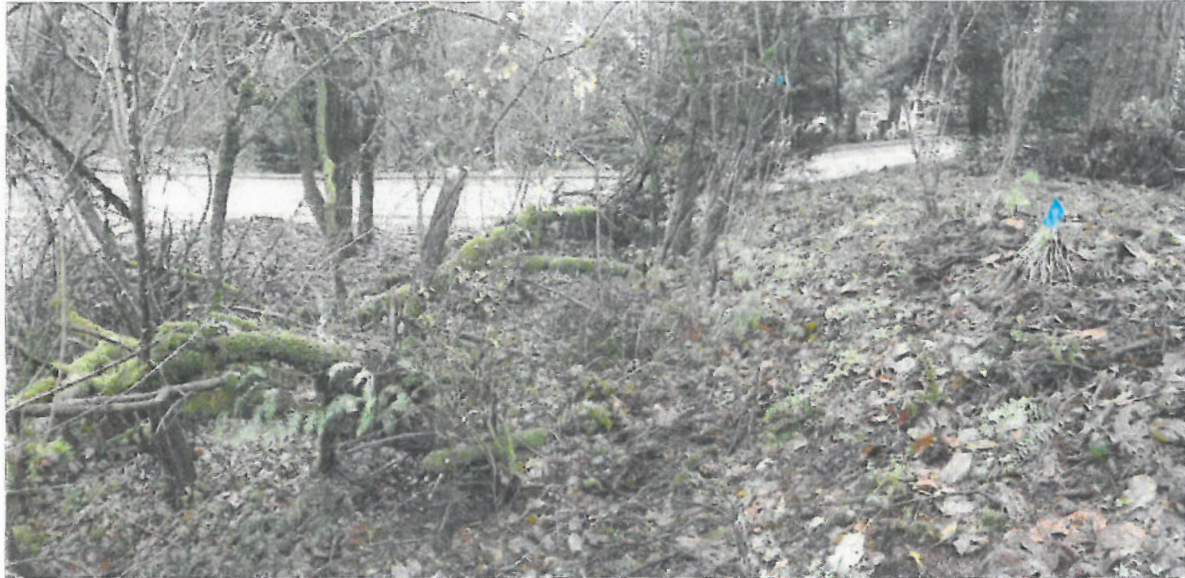
Photo Point C (above): View to south by southeast at vicinity of SP-3 (left side of photo). Blue flag near right edge of photo is riparian boundary. Area to right of blue flag is old road (possibly from past logging or clearing operations).

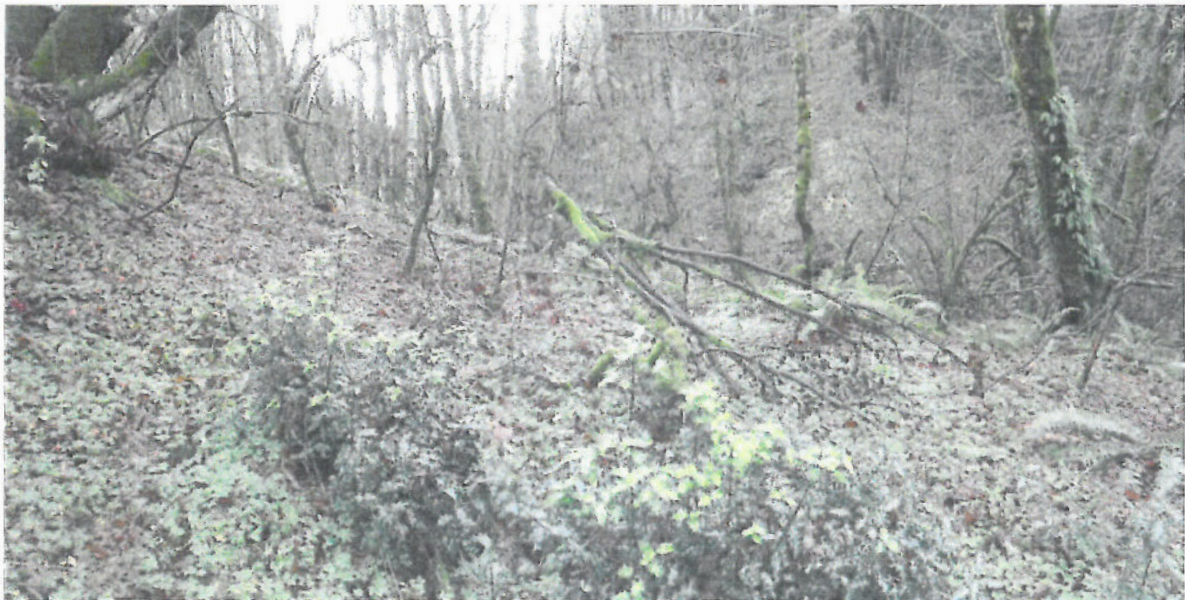
Photo Point D (above): View north at vicinity of SP-4. This location is offsite (northeast of subject lot) and it is relatively undisturbed. This vicinity is considered upland forest, rather than riparian forest, since it is dominated by bigleaf maple trees. Riparian area is the right part of photo (where red alder trees and willows become dominant).

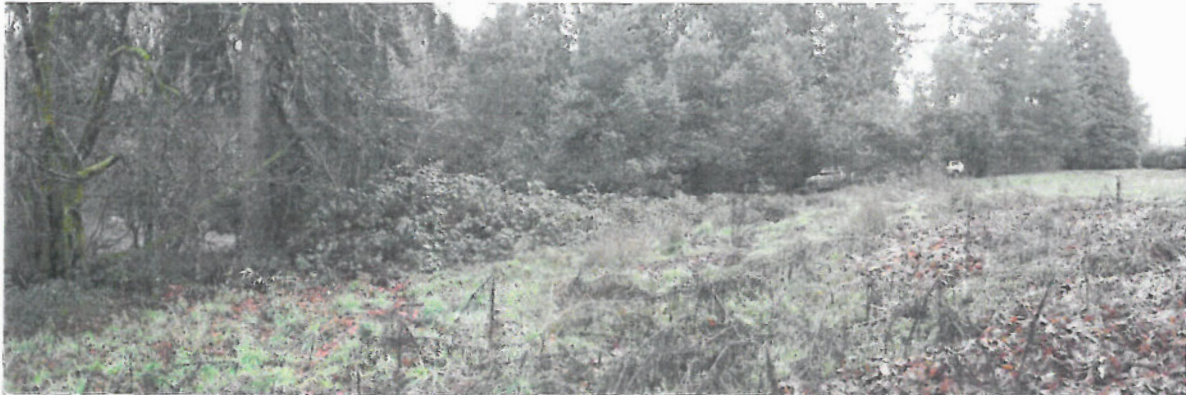
Photo Point E (above): View to southwest upslope from SP-2. The western edge of Tax lot 6801 generally lacks trees (except along Carriage Way). This part of the site has the flattest slopes, typically 5 to 15 percent. The grassy areas appear infrequently mowed or trimmed. There are also small piles of yard debris from the neighboring property to the west. The upland forest plant community begins near the left edge of photo where the Douglas-fir are growing.

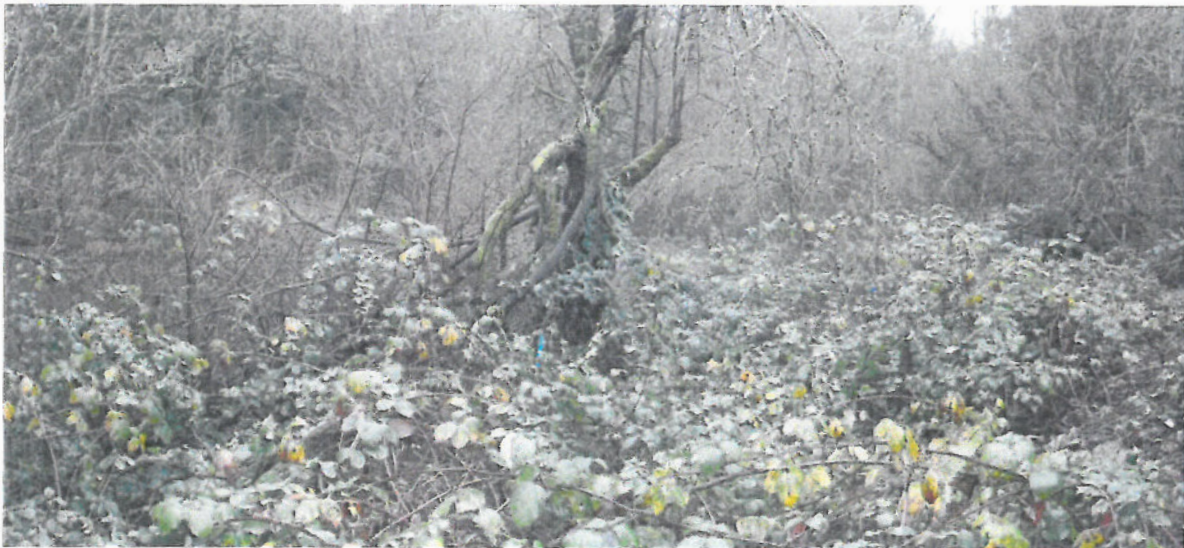
Photo Point F (above): View south at interface of riparian area and disturbed upland. Himalayan blackberries are the dominant species in the disturbed upland plant community. The riparian boundary was flagged just on the right side of the willow in the center of the photo. In general, the riparian area is defined by 1) steeper slopes; 2) native trees/shrubs that are rated FAC and FACW; 3) native understory vegetation; and 4) land that is contiguous with downslope Water Resource Area (beyond left edge of photo).
