**DEVELOPMENT REVIEW APPLICATION**

<b>Site Location/Address:</b>  18000 Upper Midhill Drive	Assessor's Map No.: 21E14CA
	Tax Lot(s): 200
	Total Land Area:

## **Preliminary Geotechnical Engineering Report & Landslide Hazard Study**

EXISTING CONDITIONS PLAN  
**CHÉNE BLANC ESTATES**  
**LAND USE DOCUMENTS**  
1800 UPPER MIDHILL DRIVE, LLC  
WEST LINN, OR

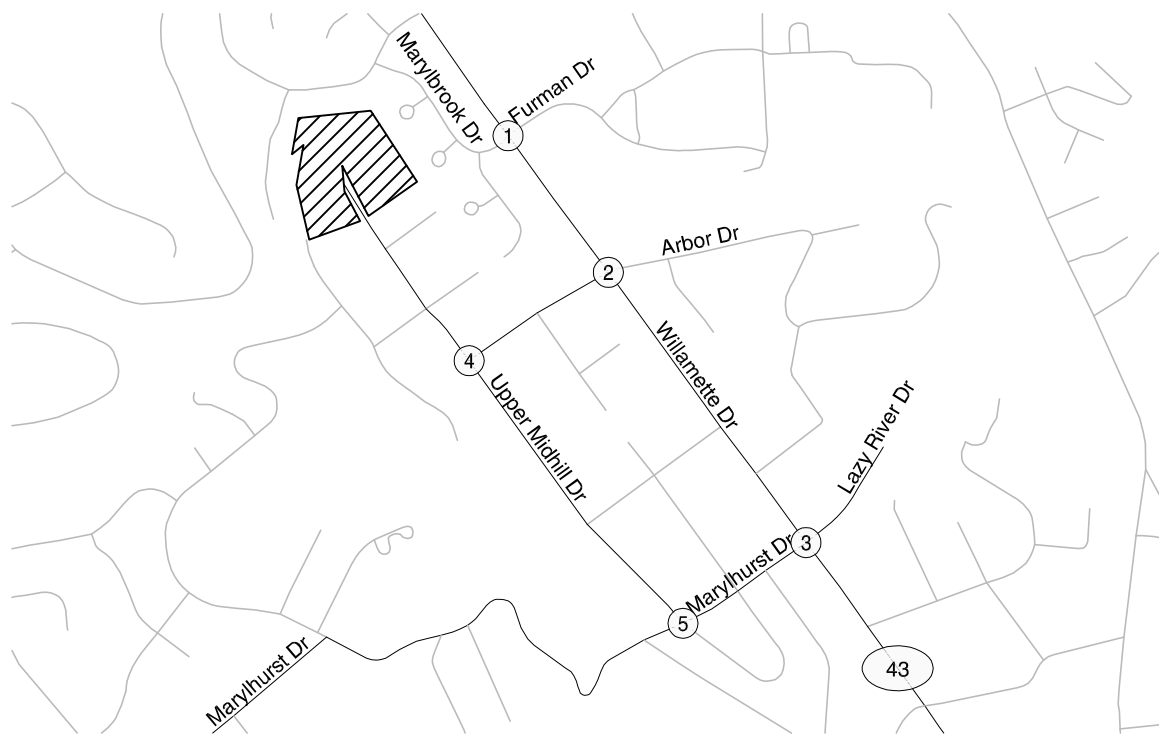
The traffic volumes shown in Figure 5 were used to conduct an operations analysis at the study intersections under year 2018 background traffic conditions. As shown, all of the study intersections are expected to operate acceptably during the weekday a.m. and p.m. peak hours with the exception of the Willamette Drive/Arbor Drive intersection. Additional information on the operational issues identified at the study intersection is provided below. *Appendix "E" includes the worksheets used to evaluate year 2018 background traffic conditions at the study intersections.*

Year 2018 Background Traffic Conditions  
 Weekday AM & PM Peak Hour  
 West Linn, OR

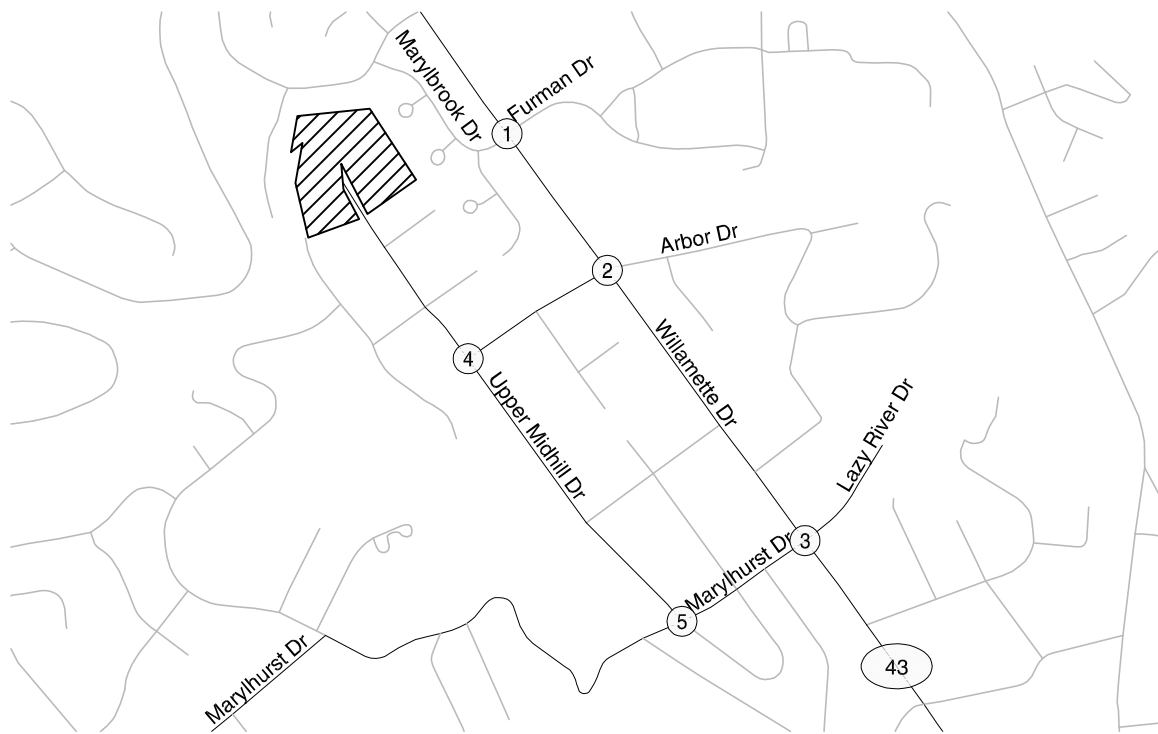
Existing Traffic Conditions  
 Weekday AM & PM Peak Hour  
 West Linn, OR

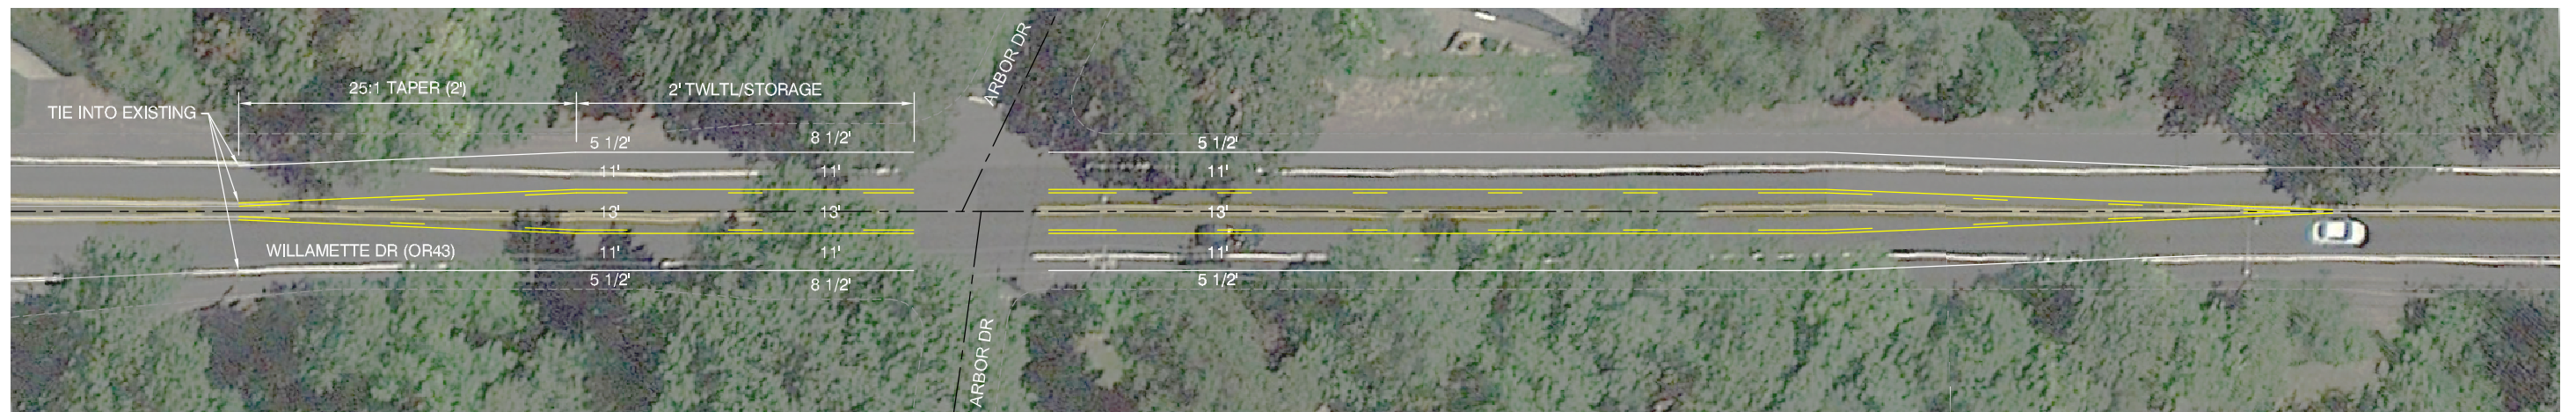
Figure  
9

Willamette Drive (OR 43)/Arbor Drive Intersection Concept  
West Linn, OR

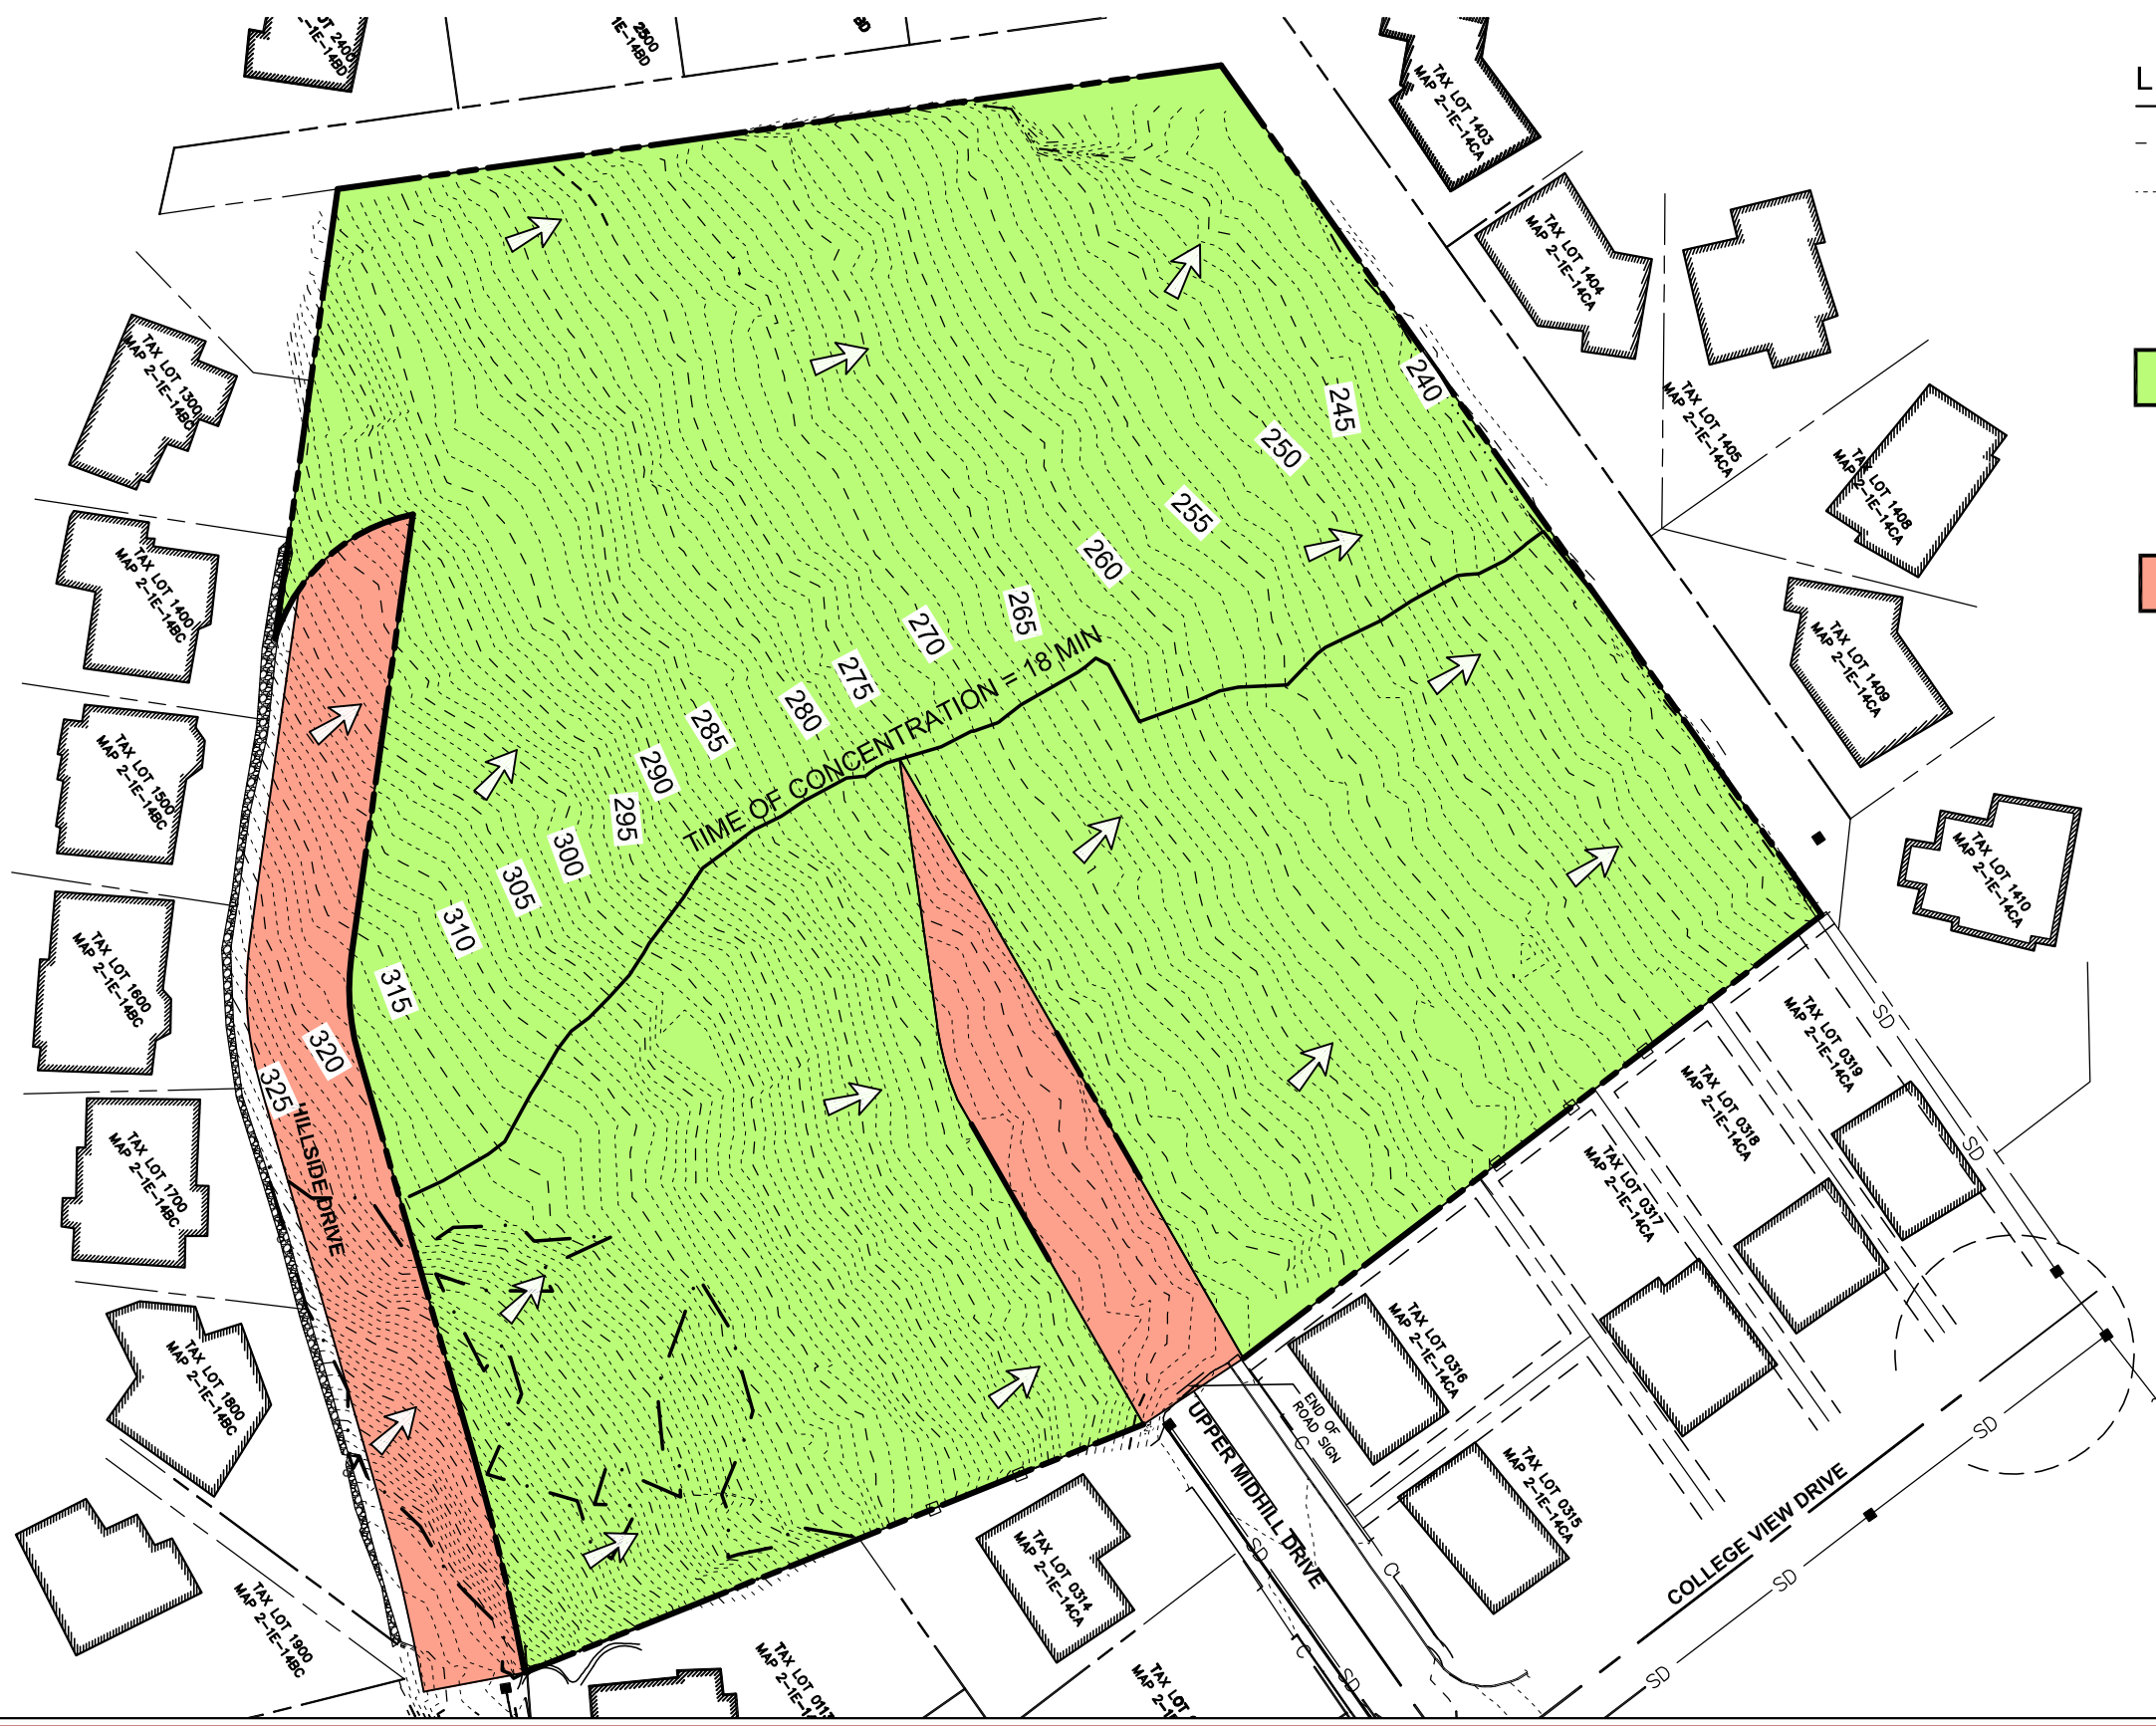
LEGEND	
---100---	EXISTING MAJOR CONTOUR
.....	EXISTING MINOR CONTOUR
➔	SURFACE RUN-OFF FLOW ARROW
<span style="display:inline-block; width:20px; height:10px; background-color:#90EE90; border:1px solid black;"></span>	EXISTING SITE AREA = 6.10 AC IMPERVIOUS AREA = 0.00 AC PERVIOUS AREA = 6.10 AC PERVIOUS CURVE NUMBER = 77 TIME OF CONCENTRATION = 18 MIN
<span style="display:inline-block; width:20px; height:10px; background-color:#FF8C00; border:1px solid black;"></span>	EXISTING OFFSITE AREA = 0.74 AC IMPERVIOUS AREA = 0.00 AC PERVIOUS AREA = 0.74 AC PERVIOUS CURVE NUMBER = 77 TIME OF CONCENTRATION = 18 MIN

# EXISTING SITE CONDITIONS CHÊNE BLANC ESTATES
