SCHOTT & ASSOCIATES
Ecologists & Wetlands Specialists

RE: Willow Ridge at Cornwall Street HCA Mapped Boundaries

March 30, 2017

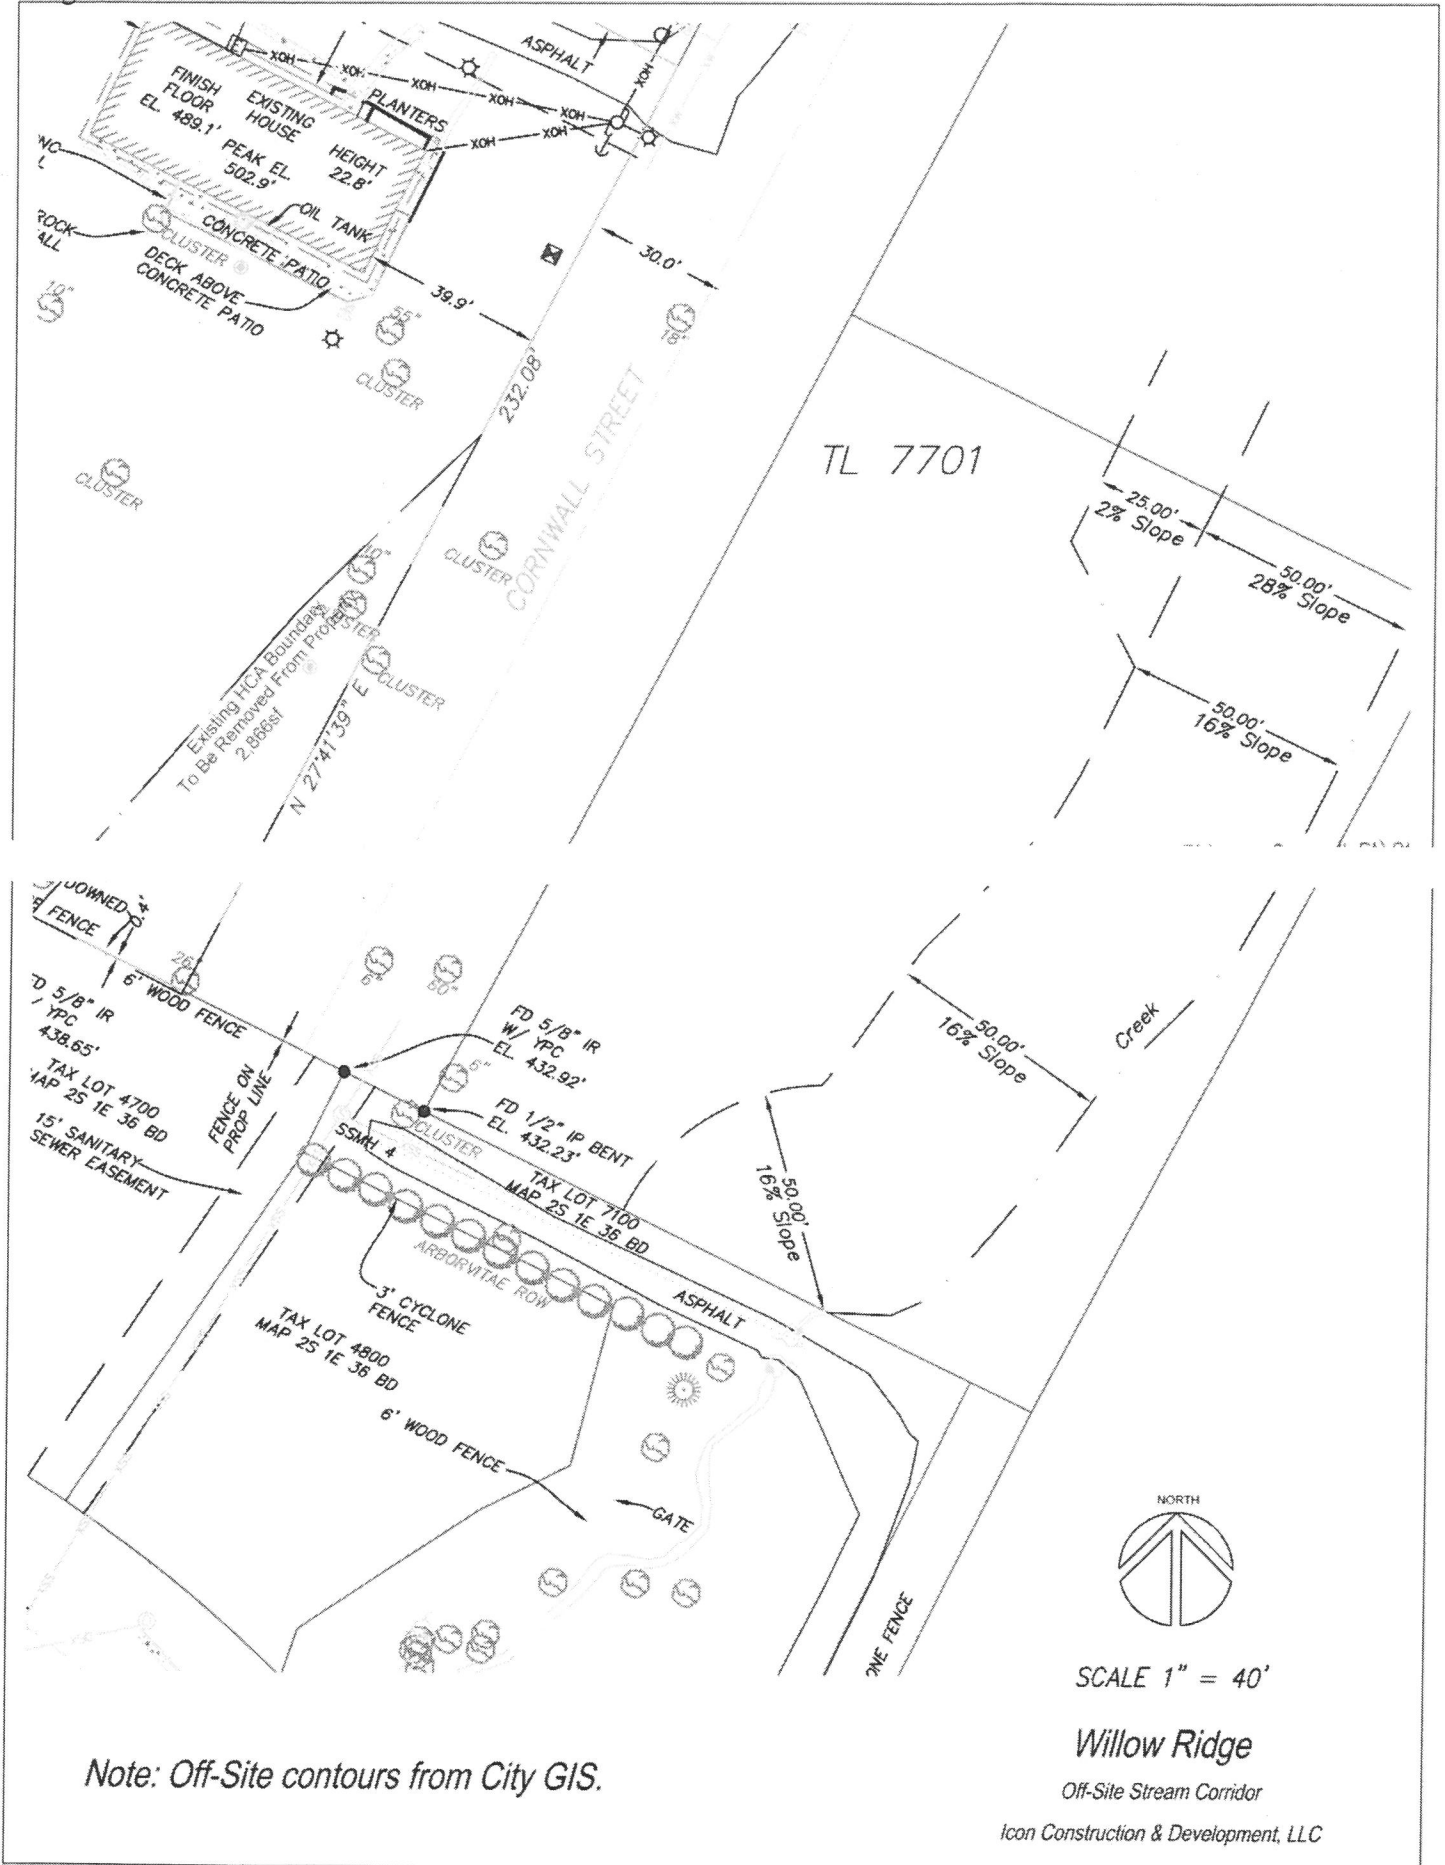
Figure 2. HCA Stream Detail Area

Note: Off-Site contours from City GIS.

Off-Site Stream Corridor

An unidentified tributary to Salamo Creek is located east of the site. The landscape surrounding the tributary was steeply sloped and dominated by non-native Himalayan blackberry. The tributary is approximately 170 feet off site to the southeast located in the bottom of a draw. Slopes within 50 feet of the creek were digitally measured and found to range from 16 to 28 percent.

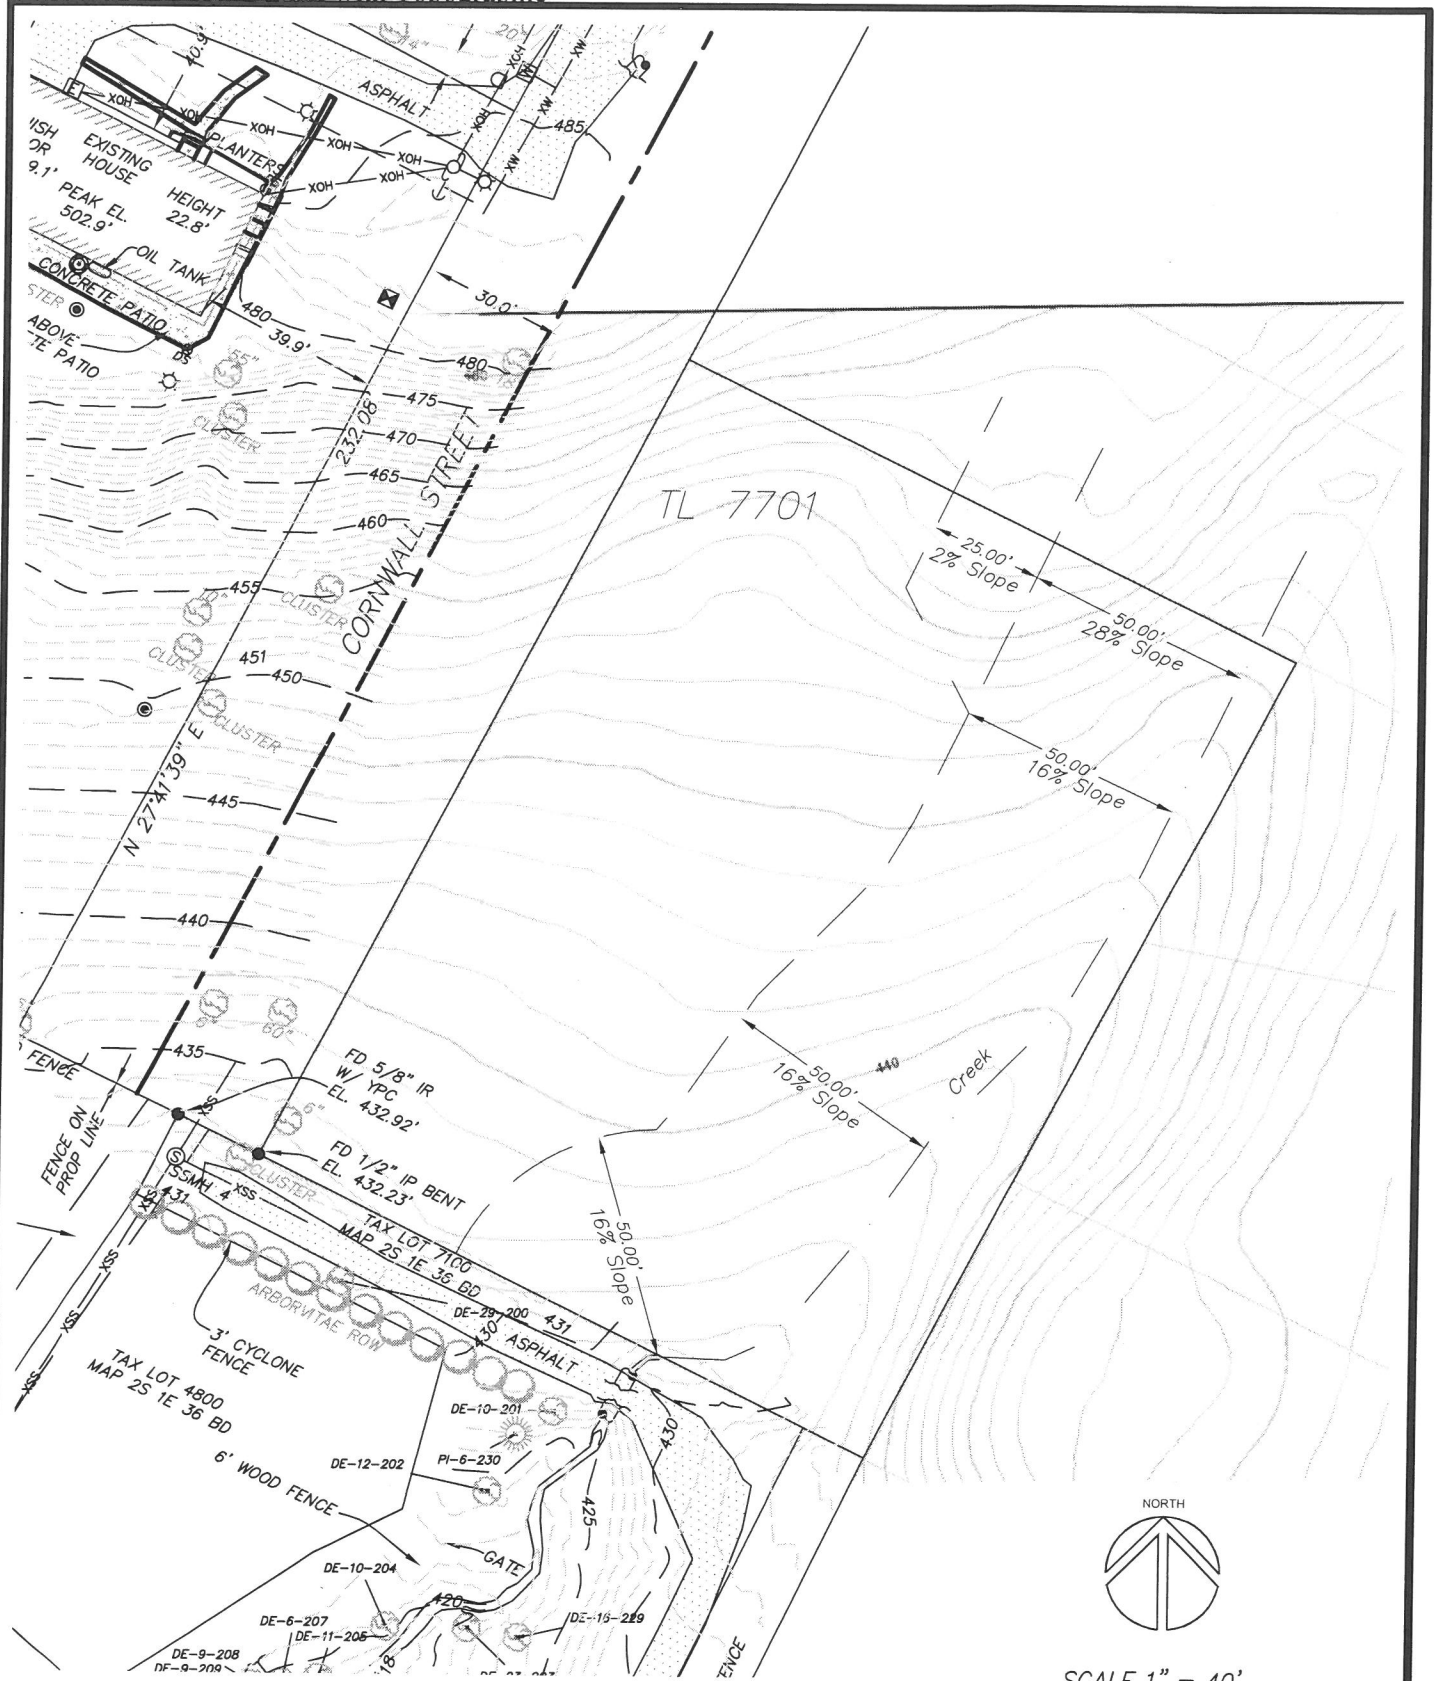
Figure 3. Stream Detail with Topographic

Note: Off-Site contours from City GIS.

Willow Ridge
Off-Site Stream Corridor

Slopes surrounding the creek ranged from 16 to 28 percent. No flood areas were identified within 100 feet of the property.

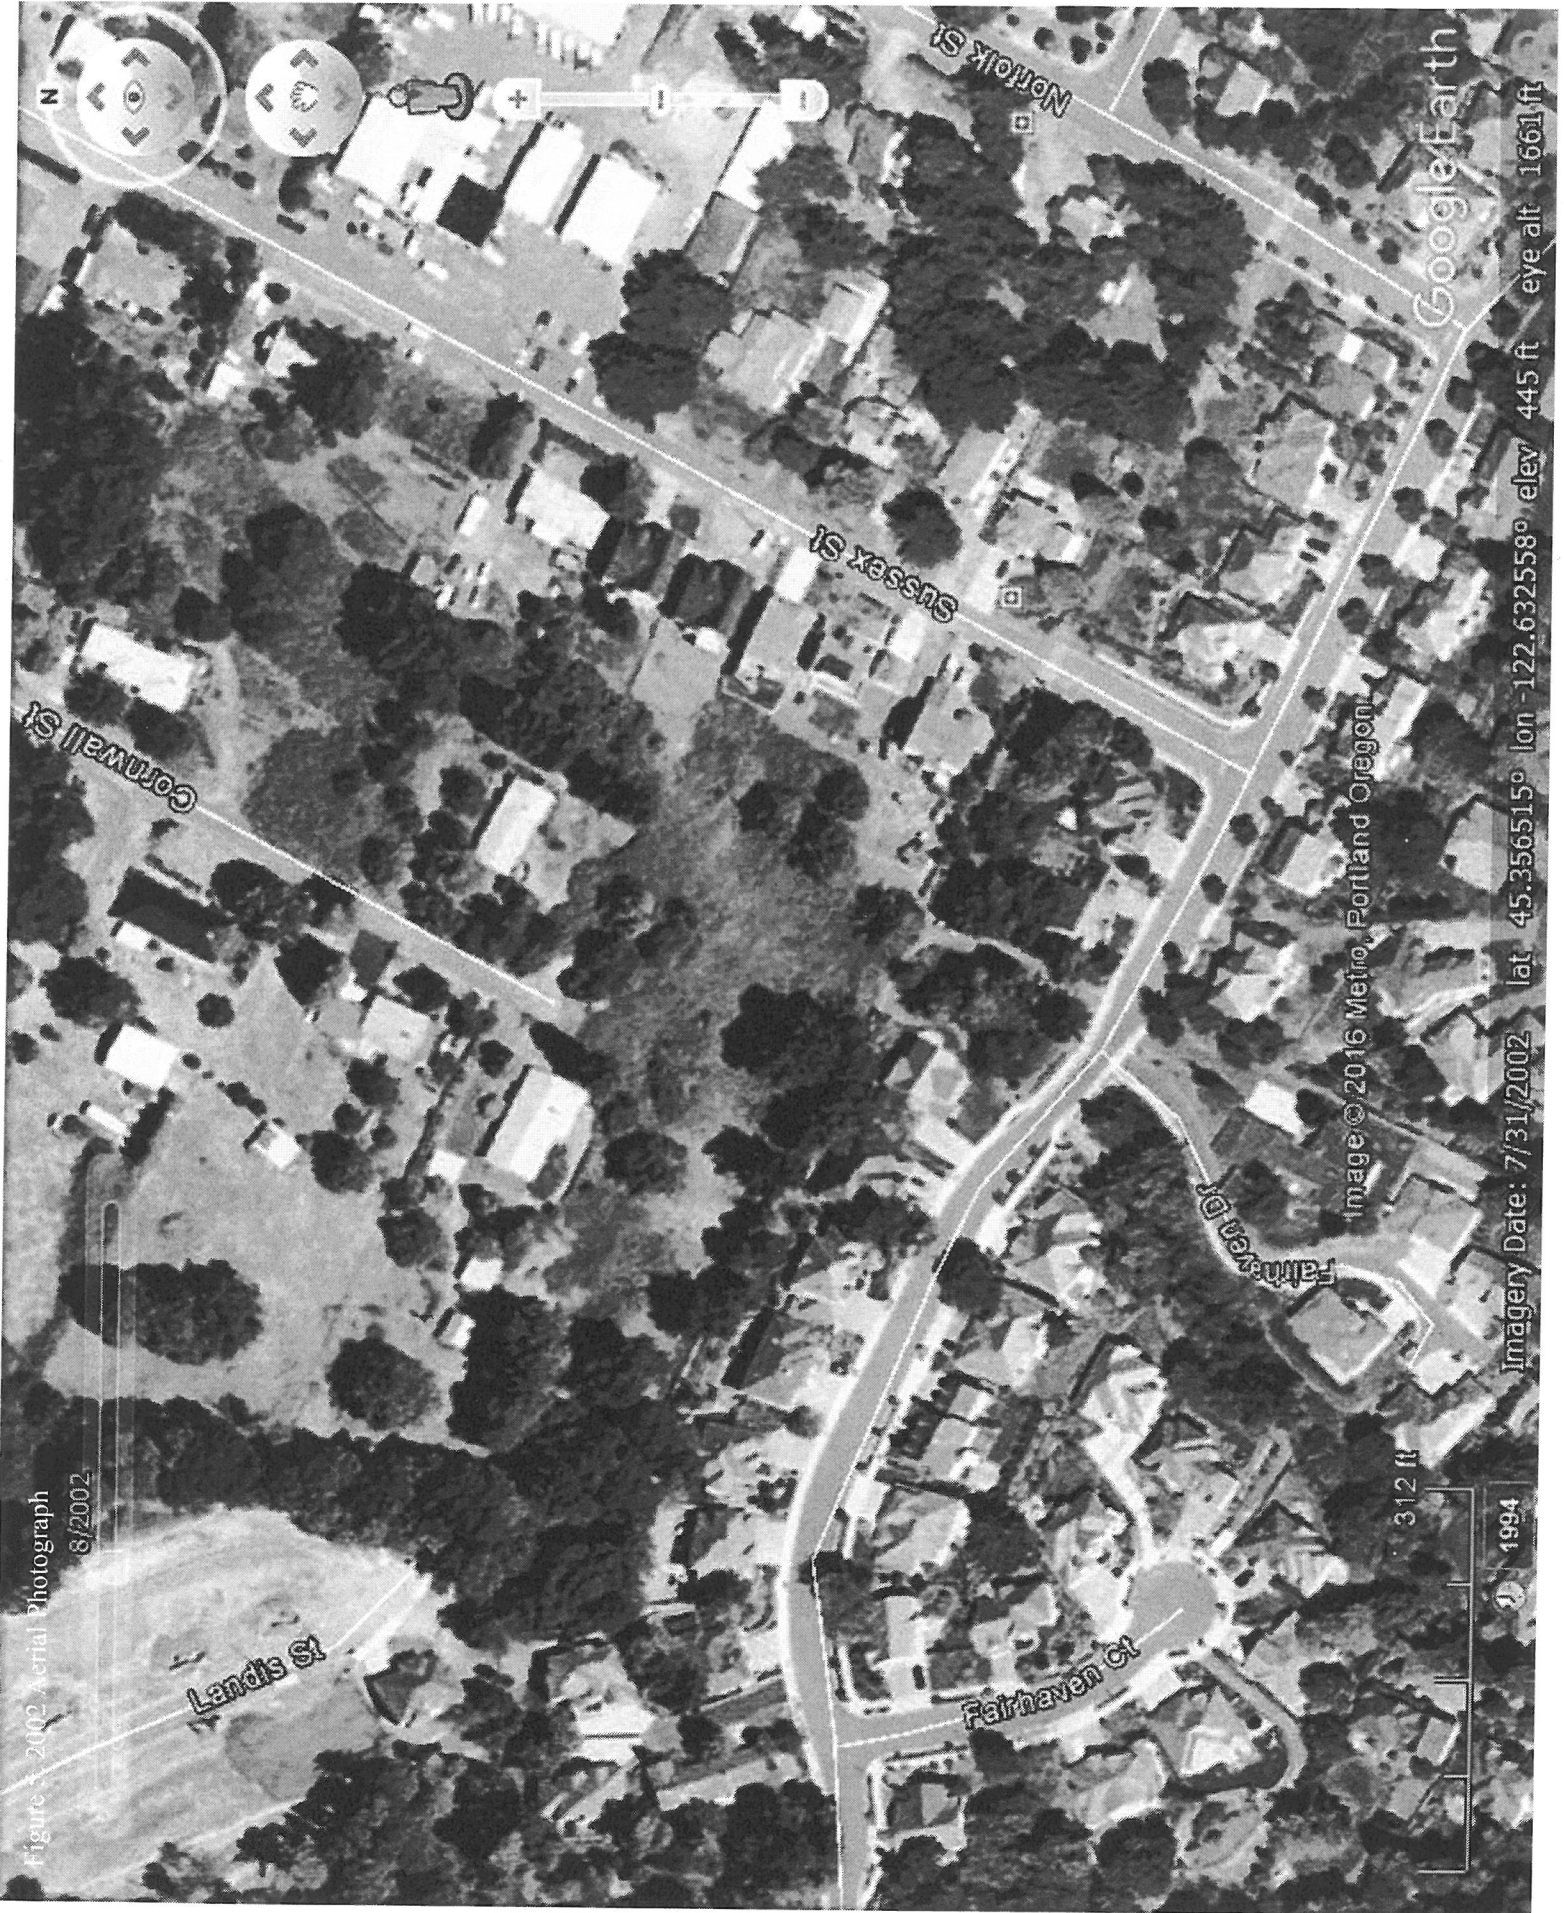
Figure 3. 2002 Aerial Photograph
8/2002

Imagery Date: 7/31/2002 lat 45.356515° lon -122.632558° elev 445 ft eye alt 1661ft

Through observation of the summer 2002 Google Earth aeriels we believe the HCA boundary was mapped using the vegetative cover of the scrub/shrub canopy. The shape of the boundary basically matches the aerial (see Figure 1: Metro HCA, Figure 4: 2002 Aerial Photo). While the

mapping of the habitat may be scrub/shrub, the cover was predominantly Himalayan Blackberry, which is considered an invasive species and offers little ecological function. Additionally, the area was not found to be a Riparian Zone. Adjacent properties identified within the HCA overlay had existing buildings.
