DEVELOPMENT REVIEW APPLICATION

Brief Description of Proposal: Build a New Single Family Residence

Willamette River Greenway Approval Criteria Narrative Response

19155 Nixon Avenue
PA – 17 - 03

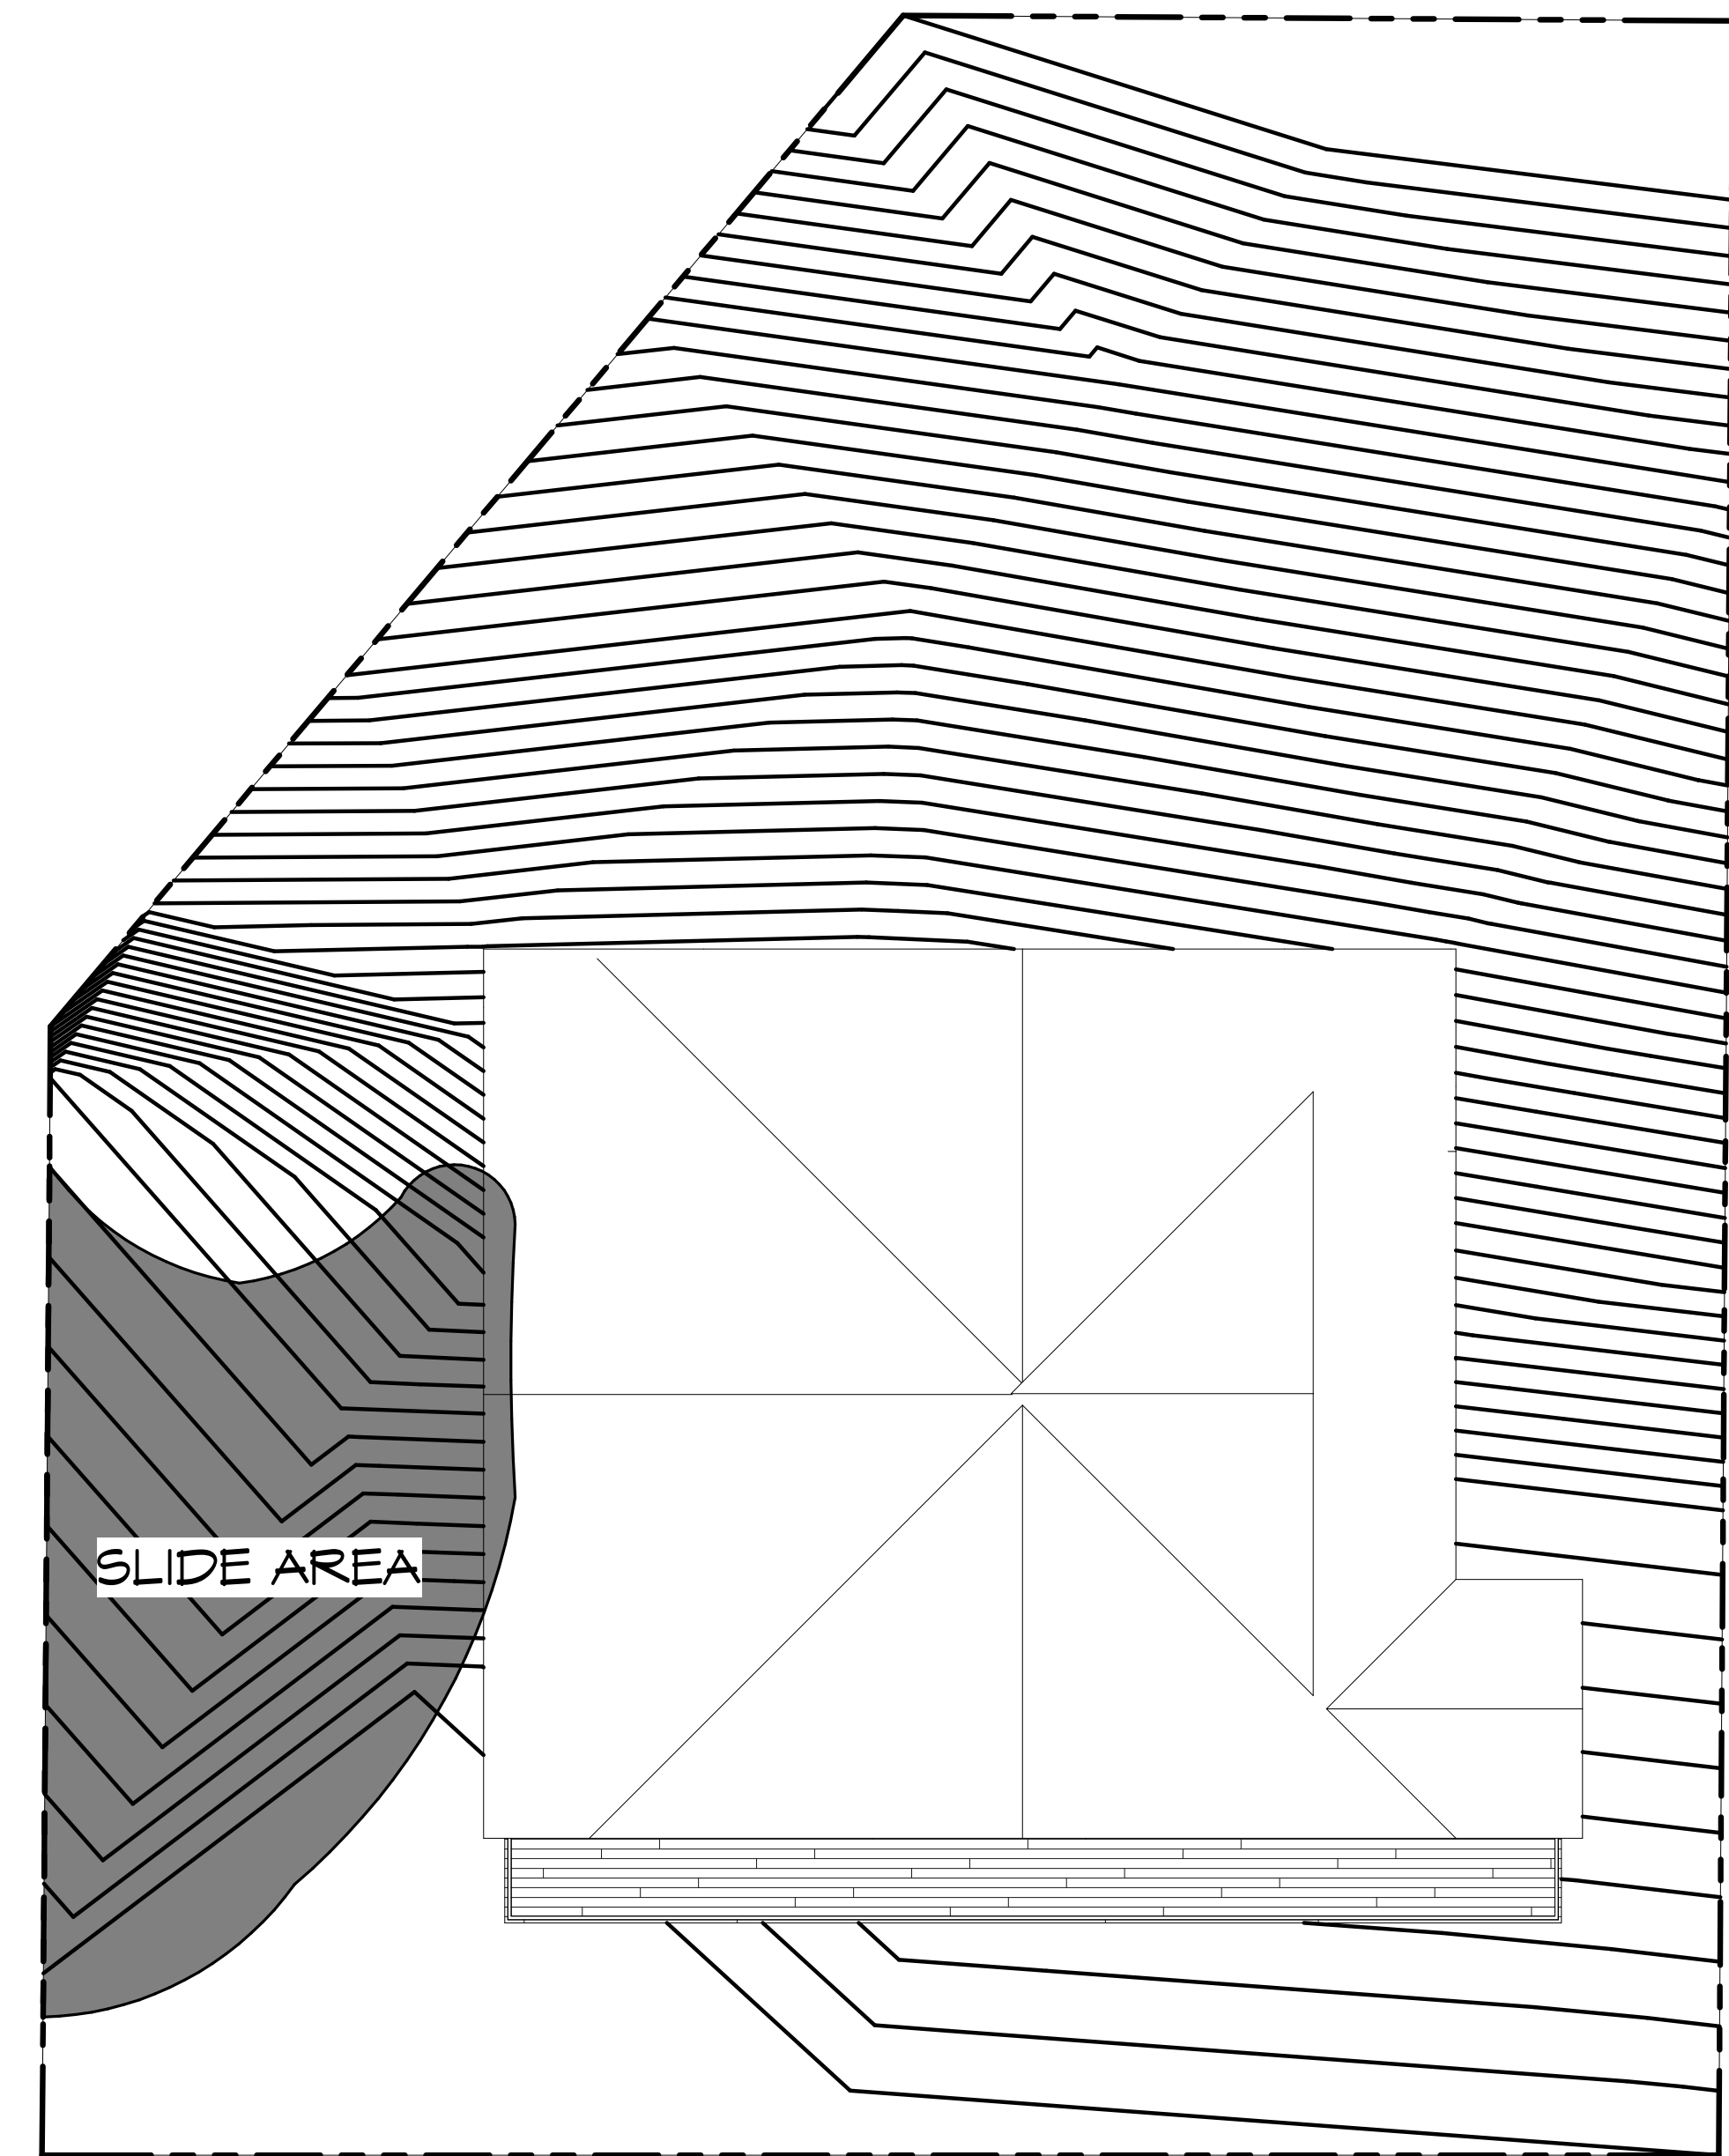
Site Plan W/ SLIDE AREA
1/8" = 1'-0"

The forested property slopes steeply uphill from Nixon Avenue, averaging 60 percent. The lower portion, where the house is proposed to be built, has a lesser slope: averaging 46 percent. Staff notes the presence of a landslide hazard designation which covers the southern portion of the property (1,093 square feet). The applicant will be required to provide a stamped geotechnical engineer's report to demonstrate that site preparation and construction techniques can be used to allow for the safe development of the property. The Building Official may require additional geotechnical studies and development monitoring.

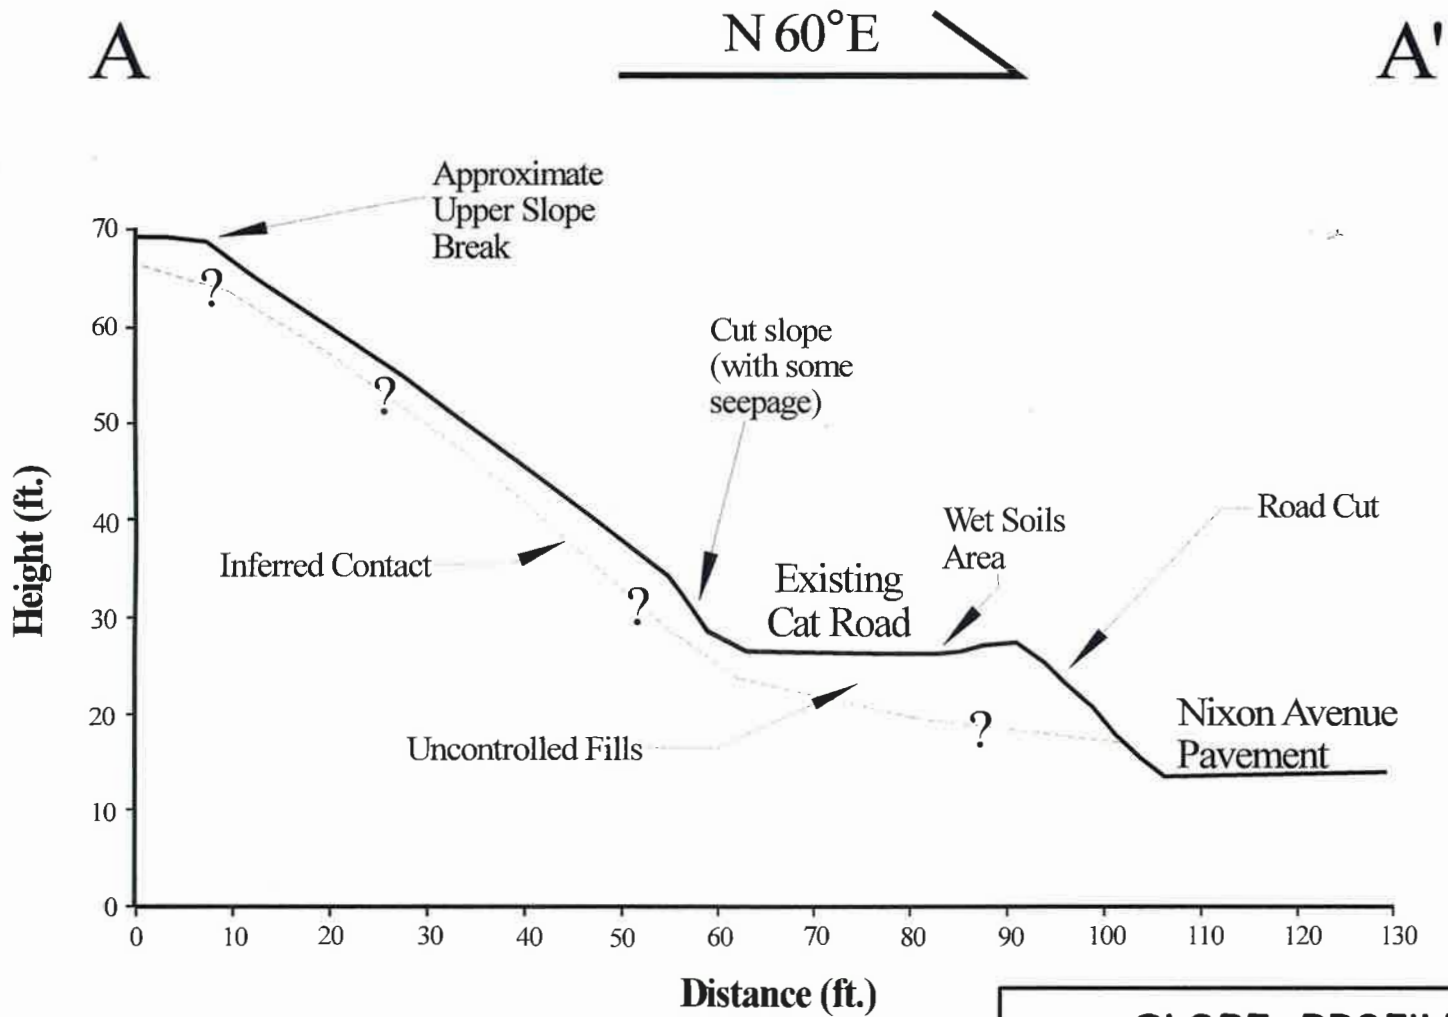
SLOPE PROFILE A-A'

Much of the site is located on a steep 40 to 45 degree generally northeast-facing slope overlooking the Willamette River and Cedar Island to its east. The site shows indications of past shallow landsliding which appears to have extended to depths of approximately 1 to 4 feet. We observed several shallow landslide features at and near the site that appear to have occurred within the past 20 years. Historical failures at the site were likely caused by the placement of fills along the hillside, past clearing activity, and the steep nature of the site. We observed the remains of erosion control material near the ground surface, currently overgrown with blackberries, which appears to have been placed to help control erosion and promote vegetation growth. It is likely that this material was placed following a shallow slide event or following vegetation clearing. At the time of our site visit, we observed indications of recent storm water erosion and shallow sloughing near the northern and southern boundaries of the site, which appeared to have been caused by exposure due to recent clearing activity. We also observed several springs on the lower and middle slope, causing saturated surface soil conditions in localized areas along the slope, and ponded water in the area of the cat road. Saturated soil conditions caused by springs contribute to the instability of the slope. Future shallow failures should be anticipated, unless mitigated for. The slope is prone to fairly rapid soil creep as a result of the steep conditions.

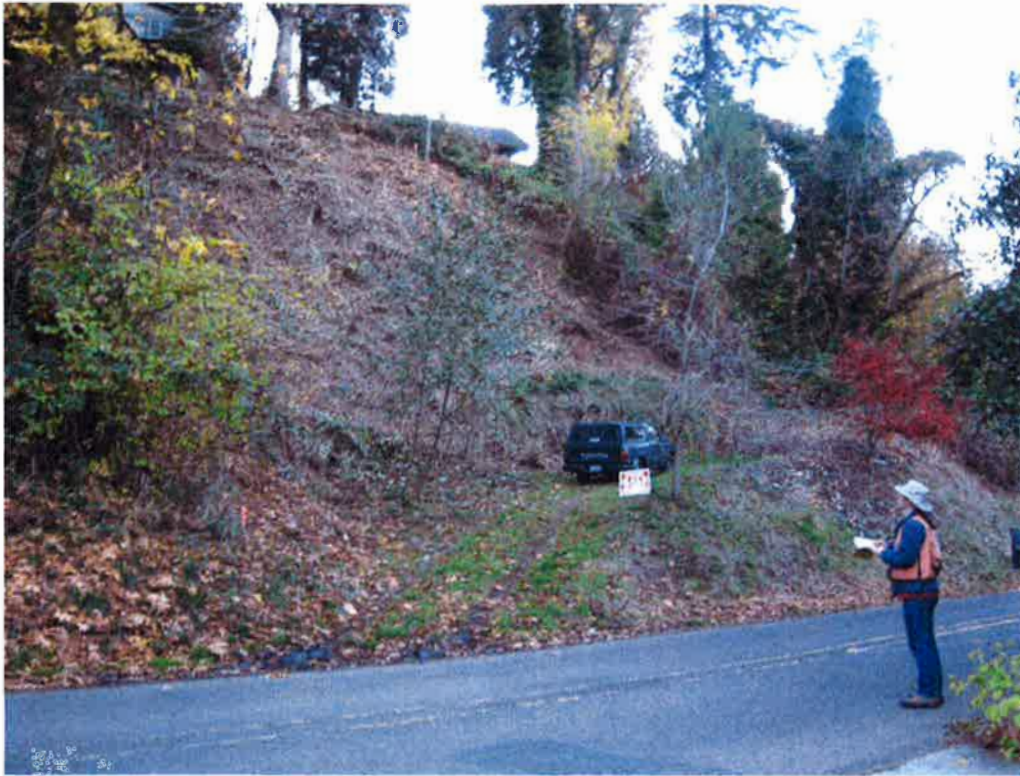
Photo 1 – Looking northwest toward site.

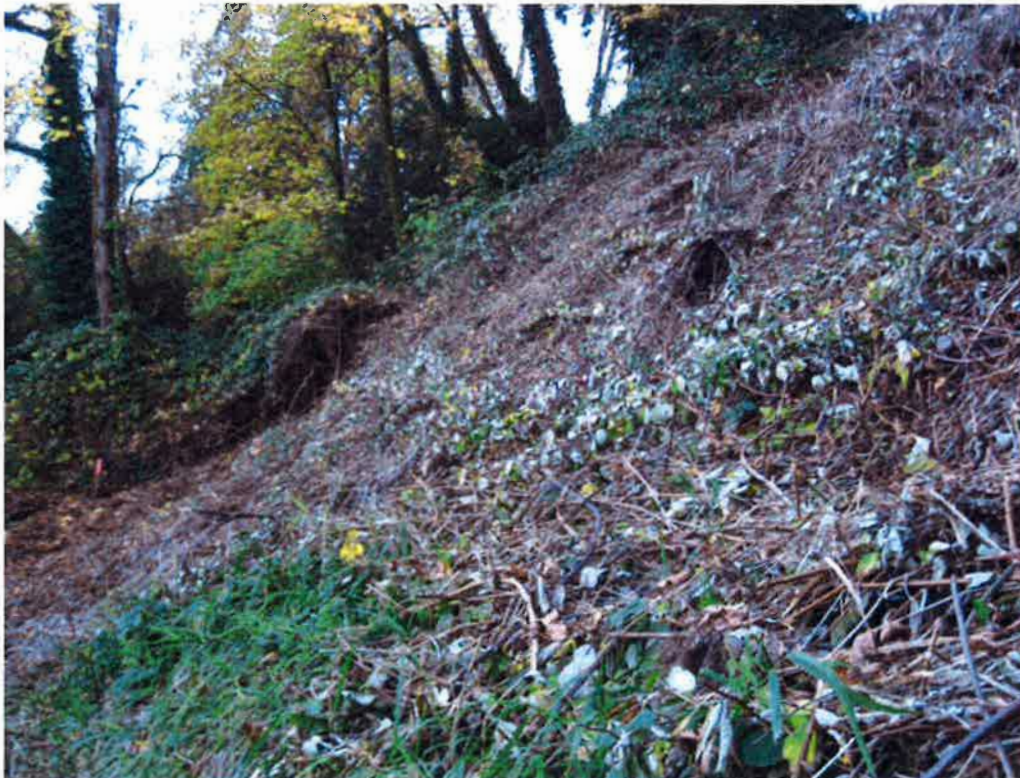
Photo 2 – Looking south toward slope.
