RE: Ferndell Estates (SUB-18-01, WRG-18-02)

Ferndell Estates SUBDIVISION
Preliminary
STORM DRAINAGE REPORT
April 2018

PREPARED BY:
BRUCE D GOLDSON, PE
THETA ENGINEERING

Ferndell Estates
 HCA Analysis

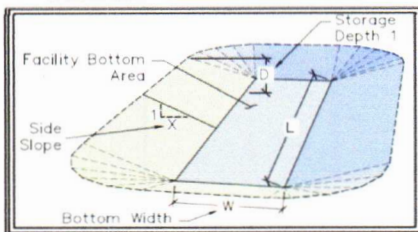
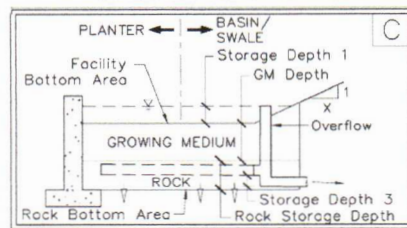
Calculation Guide
Max. Rock Stor.
Bottom Area
600 SF

Surface Capacity at Depth 1 = **744** cf
 Infiltration Area at 75% Depth1 = **486** SF
 GM Design Infiltration Rate = **2.00** in/hr
 Infiltration Capacity = **0.023** cfs

Rock Storage Capacity = **30** cf
 Native Design Infiltration Rate = **0.50** in/hr
 Infiltration Capacity = **0.002** cfs

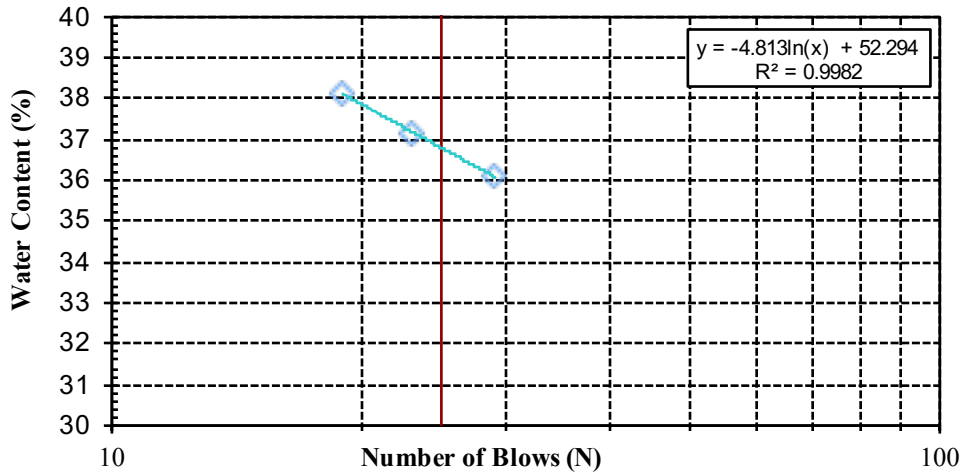
Liquid Limit (%) 36.80
 Plastic Limit (%) 27.13
 Plasticity Index (%) 9.68
 USCS Classification ML

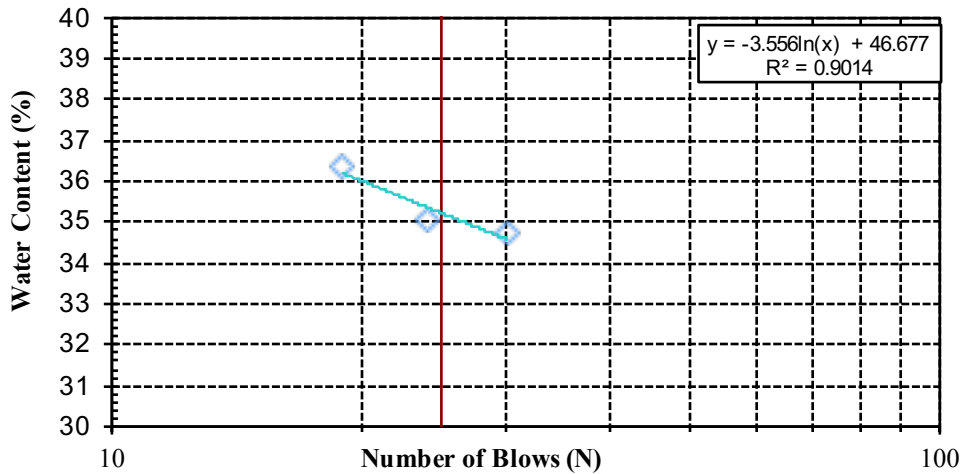
Liquid Limit (%) **35.23**
 Plastic Limit (%) **33.75**
 Plasticity Index (%) **1.48**

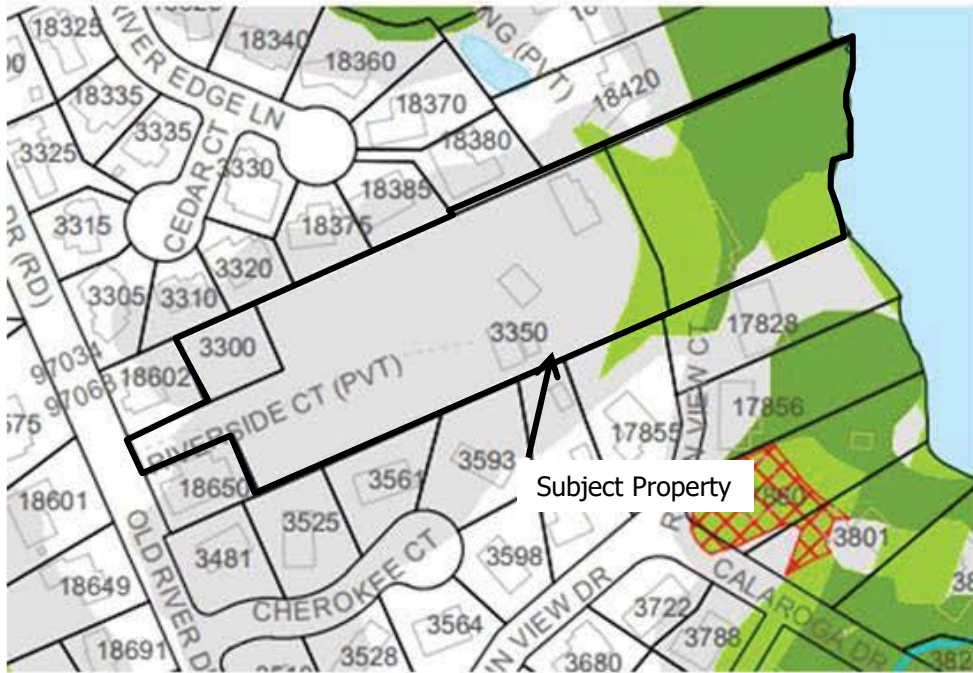
Metro 2005 Habitat Conservation Areas (HCAs)

Data Source: Metro Data Resource Center
Habitat Conservation Areas Map December 15, 2005
Urban Growth Management Functional Plan
Title 13, Nature in Neighborhoods
Adopted Sept. 29, 2005 (Metro Ordinance No. 05 -1077C)
Amended Dec. 8, 2005 (Metro Ordinance No. 05 -1097A)

An HCA map with a development overlay is attached. As described above onsite conditions and review of historical aerials indicate a mapping error and no actual HCA was found to be onsite.

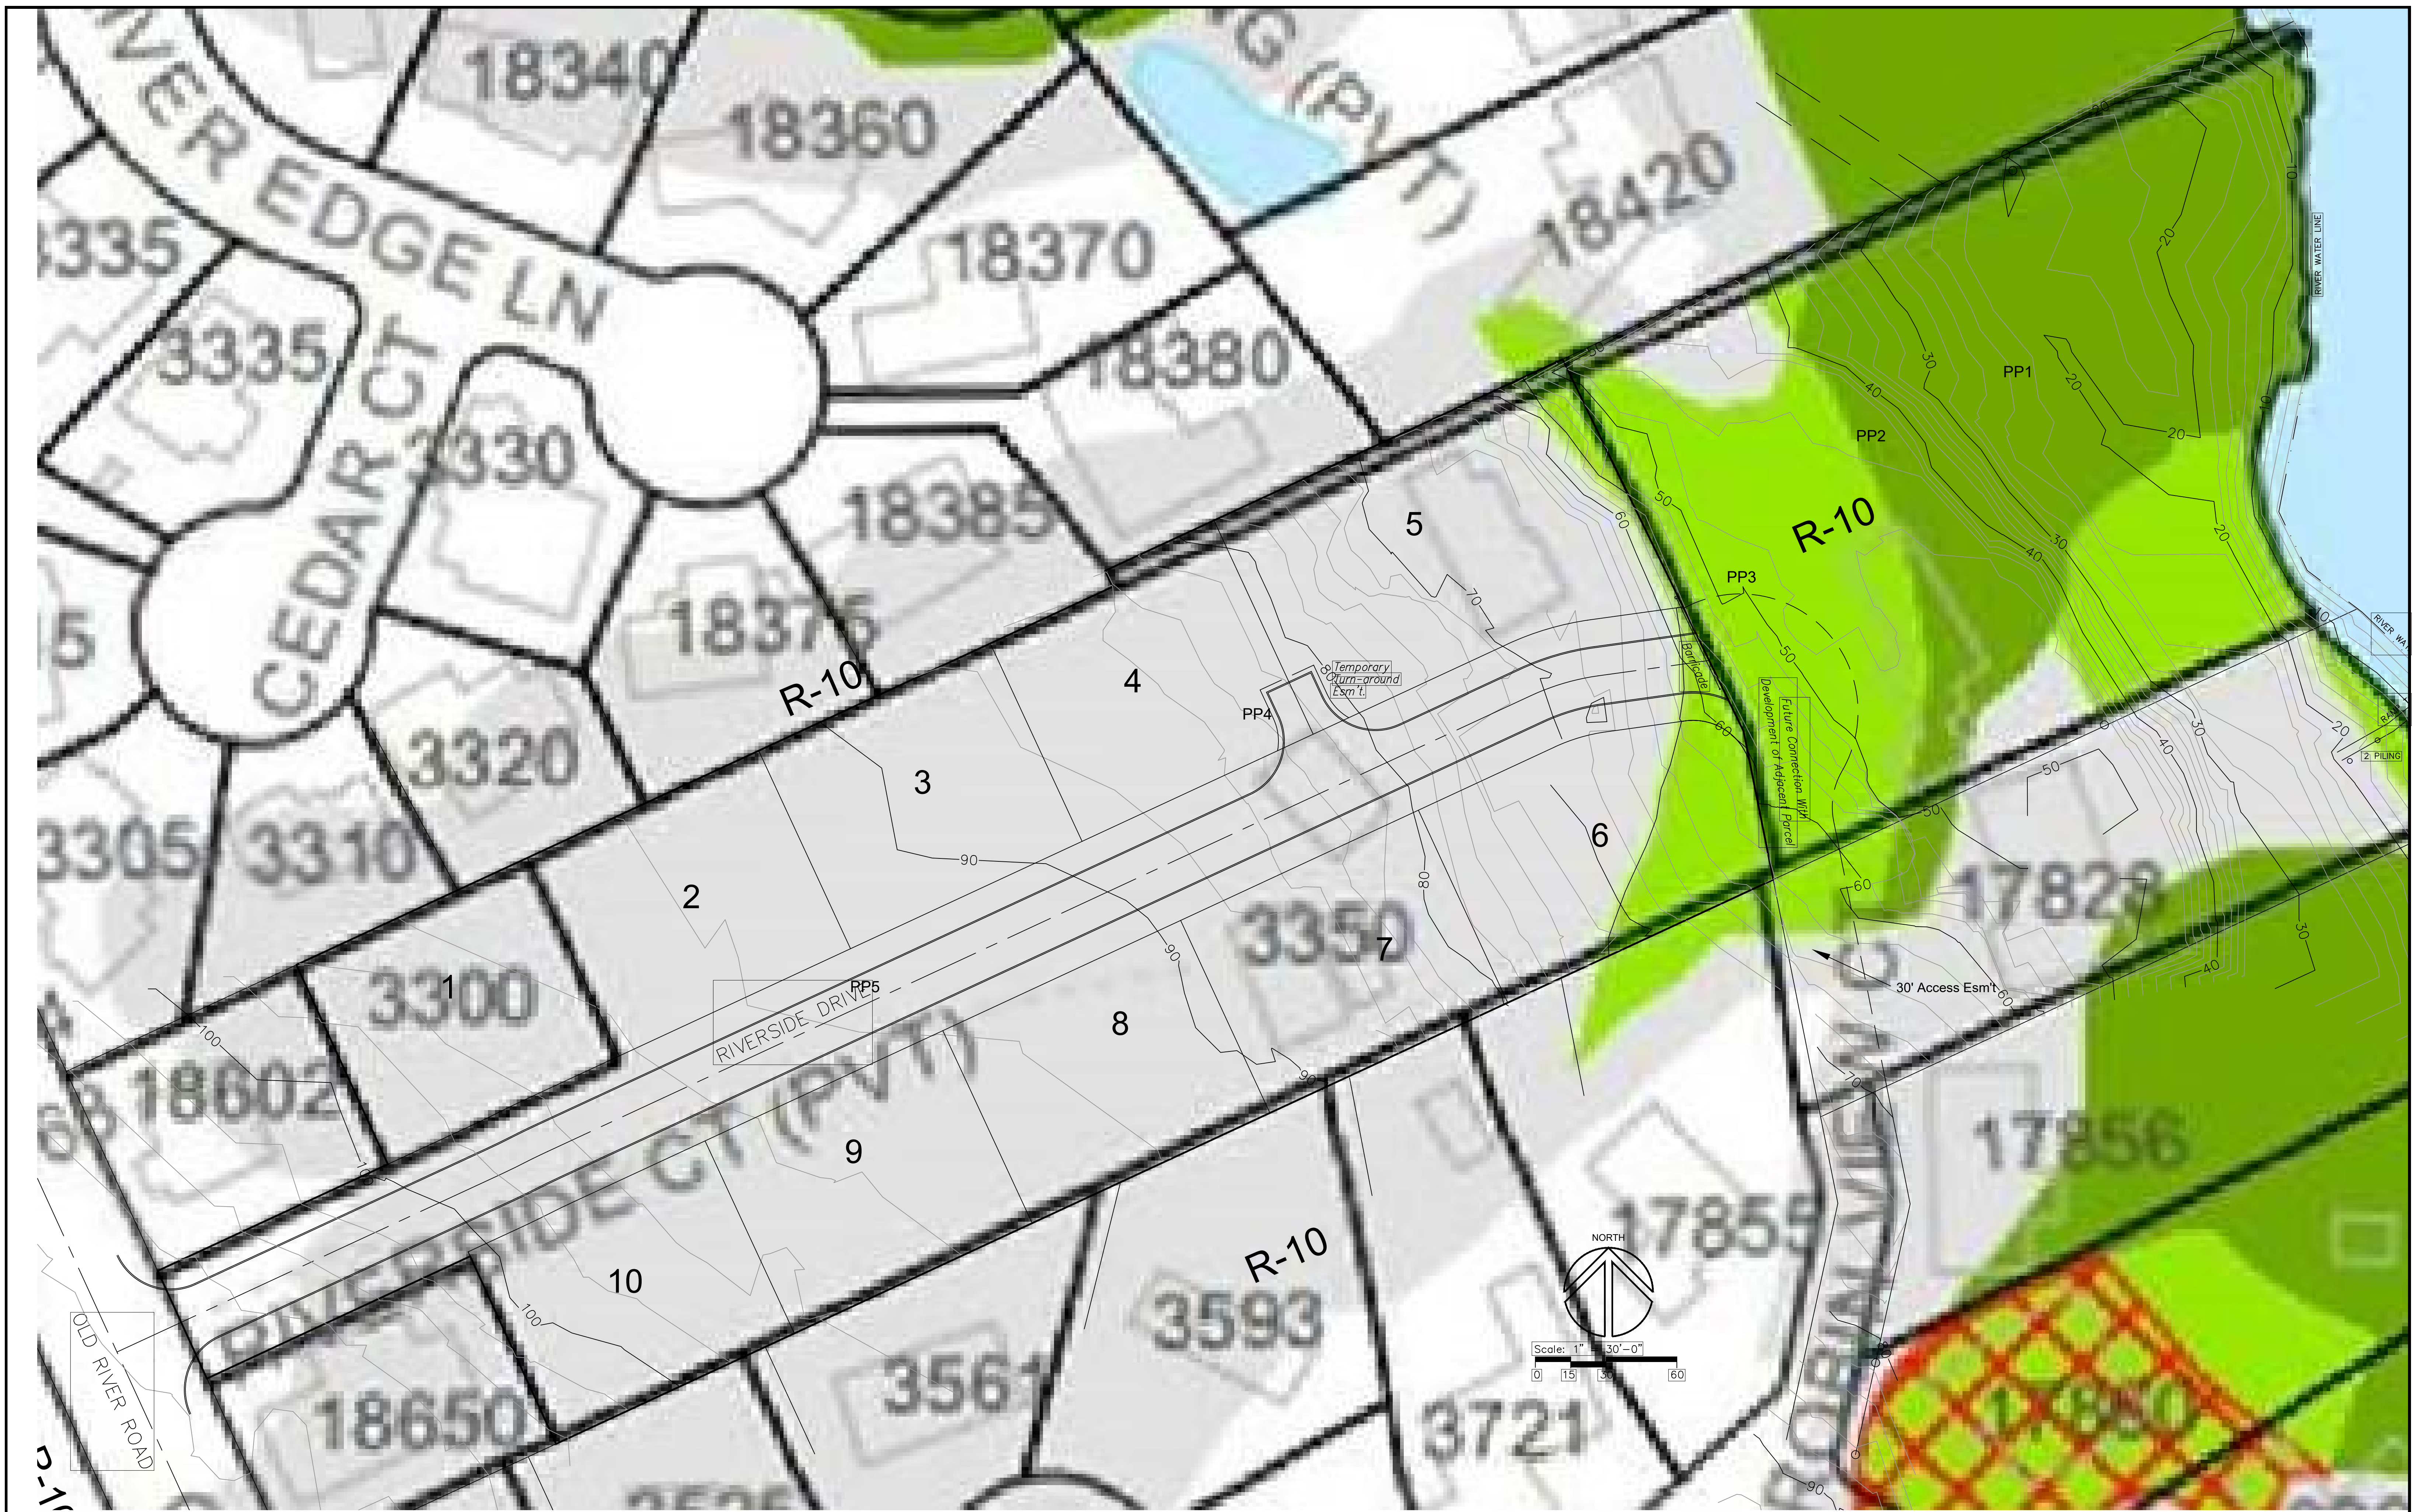
DESIGNED: REG			PP= Photo Point
DRAWN: REG			
SCALE: 1" = 30'			
DATE: April 2018			
FILE: 16-VAR-100	DATE	NO.	REVISION

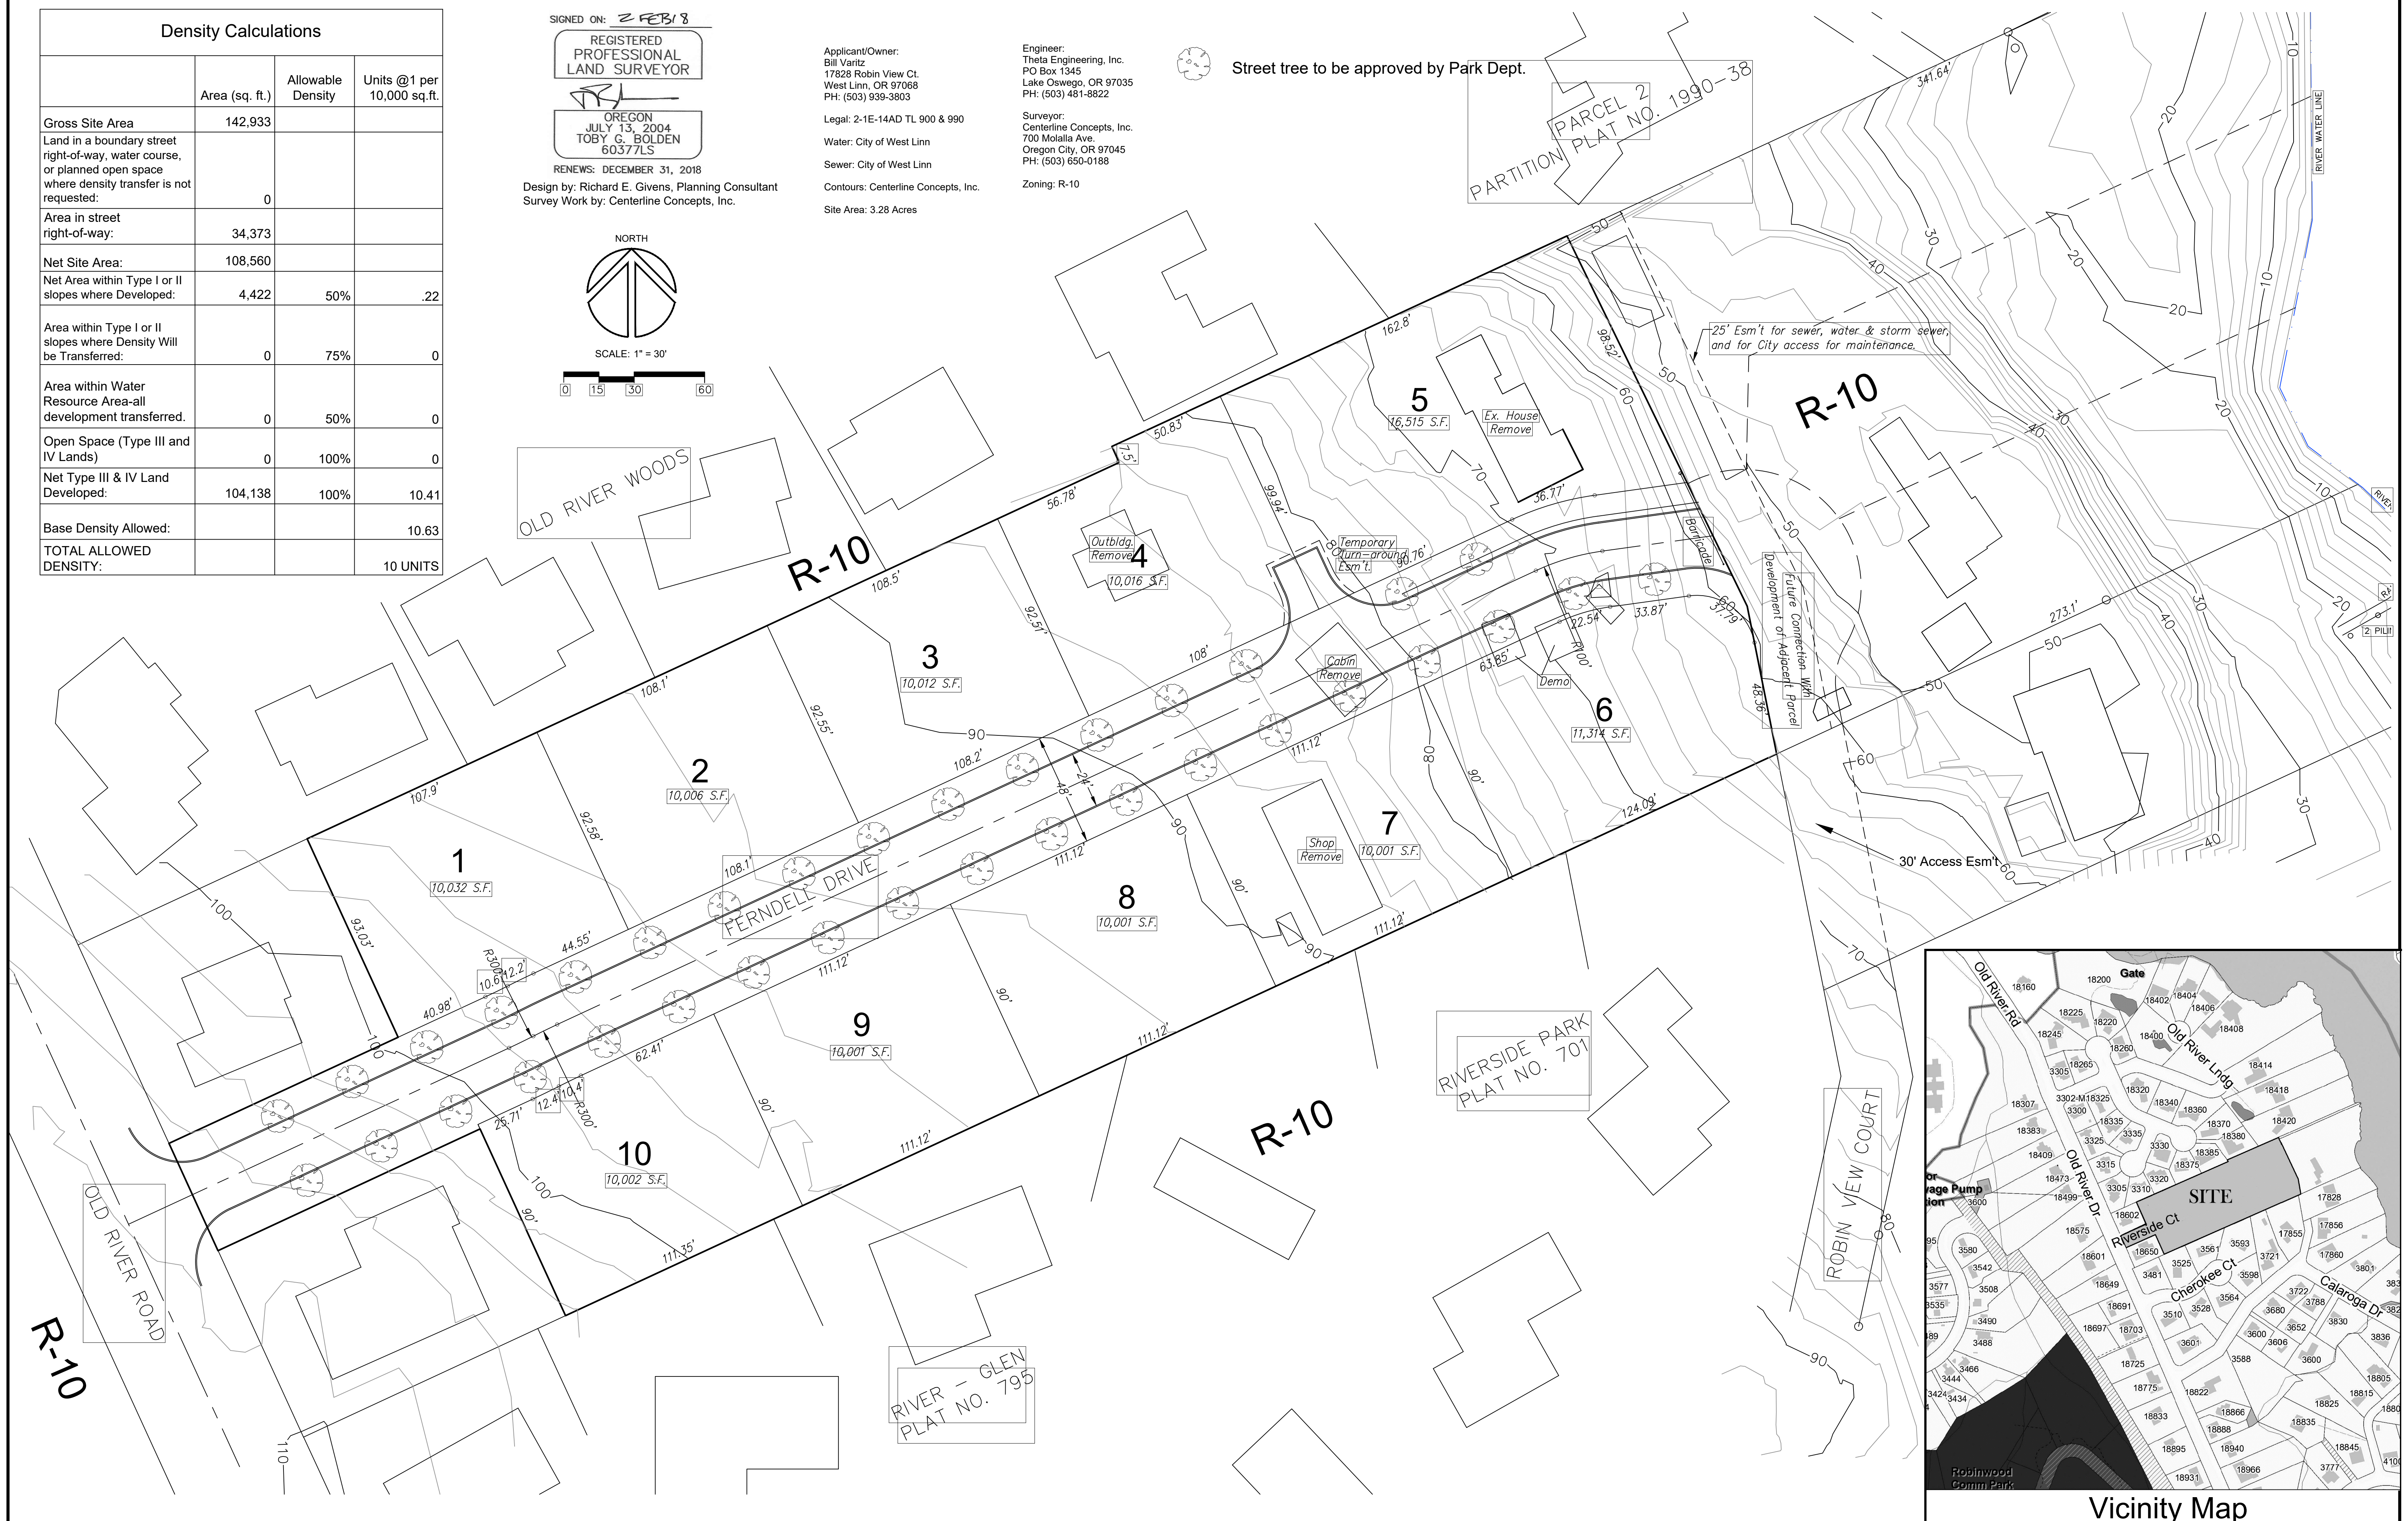
DESIGNED: REG	5-3-2018	1	Added street trees, re-development plan for TL 1000, access & utility esm't on TL 1000
DRAWN: REG			
SCALE: 1" = 30'			
DATE: February 2018			
FILE: 13-VAR-100	DATE	NO.	REVISION

3. Street trees are now shown on the revised Tentative Plan.
4. A copy of the deed to the subdivision tract with legal description is attached.
5. A re-division plan for TL 1000 is now shown on the Tentative Plan.
