Wildwood Drive Natural Resource Assessment

Date: 9/4/2018
To: City of West Linn Planning Department
From: Stacey Reed, PWS, Senior Wetland Scientist
Project: 19738 Wildwood Drive Single Family Residence on Lot of Record
Subject: WRA Permit and Hardship Variance
Site Location: T2S, R1E, Section 23AC, Tax Lot 9004
West Linn, Clackamas County, Oregon

USGS VICINITY MAP		FIGURE
WILDWOOD DRIVE WEST LINN NATURAL RESOURCE ASSESSMENT MEMO		1
AKS ENGINEERING & FORESTRY, LLC		DRWN: KMK
12965 SW HERMAN RD	SUITE 100	CHKD: HS
TUALATIN, OR 97062	www.aks-eng.com	AKS JOB:
PHONE: 503.563.6151	FAX: 503.563.6152	6786

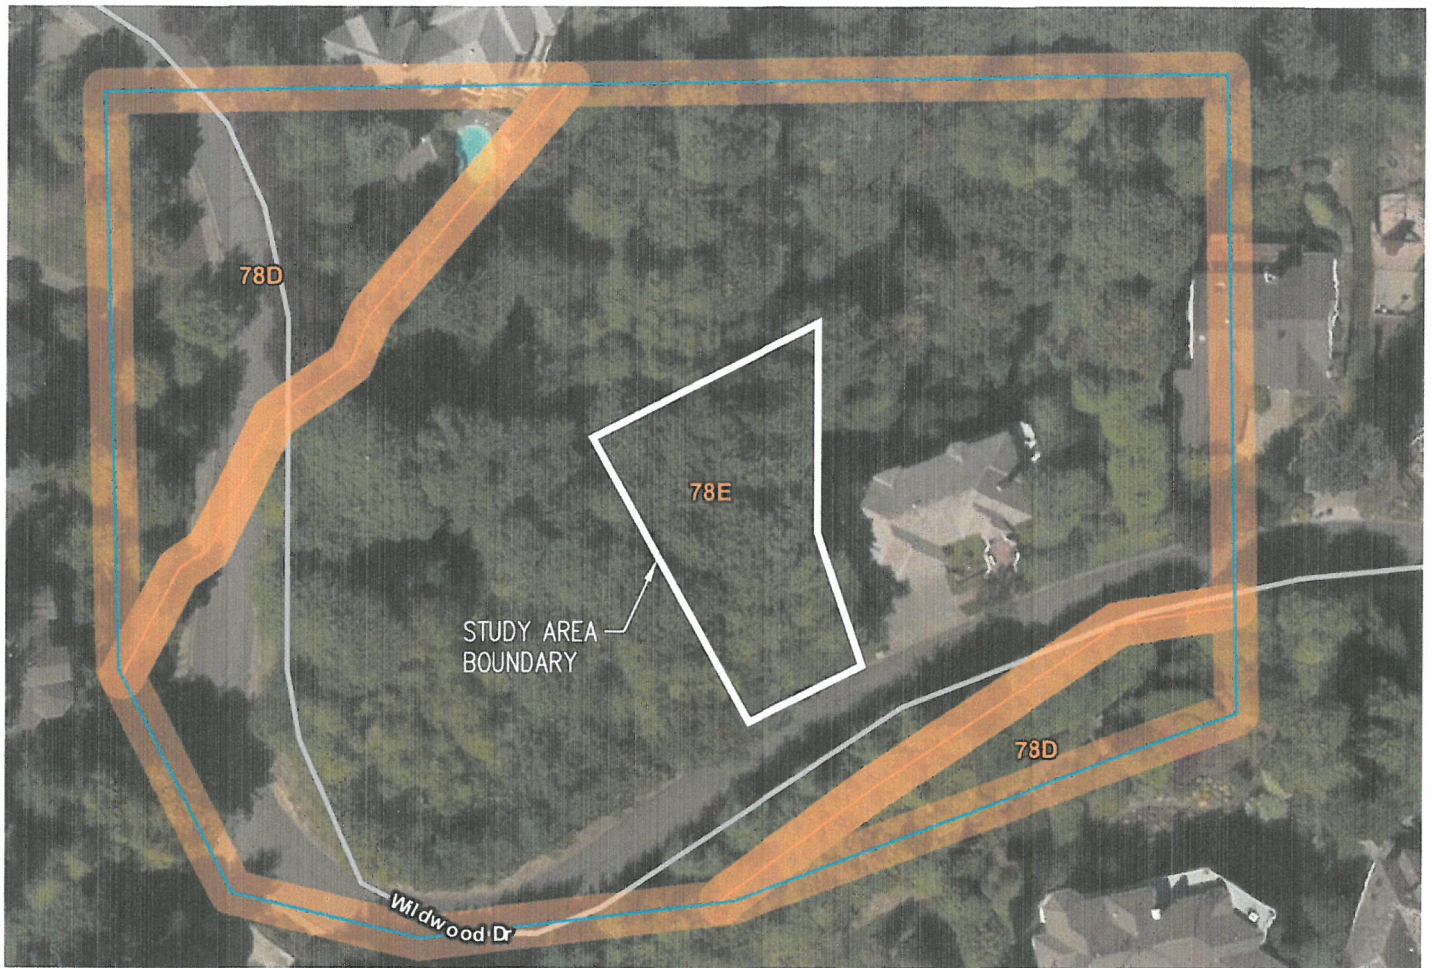
NRCS SOIL SURVEY MAP WILDWOOD DRIVE WEST LINN NATURAL RESOURCE ASSESSMENT MEMO		FIGURE 3
AKS ENGINEERING & FORESTRY, LLC 12965 SW HERMAN RD SUITE 100 TUALATIN, OR 97062 www.aks-eng.com PHONE: 503.563.6151 FAX: 503.563.6152		DRWN: KMK CHKD: HS AKS JOB: 6786

According to the Natural Resources Conservation Service (NRCS) soil survey map for Clackamas County, Oregon Area soil survey and the Clackamas County hydric soil list Saum silt loam with 30%-60% slopes are mapped extending throughout the entire site (Figures 3). Saum silt loams are not listed as hydric, nor do they have any hydric inclusions.

MAP UNIT SYMBOL	MAP UNIT NAME
78E	SAUM SILT LOAM, 30% TO 60% SLOPES; NON-HYDRIC

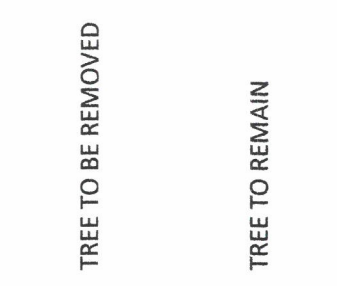
- EROSION CONTROL / TREE PROTECTION NOTES:**
1. RPZ FENCING: 6' CHAINLINK FENCING W/ 8' METAL POSTS DRIVEN 2' IN GROUND @ 10' MAX O.C. SPACING.
 2. COVER EXPOSED TOPSOIL ON SITE WITH STRAW AT ALL TIMES. TOPSOIL STOCKPILE AREAS TO BE COVERED AND PROTECTED.

MA - MAPLE TREE

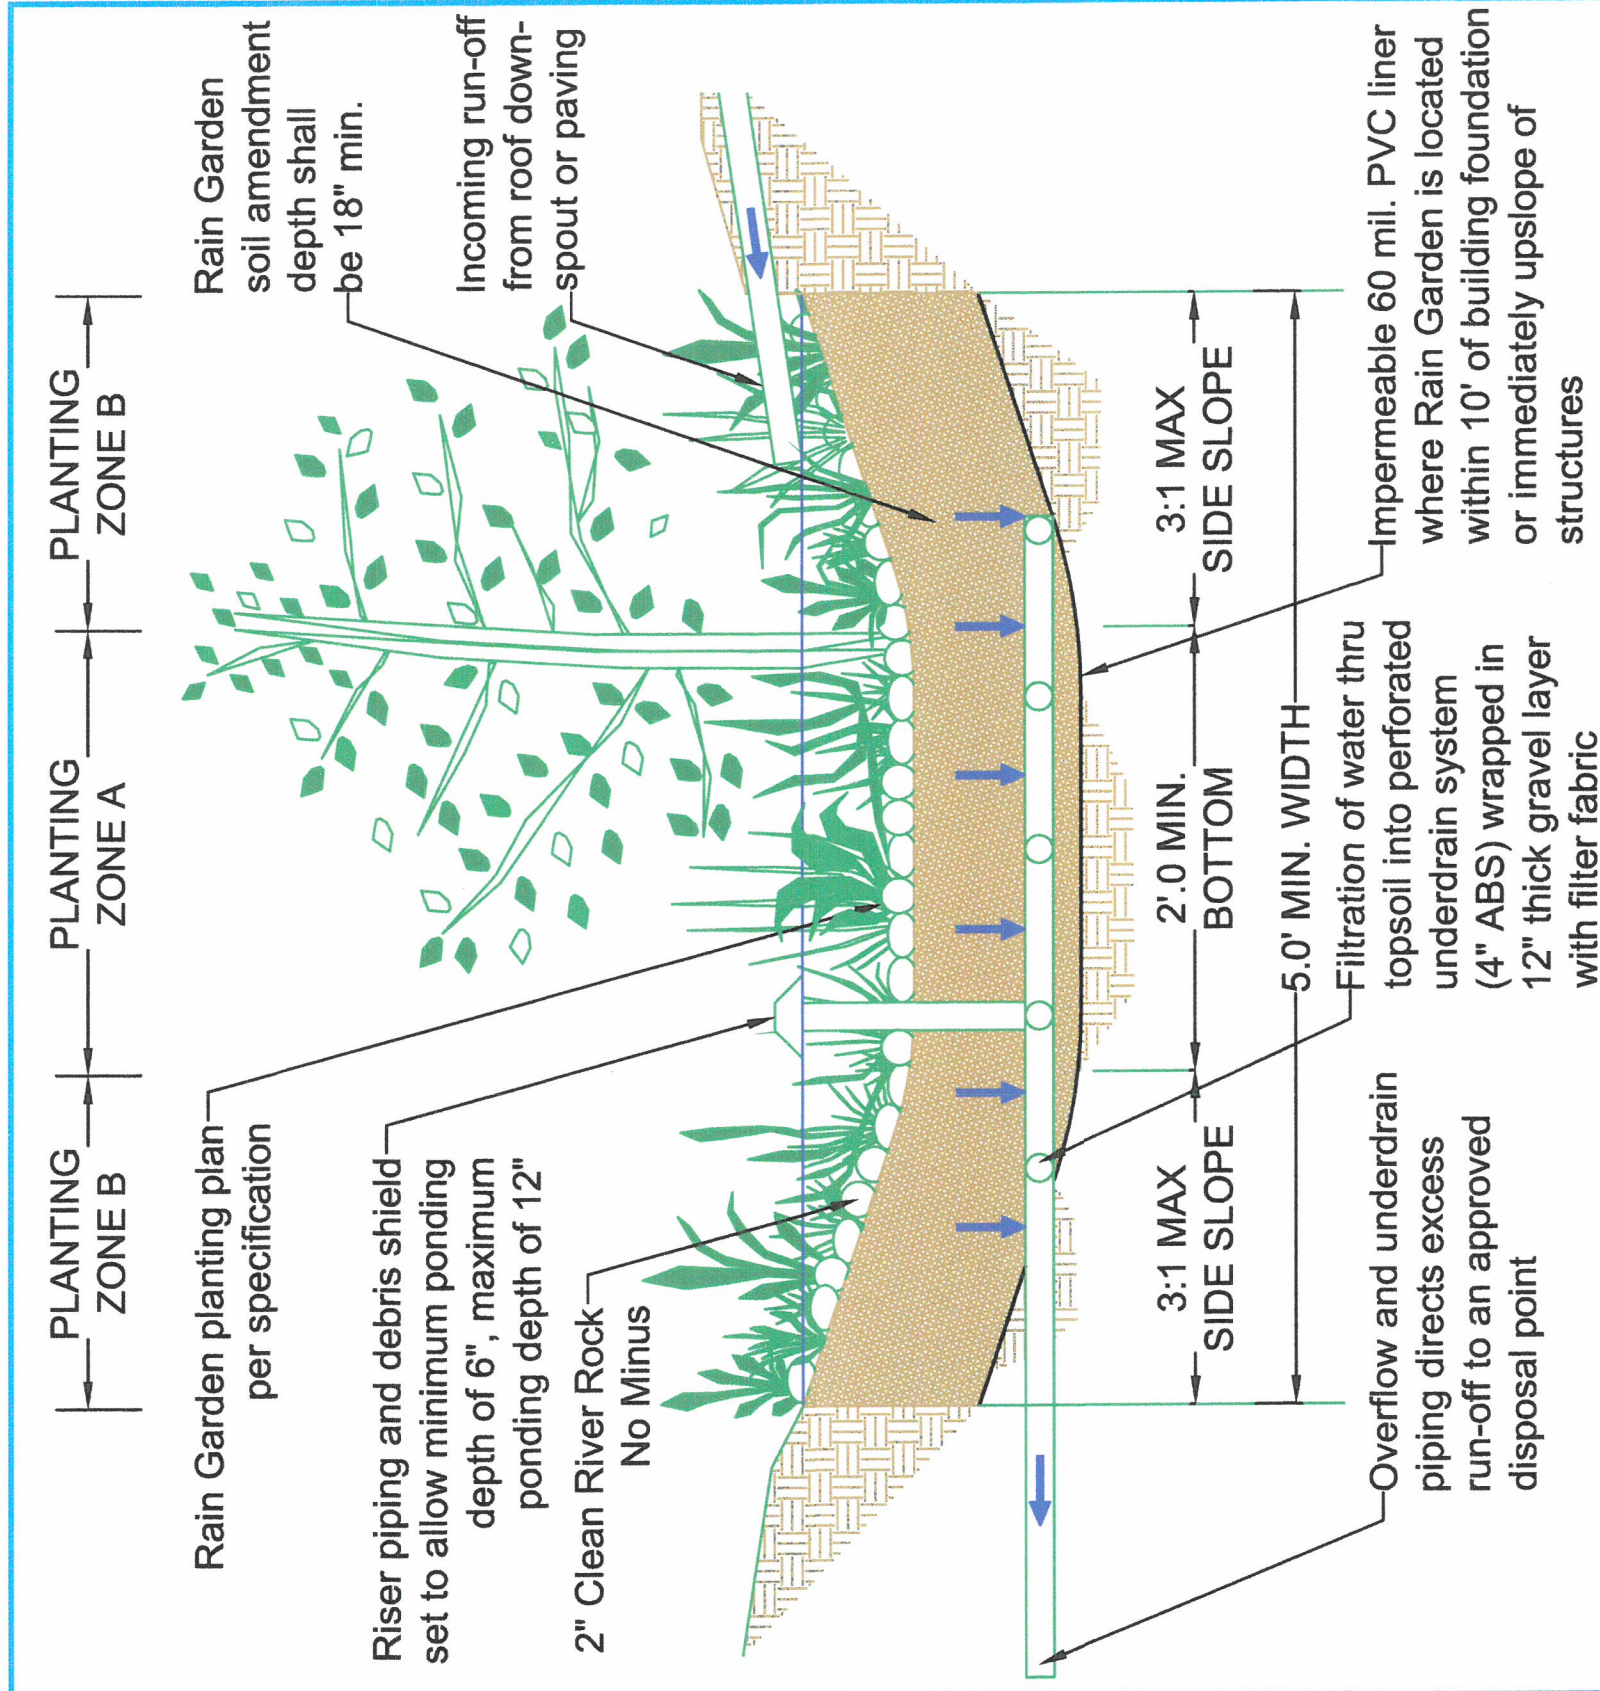
INFILTRATION RAIN GARDEN TYPE 1

RAIN GARDEN SURFACE AREA = TOTAL IMPERVIOUS AREA x 0.06

NOTE:
 PLANT 1 GALLON POTS 18" O.C. IN EACH ZONE. A MINIMUM OF 3 SPECIES SHALL BE USED IN EACH ZONE.

RAIN GARDEN PLANTS	
ZONE	BOTANICAL NAME COMMON NAME
A	CAREX APERTA COLUMBIA SEDGE
A	CAREX DENSA DENSE SEDGE
A	CAREX PANSA SANDDUNE SEDGE
A	CAREX TESTACAE NEW ZEALAND ORANGE SEDGE
A	CAREX TUMILICOLA FOOTHILL SEDGE
A	DESCHAMISIA CAESPITOSA TUFTED HAIR GRASS
A	ELEOCHARIS PALUSTRIS CREEPING SPIKE RUSH
A	JUNCUS BALTICUS BALTIC RUSH
A	JUNCUS EFFUSUS "CARMEN'S JAPANESE" COMMON RUSH
A	JUNCUS EFFUSUS "GOLD STRIKE" COMMON RUSH
A	JUNCUS EFFUSUS "CARMAN'S GRAY" COMMON RUSH
A	JUNCUS PATENS SPREADING RUSH
B	ARCTOSTAPHYLOS UVA-URSI KINNICKINICK
B	BLECHNUM SPICANT DEER FERN
B	CORNUS SERICEA VAR. KELSEY II DWARF REDTWIG DOGWOOD
B	LIRIOPE MUSCARI "BIG BLUE" BIG BLUE LILY TURF
B	GAUTHERIA SHALLON SALAL
B	MAHONIA NERVOSA LOW OREGON GRAPE
B	MAHONIA REPENS CREEPING OREGON GRAPE

Stormwater Management: Stormwater will be collected from roof drains and the driveway and directed downslope via a pipe to discharge into a City of West Linn Infiltration Rain Garden, Type 1 (see attached typical detail) for treatment prior to discharge into a riprap energy dissipation pad. The rain garden and riprap pad will be located above the delineated OHWM of the tributary. No work or disturbance will occur within the stream channel. The approximately location for the rain garden is shown on the attached Site Plan, Figure 7. According to

Table 32-5 MDA Calculation Summary of West Linn CDC, rain gardens are allowed within the WRA buffer and their footprint does not count towards the project's MDA calculation. No native trees with greater than 6-inch DBH will be removed for the installation of the rain garden. The rain garden will be planted with native vegetation per the attached detail.
