# Paradise Group of Companies, Inc.

# Hay Properties- Project Narrative

#### New SFRs in WRA – Specifically 4327 Kelly Street

12/28/2018

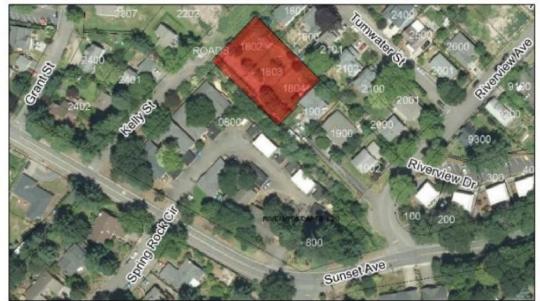
The legal description of the Study Area is SE 1/4 of NE 1/4, Section 36 in Township 2 South, Range 1 East. The centroid coordinates for the Study Area are 45.3570923°, -122.6249728°. The Study Area is situated on situated on a southeast-facing slope and local topography is influenced by the drainage swale occupied by Sunset Creek.

Study Area (shaded) overview map

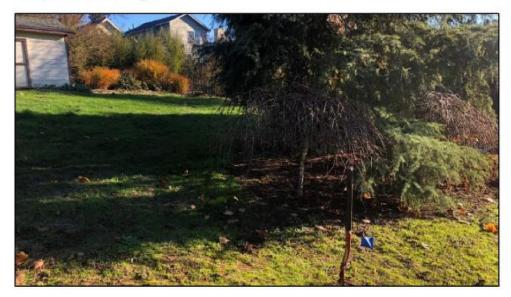
Looking northeast towards SP\_01

Field investigation of the Study Area was conducted on December 5th, 2018. The field investigation utilized the "Routine Onsite" method from the Corps Wetland Delineation Manual (USACE, 1987) as guidance. The Study Area was traversed by foot and a visual assessment was conducted for hydrophytic vegetation, suspect topographical features, and wetland hydrology indicators. Two sample plots were placed upslope of the Sunset Creek channel to document upland (non-wetland) conditions there. Sample plot soil pits were dug to a depth of 20". Absolute aerial cover of plant species was reported for tree, shrub and herb layers, utilizing 10-, 5-, 1-meter square plots respectively. Soil colors (wet) were determined using Munsell soil color charts (Gretag Macbeth 2000). Ordinary High-Water Lines (OHWLs) were determined by mapping the upland limit of the physical and biological characteristics outlined in Army Corps of Engineers Regulatory Guidance Letter 05-05 (USACE 2005). Considering that the timing of field investigation coincided with a dry period, wetland hydrology would be assumed for plots possessing both positive hydric soil and hydrophytic vegetation determinations, though in practice each sampling area resulted in upland soil and vegetation determinations.

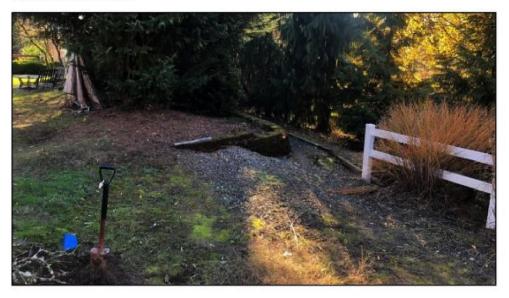
Looking south toward SP\_02

No wetlands are present within the Study Area and each of the sample plots resulted in upland determinations. The location of Study Area sample plots is illustrated in Appendix B-Figures 1 & 2. Wetland delineation data forms and ground-level photographs are included in Appendix C. Soils in the Study Area are predominately dark brown (7.5YR 3/3) and silt loam in texture and do not the redoximorphic features associated with persistent seasonally high ground water. A single soil map unit (major component) is present in the Study Area: "Saum silt loam, 8 to 15 percent slopes" (NRCS 2018). The map unit is non-hydric and described as well-drained. Soils observed during field investigation closely resemble the pedon descriptions of "Saum" soils. Study Area sample plots were dominated by ornamental trees and lawn grasses including perennial ryegrass (Lolium perenne) along with a mix of annual weeds including common groundsel (Senecio vulgaris), crabgrass (Digitalis sanguinalis), dovefoot geranium (Geranium molle), subterranean clover (Trifolium subterraneum) and annual bluegrass (Poa annua). Within the Study Area, channel of Sunset Creek is located primarily on tax lot 800 with a small portion on the adjacent public road right of way. Vegetation along the northern section of the creek is maintained as a backyard, with lawn grasses interspersed by raised beds and ornamental plantings. Vegetation along the lower, southern portion of the creek is more natural in character and hosts native riparian species including willows, western red-cedar (Thuja plicata) and ferns (Athyrium filix-femina). The channel is somewhat incised and the OHWL was determined by mapping the top of bank. The channel, along with the proposed 15' development buffer is illustrated in Appendix B-Figures 1 & 2.

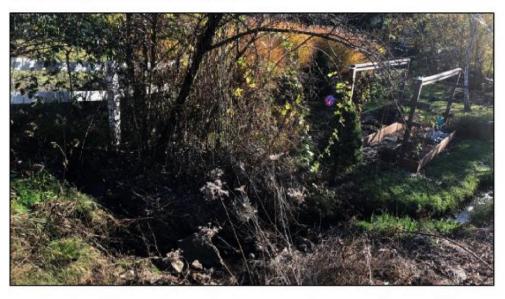
Looking at Sunset Creek on the north portion of tax lot 800.

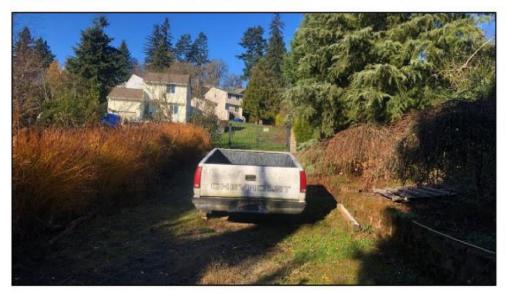
Looking northwest from the south-central portion of the Study Area
