**DEVELOPMENT REVIEW APPLICATION**

For Office Use Only		
STAFF CONTACT <b>Chris Myers</b>	PROJECT NO(S). <b>MIP-22-01/WAP-22-01/MISC-22-06/WRG-22-01</b>	PRE-APPLICATION NO. <b>PA-22-01, 02</b>
NON-REFUNDABLE FEE(S) <b>\$500</b>	REFUNDABLE DEPOSIT(S) <b>\$2,800 + \$1,700 + 1,050 + 1,850 = \$7,900</b>	TOTAL

**Proposal:** This application requests approval of a three-lot partition, including WRG and WRAP reviews, for property located at 1220 9th St, West Linn in West Linn. The property is located at the intersection of 9<sup>th</sup> Street and 3rd Avenue in the Willamette area of West Linn. It is presently developed with one single-family home and a large outbuilding. The subject property is 49,208 square feet in area and is zoned R-10. The Clackamas County Assessor's description of the property is the eastern portion of Tax Lot 31E02AC000300. Tax Lot 300 is comprised of two legal platted lots of record: Tract C and Tract D. The partition is located on Tract D. Tract C will be developed separately with one single-family residence and is not a part of the partition application. It is included, however, with the HCA application relating to wetlands on the property.

1220 9th Street -

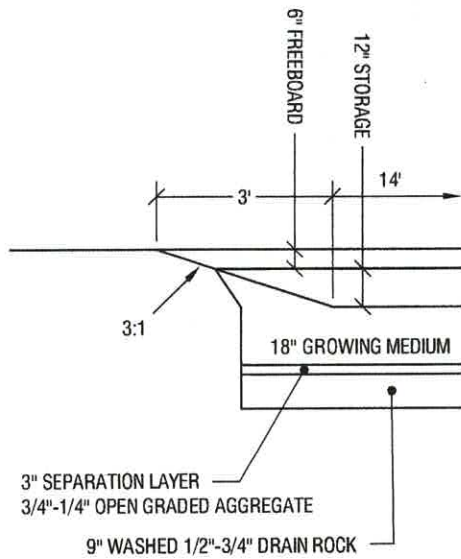
**SECTION**

- ⊙ POLYPODIUM MUNITUM (SWORD FERN)
- @ 24" O.C. - ZONE B
- JUNCUS TENUIS (SIENDER SEDGE)
- CAREX DENSAI (DENSE SEDGE)
- SCRIPTUS AMERICANUS (AMERICAN BULLRUSH)
- 1/3 EACH @ 12" O.C.

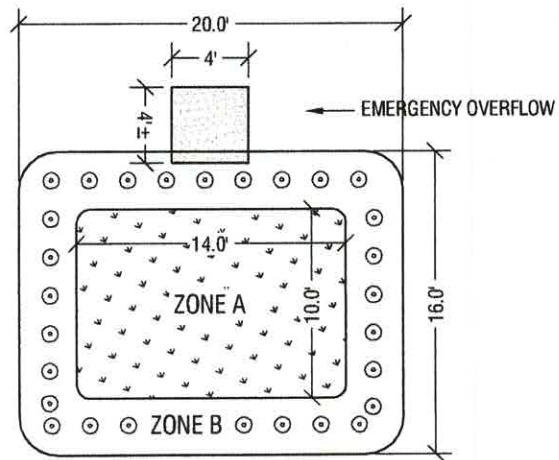
**RAIN GARDEN**

Applying the site information to the City of Portland software a facility was sized with a rain garden having a facility bottom area of 140 SF and meeting the pollution reduction and onsite infiltration. (See Attached). These calculations demonstrate feasibility and will be modified when actual development plans are available.

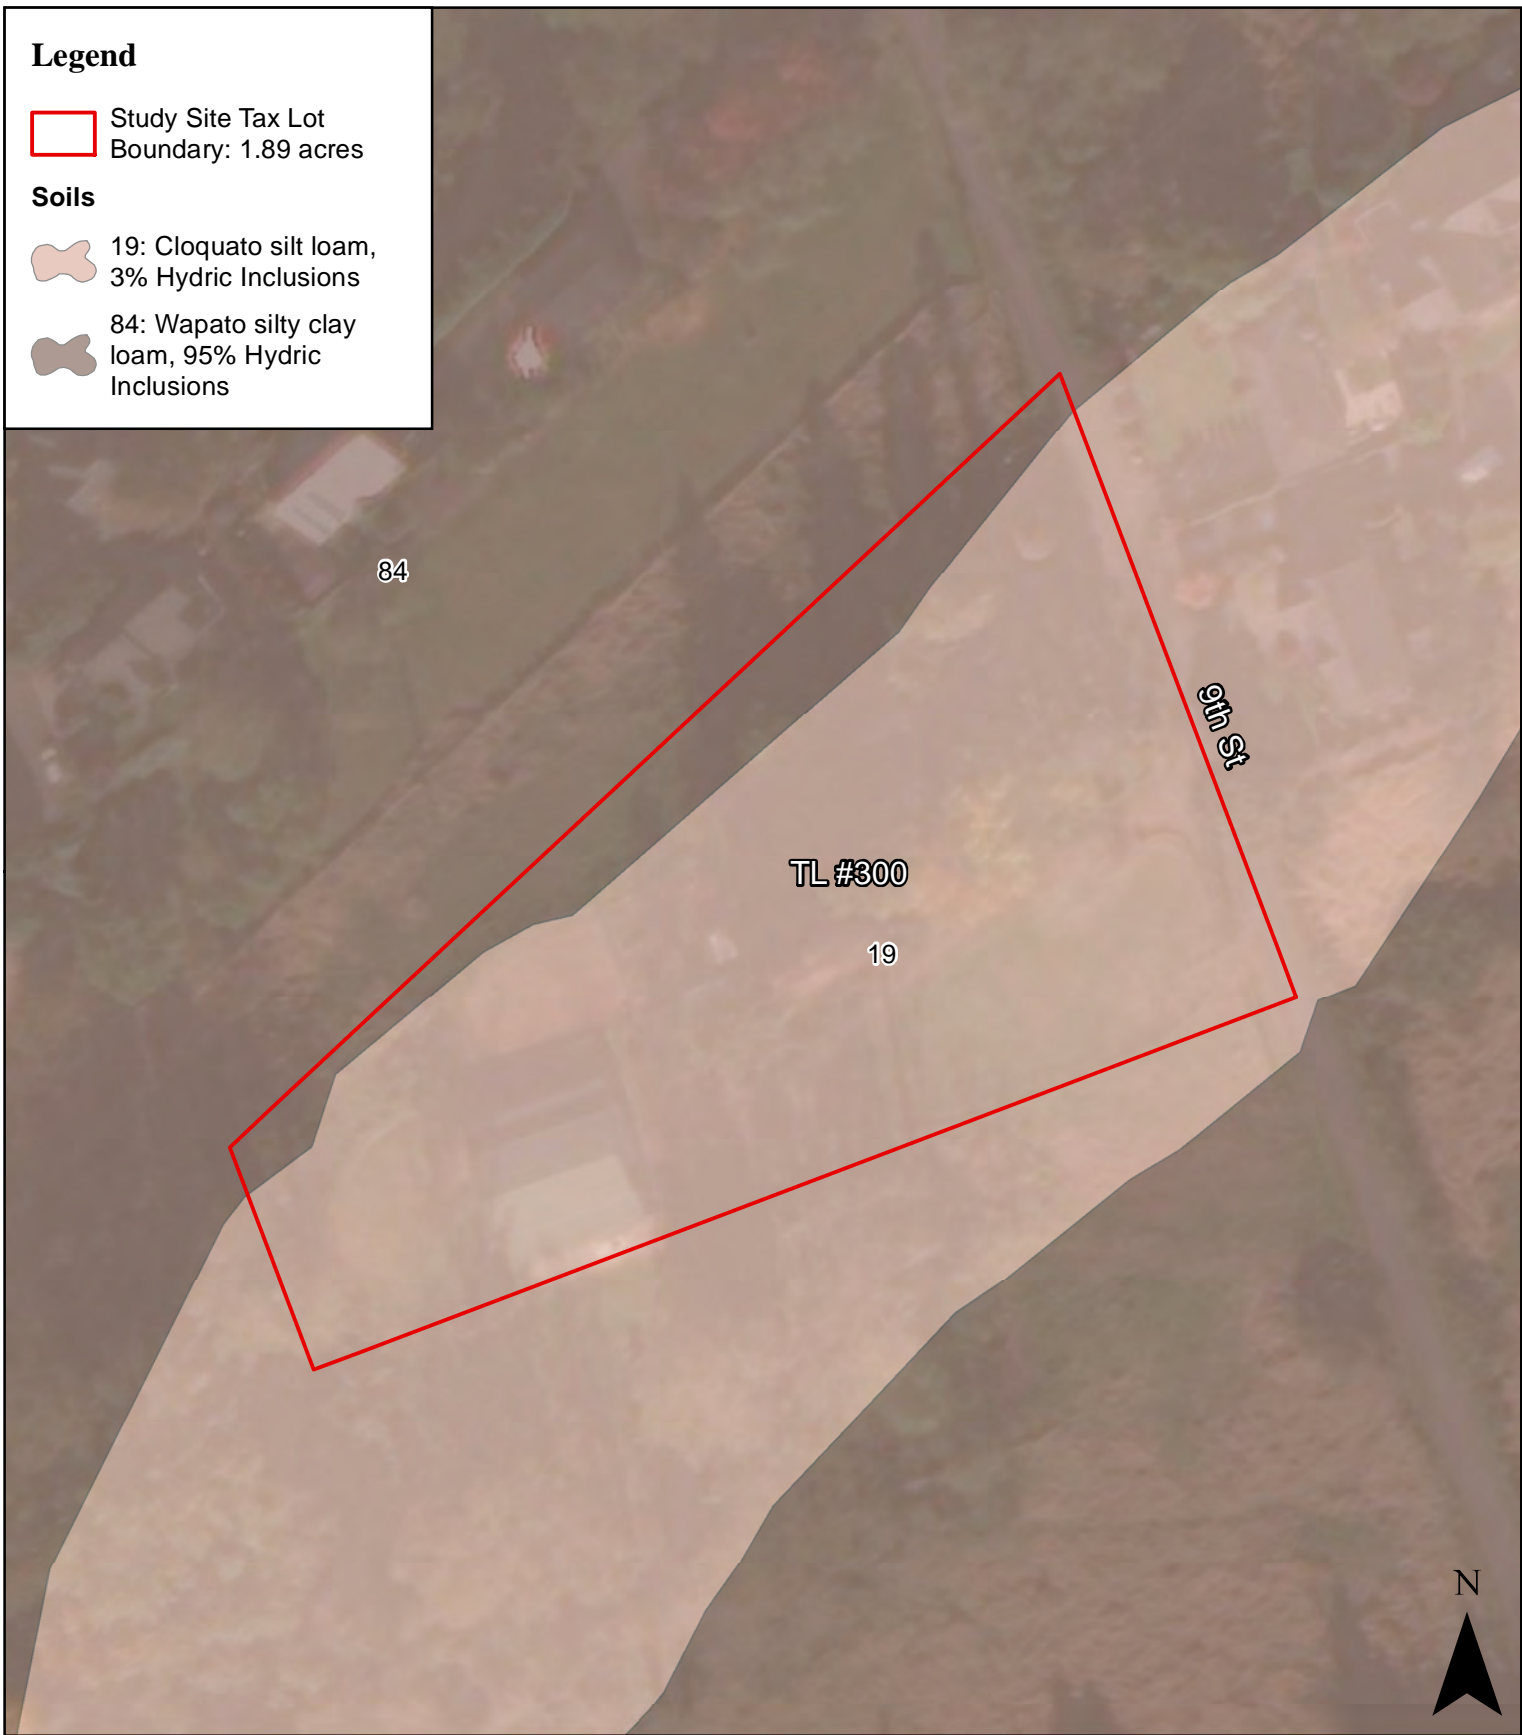
FIGURE 4: USDA/NRCS SOIL SURVEY MAP

Two soil series were mapped within the study site boundary according to the USDA NRCS soil survey for Clackamas County. Cloquato silt loam was mapped over most of the site. This is a well-drained series found predominantly in flood plains with 3% hydric inclusions. Wapato silty clay loam mapped was at the northern margin of the site. This poorly drained soil is listed as a hydric soil series as well as containing inclusions of other hydric soils.

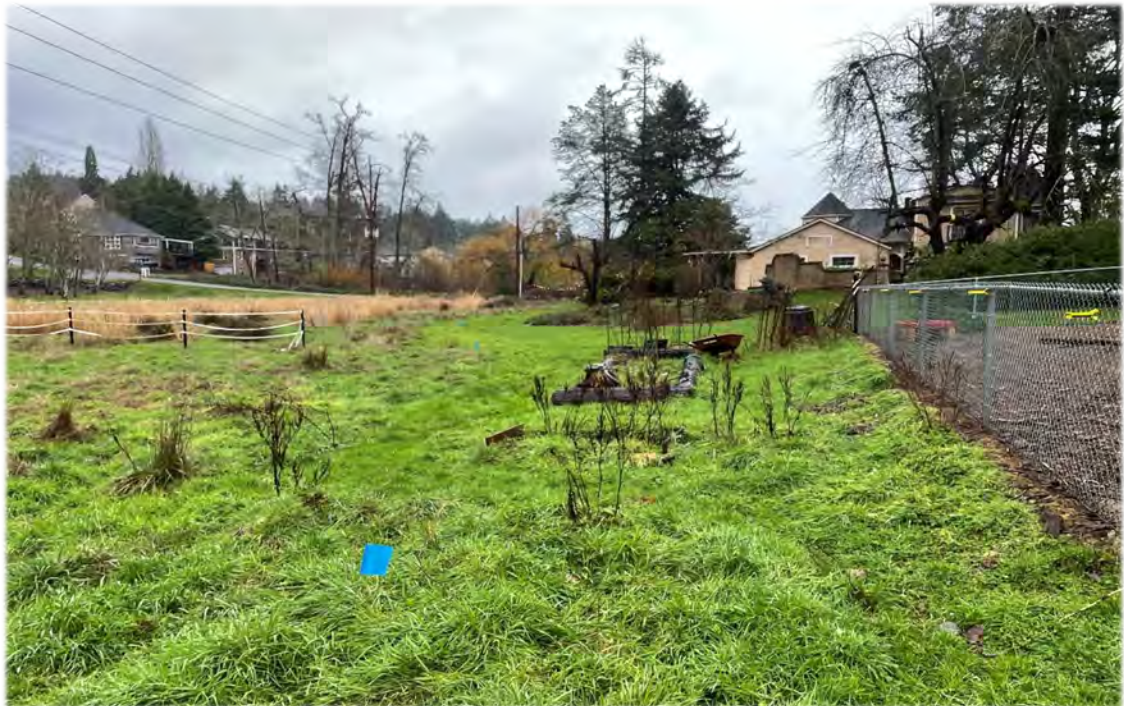
Photo Point 2. Facing northeast. Blue flags demarcate approximate wetland boundary.

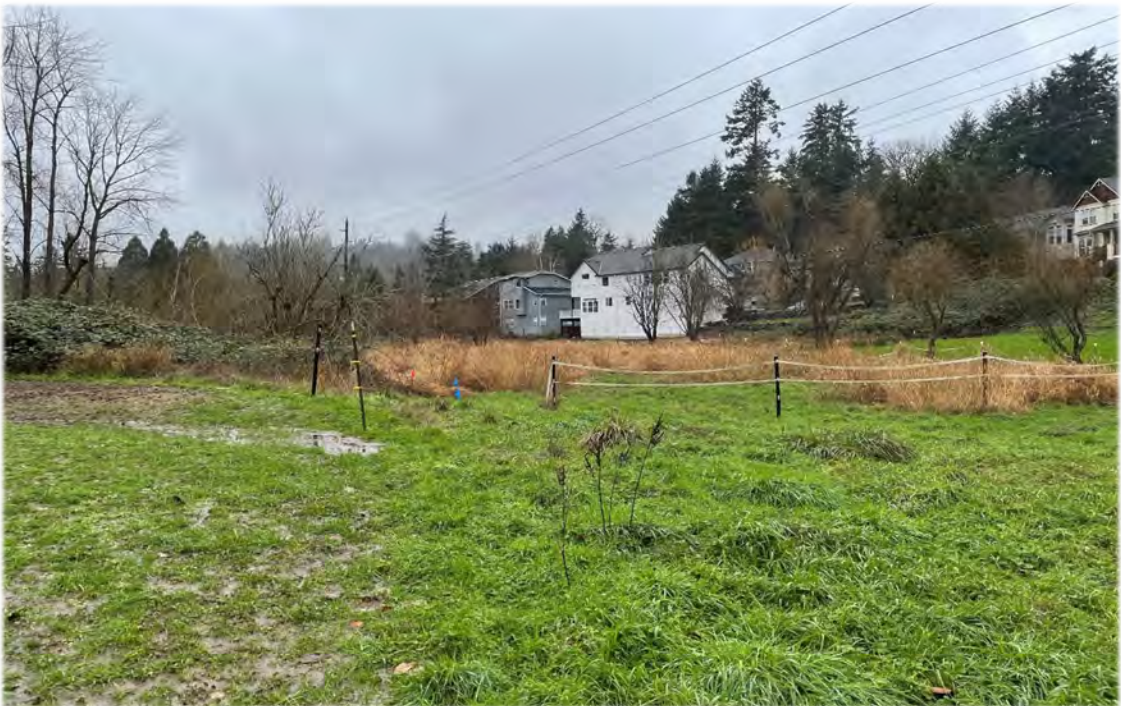
Photo Point 2. Facing southwest. Blue flags demarcate approximate wetland boundary.

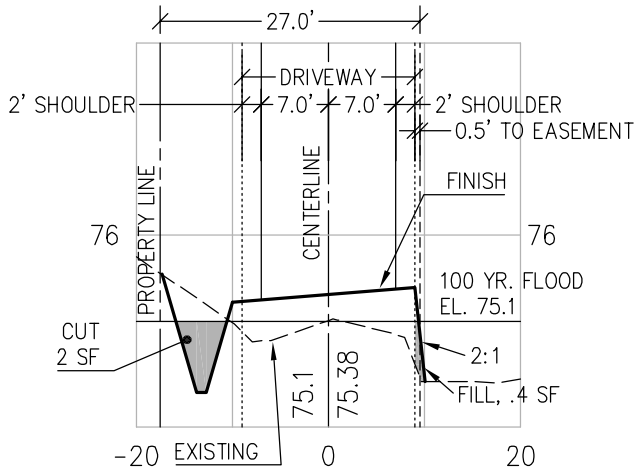
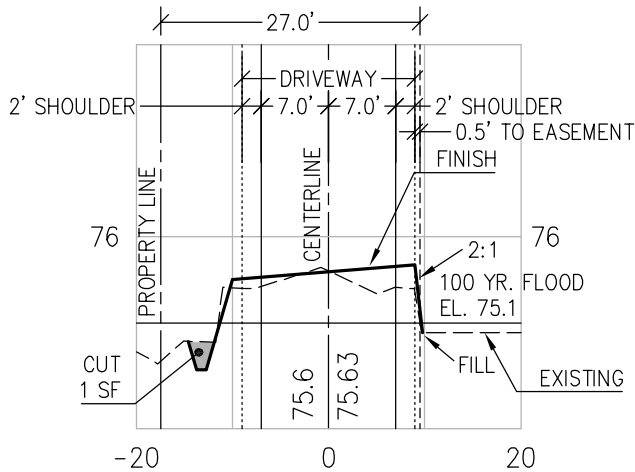
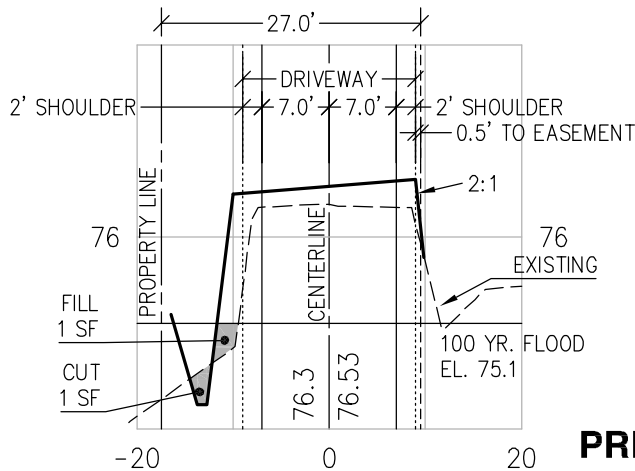
## PRELIMINARY CALCULATIONS FOR PRIVATE DRIVE CUT/FILL IN 100 YEAR FLOOD PLAIN

STATION	DIST.	CUT	FILL	VOL. CUT	VOL. FILL
0+00		0 SF	0 SF		
0+50	50	2 SF	0 SF	50	
1+00	50	1 SF	0 SF	75	
1+35	35	1 SF	1 SF	85	18
TOTAL				5.9 C.Y. CUT	0.6 C.Y. FILL
				NO NET FILL

Response: A small portion of the subject property is indicated on FEMA flood hazard maps as being located within the 100-year floodplain of the Willamette River. This area affects the access driveway near 9<sup>th</sup> Street and a small area in the southerly portion of Parcel 2. The approved plans for the construction of the driveway and the homes on land to the south of the subject property call for the finished grade of the driveway to isolate the floodplain area of the subject property from the balance of the 100-year floodplain. This will effectively remove the subject property from the floodplain as no flood waters will be able to access the lower portion of this site. For this reason, the subject property is no longer subject to the provisions of the Flood Management Area Overlay Zone.
