**NATURAL RESOURCE ASSESSMENT**

**19679 Wildwood Drive**

T2S, R1E, Section 23AC, Tax Lot 4600  
West Linn, Oregon

September 2022

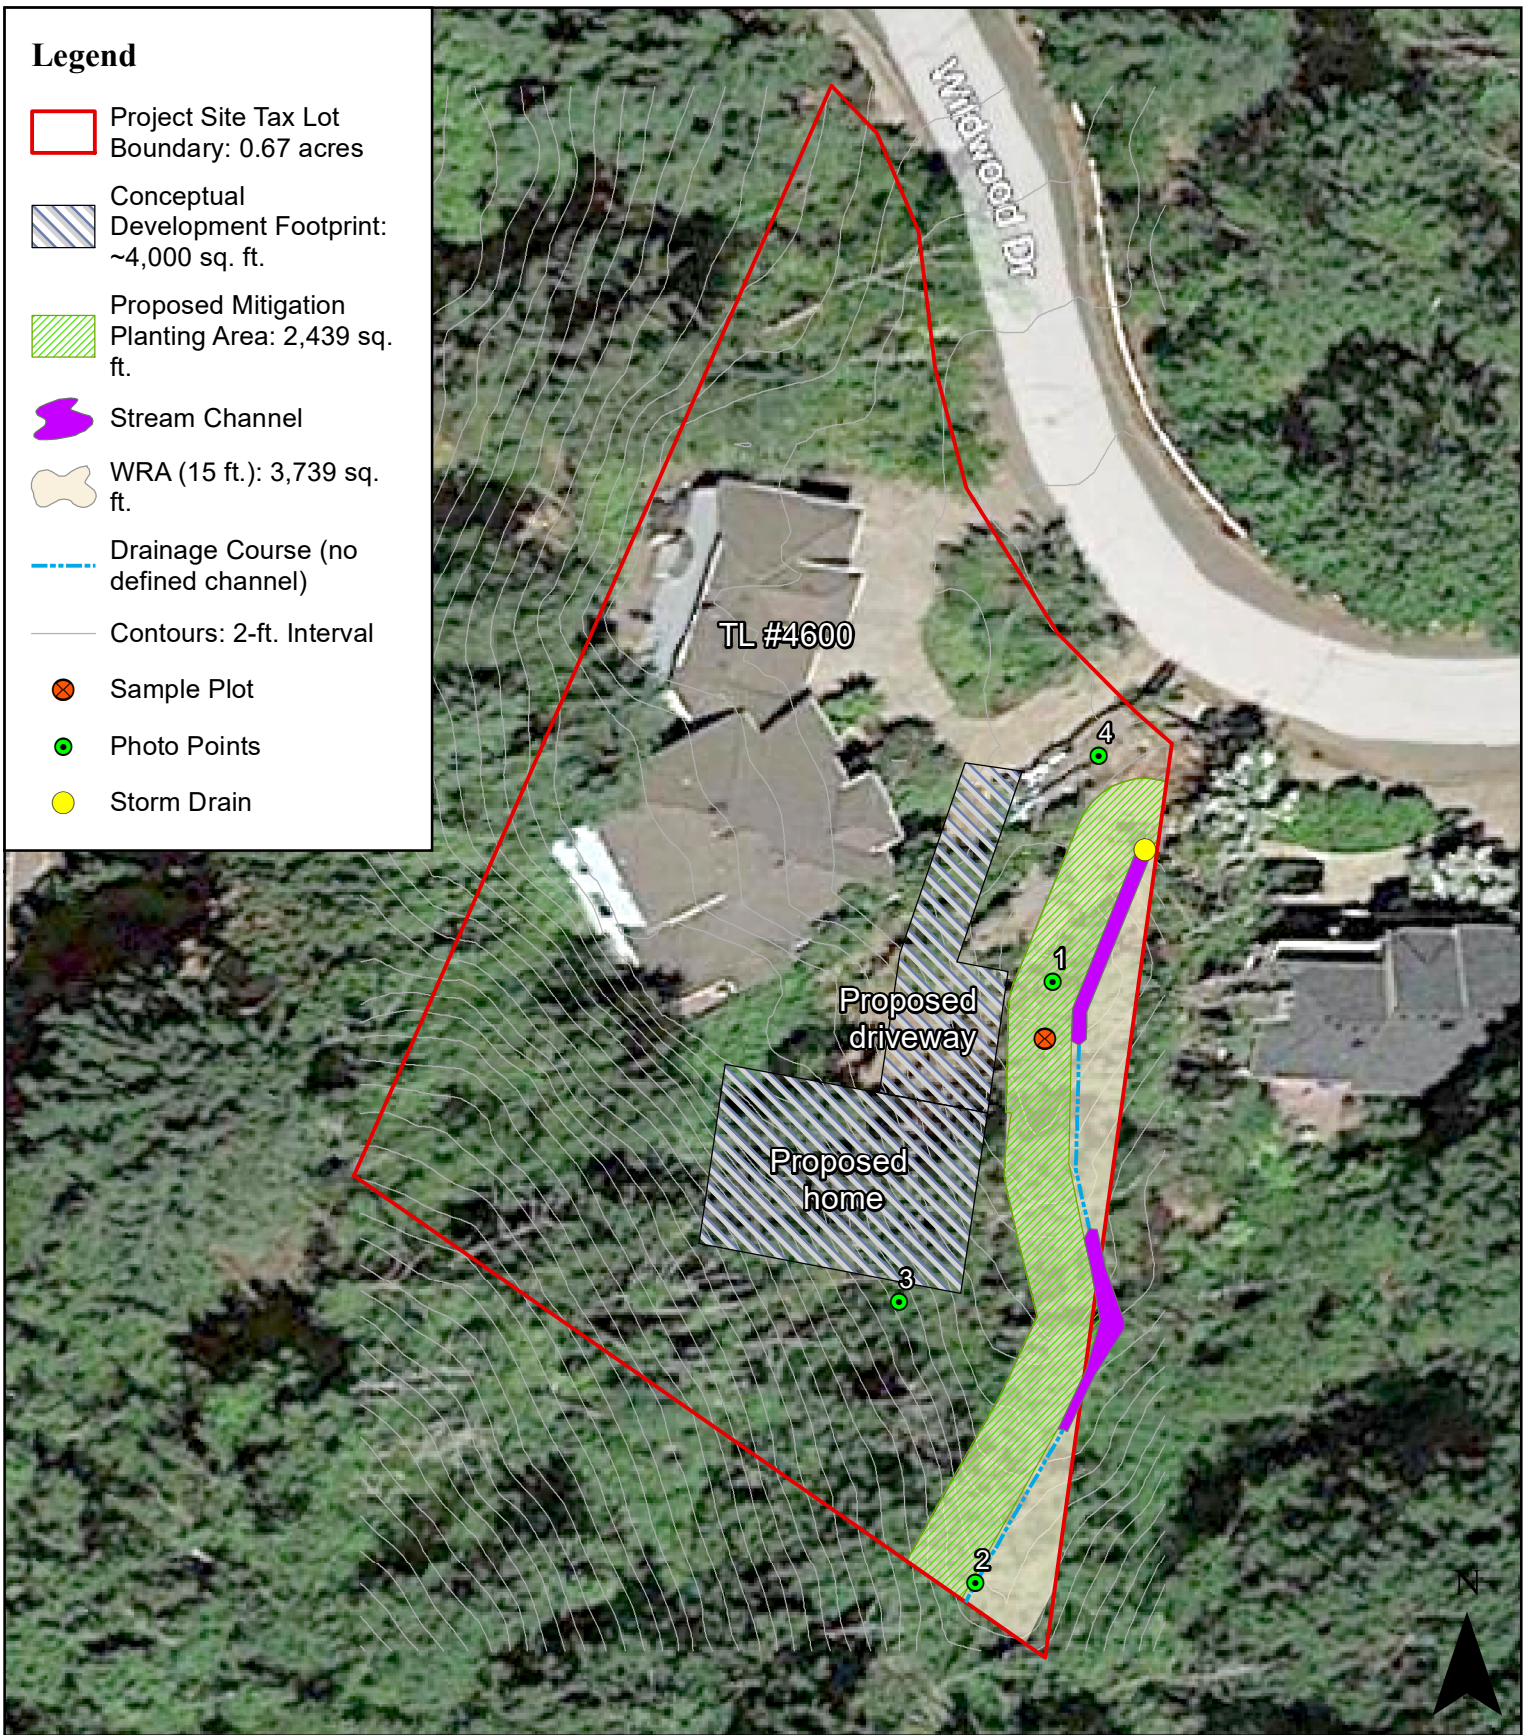
Figure 2. Existing and Proposed Conditions

**FIGURE 2: EXISTING AND PROPOSED CONDITIONS**

The applicant proposes a minor partition of the lot and construction of a new residential development and driveway in the northern portion of the tax lot. The proposed construction will be adjacent to the existing home with an approximate footprint of 4,000 sq. ft. The home has not been designed yet, but a conceptual sketch is shown on Figure 2. This sketch is provided for illustrative purposes only and has not been designed to meet City zoning or building ordinance.

The riparian corridor accorded to ephemeral streams is 15 feet from the stream centerline according to Table 32-2 of the CDC. The applicant requests approval of the 15-foot WRA under the Alternative Review Process per Section 32.080 based on the flow-period of the stream which has been established as ephemeral according to assessment by a natural resource professional. No impacts to the 15-foot WRA are proposed by this project. The applicant proposes voluntary enhancement of the WRA on the western side of the stream (2,439 sq. ft.) to improve functions and serve as a vegetated buffer between the proposed development and the stream. Enhancement would consist of removing invasive species and planting native trees, shrubs, and groundcover.

No impacts are proposed to the 15-foot WRA and no mitigation is required. However, the applicant proposes voluntary enhancement of the WRA along the west side of the stream. The enhancement plan shall consist of removal of invasive species and planting of a diverse assemblage of native trees, shrubs, and groundcover species to improve hydrological and water quality functions including slowing runoff and filtration of sediment, excess nutrients, and pollutants. Proposed enhancement will substantially improve adjacent terrestrial habitat of the WRA onsite by increasing cover, nesting or burrowing sites and food availability and type. Proposed enhancement area is 2,439 sq. ft. and no impact to WRA is proposed which exceeds the standards of CDC 32.090(C).

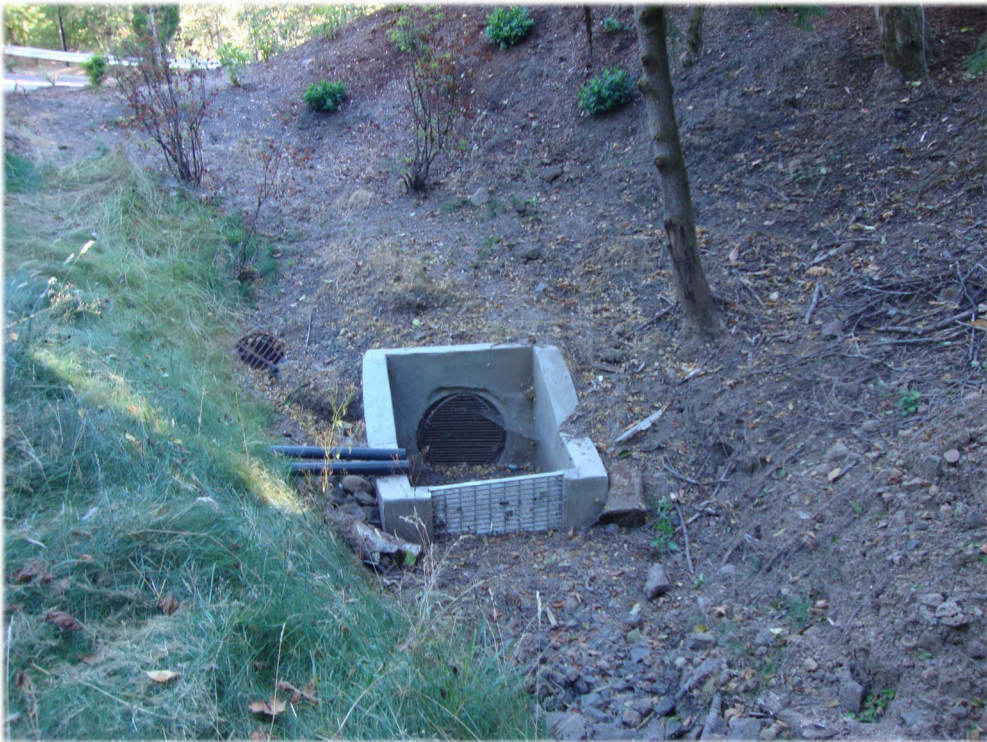
Photo Point 1. From the lower end of the drainage facing north toward the newly constructed storm drain.

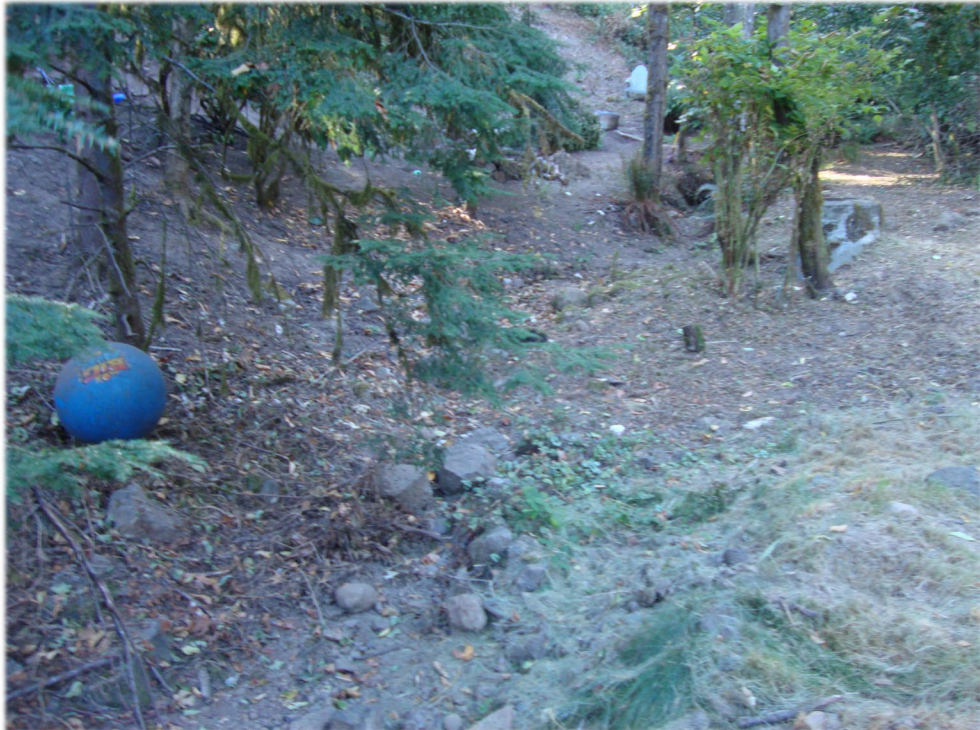
Photo Point 1. From the lower end of the drainage facing south, upstream. No defined stream channel is present.

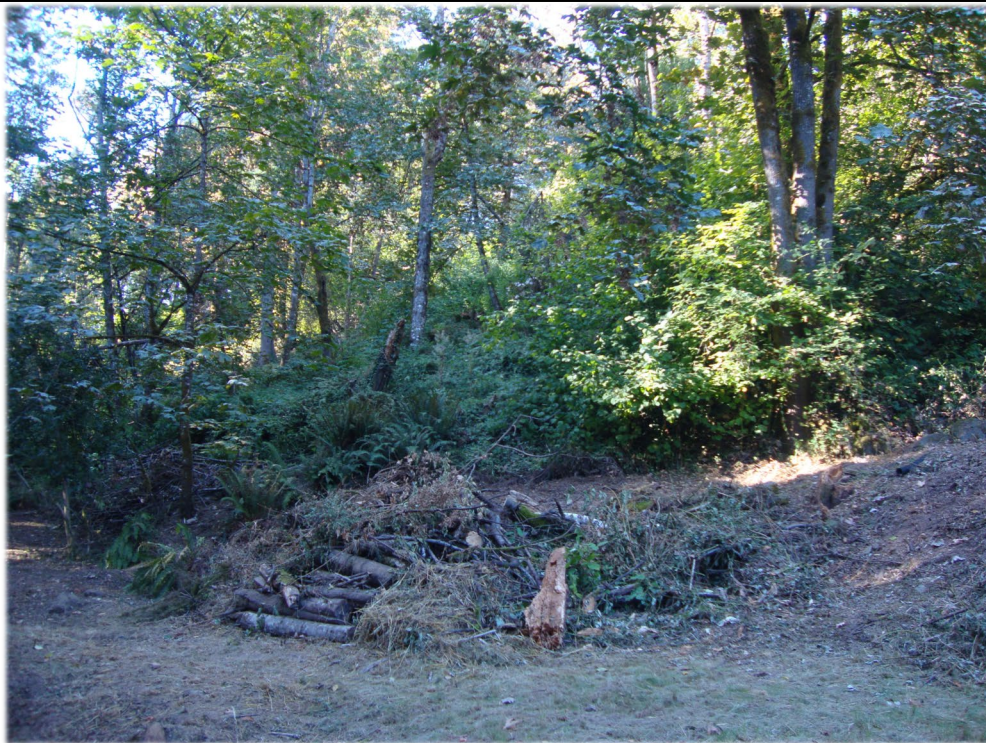
Photo Point 1. From the lower end of the drainage facing southwest toward stream terrace and area of cleared Himalayan blackberry.

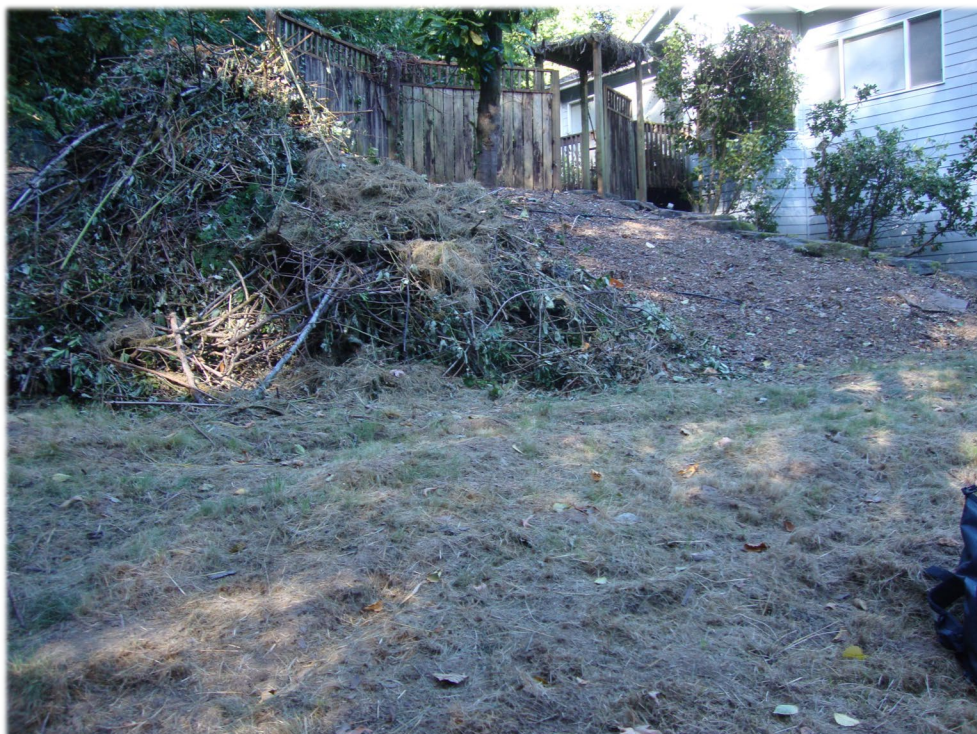
Photo Point 1. From the lower end of the drainage facing northwest toward stream terrace and area of cleared Himalayan blackberry.

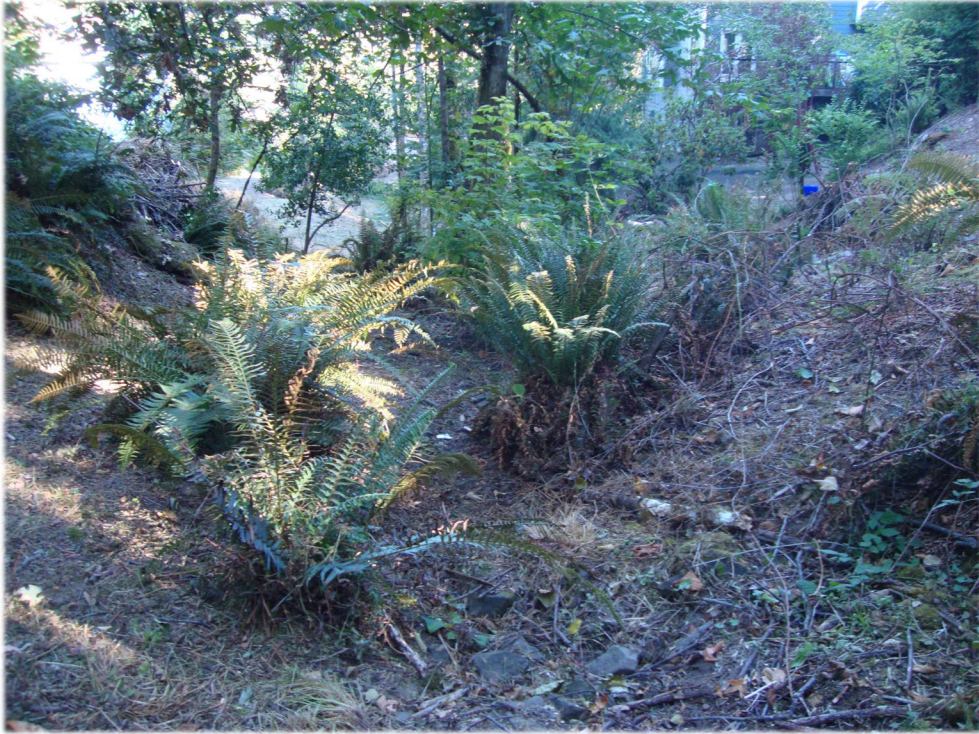
Photo Point 2.. From the upper end of the drainage at the southern property boundary facing north, downstream. No defined channel is present.

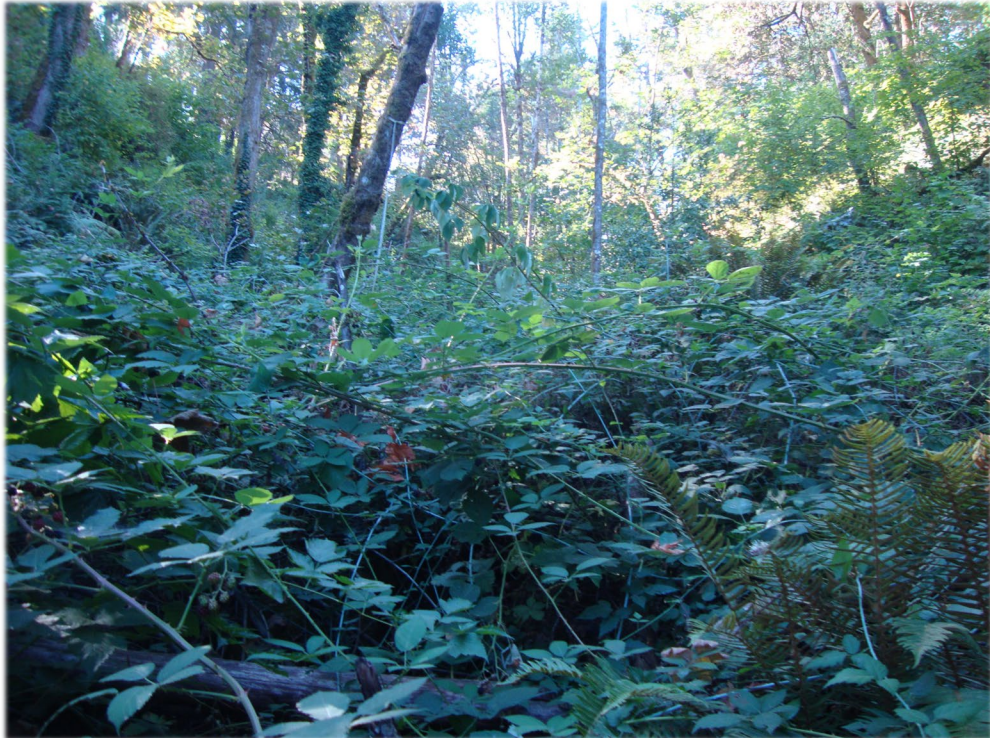
Photo Point 2.. From the upper end of the drainage at the southern property boundary facing south, upstream and offsite. No defined channel is present.

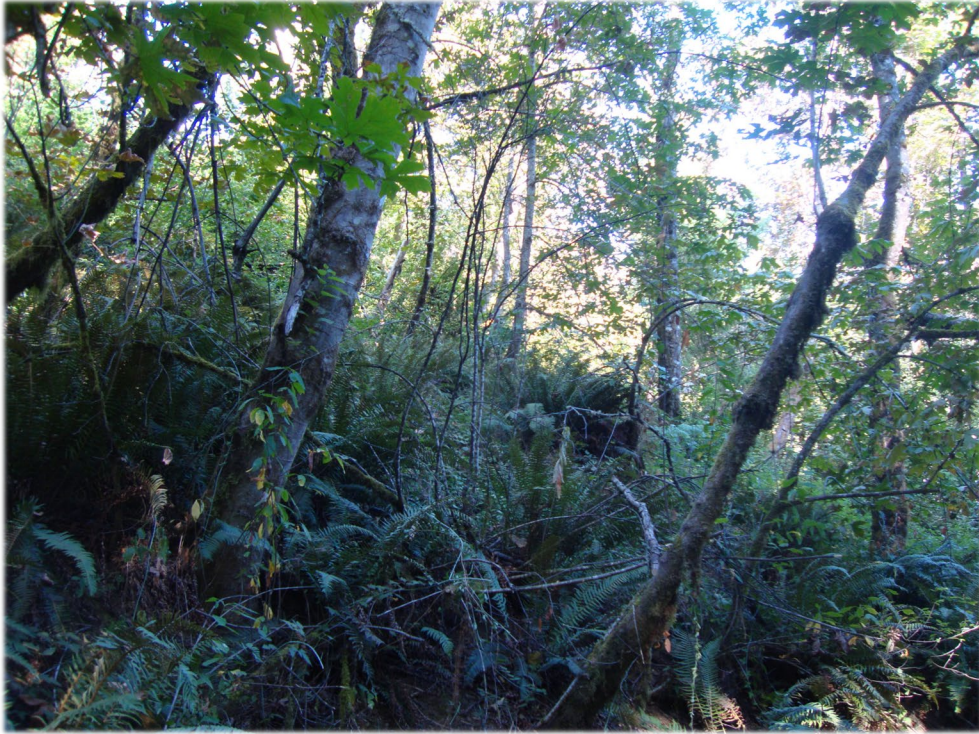
Photo Point 3. From the steep, forest hillside in the southern portion of the site facing southwest.

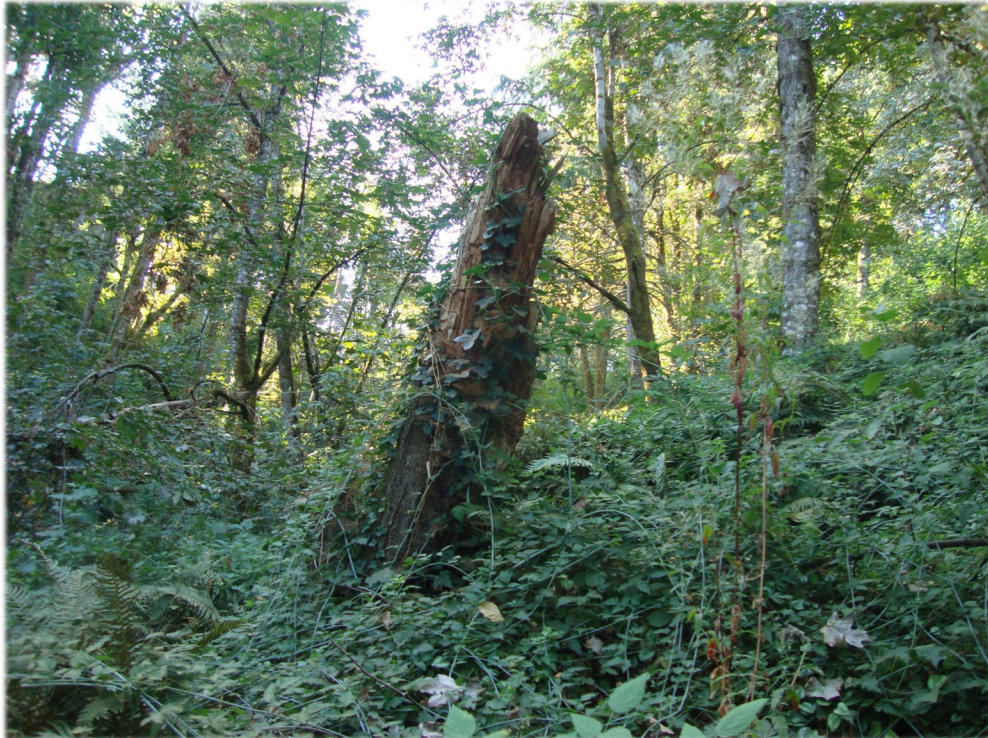
Photo Point 3. From the steep, forest hillside in the southern portion of the site facing northwest.

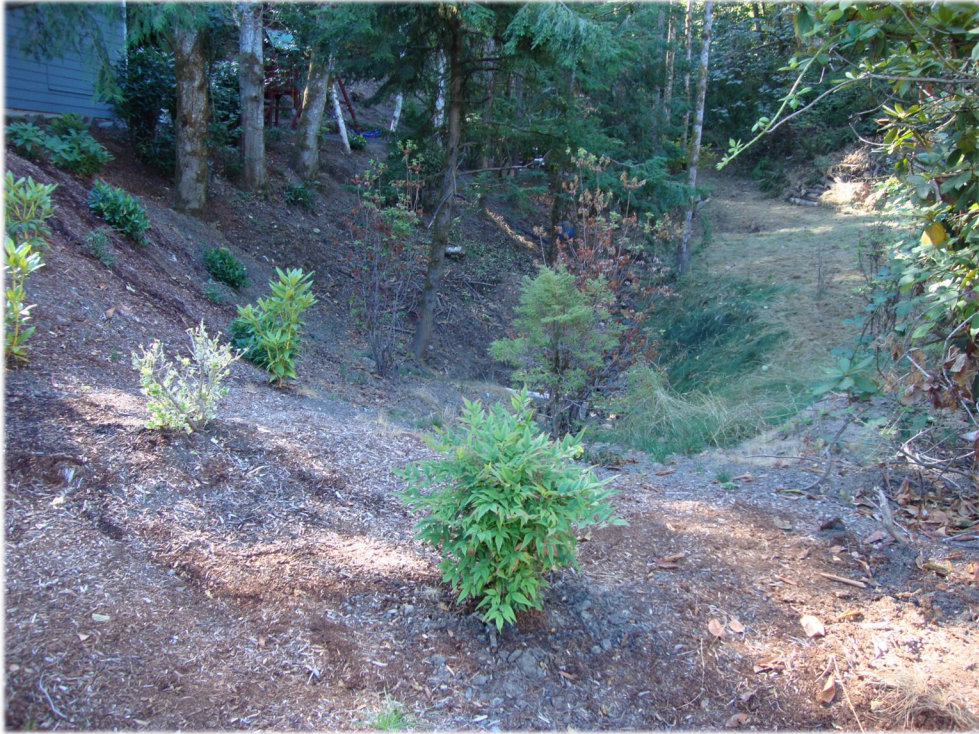
Photo Point 4. From the northern property boundary facing south toward the lower end of the drainage where it enters the storm drain.

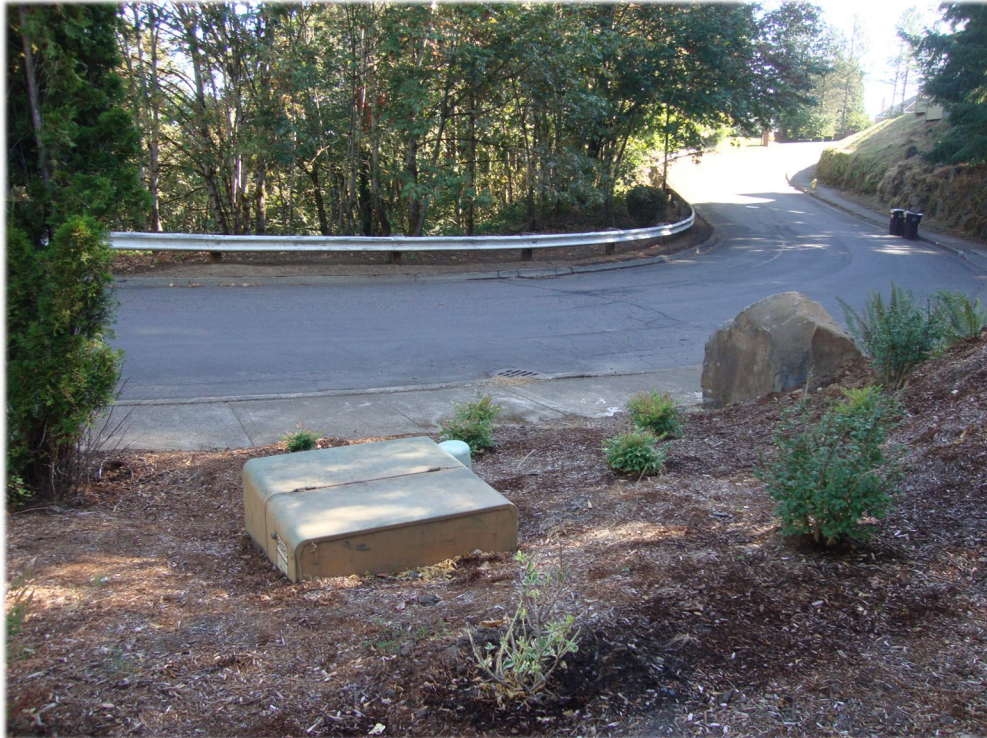
Photo Point 4. From the northern property boundary facing north, offsite. It is assumed the drainage continues on the other side of the road in a very deep ravine..
