3801 Calaroga Drive Flood Management Area Development Permit

Date: October 2023

Submitted to: City of West Linn

Applicant: Shaun Catlin

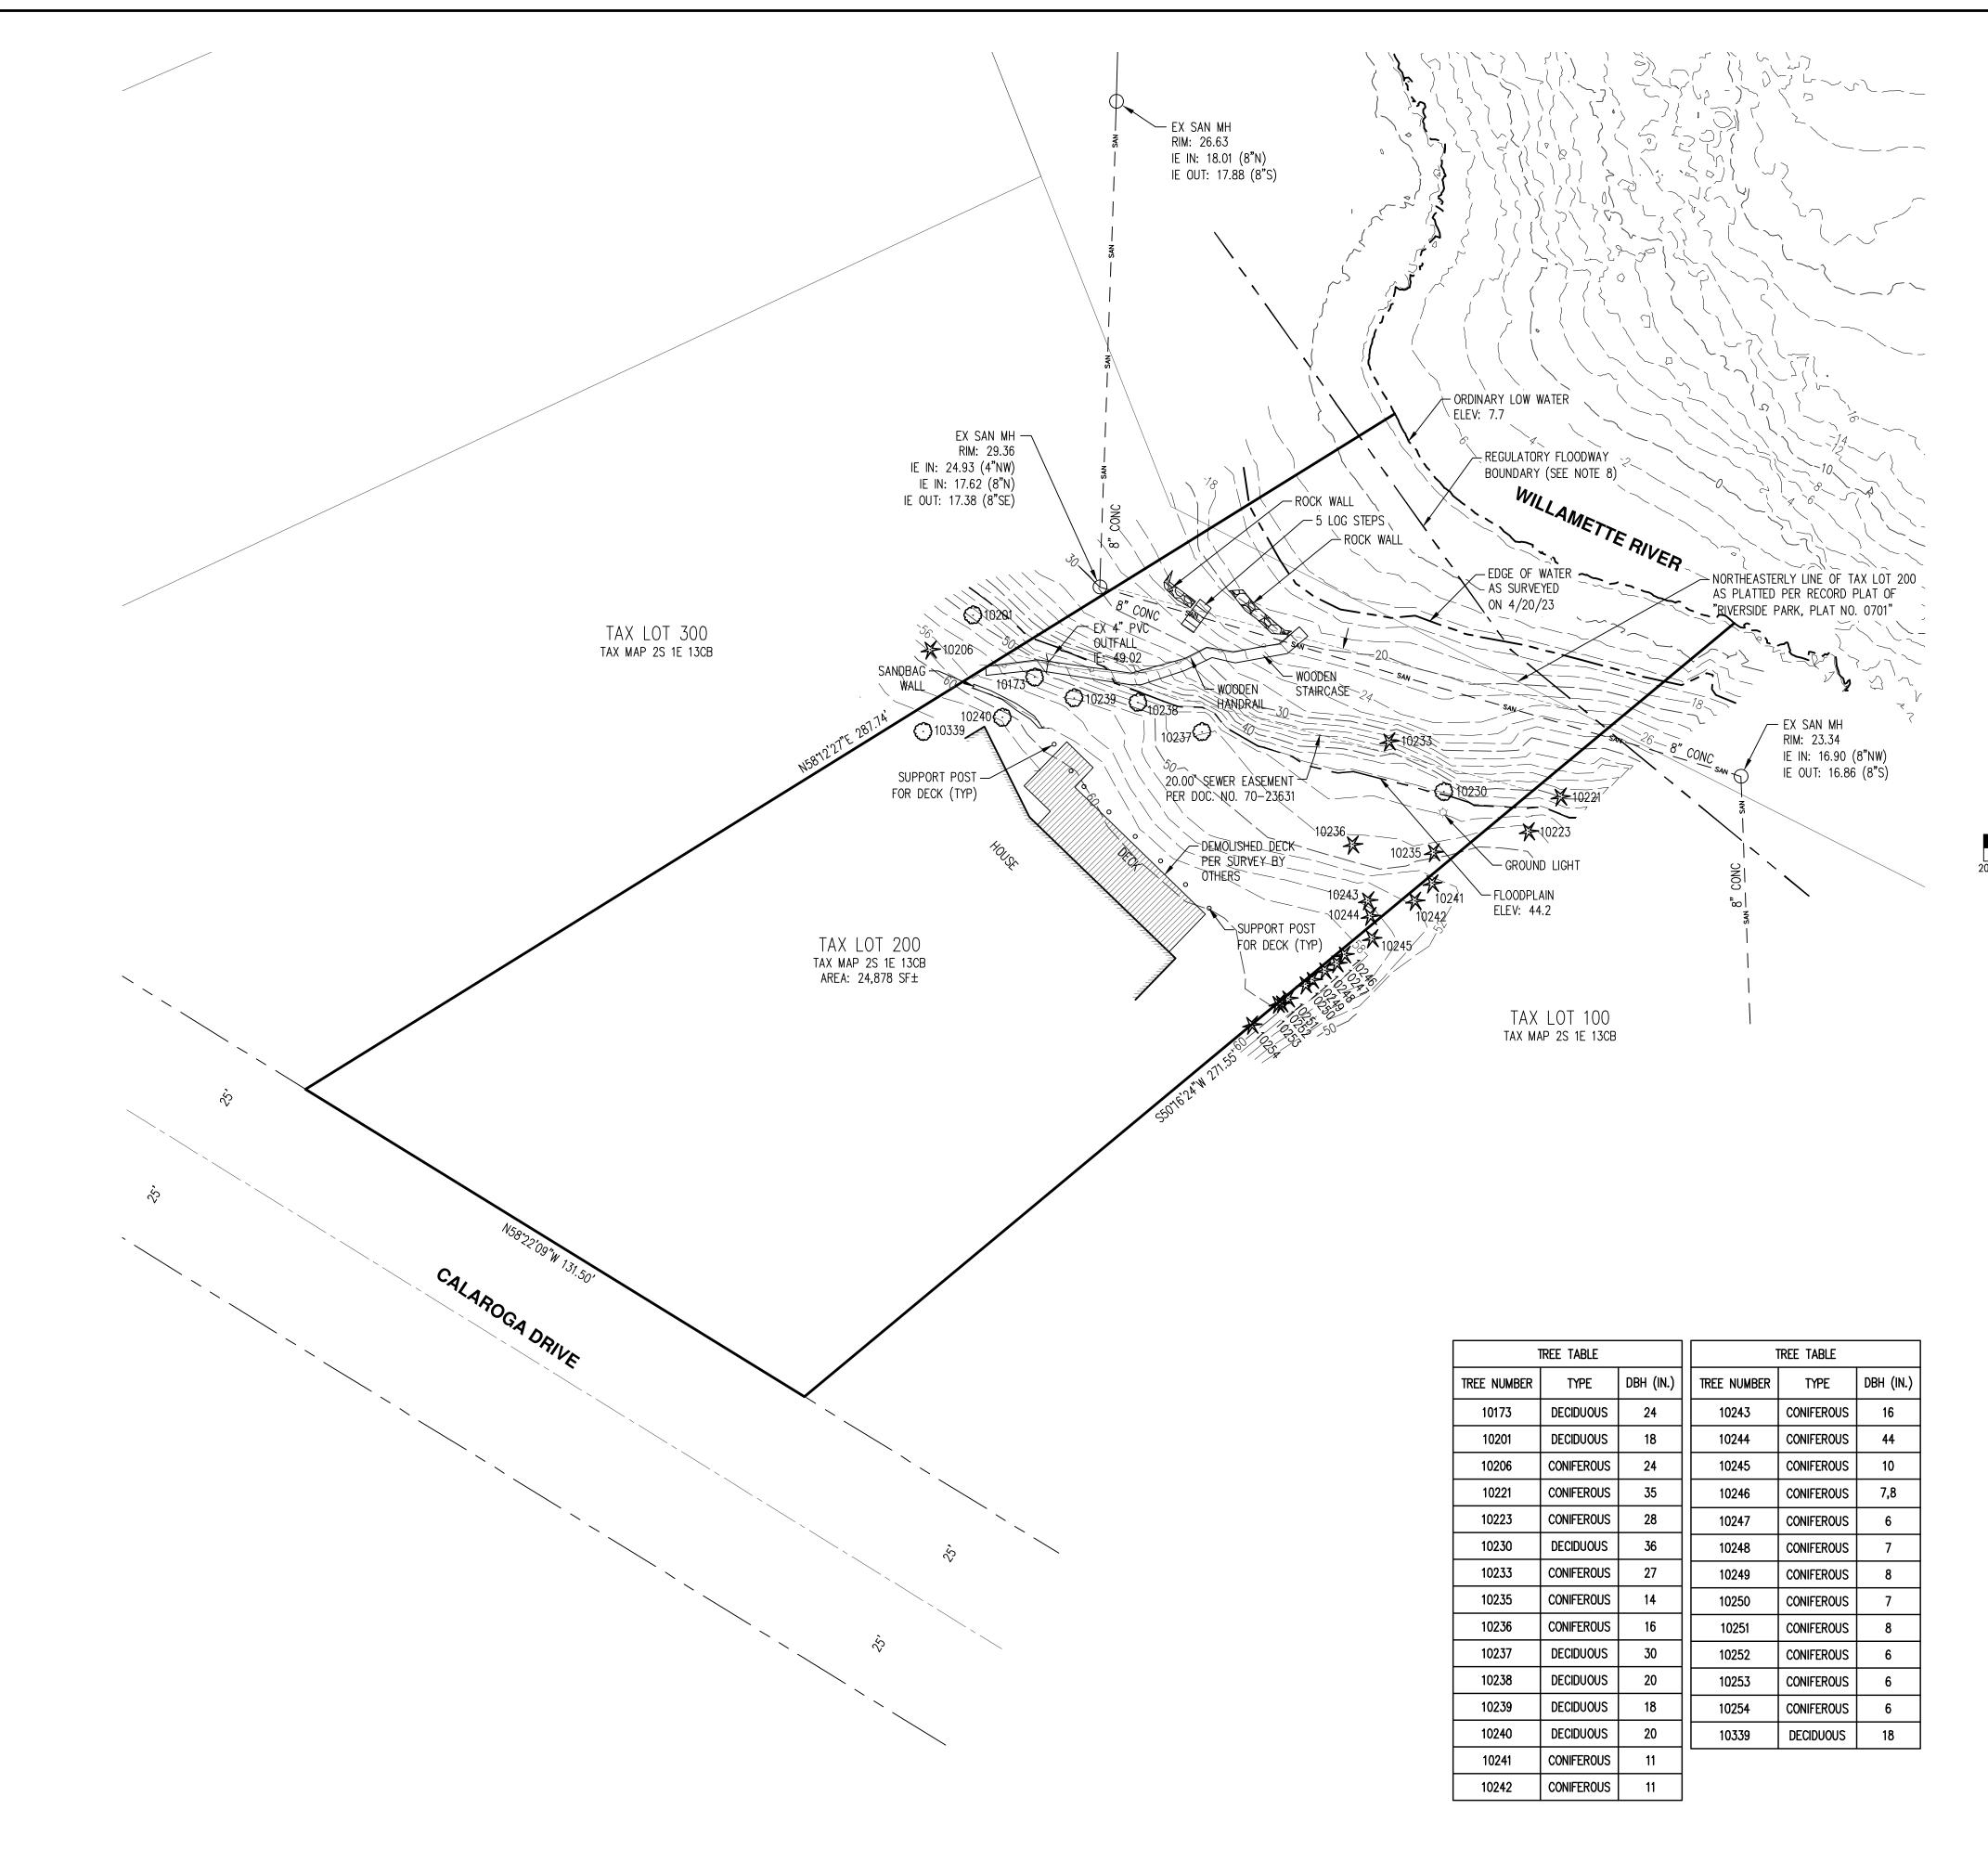
> SHEET **P01**

The Existing Conditions plan in Exhibit B confirms the presence of an existing staircase, log steps, and two separate rock walls that extend through the HCA toward the bank of

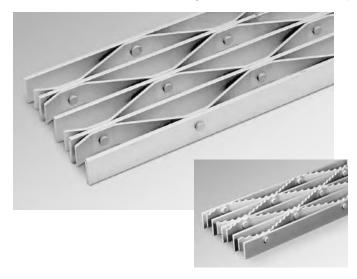
Riveted Grating Table of Spacings Available

Riveted gratings are the oldest form of grating and offer superior resistance to impact. Ideal for applications where high strength and stiffness are required. Manufactured by cold press riveting straight bearing bars to crimped rectangular flat bars, riveted gratings are available in carbon steel, 6000 series aluminum, and 300 series stainless steel. Bearing bars are spaced either 1-1/8" or 3/4" apart and the standard rivet spacing is 7 inches on center. Optional close rivet spacing of 3-1/2" on center is also available.

Standard serration includes serration of the reticuline bars which are raised slightly above the top plane of the bearing bars. Users may specify 100% serrated where both the bearing bars and cross members are provided with serration.

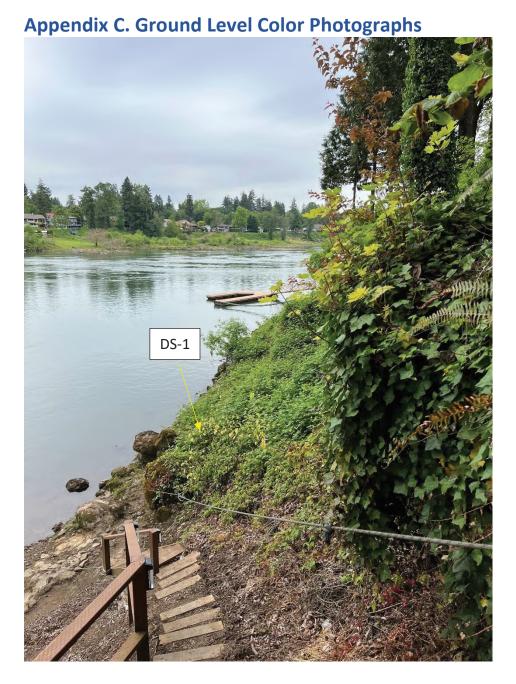
Figure 7a. Ground level photograph of cliff on Site between the house and Willamette River facing northeast; DS-1 is located within the toe slope between the cliff and the Willamette River. Flag presence is hard to spot due to vegetation growth. Note the boulders present.

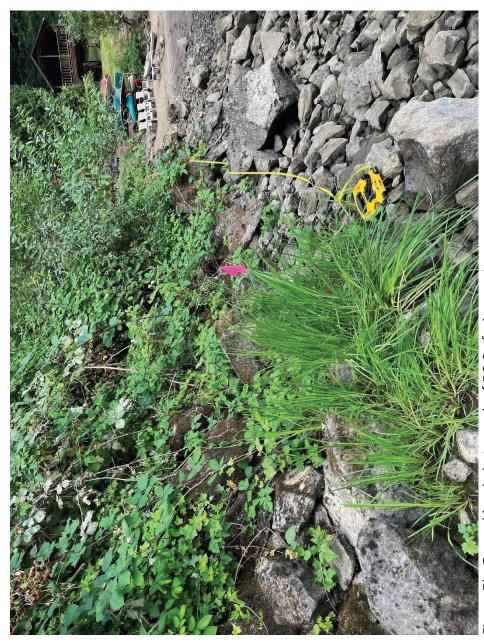
Figure 7b. Ground level photograph of DS-2a facing west.

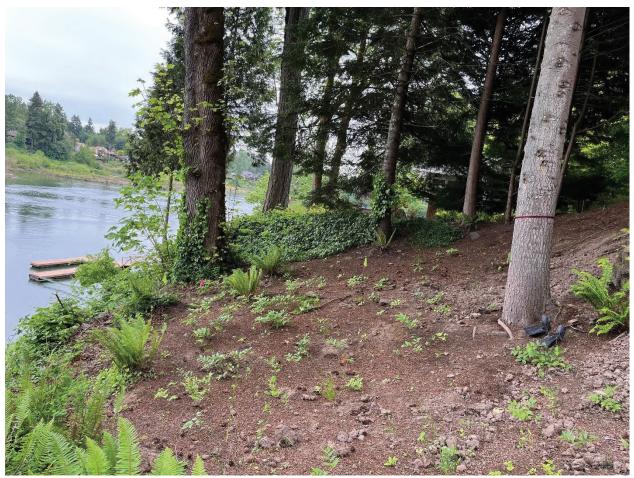
Figure 7c. Ground level photograph of DS-2b facing east.

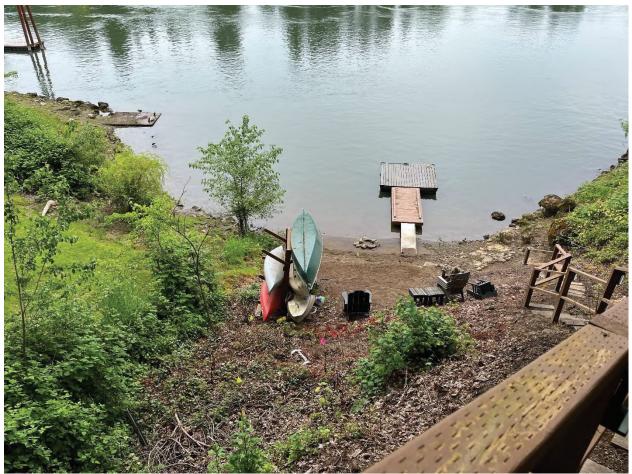
Figure 7d. Ground level photograph facing northeast of DS-3 (between the kayaks and the Willamette River) and DS-4 (between the kayaks and the stairway).

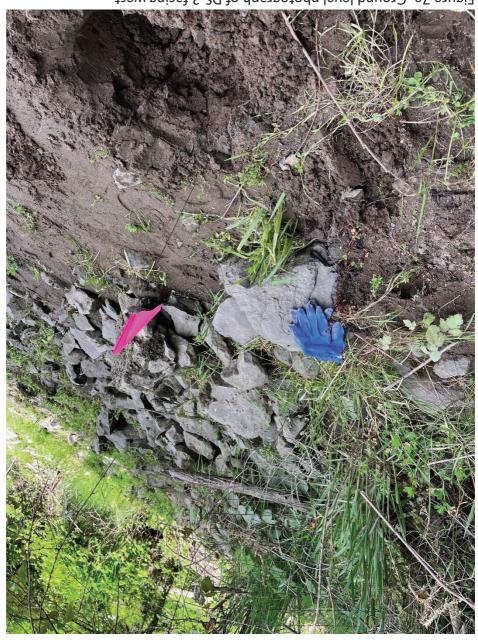
Figure 7e. Ground level photograph of DS-3 facing west.

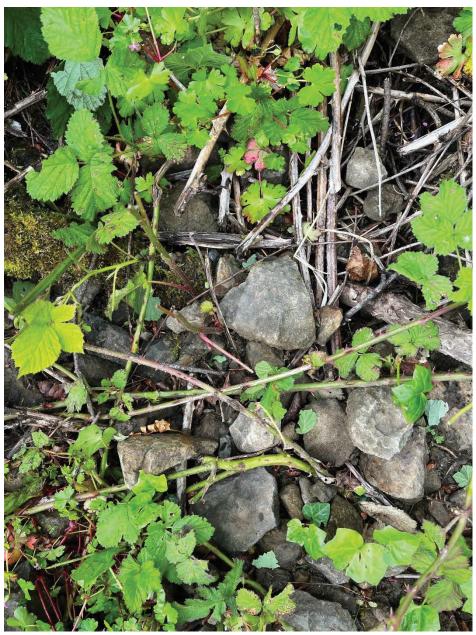
Figure 7f. Ground level photograph of restrictive soil layer at and adjacent to DS-1.

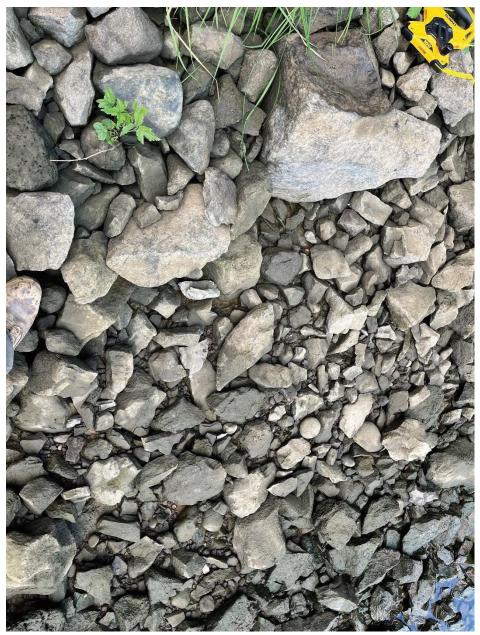
Figure 7g. Ground level photograph of restrictive soil layer at and adjacent to DS-2a.

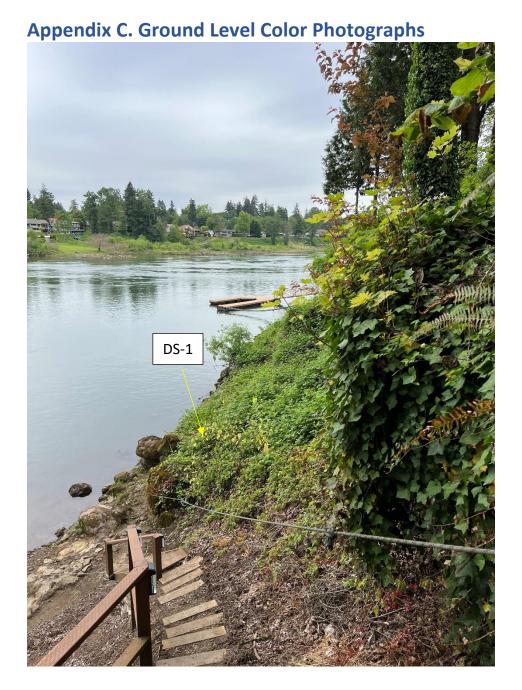
Figure 7a. Ground level photograph of cliff on Site between the house and Willamette River facing northeast; DS-1 is located within the toe slope between the cliff and the Willamette River. Flag presence is hard to spot due to vegetation growth. Note the boulders present.

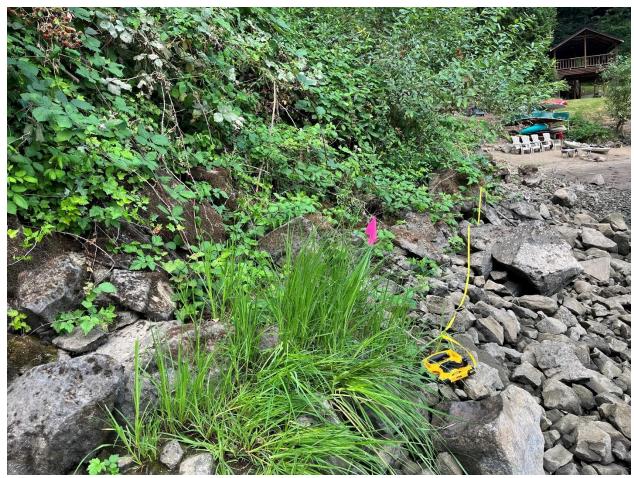
Figure 7b. Ground level photograph of DS-2a facing west.

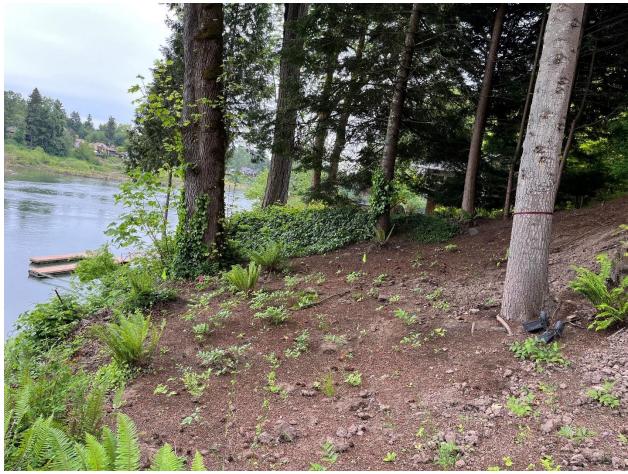
Figure 7c. Ground level photograph of DS-2b facing east.

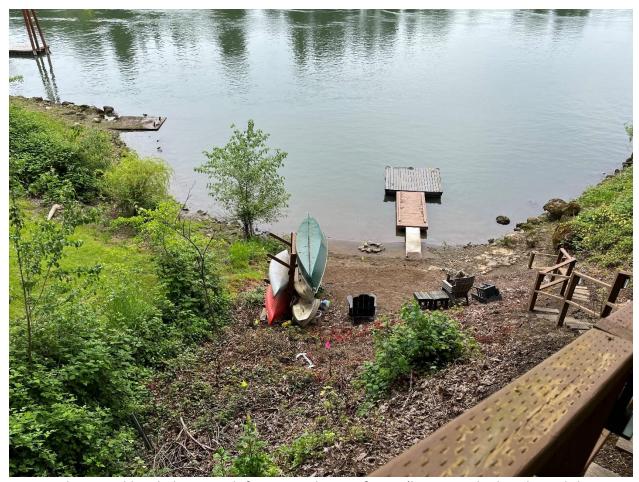
Figure 7d. Ground level photograph facing northeast of DS-3 (between the kayaks and the Willamette River) and DS-4 (between the kayaks and the stairway).

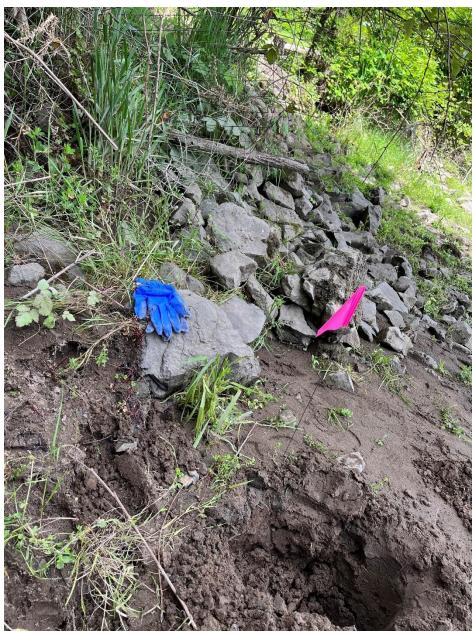
Figure 7e. Ground level photograph of DS-3 facing west.

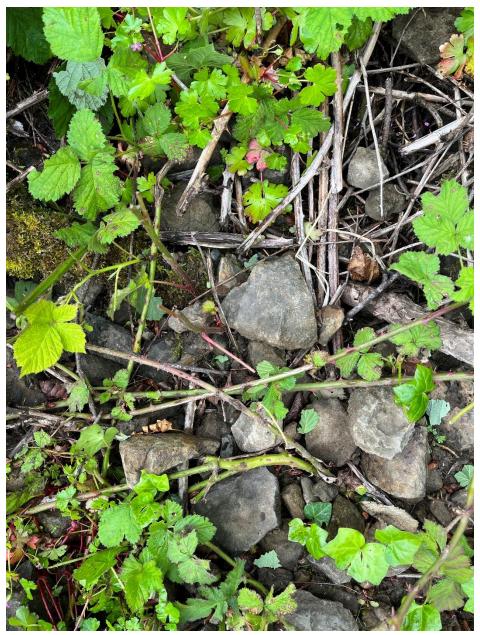
Figure 7f. Ground level photograph of restrictive soil layer at and adjacent to DS-1.

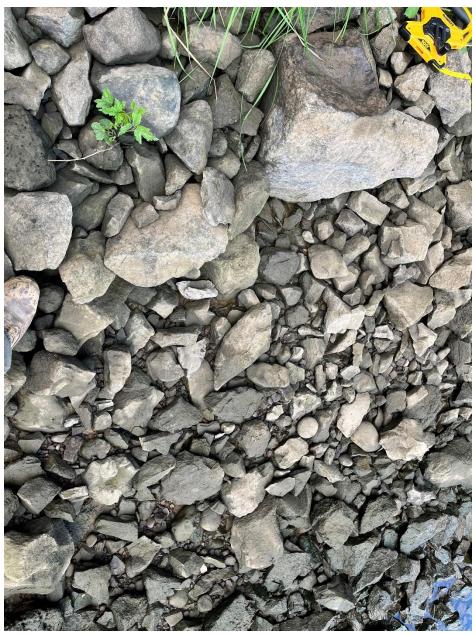
Figure 7g. Ground level photograph of restrictive soil layer at and adjacent to DS-2a.
