DEVELOPMENT REVIEW APPLICATION

Brief Description of Proposal: THE PROPOSED SINGLE FAMILY RESIDENCE WILL BE REPLACING AN EXISTING DWELLING OVER 60 YEARS OLD. THE NEW HOME WILL BE IN THE SAME LOCATION AS THE EXISTING ONE. MINIMAL GRADING WILL BE TAKING PLACE IN THE ERA ZONE. LANDSCAPING WILL CONSIST OF GRASSES, NATIVE PLANTING AND A VARIETY OF FLOWERING AND EVERGREEN TREES.

John Floyd
Senior Planner
City of West Linn
Re: Proposed residential replacement dwelling
5494 Linn Ln.
West Linn, OR

Schott & Associates (S&A) was contracted to conduct wetland delineation and natural resource assessment for the project site at 5494 Linn Lane, West Linn, Clackamas County, Oregon (T2S, R1E, Section 25BD, Tax Lot 500; Figure 1). This property contains a Water Resource Area (WRA) that is subject to regulation under Chapter 32 of the West Linn Community Development Code (CDC). The purpose of this report is to document existing and proposed conditions with regards to regulated natural resources and meet City approval criteria for the proposed project. The applicant participated in a pre-application meeting with the City on July 20, 2023 (File PA-23-20). An online meeting was held with the applicant

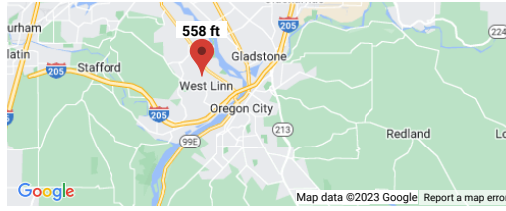
MCER Horizontal Response Spectrum

Address: 5494 Linn Ln, West Linn, OR 97068, USA
Coordinates: 45.3688072, -122.633368
Elevation: 558 ft
Timestamp: 2023-02-20T21:48:00.928Z
Hazard Type: Seismic
Reference Document: ASCE7-16
Risk Category: II
Site Class: C

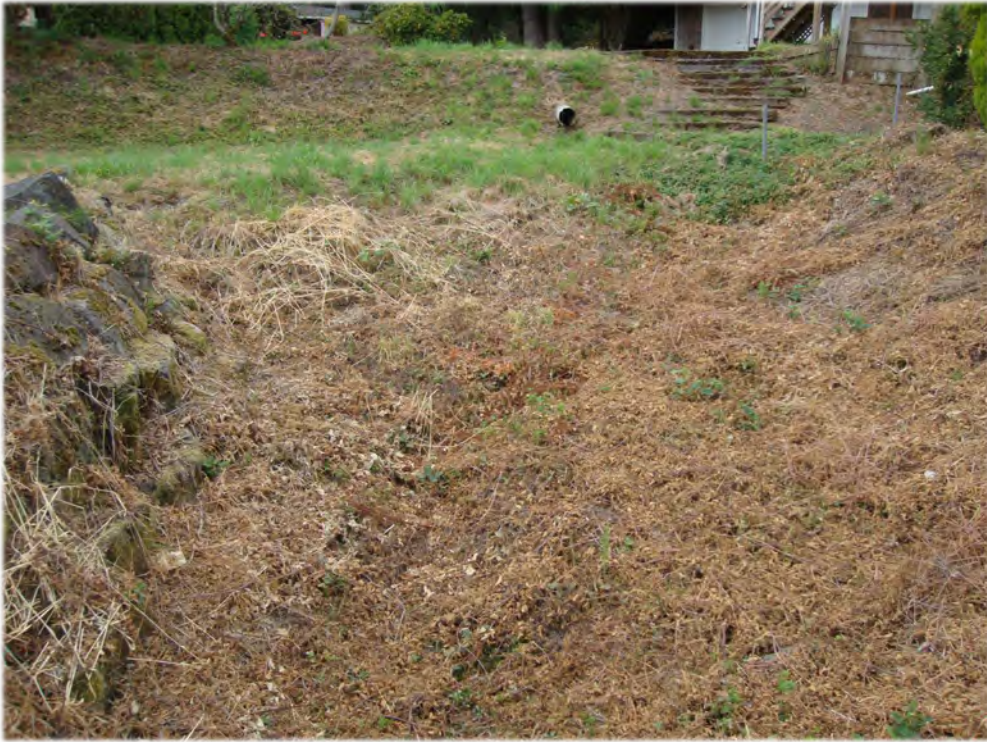
Photo Point 1. From the driveway facing southwest toward Wetland 1. The stormwater pipe which discharges into the wetland is visible in the background (offsite).

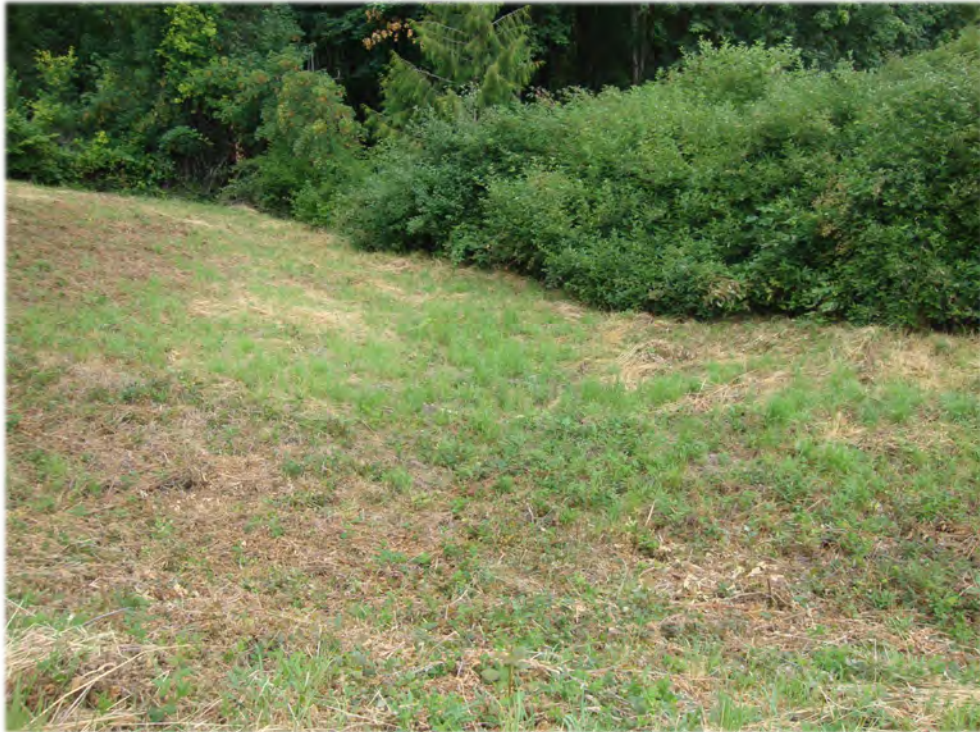
Photo Point 1. From the driveway facing northeast toward Wetland 2 occupying the bottom of the steep-sided swale.

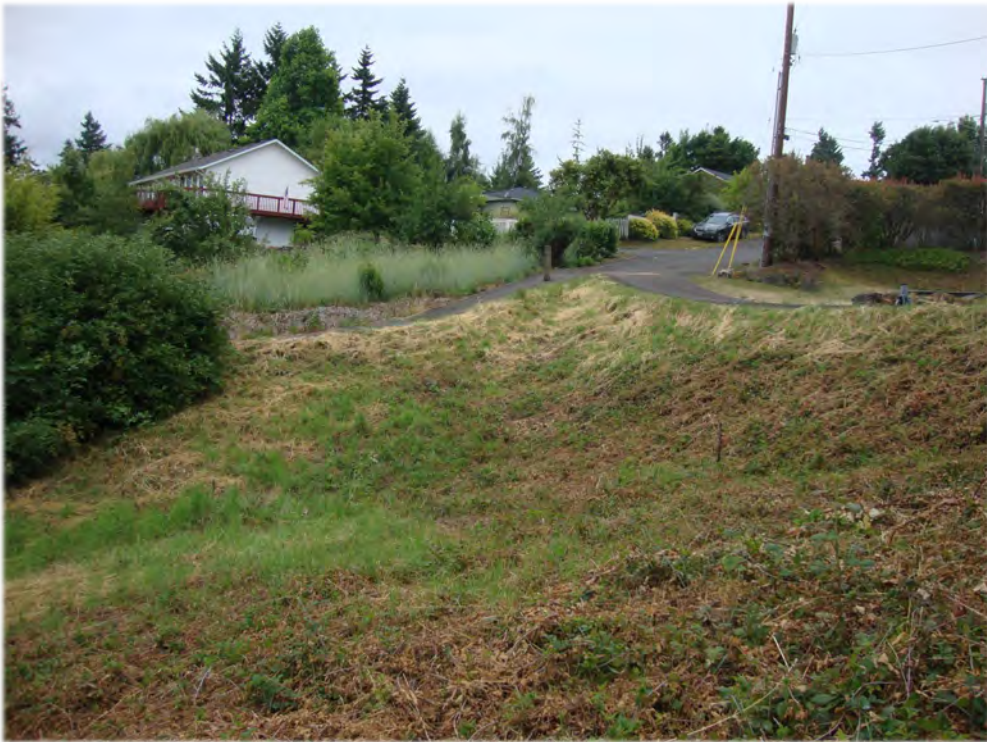
Photo Point 2. From the central portion of the site facing southeast toward the upper portion of Wetland 2 bound by the driveway and road embankments and steep slopes.

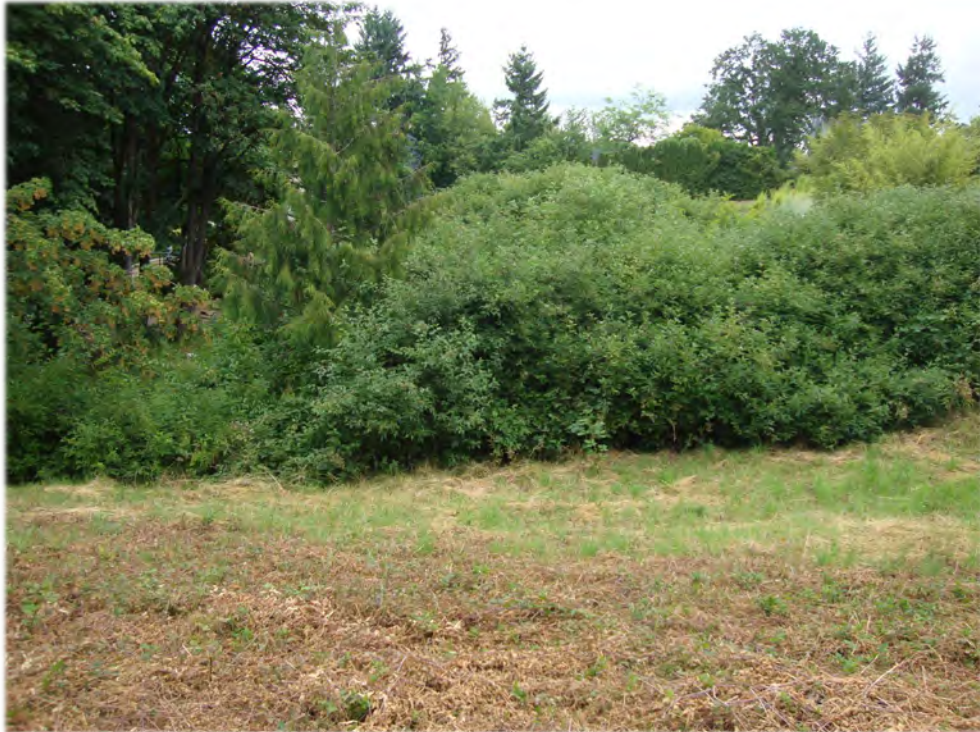
Photo Point 2. From the central portion of the site facing northeast toward the lower portion of Wetland 2 and redosier dogwood thicket at the site boundary.

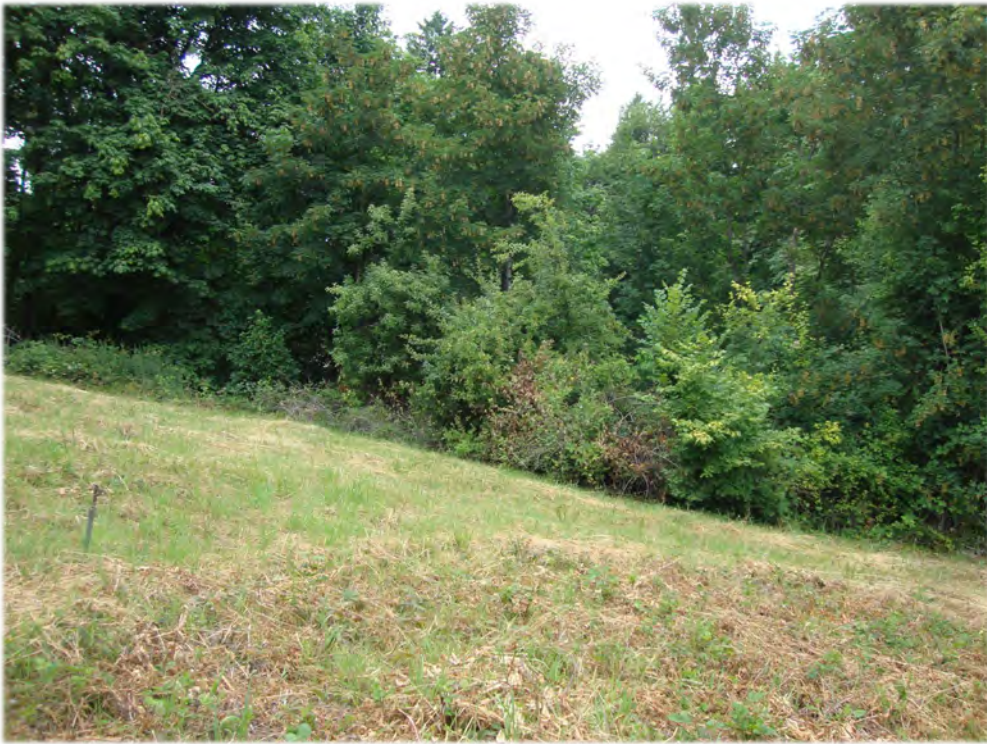
Photo Point 2. From the central portion of the site facing northwest along the Wetland 2 side slope.

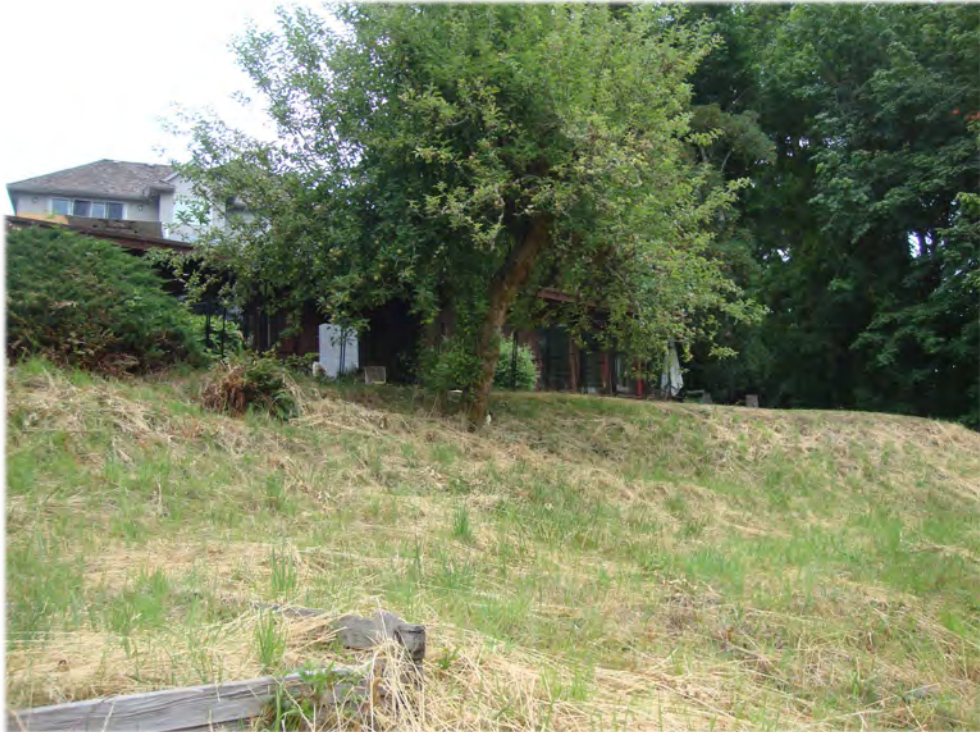
Photo Point 2. From the central portion of the site facing southwest toward the existing residence at the top of the slope.

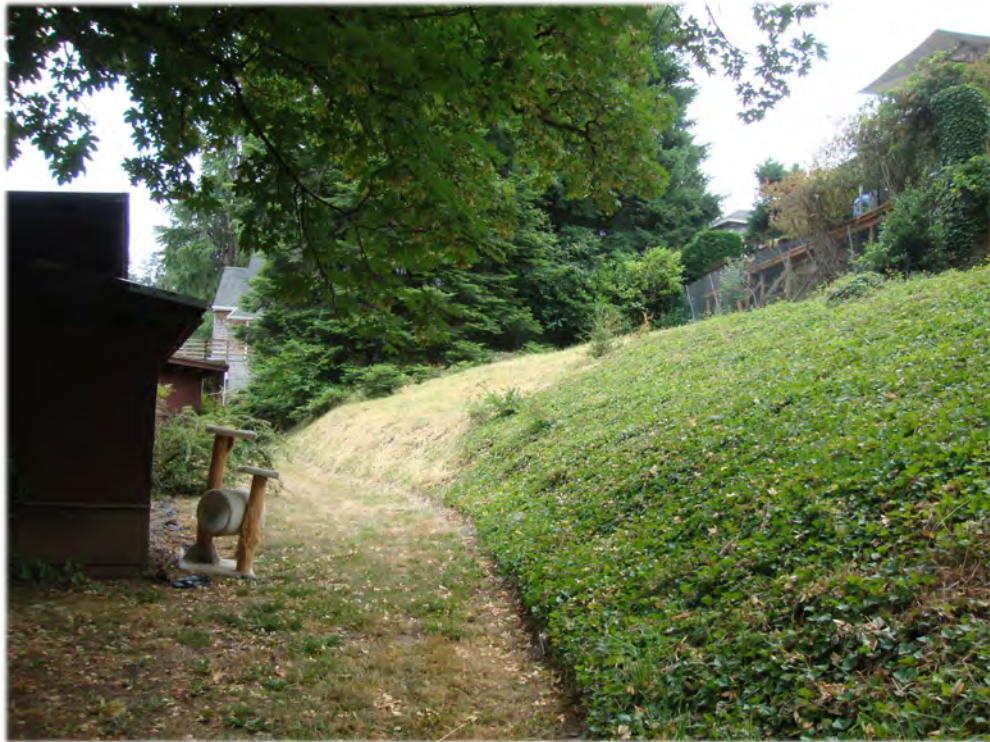
Photo Point 3. From the northwestern site corner facing south along steep slope behind the existing residence.

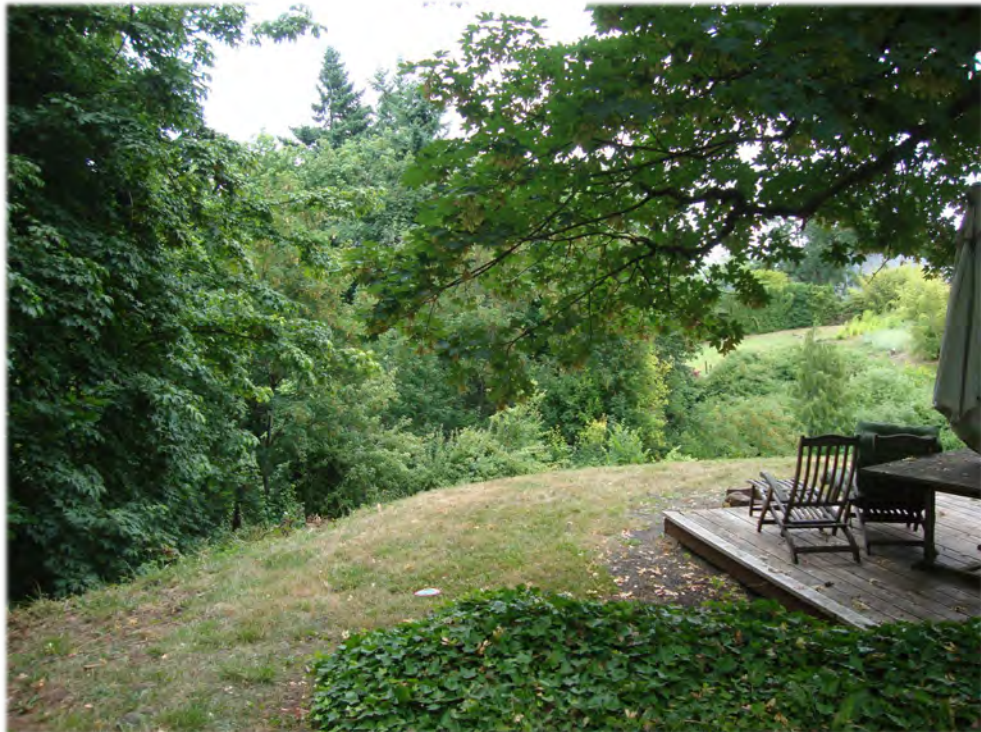
Photo Point 3. From the northwestern site corner facing east toward the top of the slope.

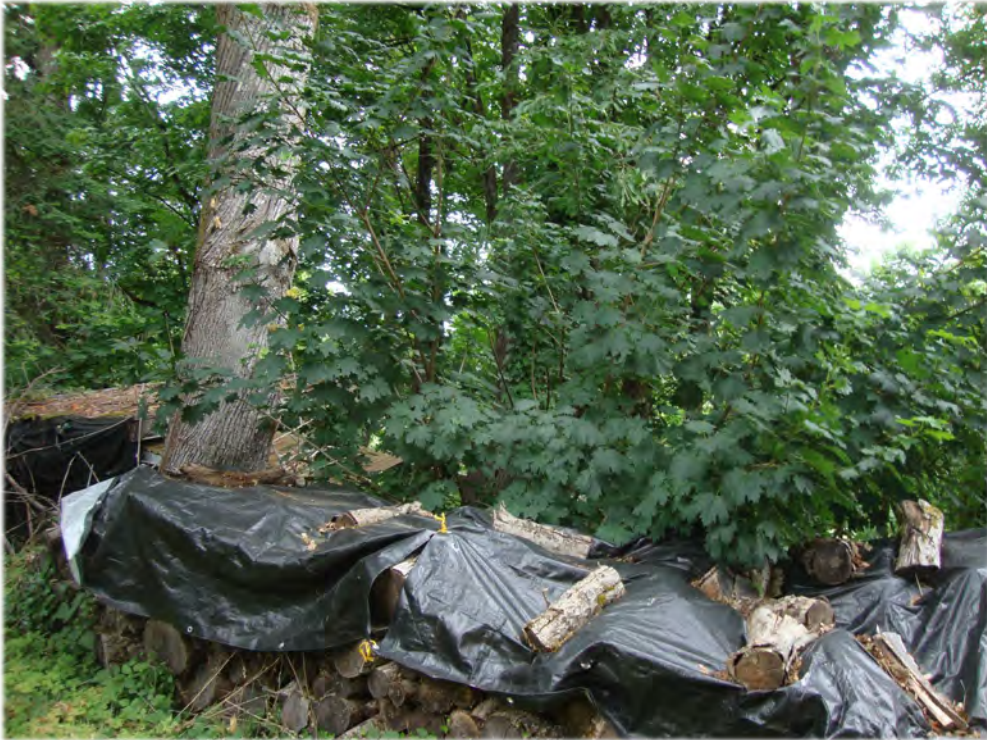
Photo Point 3. From the northwestern site corner facing north
