DEVELOPMENT REVIEW APPLICATION

SUBJECT: 4685 Riverview Ave – West Linn – Non-Conforming Development Approval Criteria.

SUBJECT: 4685 Riverview Ave – West Linn – Non-Conforming Development Review Written

Arborist Report 8/19/25

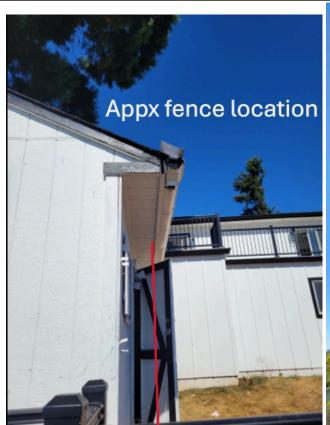
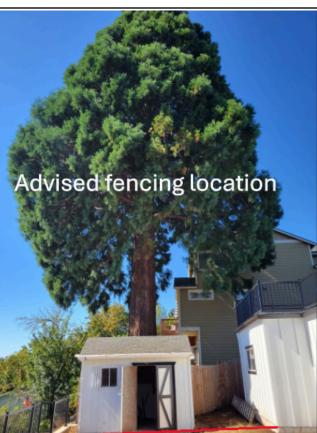
Photos:

The canopy displays minor asymmetry, and several limbs are becoming overextended in the space between the two houses. Reduction pruning is advised to alleviate end weight in this area. Specifically, recommend making approximately (6–10) reduction cuts, each targeting limbs 2–4" in diameter.

A previously installed clothesline is beginning to be engulfed by the trunk on the northeast (NE) side of the tree. In addition, visible surface girdling roots are present—particularly on the south and southeast (SE) sides. It is recommended to use an Air Spade in the fall or winter to expose and selectively remove these girdling roots. Depending on the number and severity of the roots encountered, this work may need to be phased to minimize stress on the tree.

To support the tree's health during this process, the application of a bio-root stimulant is recommended prior to any construction activity.

A proposal for girdling root pruning and bio-root stimulant application will accompany this report.

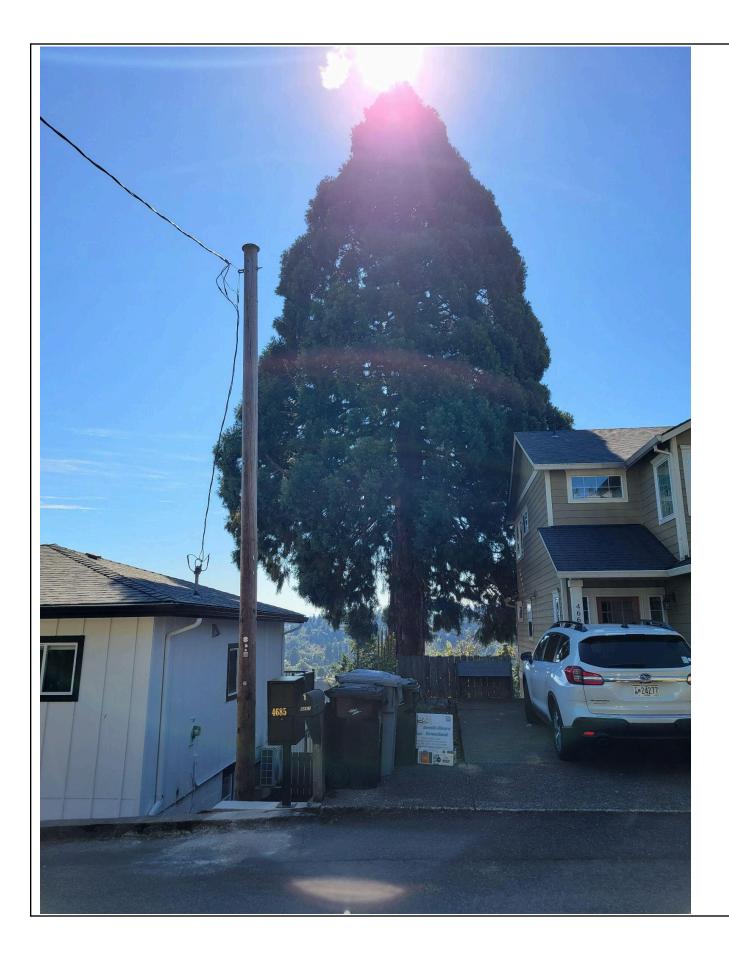
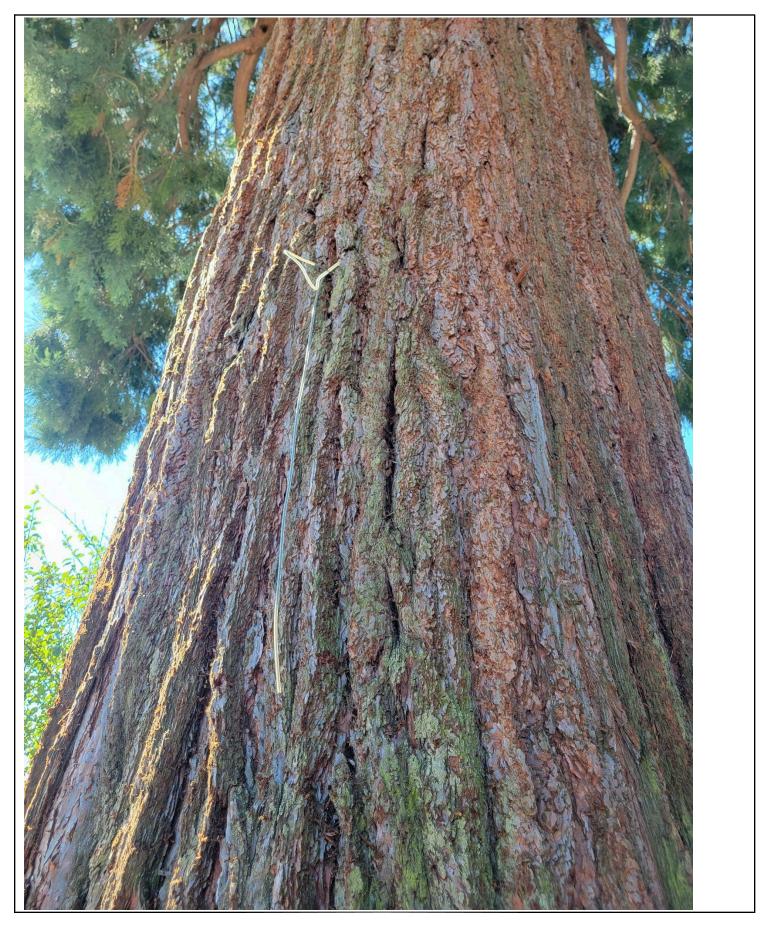
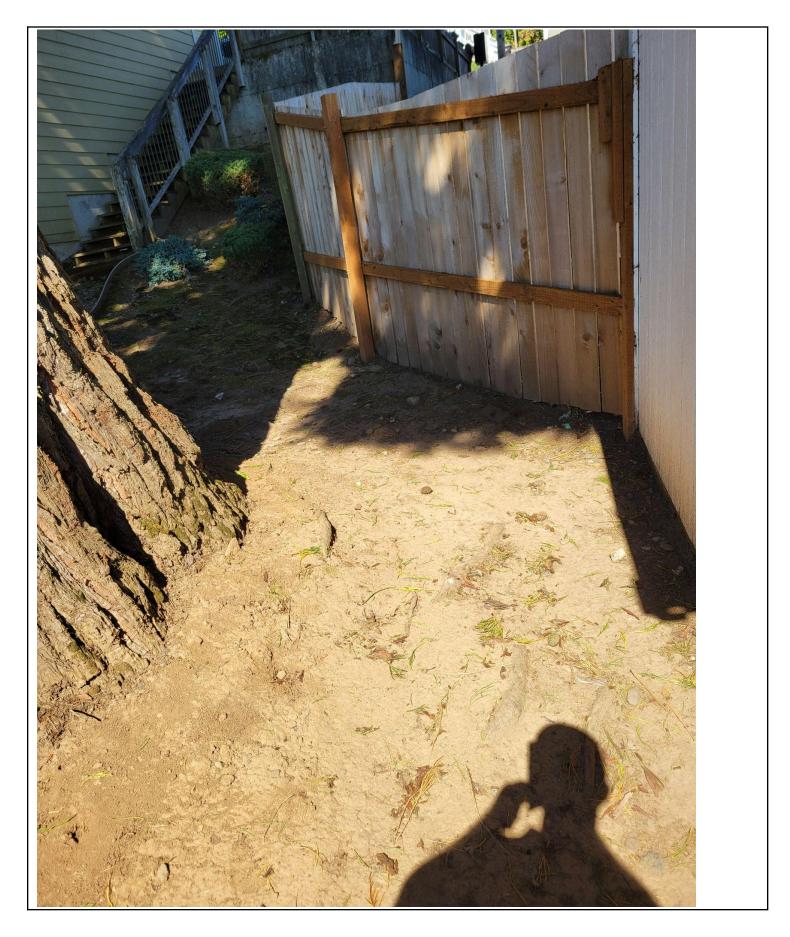
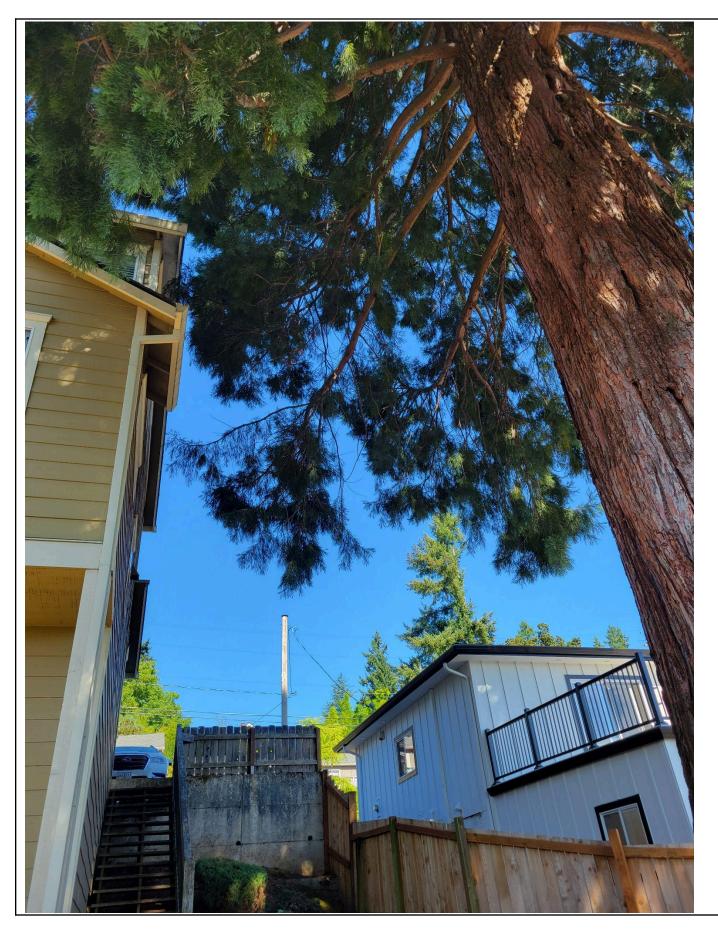
This report concerns the 79" Sequoiadendron giganteum located at the rear of the property, positioned between the client's house and the neighboring structure. The specimen is in good overall health.

A shed has been constructed beneath the tree's NE dripline. It is strongly advised that this structure be dismantled by hand to avoid the use of heavy equipment within the root zone. To further protect the tree, all construction activity should be avoided beneath its dripline.

The most effective protection measure would be the installation of a 6–10' tall chain-link fence with steel posts spaced no more than 10' apart. This fence should extend just in front of the existing shed (see attached photo) and be positioned approximately 26' from the southeast corner of the driveway.
