RE: CUP-10-03 New West Linn Primary School

NEW WEST LINN PRIMARY SCHOOL Conditional Use, Class II Design Review, Water Resource Area and Variance

For Conditional Use, Class II Design Review, Water Resource Area, and Variance approval to construct a 67,000 square foot primary school located on a 15.98-acre site. Variances are requested to: 1) allow two, 95' wide driveways (from curb return to curb return); 2) allow parking spaces that are more than 200 feet from the building entrance; 3) reduce the transition setback for an intermittent drainage from 65 to 15 feet; and 4) allow two wall signs of approximately 38 and 84 square feet and a 32 square foot monument sign at the driveway entrance.

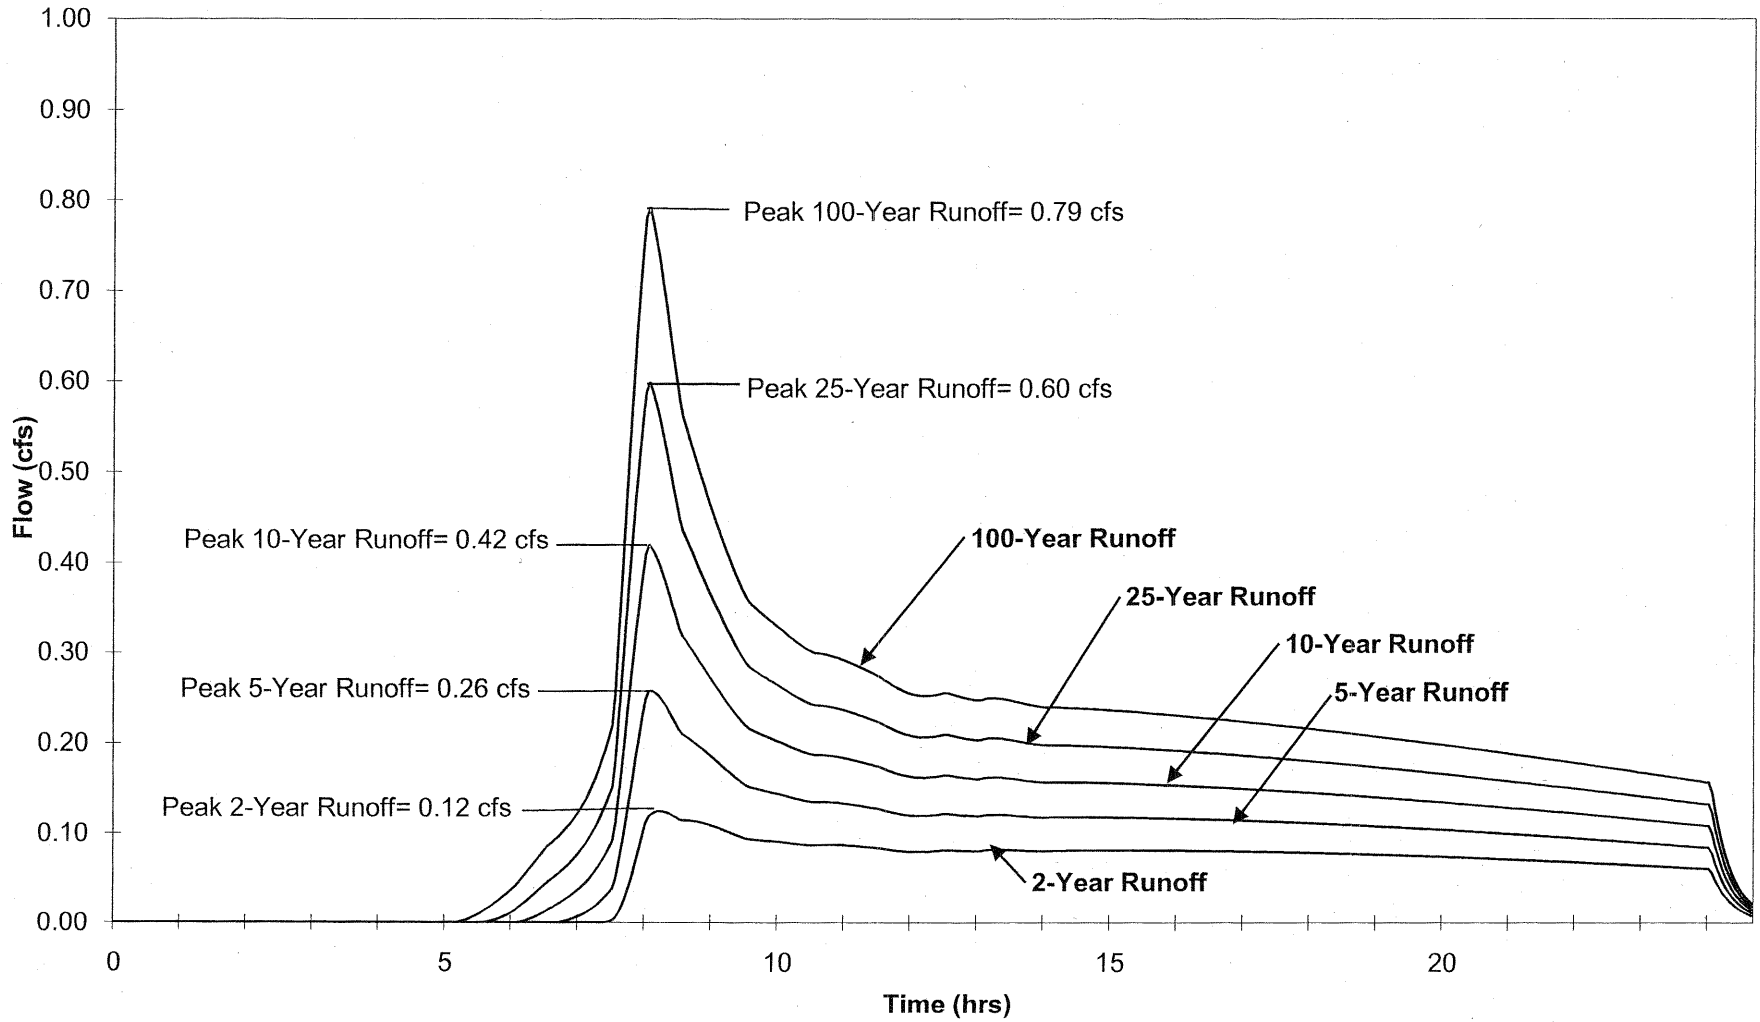
NEW WEST LINN PRIMARY SCHOOL
Runoff Hydrographs for Existing Conditions
SUB-BASIN A

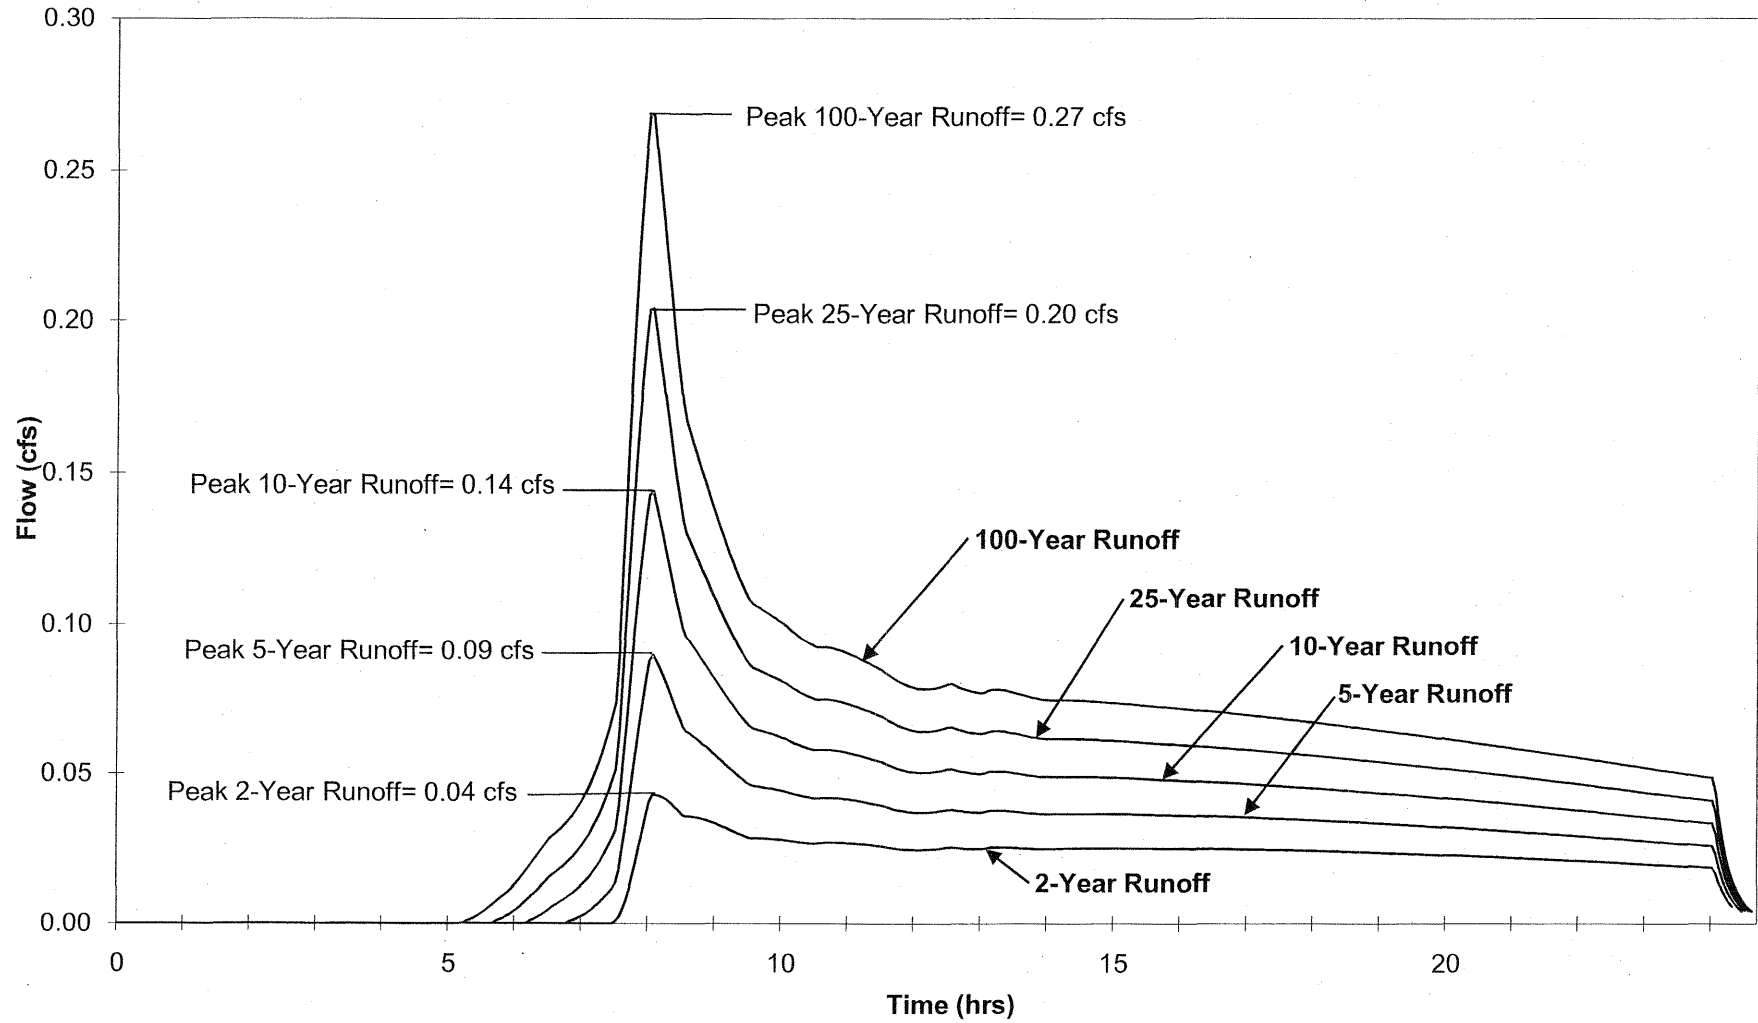
NEW WEST LINN PRIMARY SCHOOL
Runoff Hydrographs for Existing Conditions
SUB-BASIN C

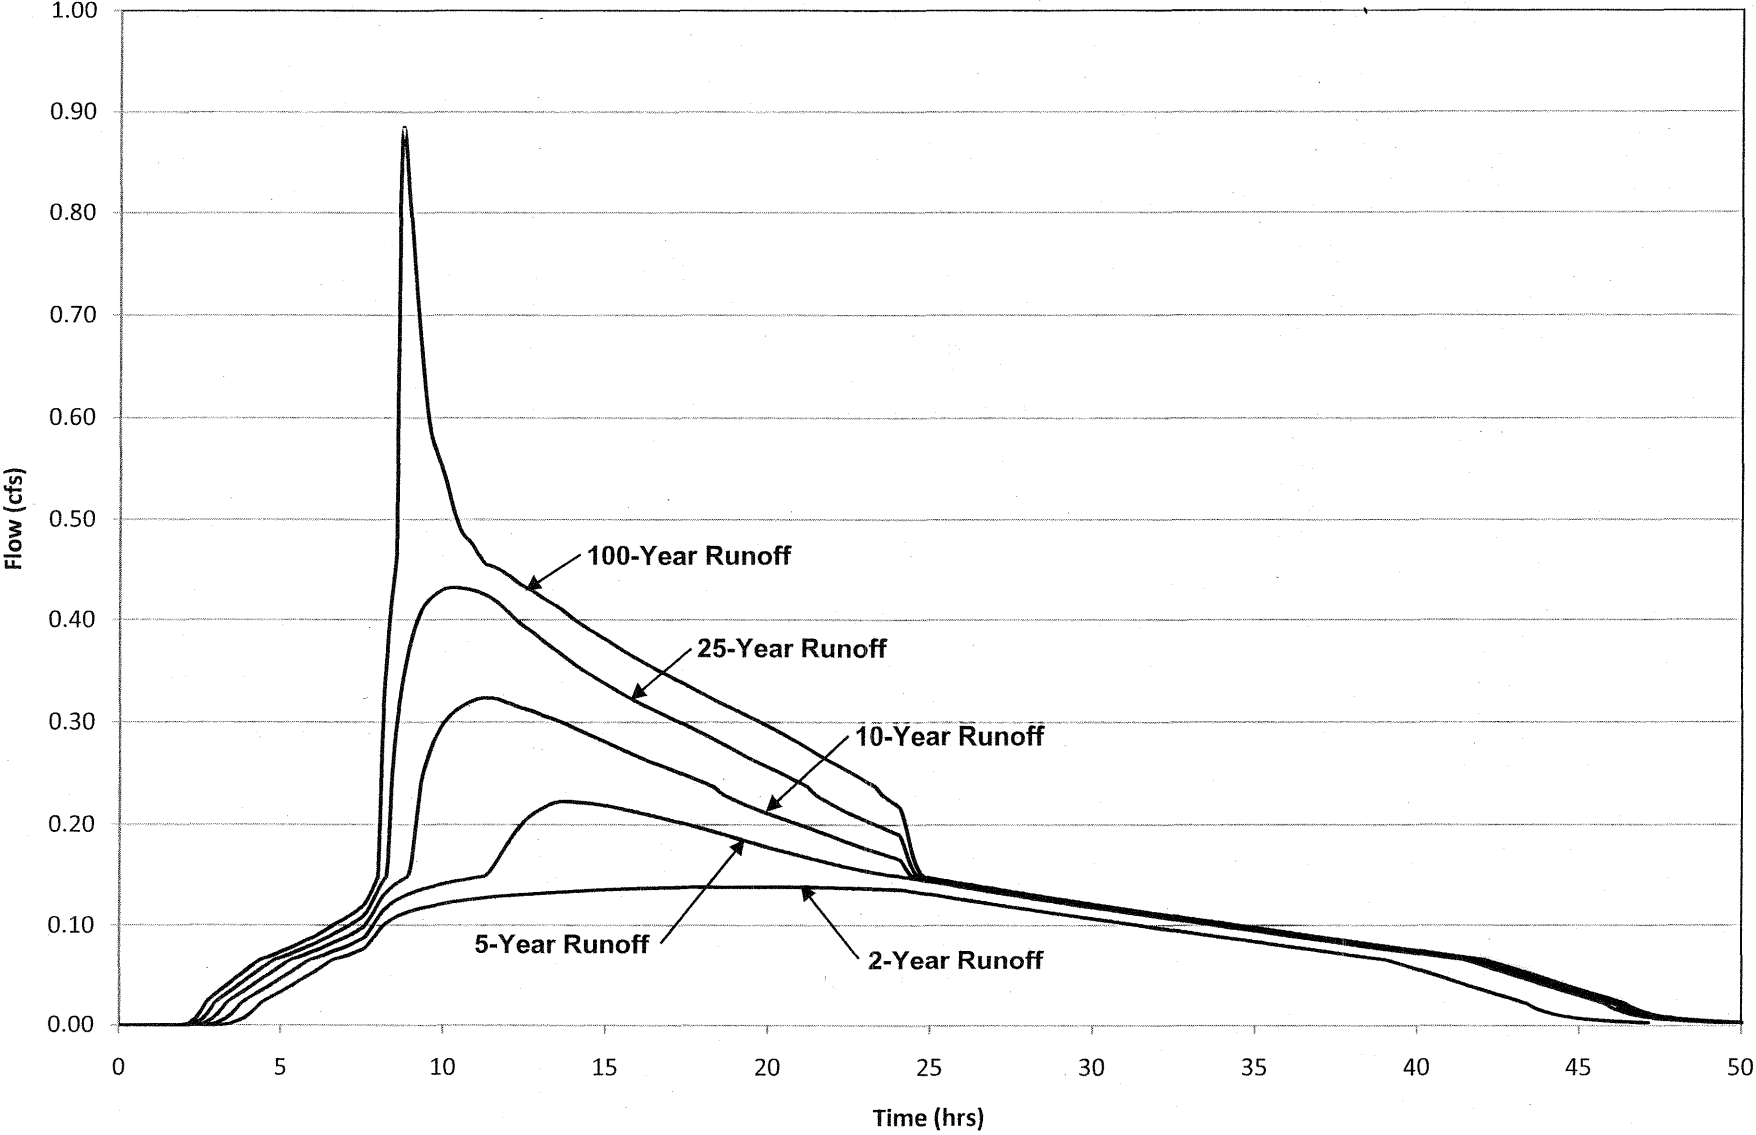
NEW WEST LINN PRIMARY SCHOOL
Hydrograph for Proposed Conditions - Flow out of Detention Chambers
SUB-BASIN A

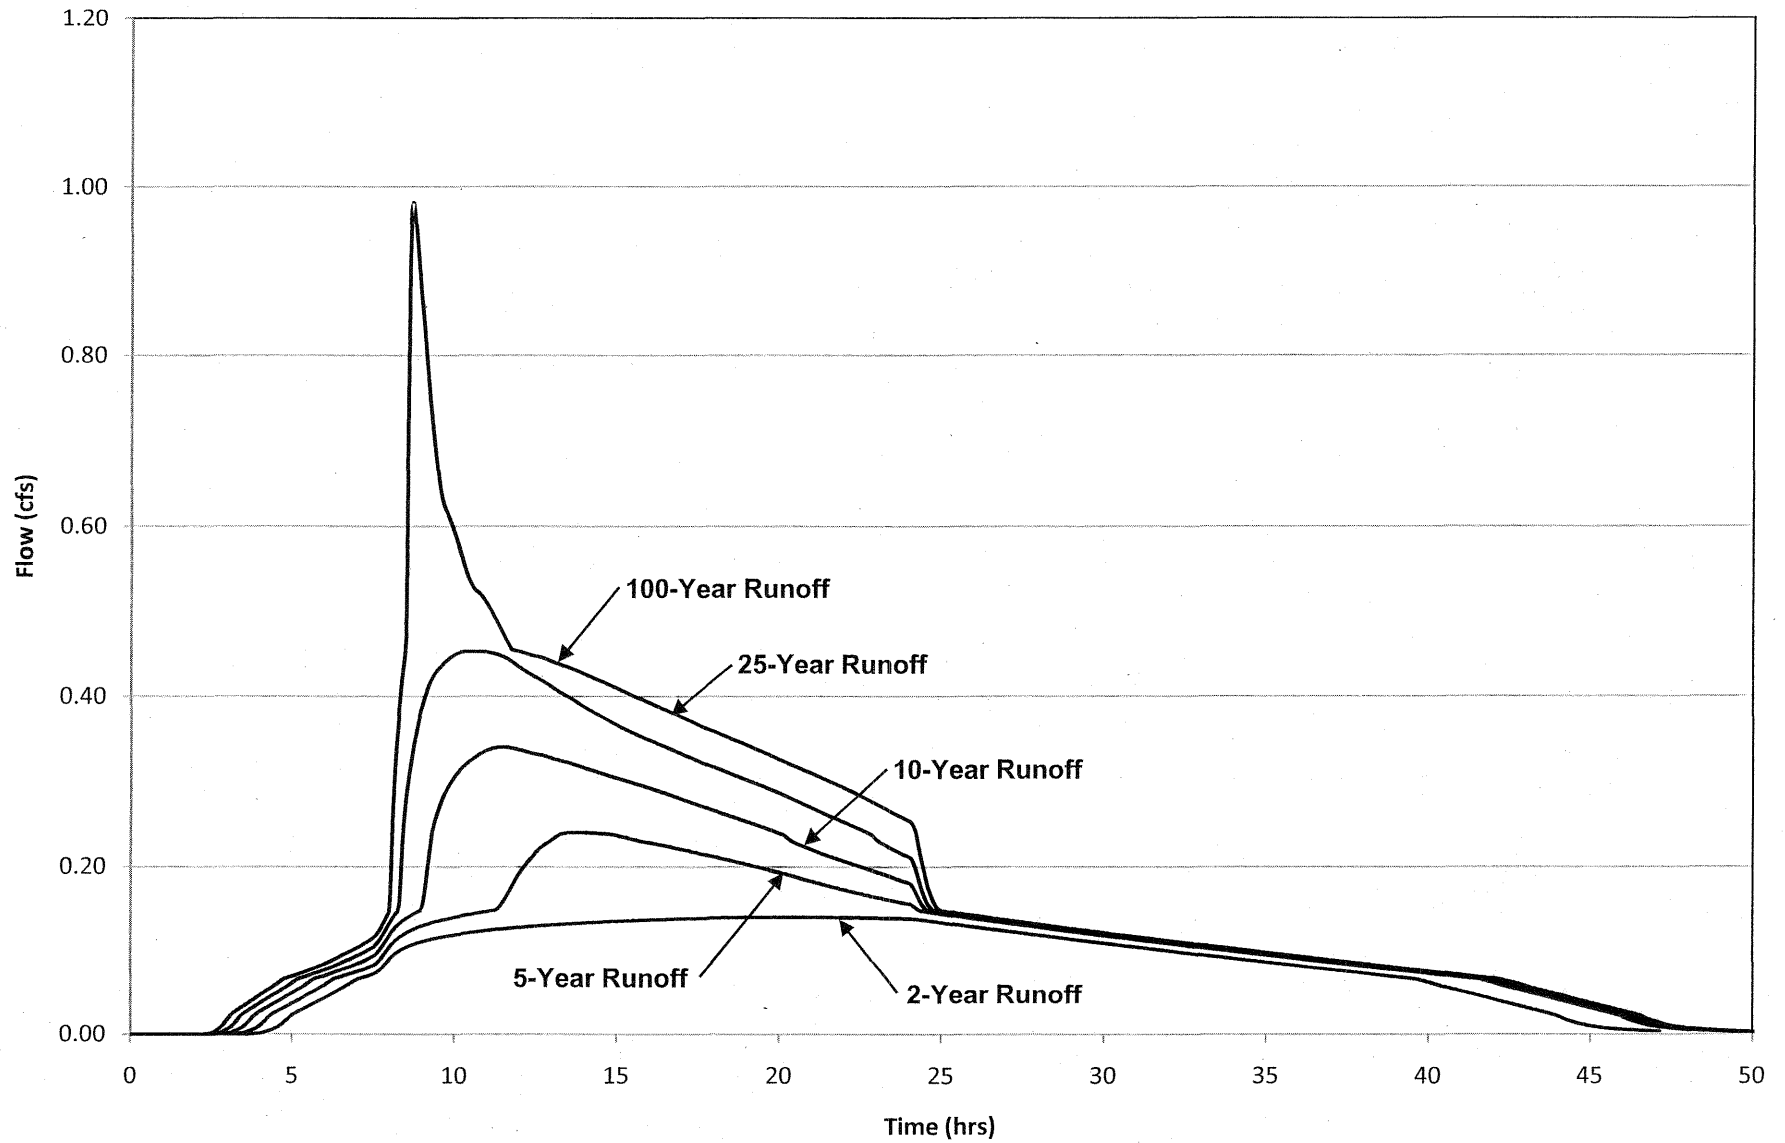
NEW WEST LINN PRIMARY SCHOOL
Hydrograph for Proposed Conditions - Flow out of Detention Chambers
SUB-BASIN B

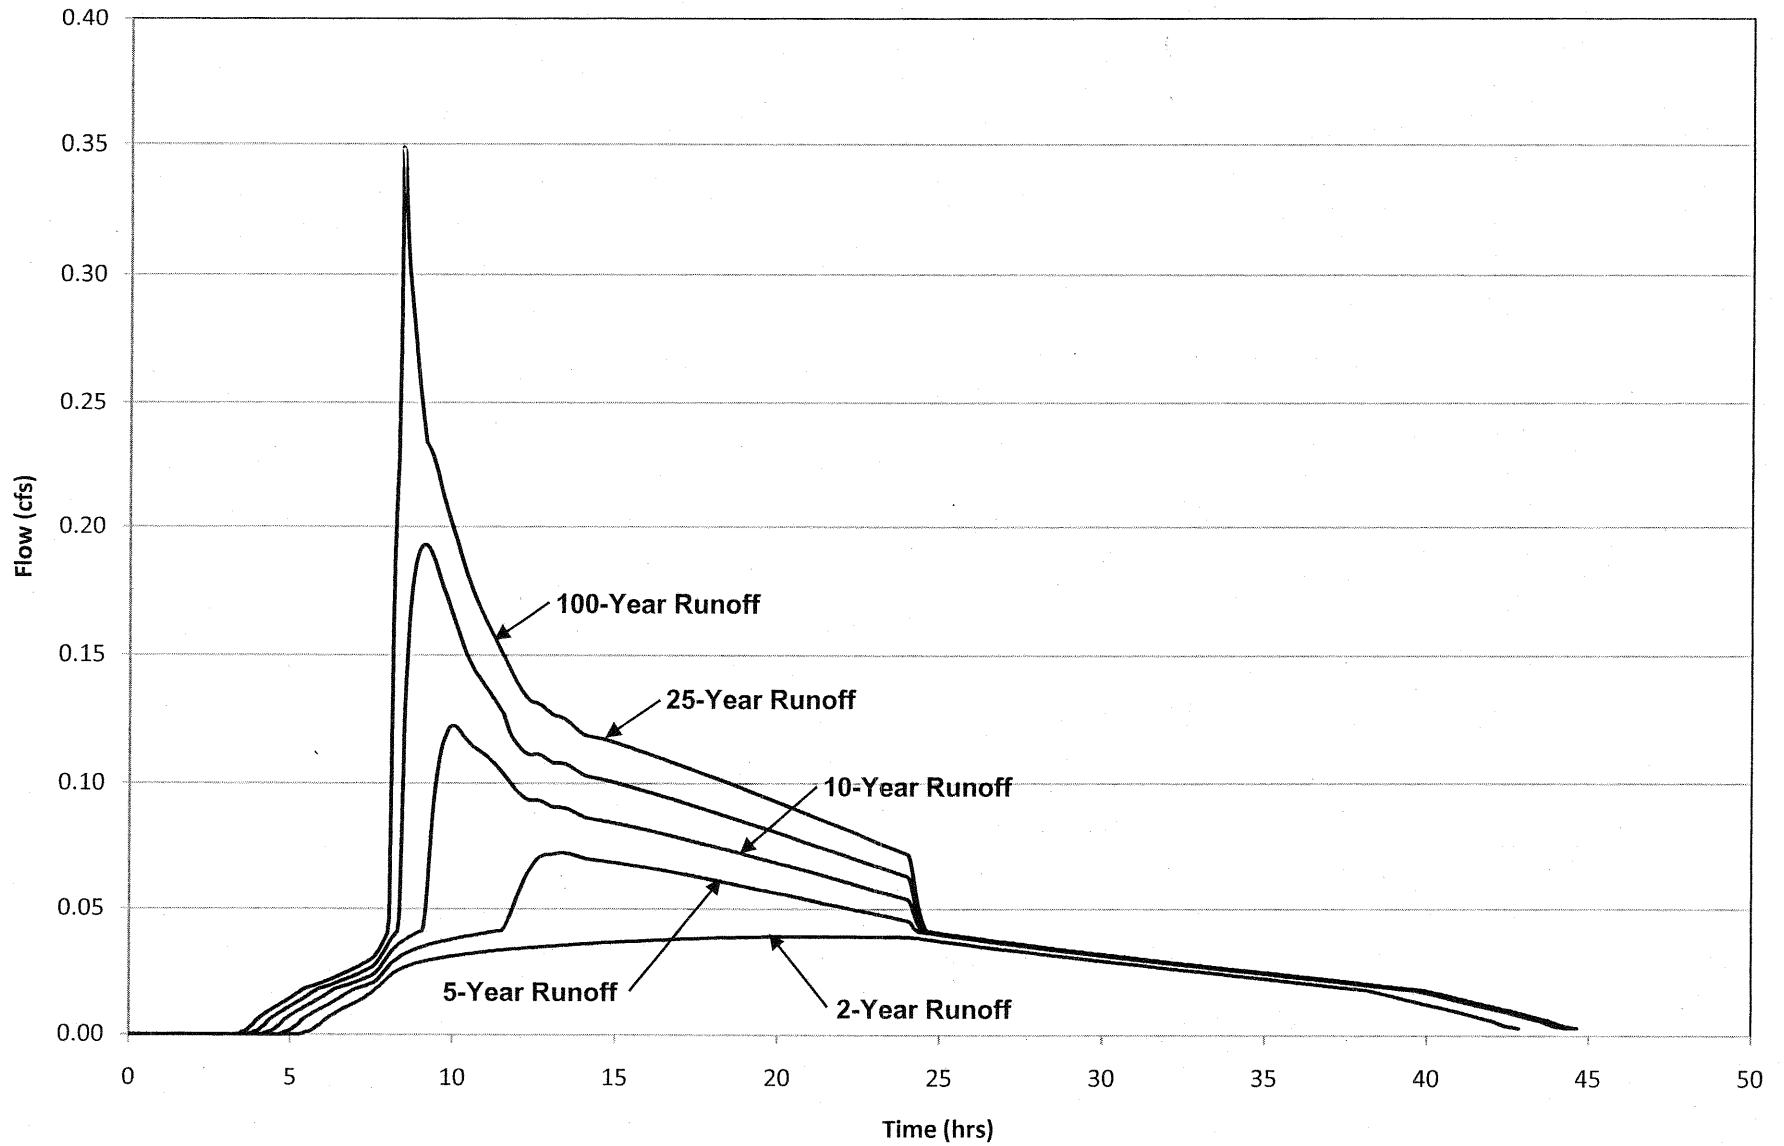
NEW WEST LINN PRIMARY SCHOOL
Hydrograph for Proposed Conditions - Flow out of Detention Chambers
SUB-BASIN C

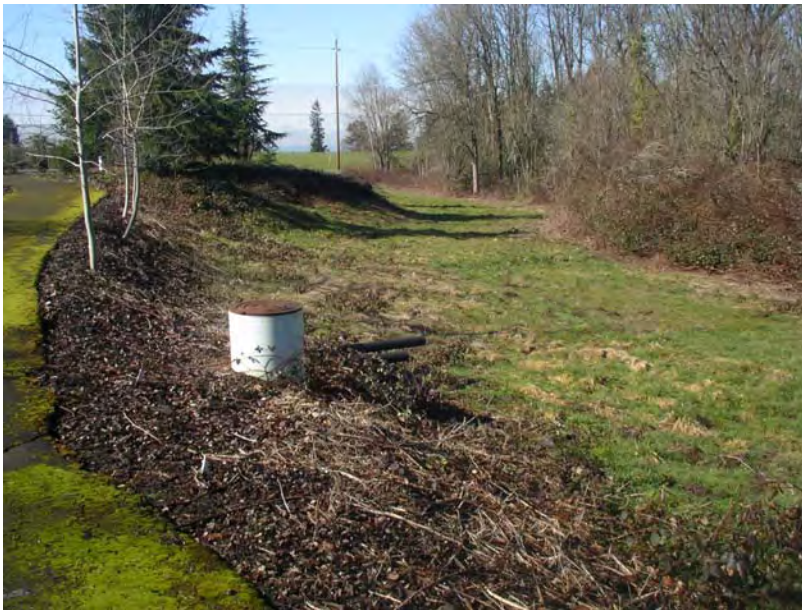
At the southwestern side of the study area, impervious surfaces, streets, and rooftops directly discharge runoff through a series of pipes and culverts to the grassy area of the study area (Photo 3).

Photo 3 Hydrology alteration – Storm water drain pipe from Bay Meadows Drive subdivision

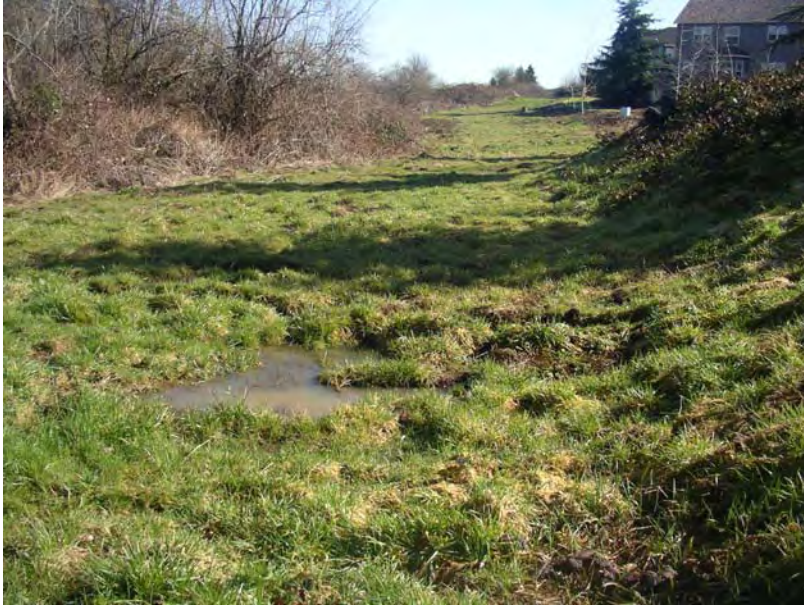
Photo 4 Hydrology alteration – Wet area formed by storm drainage discharging directly to project study area

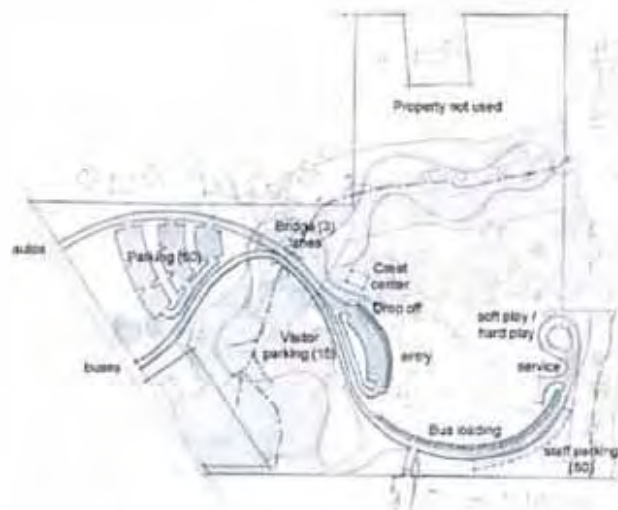
Figure 4. Erickson Primary School alternative site design D.

Figure 4 shows alternative site design D with a three lane crossing over the wetland. Having additional lanes (more than 2) at this wetland location would not have reduced wetland impacts and would have cleared more of the intact forest community.

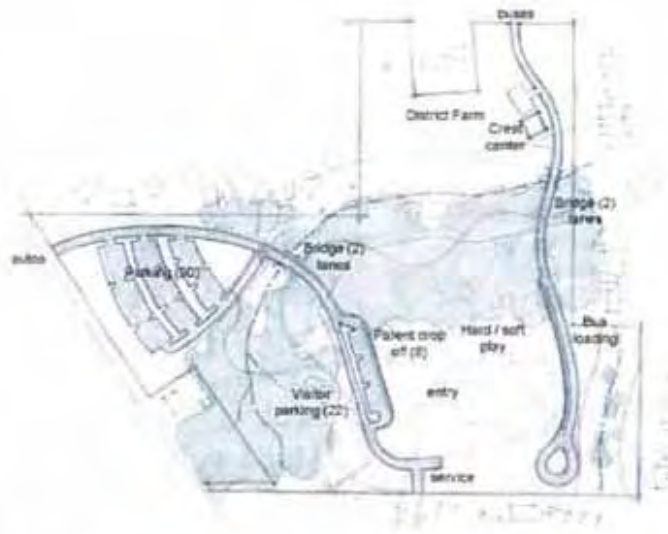
Figure 5. Erickson Primary School alternative site design E.

Figure 5 shows site design E. The access road from Hidden Springs Road was determined to be too steep for icy winter conditions.
