Sahallie Illahee Play Equipment Evaluation

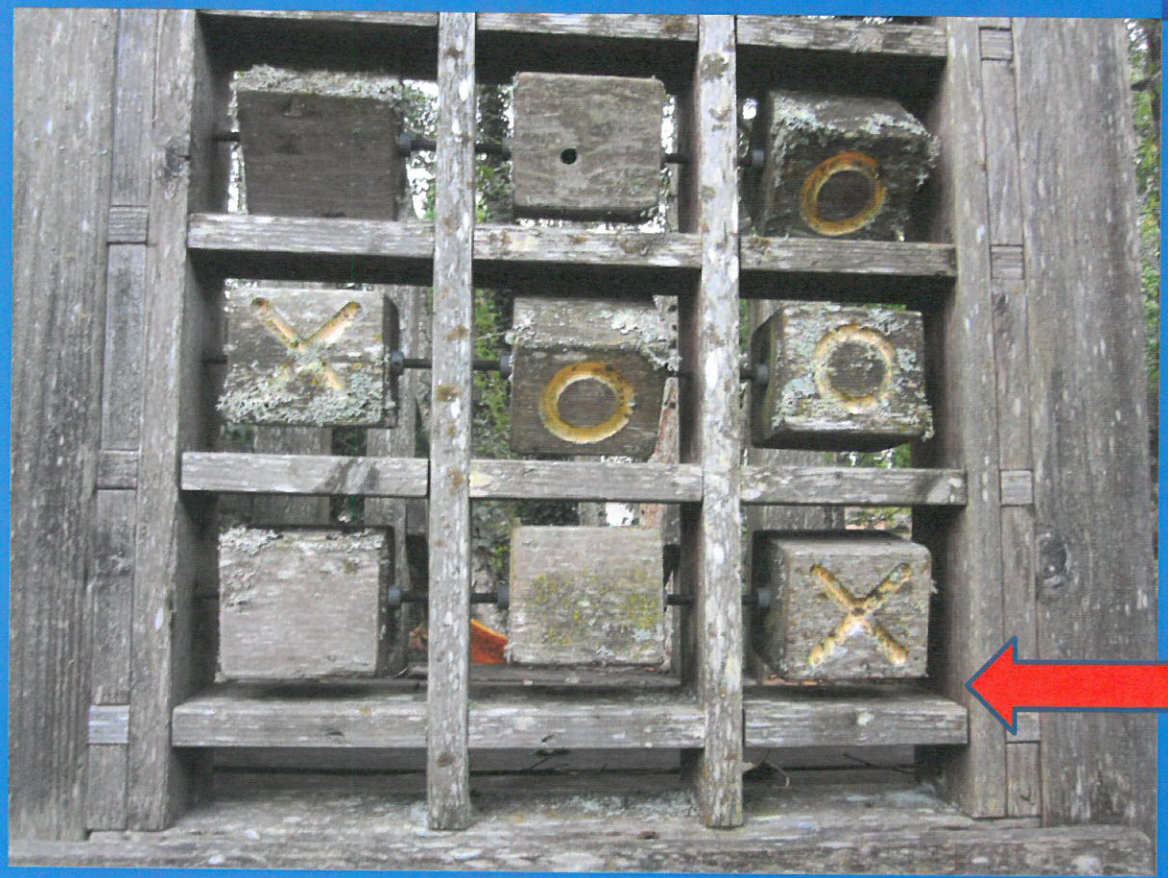
Wood and paint are extremely weathered

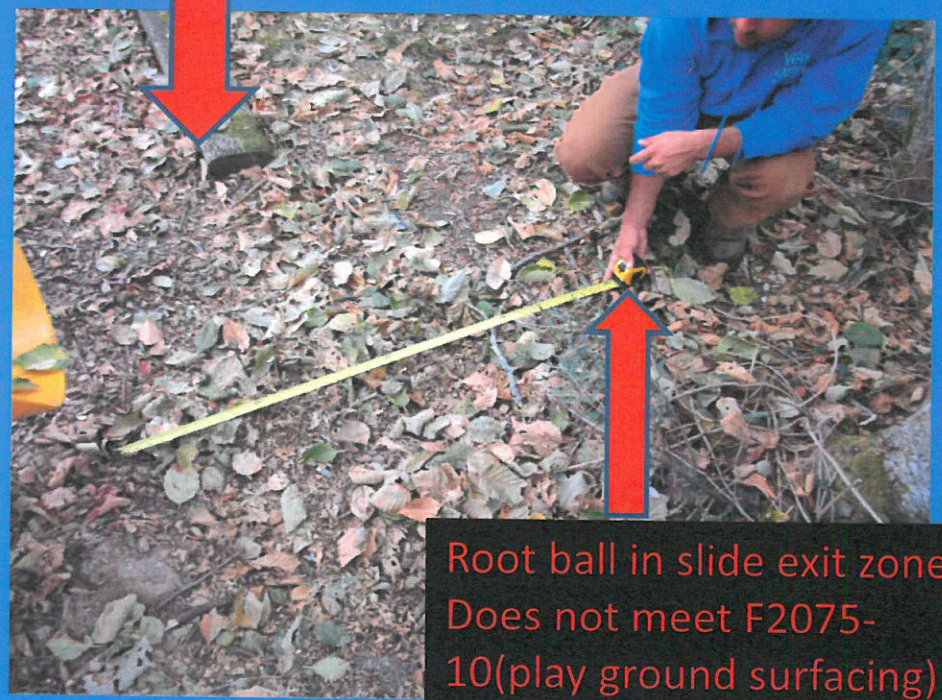
Objects in slide exit zone. Slide exit zone should be clear (6 feet minimum)

Root ball in slide exit zone. Does not meet F2075-10(play ground surfacing)
