## Memorandum

**Subject:** September 17 Work Session and Council Schedule

**RE:** City of West Linn, 4.0 Million Gallon Bolton Reservoir Project  
Conceptual Siting Analysis

The City of West Linn (City) is proposing to replace the existing 2.5 Million Gallon (MG) Bolton Reservoir with a new 4.0 MG reservoir. In accordance with the City's authorization, Murray, Smith & Associates, Inc. (MSA) has completed a conceptual siting analysis for the contemplated project, which consists of demolition of the existing reservoir and construction of a new 4.0 MG reservoir within the existing site boundaries. Siting analysis work included confirming floor and overflow elevations and preliminary tank dimensions, evaluating and recommending reservoir type, completing a preliminary geotechnical evaluation of the site, confirming the orientation of the structure on the site and developing budget level cost estimates to allow the City to proceed with project financing. The purpose of this memorandum is to present findings, recommendations and conceptual cost estimates resulting from the siting analysis work.

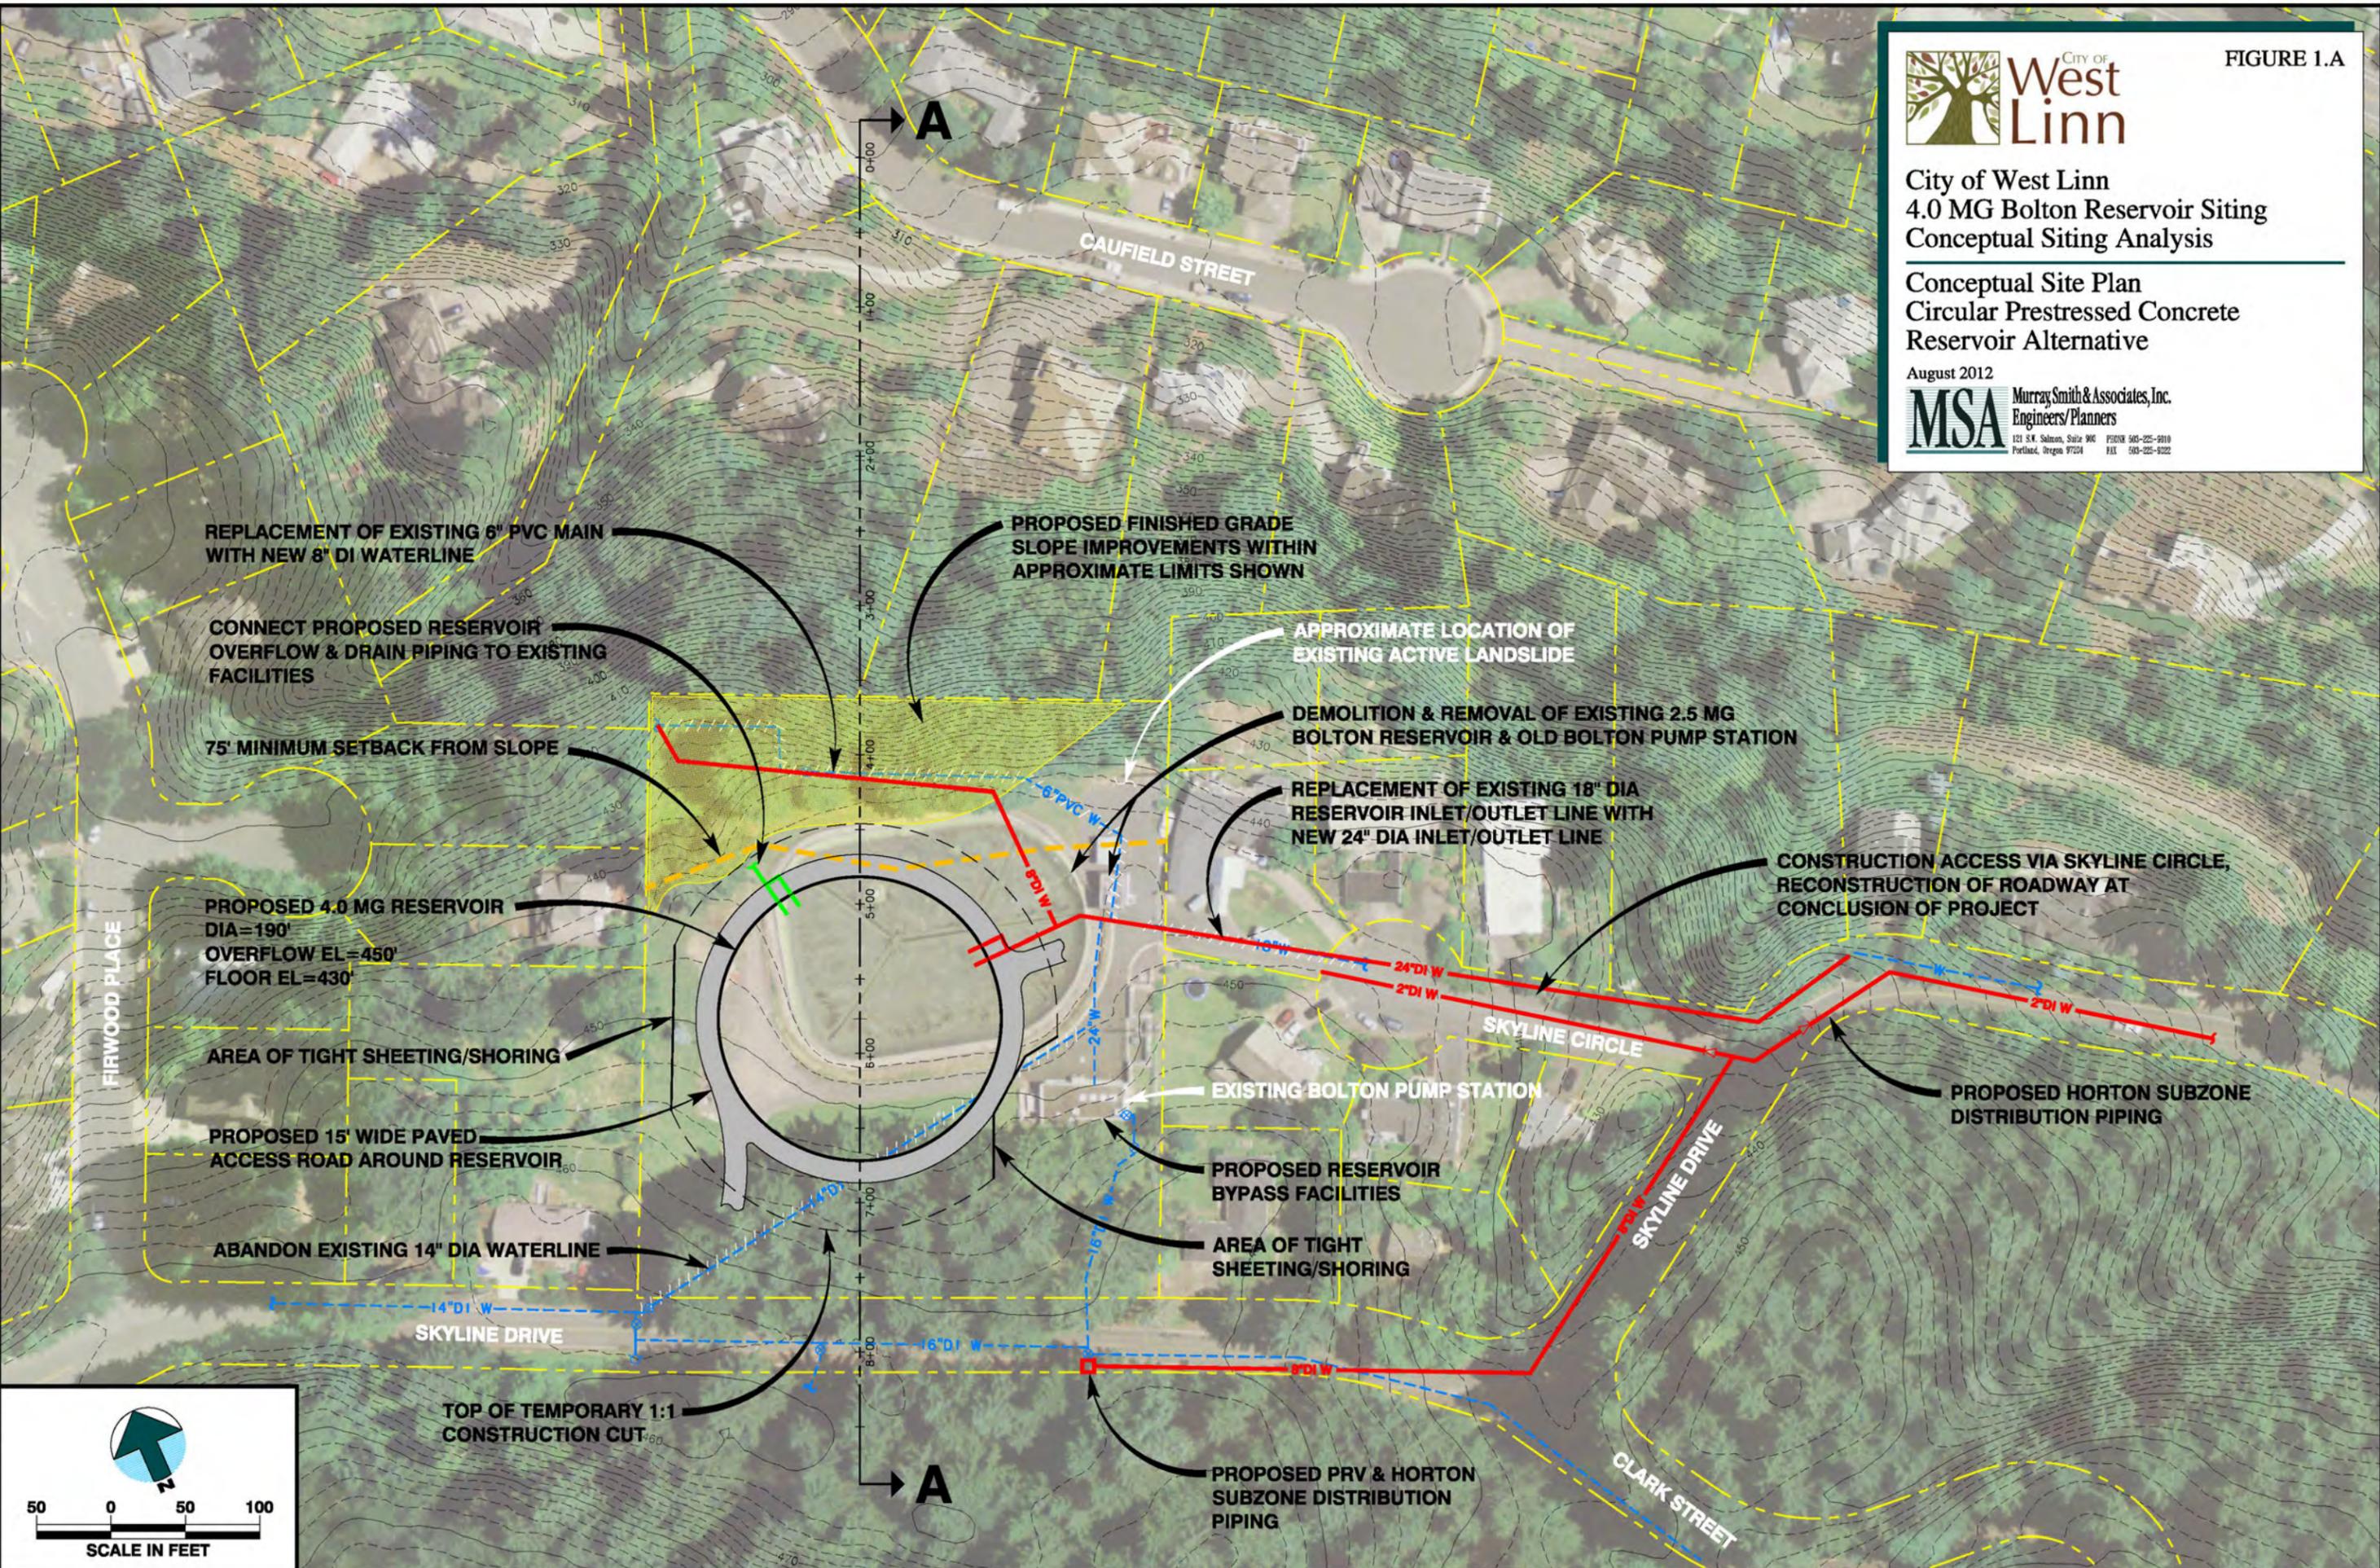
G:\PDX\_Projects\12\1334\CAD\SHEETS\12-1334-401-OR-CIRCULAR RES ALT.dwg FIG 1.A - PLAN 8/29/2012 1:11 PM DAK (LMS Tech)

REPLACEMENT OF EXISTING 8" PVC MAIN WITH NEW 8" DI WATERLINE

CONNECT PROPOSED RESERVOIR OVERFLOW & DRAIN PIPING TO EXISTING FACILITIES

*Circular Prestressed Concrete Reservoir* -- The reservoir site layout for the circular prestressed concrete structure, shown on Figures 1.A and 1.B, was developed to meet minimum siting requirements including a minimum 10-foot circumferential clearance from the reservoir wall for prestressing equipment, maximum 1:1 (horizontal: vertical) temporary excavation slopes, and maximum 2:1 final grading slopes. Excavation shoring may be required in certain areas to provide adequate setback from existing structures and property lines, or may be desired to minimize construction impacts to the existing site. A maximum 5-foot differential in backfill height around the structure was maintained as part of finished grading, and a permanent 15-foot wide perimeter access road was included to provide vehicle access around the tank. The cross section view shown on Figure 1.B shows subsurface ground improvements based on recommendations from the preliminary geotechnical evaluation. These include subgrade over-excavation and replacement with 5 feet of crushed rock to provide a drainage layer and working mat, and rammed aggregate piers extending 20 feet below the mat, in an the area extending 10 feet beyond the reservoir footing. The cross section also shows finished grade slope improvements located to the north of the reservoir, involving removal of material at the top of the slope to improve slope stability.

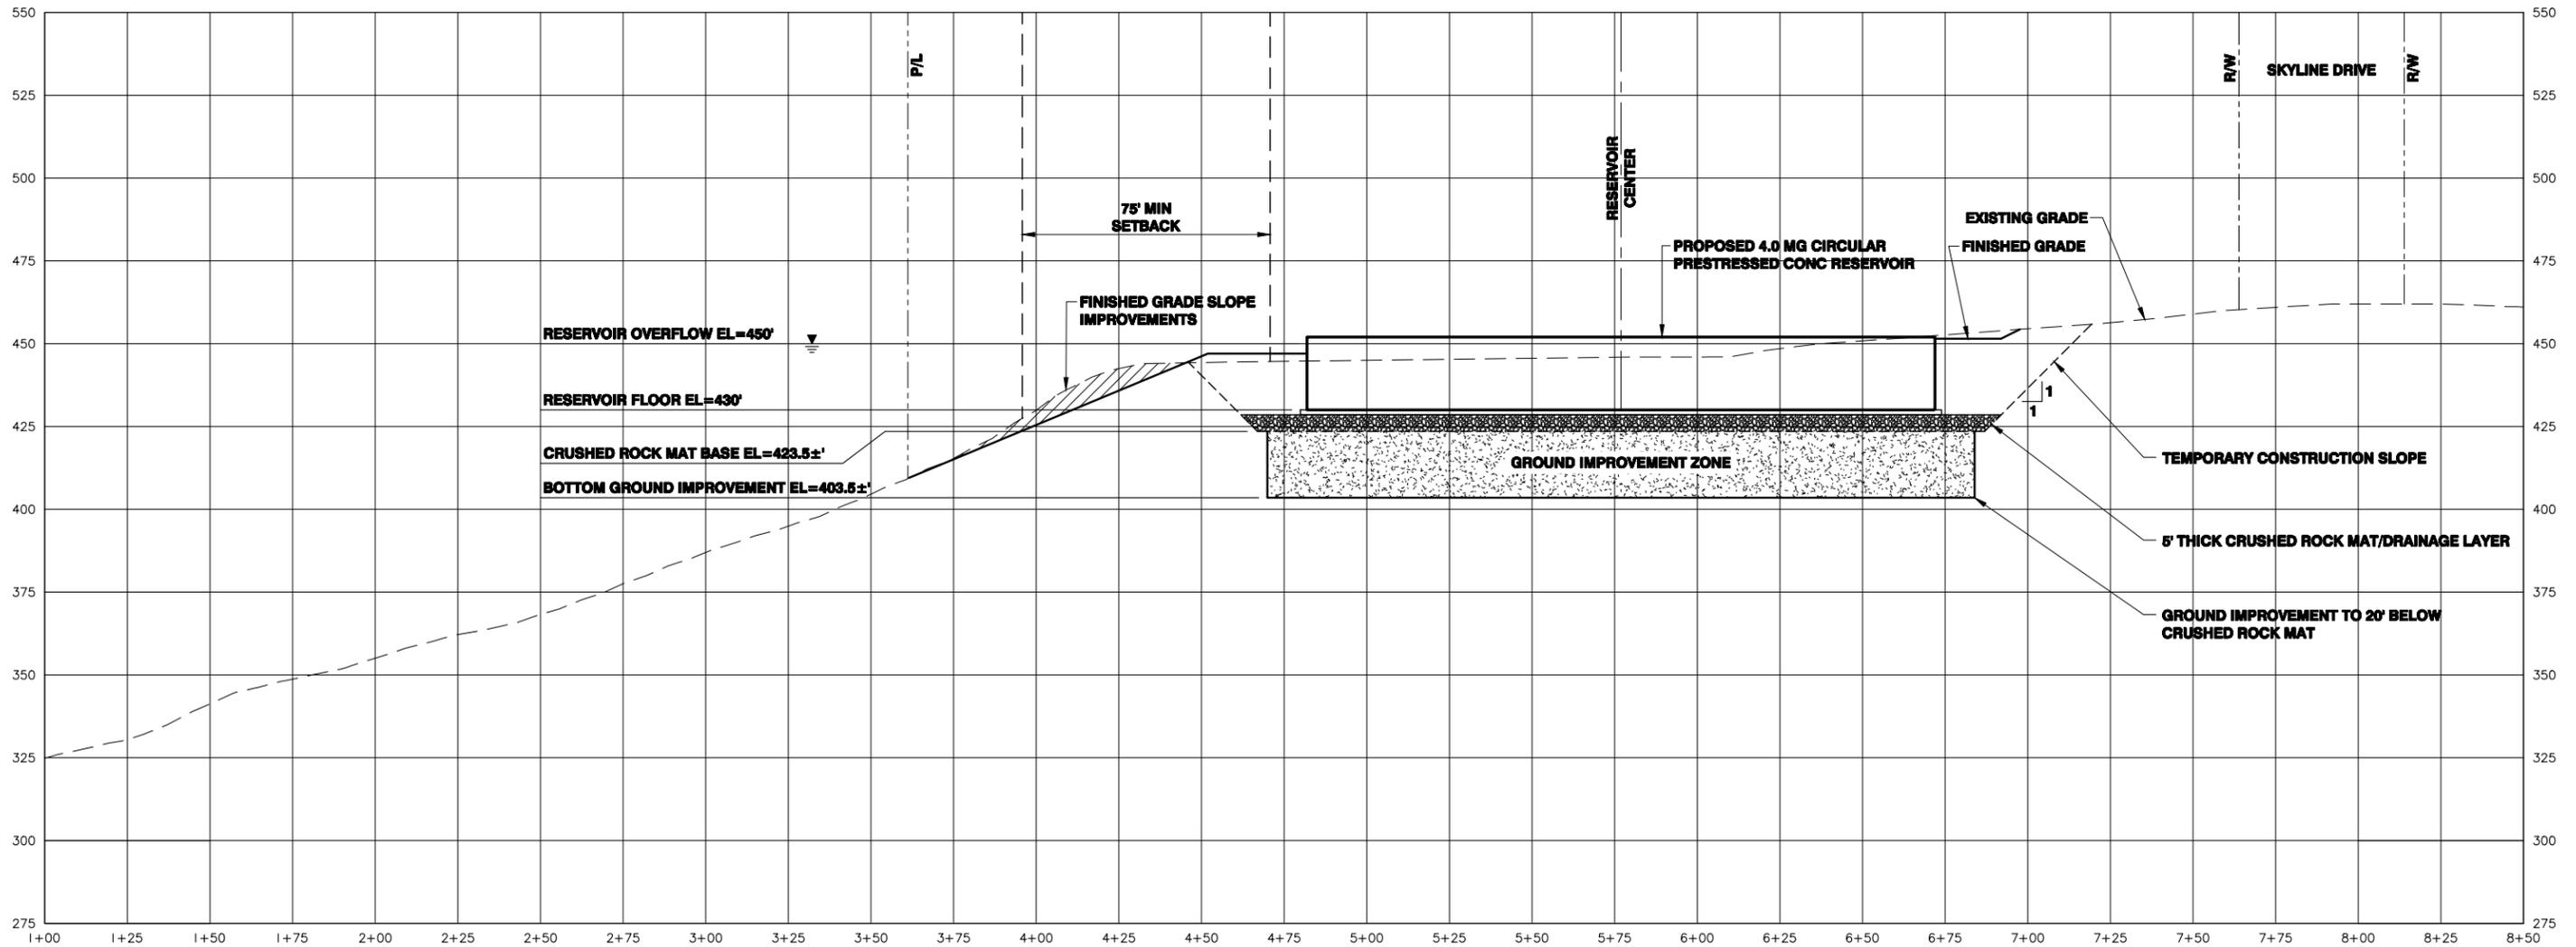
C:\PDX\_Projects\12\1334\CAD\SHEETS\12-1334-401-OR-CIRCULAR RES.ALT.dwg FIG 1B - SECTION A 8/29/2012 1:08 PM DAK 18.1.s (LMS Tech)

SECTION A  
SCALE: 1"=50' HORIZ & VERT

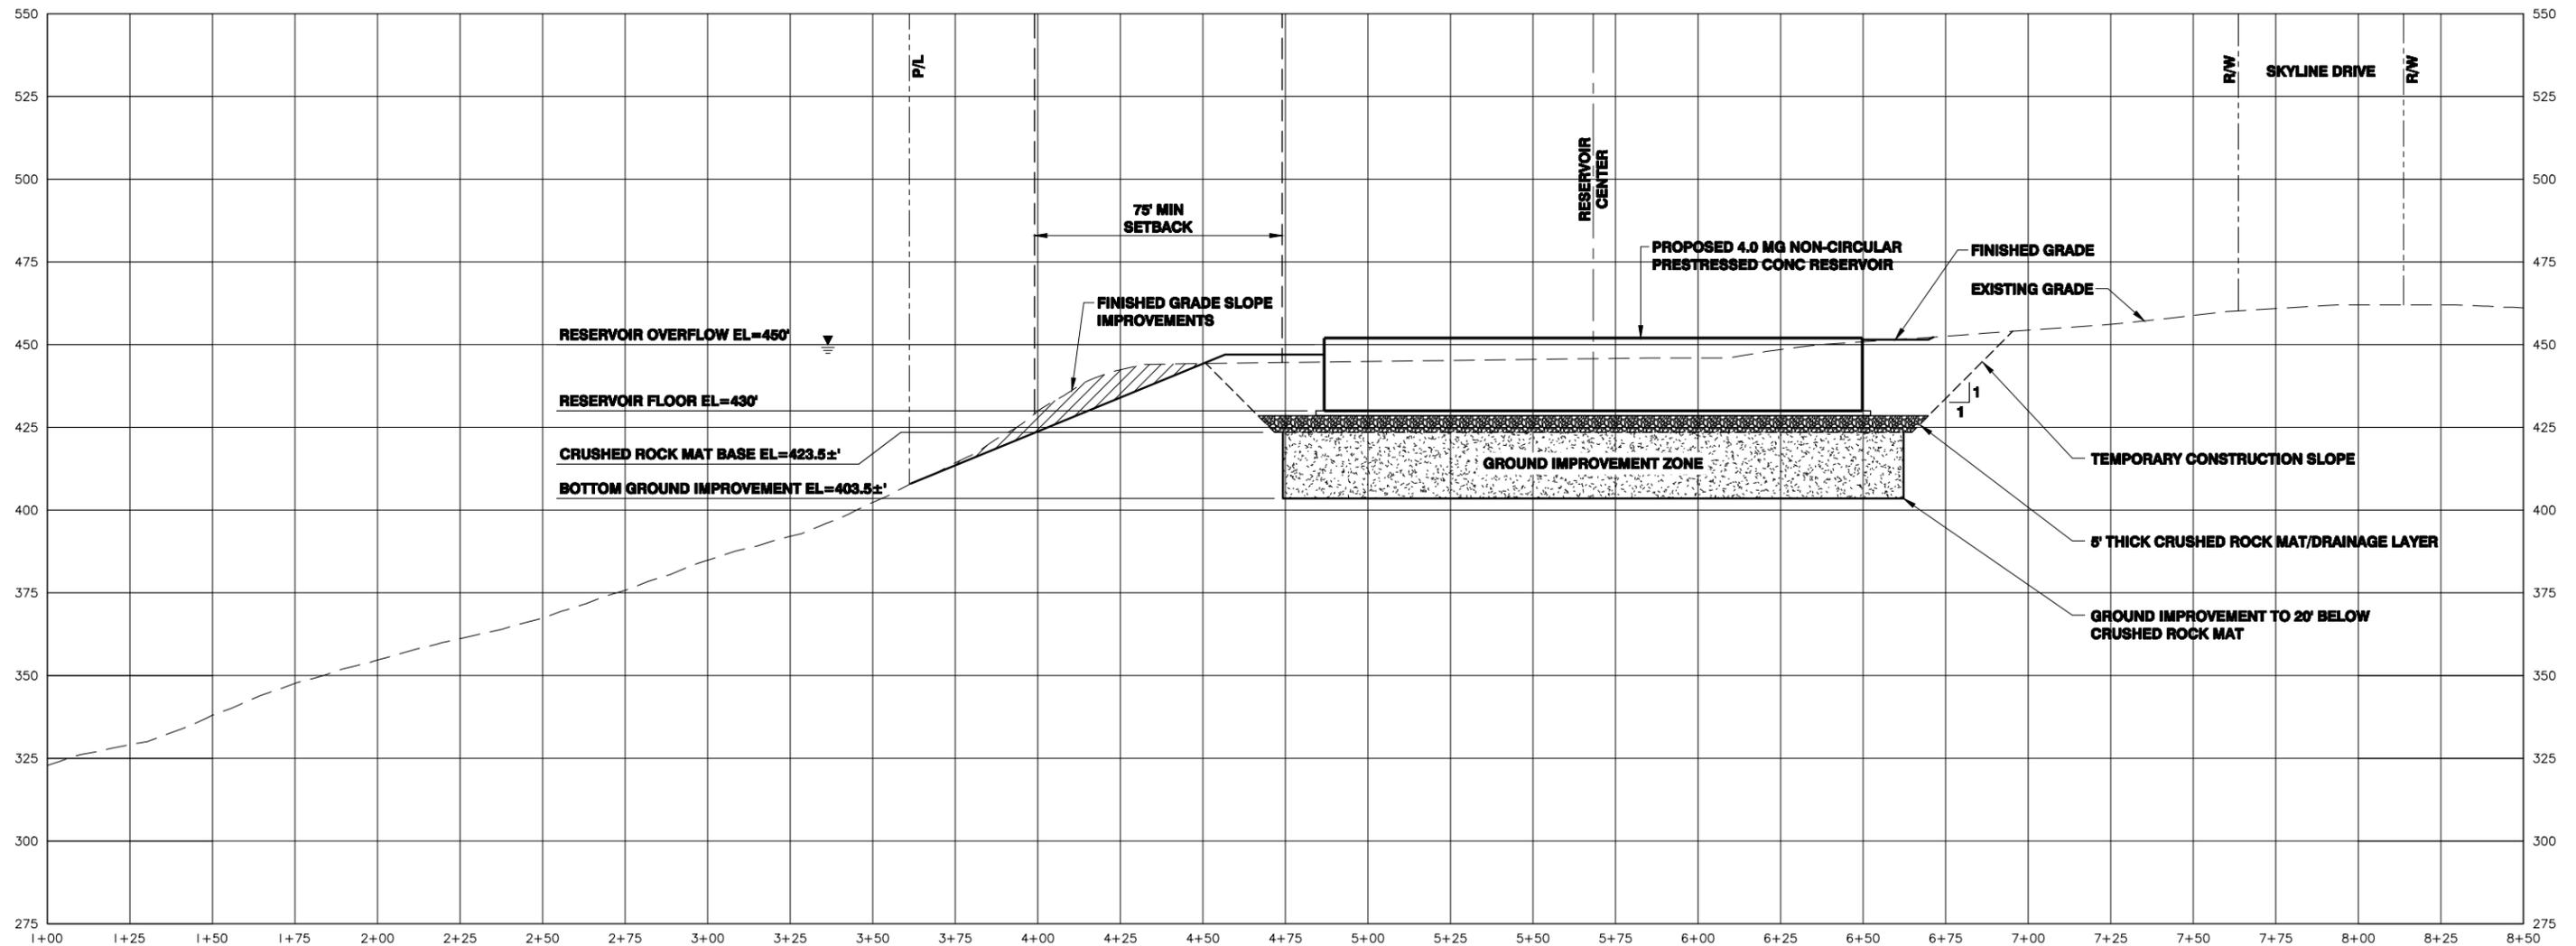
G:\PDX\_Projects\12\1334\CAD\SHEETS\12-1334-401-OR-RECTANGULAR\_RES\_ALT.dwg FIG 2B - SECTION A 8/29/2012 1:12 PM DAK j8.ls (LMS Tech)

SECTION A  
SCALE: 1"=50' HORIZ & VERT

The City requested an analysis of two alternative reservoir shapes, circular and rectangular, to determine the most economical configuration of the proposed reservoir based upon estimated construction costs. Site plans and cross sections were developed for a circular prestressed concrete structure (AWWA D110, Type I) and rectangular conventionally reinforced concrete structure (ACI 350) with appropriate dimensions needed to achieve a 4.0 MG reservoir capacity with the proposed 20-foot water depth identified above. The circular configuration shown on the attached Figures 1.A and 1.B, has a diameter of 190 feet, and a water depth of 20 feet. The rectangular (or non-circular) configuration, with dimensions shown on the attached Figures 2.A and 2.B, is a two cell structure with a center dividing wall and water depth of 20 feet. The

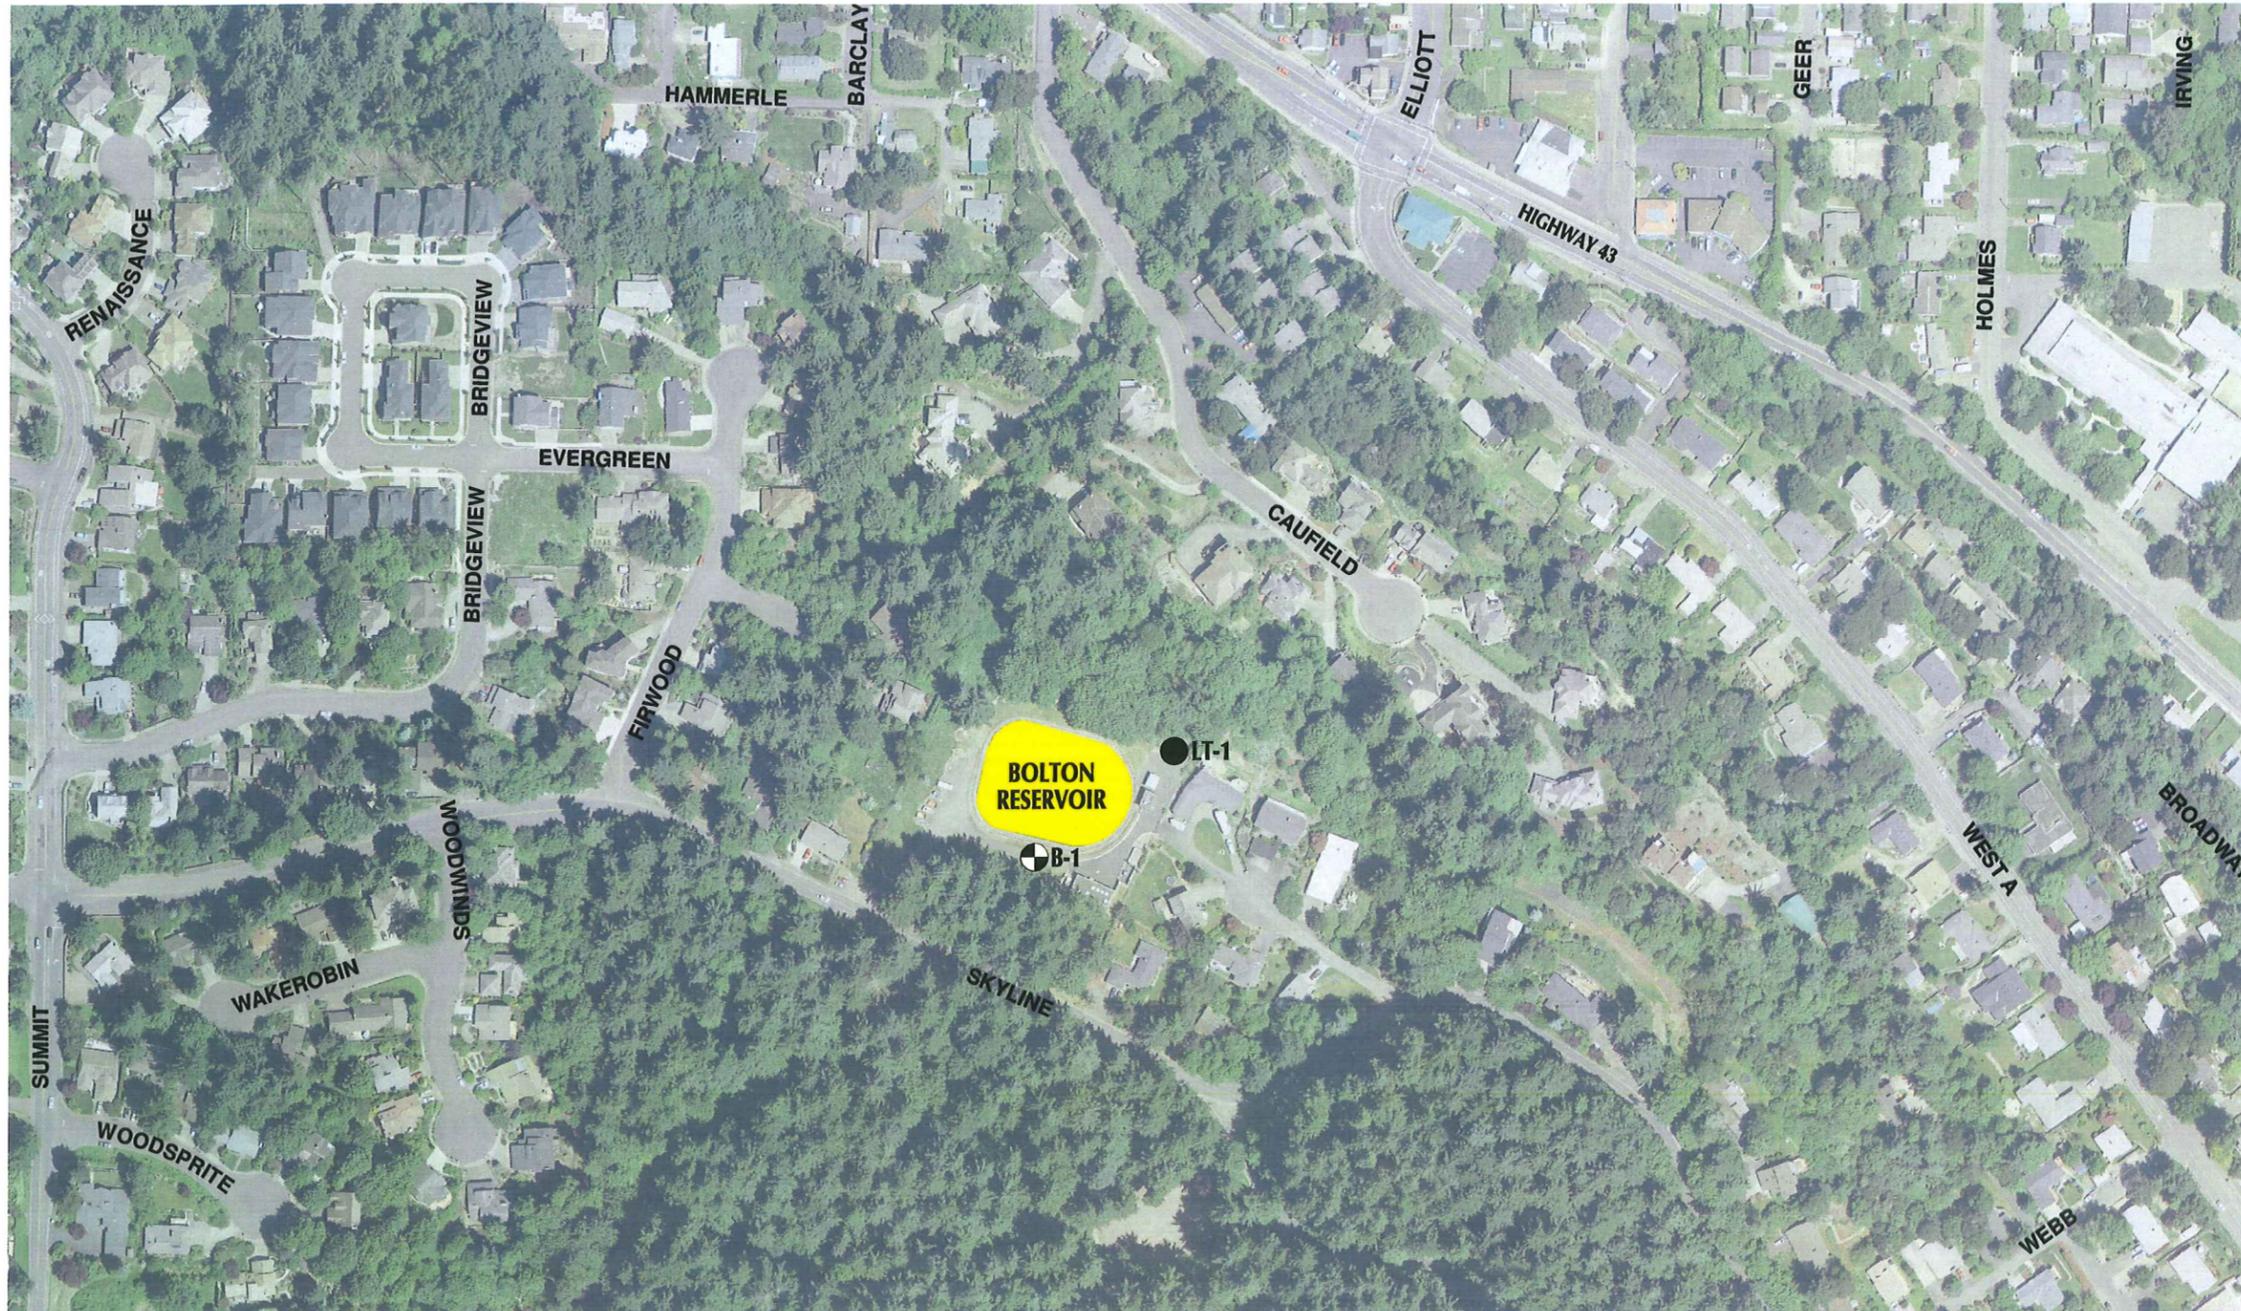
● INCLINOMETER INSTALLED BY LANDSLIDE TECHNOLOGIES (1997)

⊕ BORING MADE BY GRI (JUNE 15, 2012)

Subsurface information previously obtained by NTL and Landslide Technologies along the north side of the reservoir was supplemented with one boring, designated B-1, completed by GRI on June 15, 2012. Boring B-1 was advanced to a depth of 76 ft at the location shown on Figure 2. The field exploration program completed for this study is discussed in detail in Appendix A. The log of the boring is provided on Figure 1A. The terms used to describe the materials encountered in the boring are defined in Tables 1A and 2A.

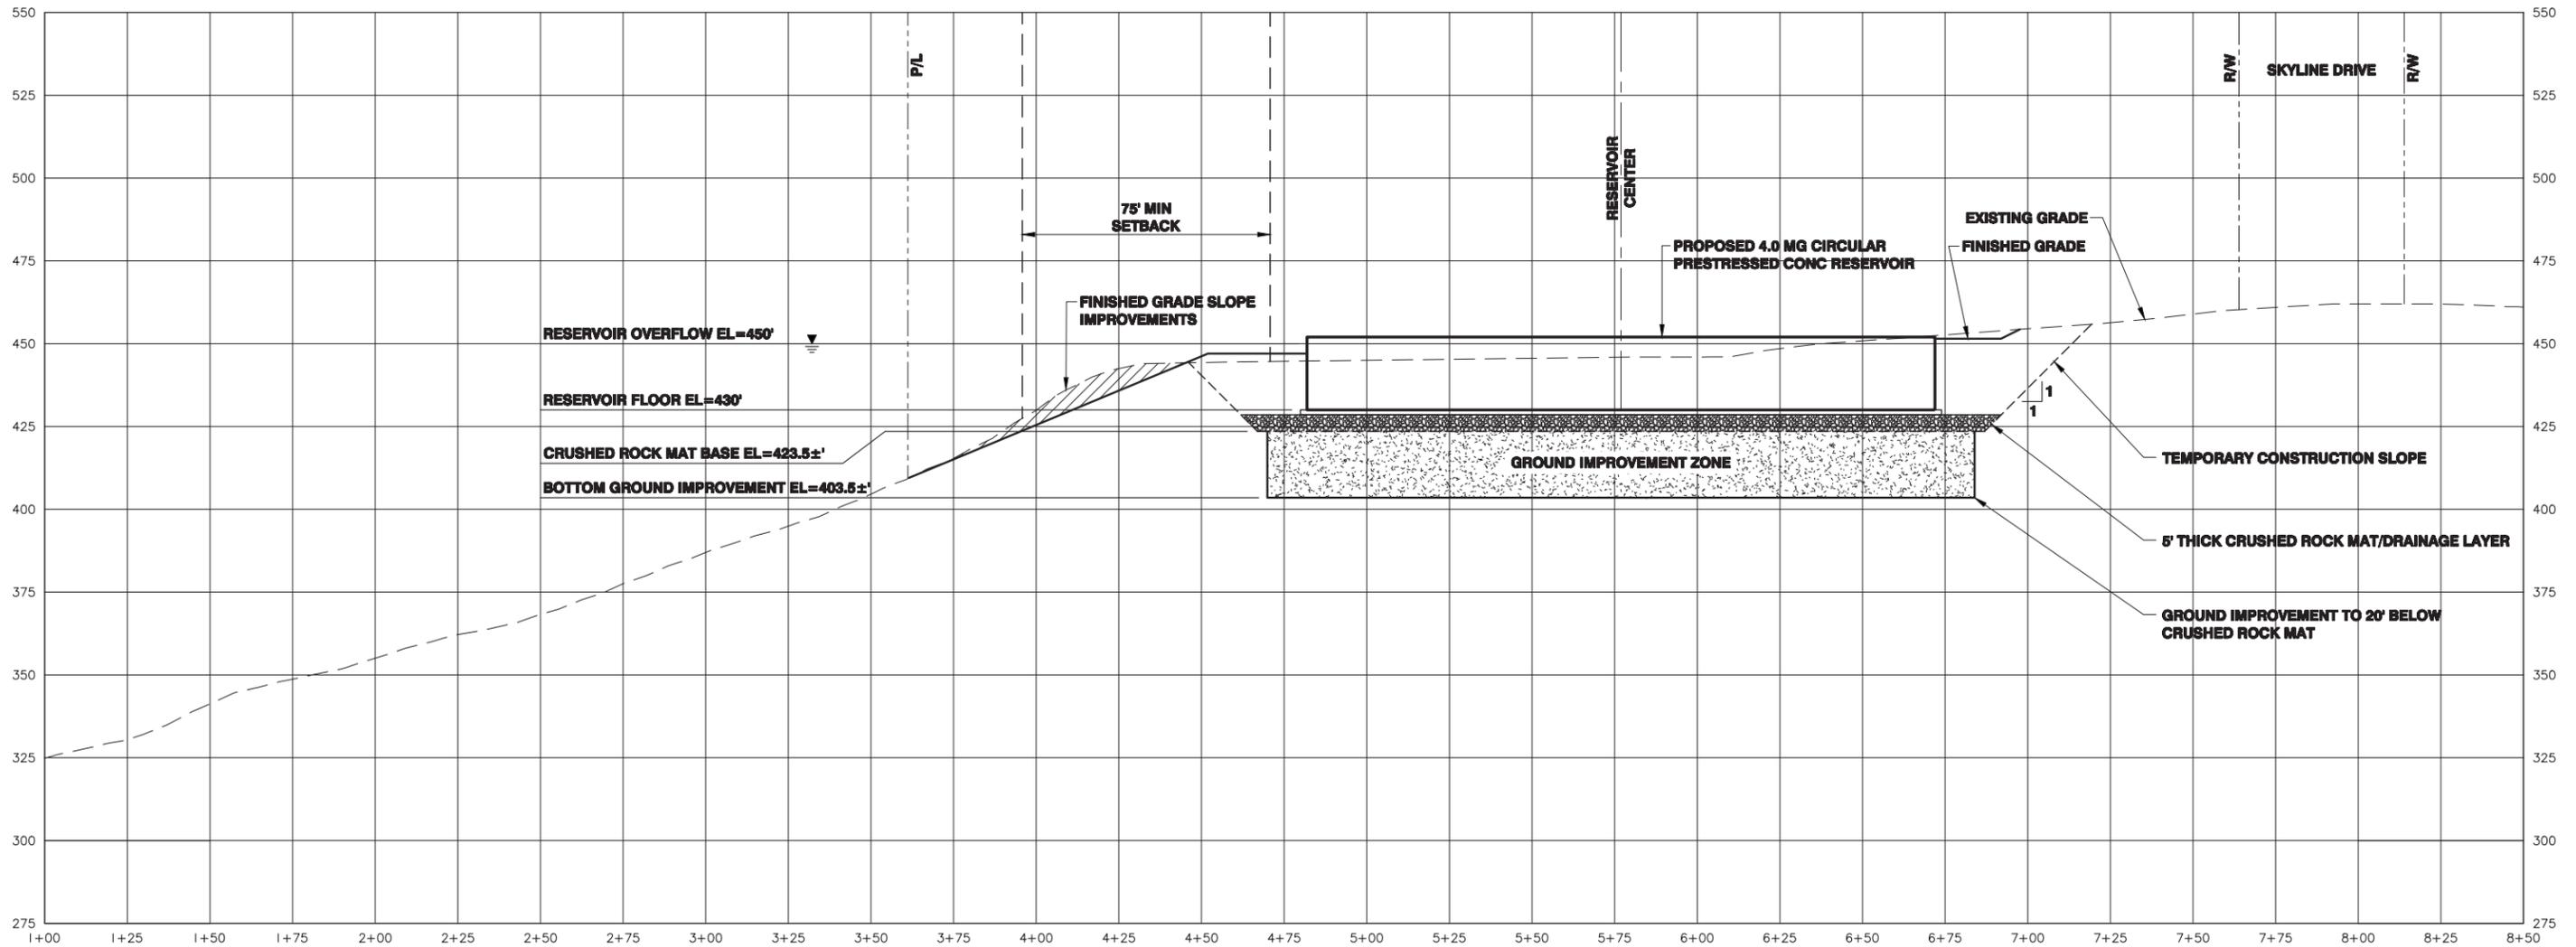
C:\PDX\_Projects\12\1334\CAD\SHEETS\12-1334-401-OR-CIRCULAR RES.ALT.dwg FIG 1.B - SECTION A 8/29/2012 1:08 PM DAK 18.1.s (LMS Tech)

SECTION A  
SCALE: 1"=50' HORIZ & VERT

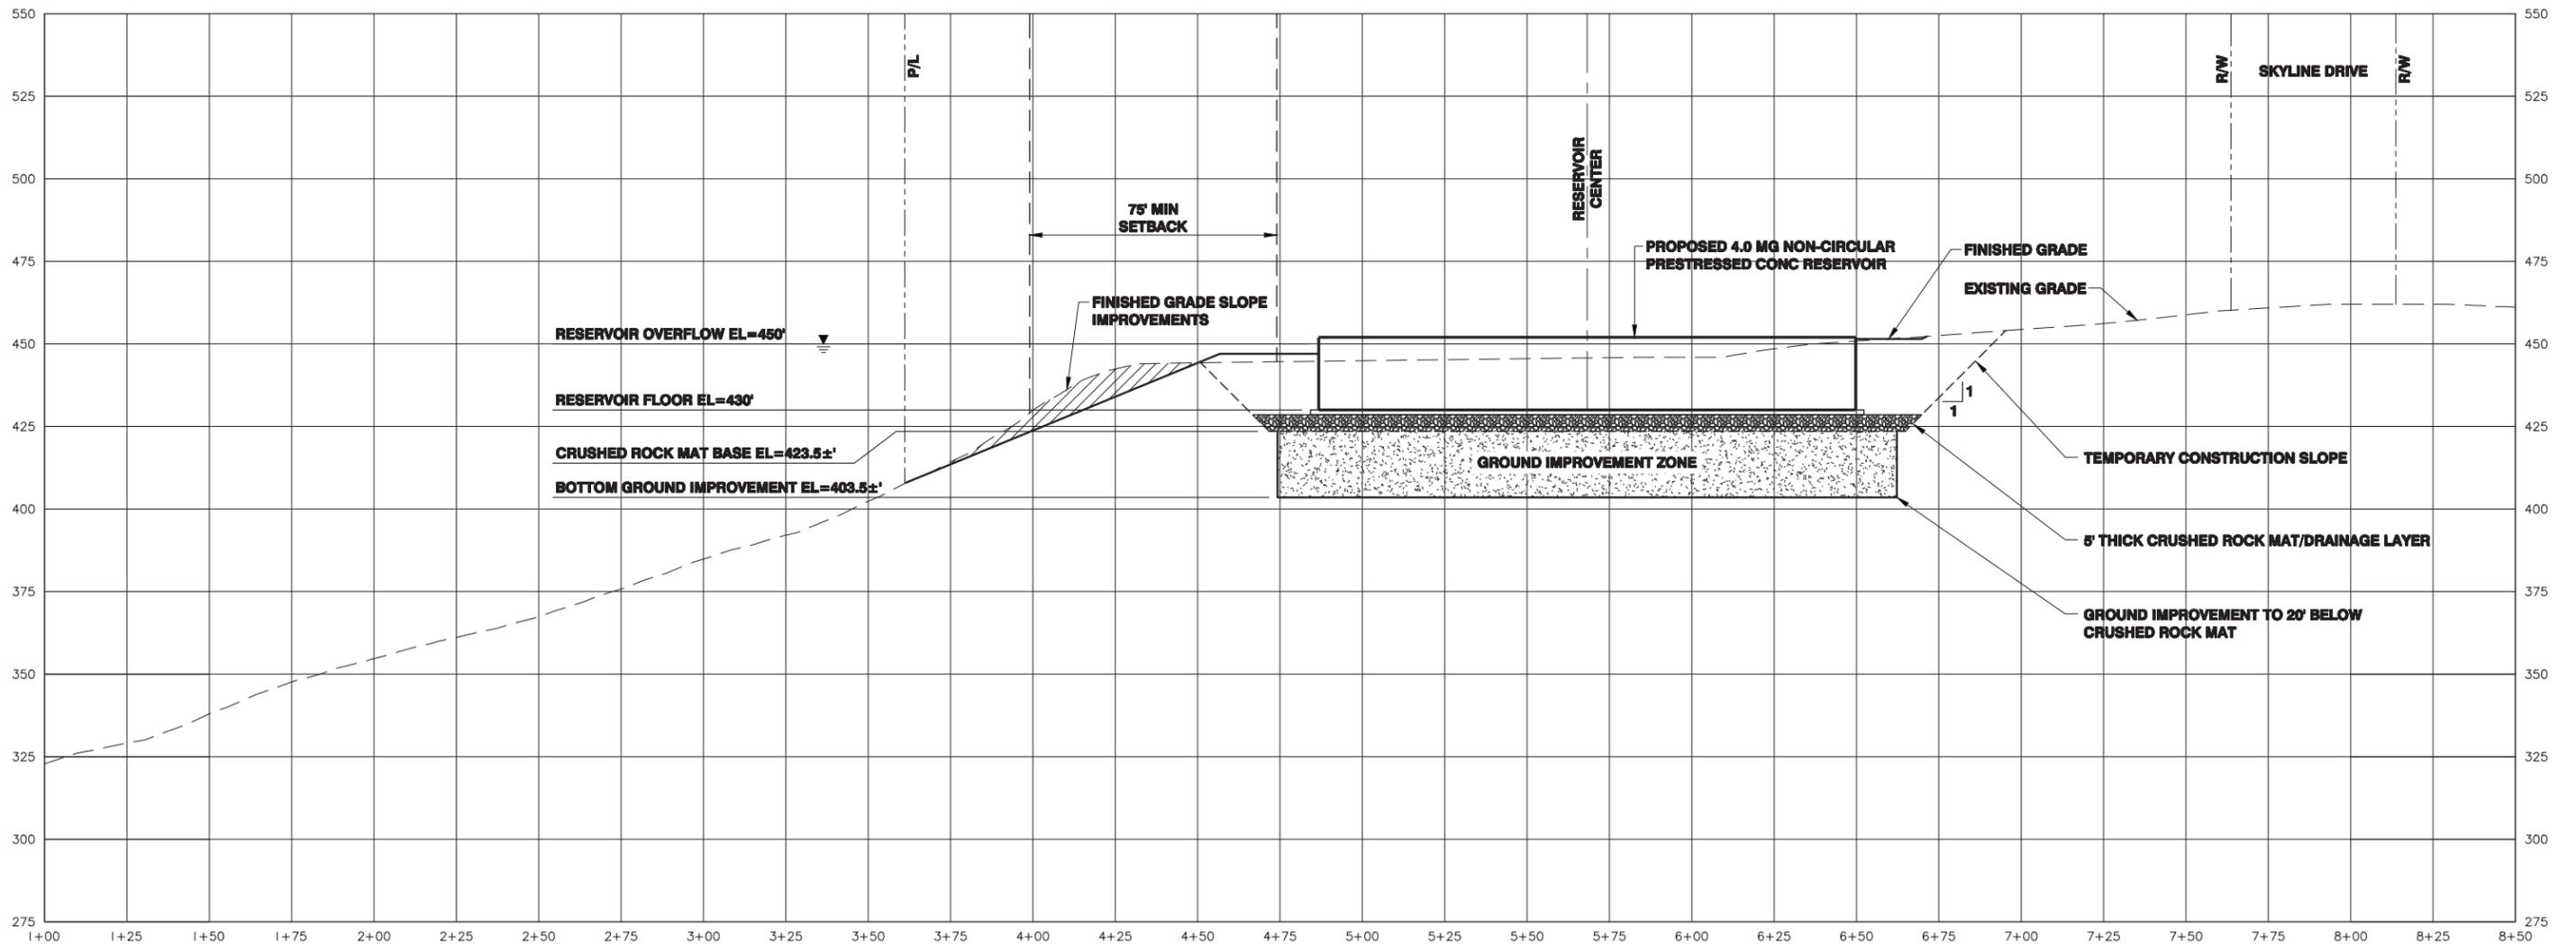
G:\PDX\_Projects\12\1334\CAD\SHEETS\12-1334-401-OR-RECTANGULAR\_RES\_ALT.dwg FIG 2B - SECTION A 8/29/2012 1:12 PM DAK j8.1s (LMS Tech)

SECTION A  
SCALE: 1"=50' HORIZ & VERT

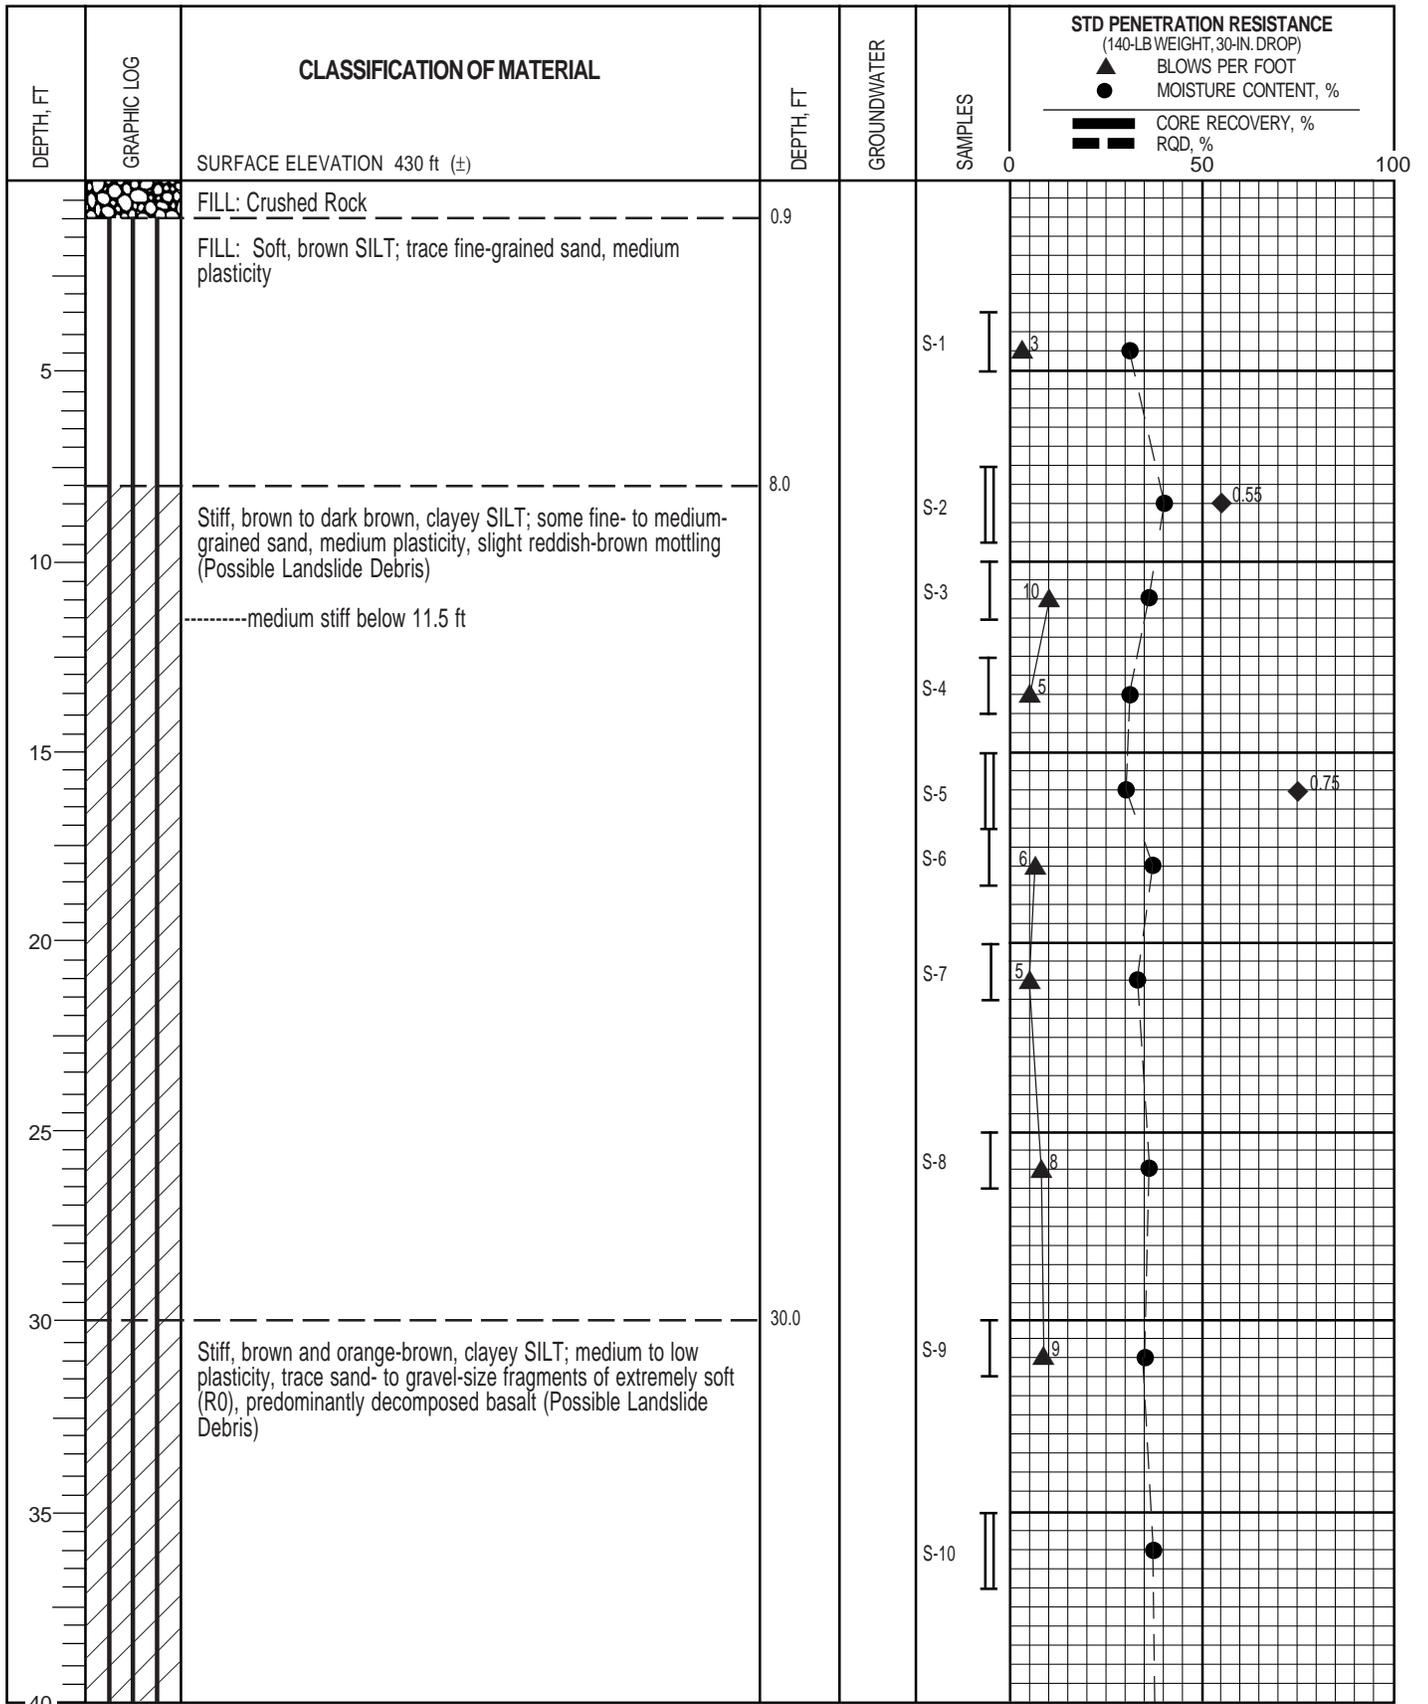
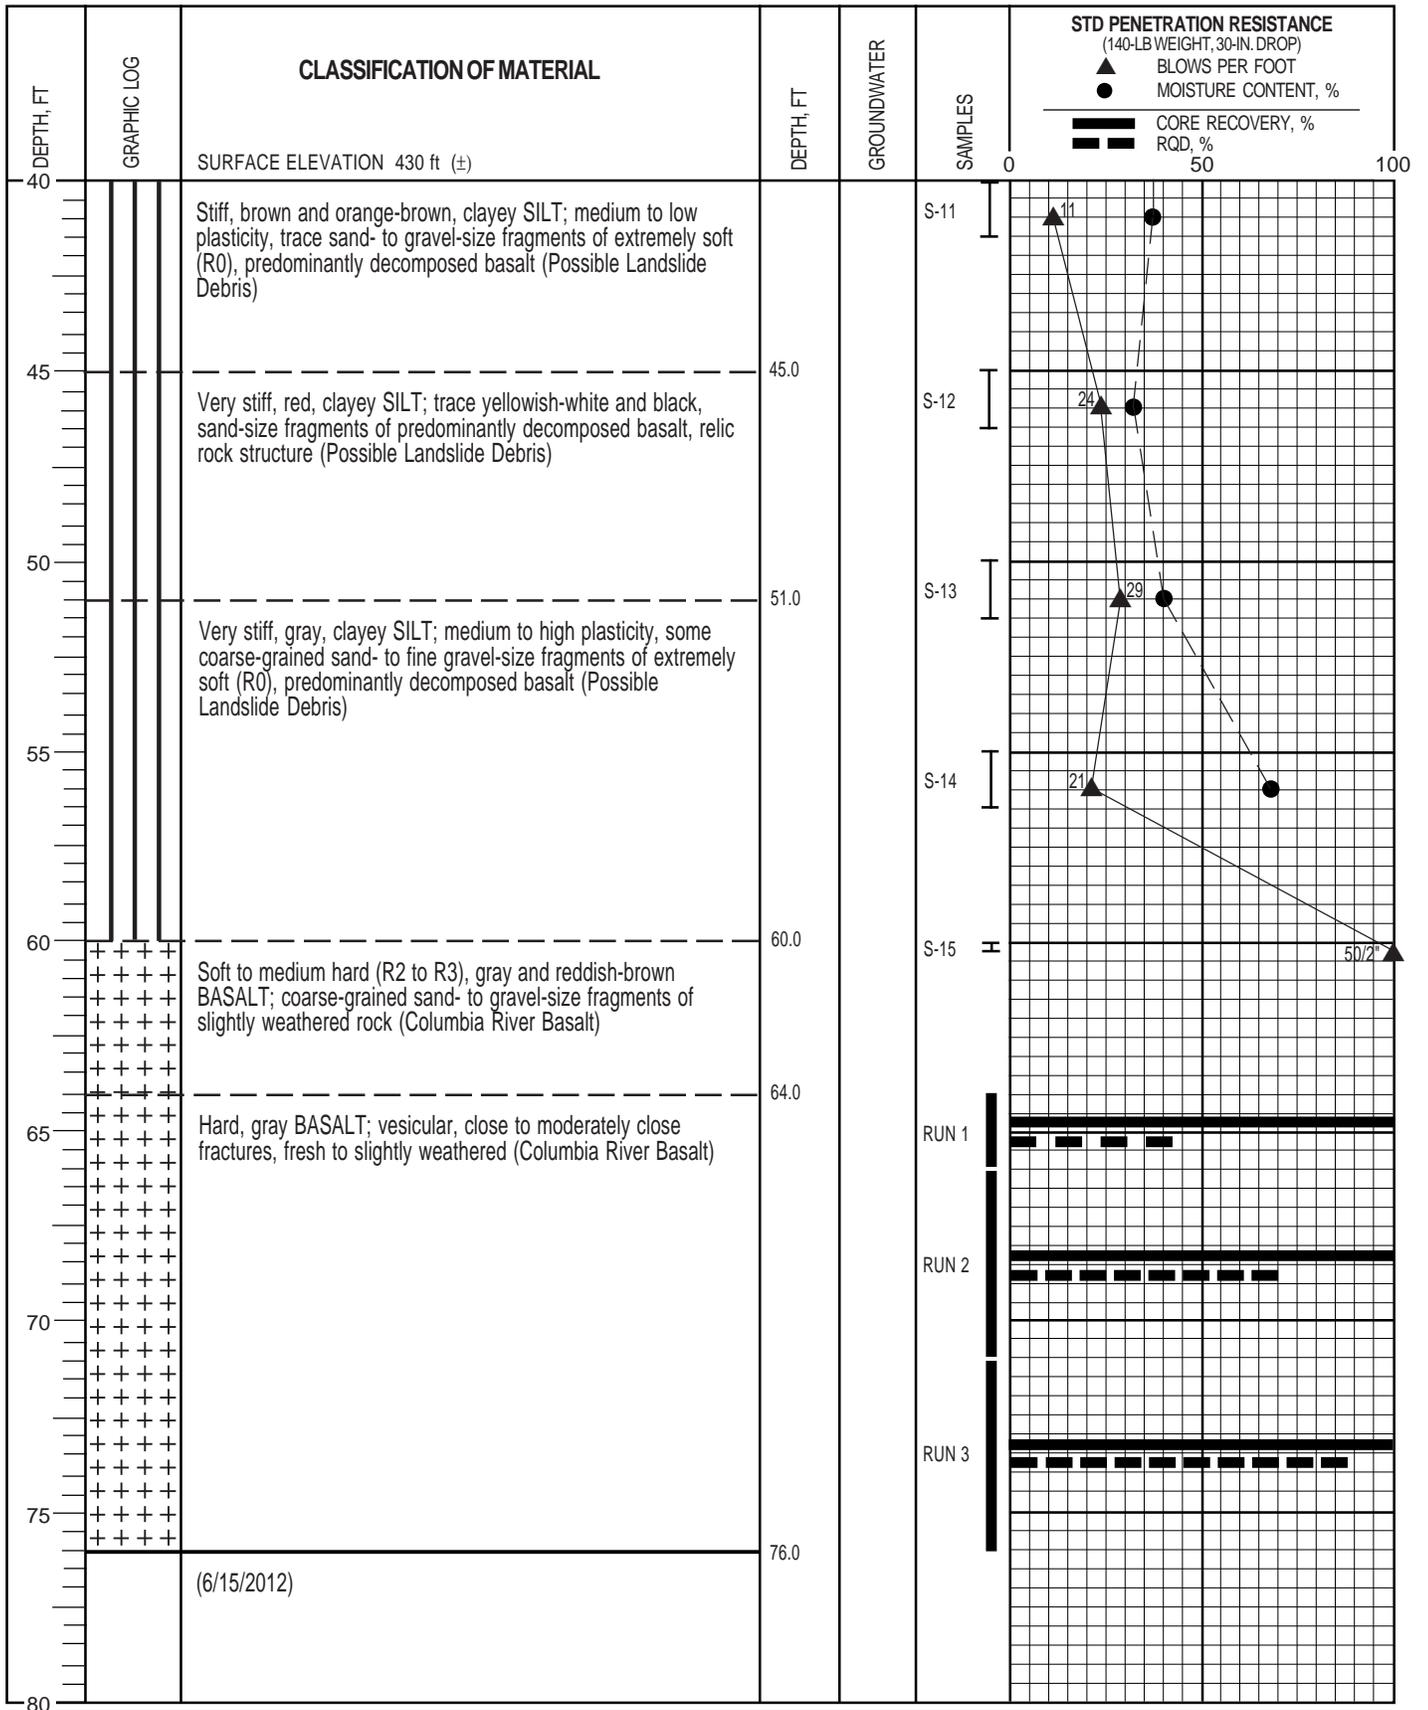
# BORING B-1

- I 2-IN.-OD SPLIT-SPOON SAMPLER
- II 3-IN.-OD THIN-WALLED SAMPLER
- G GRAB SAMPLE OF DRILL CUTTINGS
- NX CORE RUN
- SLOTTED PVC PIPE
- ▼ Water Level (date)
- ◆ TORVANE SHEAR STRENGTH, TSF
- PERCENT PASSING NO. 200 SIEVE (WASHED)
- \* NO RECOVERY
- Liquid Limit
- Moisture Content
- Plastic Limit

The log of the boring is provided on Figure 1A. The log presents a descriptive summary of the various types of materials encountered in the boring and notes the depth where the materials and/or characteristics of the materials change. To the right of the descriptive summary, the numbers and types of samples taken during the drilling operation are indicated. Farther to the right, N-values are shown graphically, along with the natural moisture contents and Torvane shear strength values. The terms used to describe the soil encountered in the borings are defined in Tables 1A and 2A.
