## Memorandum

Date: June 26, 2012  
To: West Linn Planning Commission  
From: Peter Spir, Associate Planner  
Subject: Chase Bank (DR-12-08)

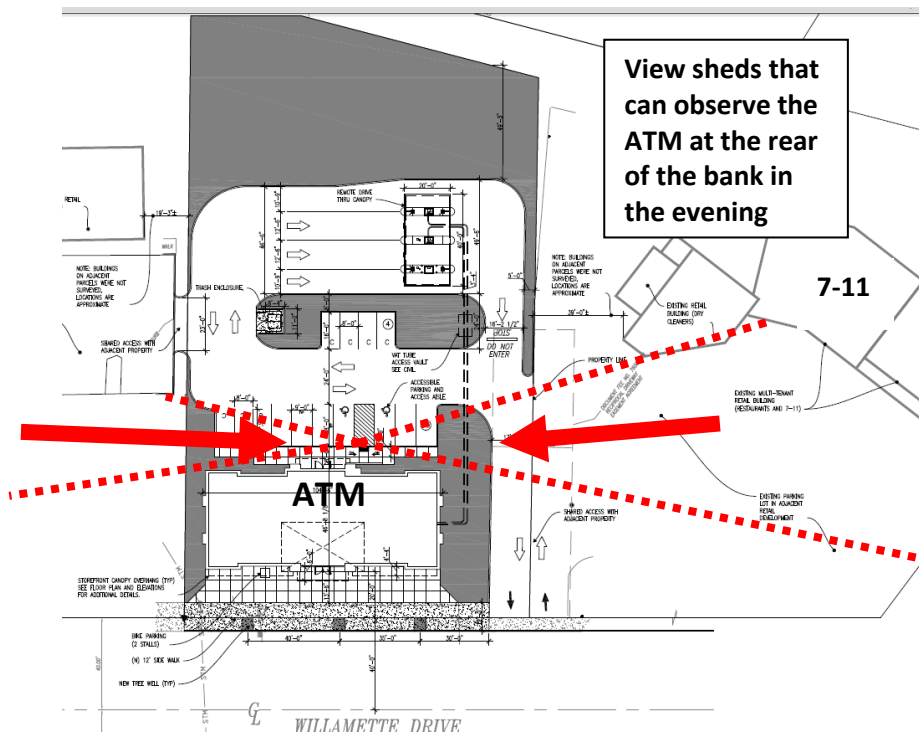
During daylight/business hours, the issue of surveillance is not as acute since the area will be observed by bank employees. During non-daylight/non-business hours, surveillance becomes more of an issue. Compared to potential surveillance of the front elevation at night time, which can be seen by passing motorists, surveillance of the rear elevation is comparatively limited. Surveillance is limited to lines of sight from adjacent commercial properties, such as the late night 7-11 business that generates a significant amount of nighttime traffic. Other ATM customers waiting to use the ATM would also offer surveillance.

In terms of security, the vestibule that houses the ATM requires an access card, has an emergency alarm and is monitored by cameras.

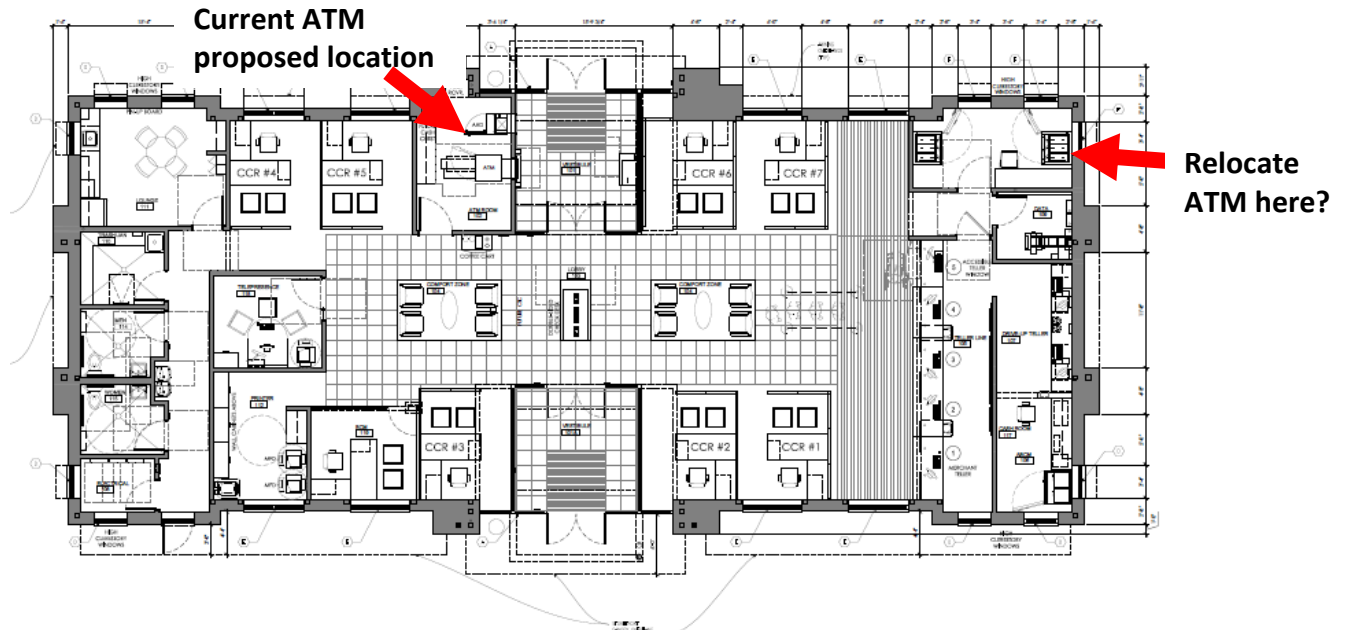
Relocating the ATM to the side of the building has some advantages in terms of improved visibility or surveillance potential and the 25-50 foot distance from the parking lot to an ATM at the southeast corner of the bank would not be unreasonable. The downside is that it would require significant redesign of the bank's interior.

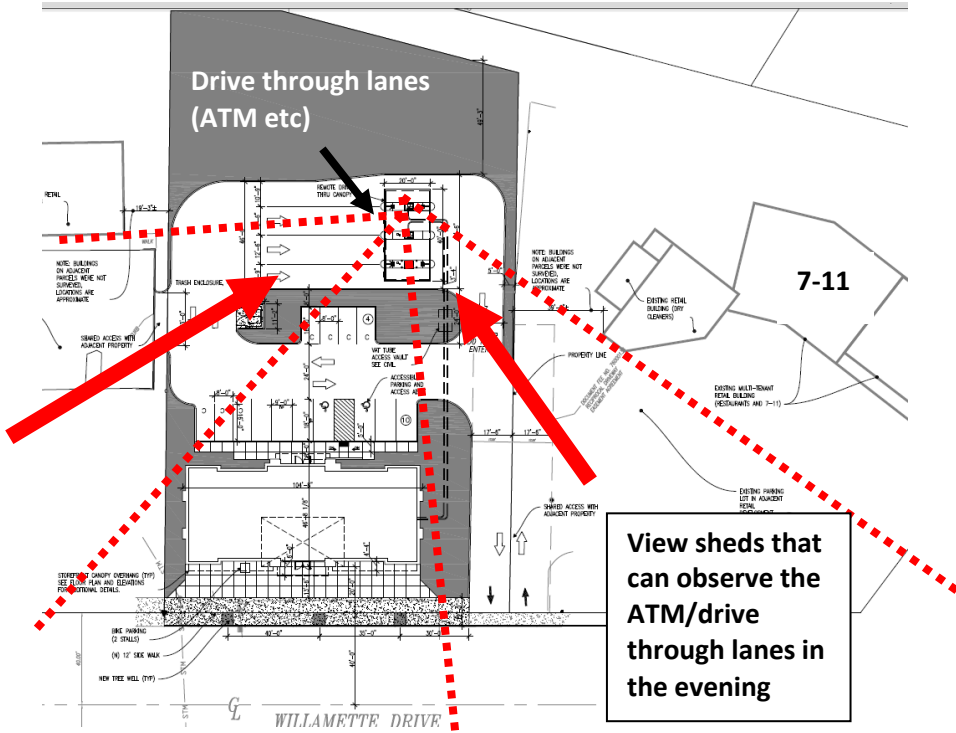
Surveillance of this area is better than the ATM in the bank as shown on page 20 (finding 8) of the staff report. In addition to views from the 7-11 parking lot, the site will be visible to north bound traffic on Willamette Drive as well as southbound traffic along with customers of Willamette Village to the north. The connecting driveways will facilitate security drive throughs by police.

Security is enhanced by a lighting system and the installation of a six foot cyclone fence on the east and side lot lines.

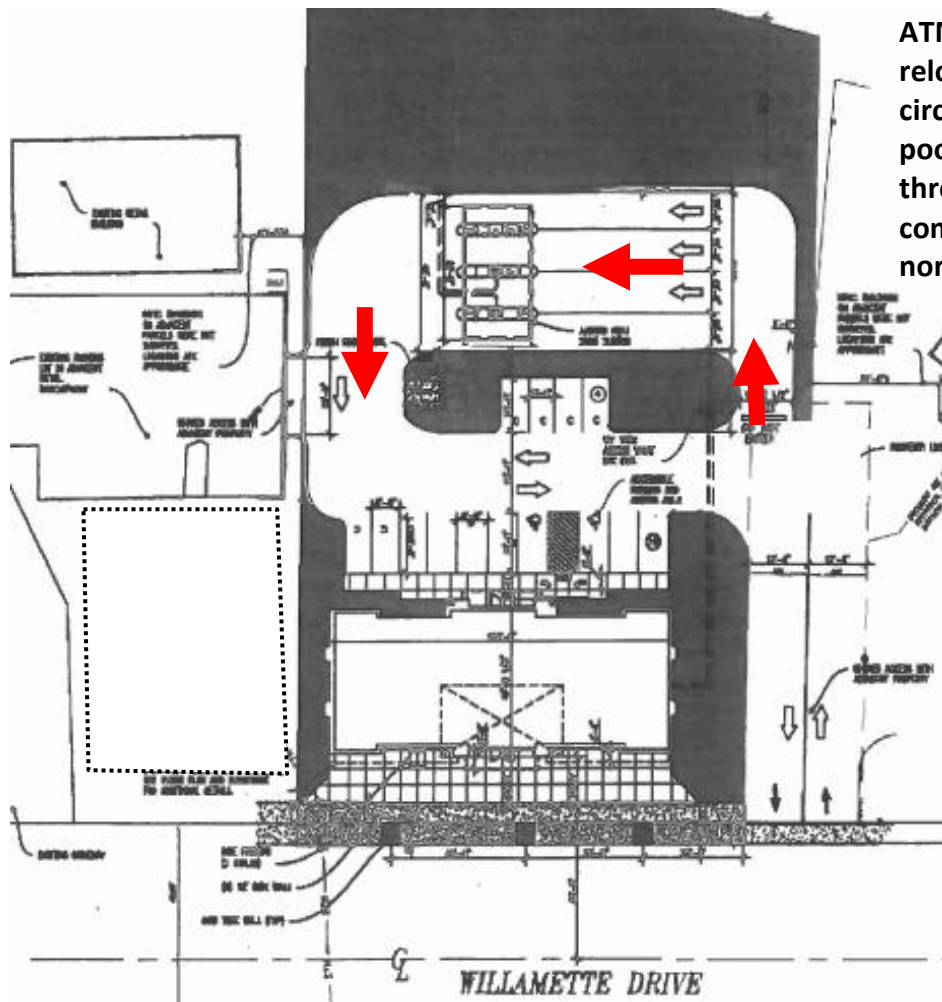
Other internal circulation patterns, such as reversing the direction that vehicle would approach the drive through ATM and VAT stations, were not seen as producing any significant advantages. For example, the reverse flow would place the drive through ATM in a location that would not be as easily observed as the current proposal.

ATM drive through relocated to reverse the circulation plan produces poor surveillance of drive through especially when commercial pad to the north is developed.
