NNA Landscape Architecture 1125 SE Madison St, Suite 201 Portland, OR 97214 503.239.0600	
	I-205: I-5 - OR213, PHASE 1 SEC. EAST PORTLAND FREEWAY CLACKAMAS COUNTY	
Designer: David Goodyke Drafter: David Goodyke	Reviewer: Ben Ngan Checker: Ben Ngan	SHEET NO. F_02
TREE INVENTORY

HDR ENGINEERING, INC 1050 SW 6TH AVENUE, SUITE 1800 PORTLAND, OR 97204-1134 503.423.3700	
	I-205: I-5 - OR213, PHASE 1 SEC. EAST PORTLAND FREEWAY CLACKAMAS COUNTY	
Designer: Jason Rahm Drafter: Connor Donovan	Reviewer: Matt Steigleder Checker: Brendan LeBlanc	SHEET NO. FB02
EROSION AND SEDIMENT CONTROL

Sec. 30, T. 2 S, R. 2 E, W.M.
WEST LINN INTERCHANGE
 EROSION CONTROL STAGE 1

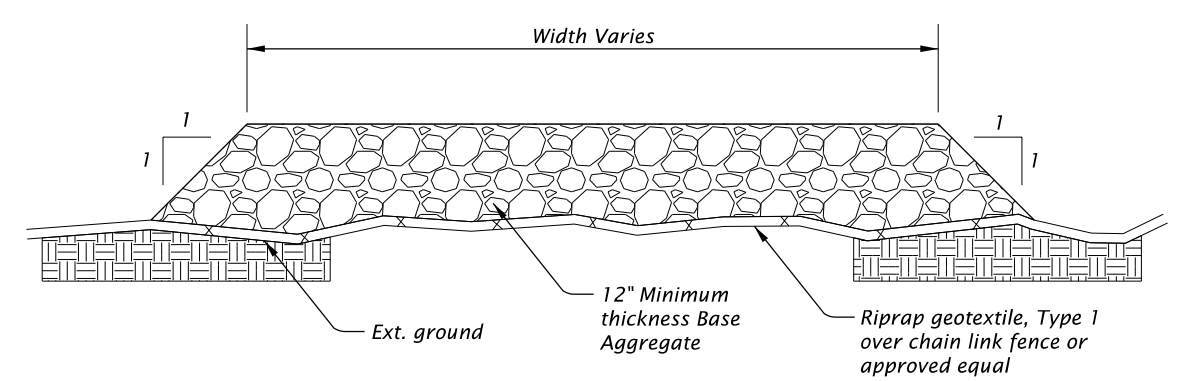
STAGING AREA DETAIL
N.T.S.

1. Existing ground shall be grubbed to a depth 6".
2. Cover existing ground under Staging Area with riprap geotextile and either chain link fence or other approved geogrid type material and cover with Base Aggregate.
3. Applies to contractor staging within environmentally sensitive and regulated work areas.

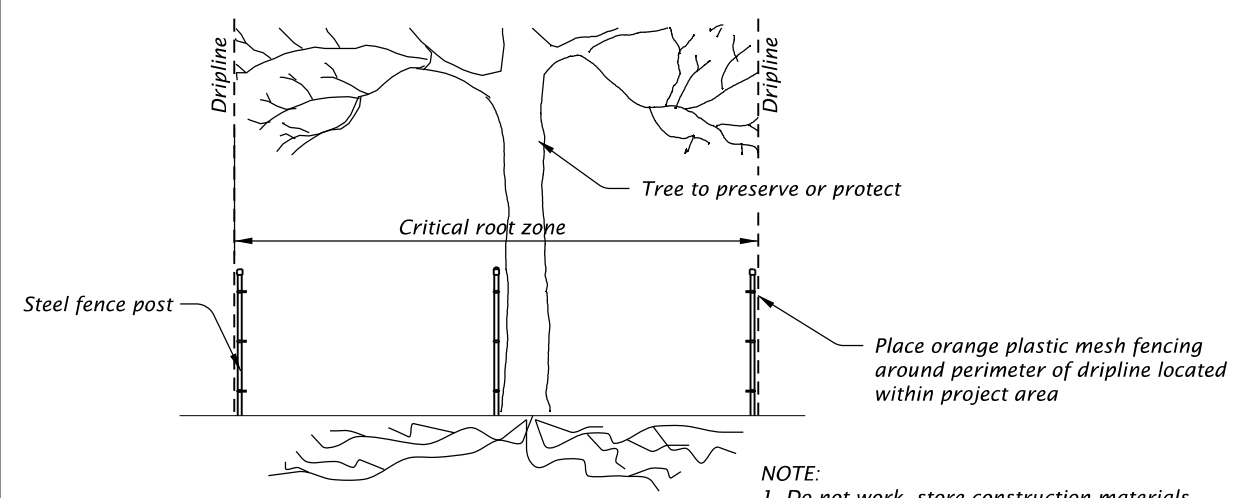
TREE PROTECTION DETAIL
N.T.S.

- NOTE:**
1. Do not work, store construction materials or park within the critical root zone of marked trees unless written approval has been obtained from the Engineer.
 2. Areas bounded by temporary orange fence denote protected no work areas such as trees, wetlands, cultural resources, etc.
 3. Place check dams in ditch sections.

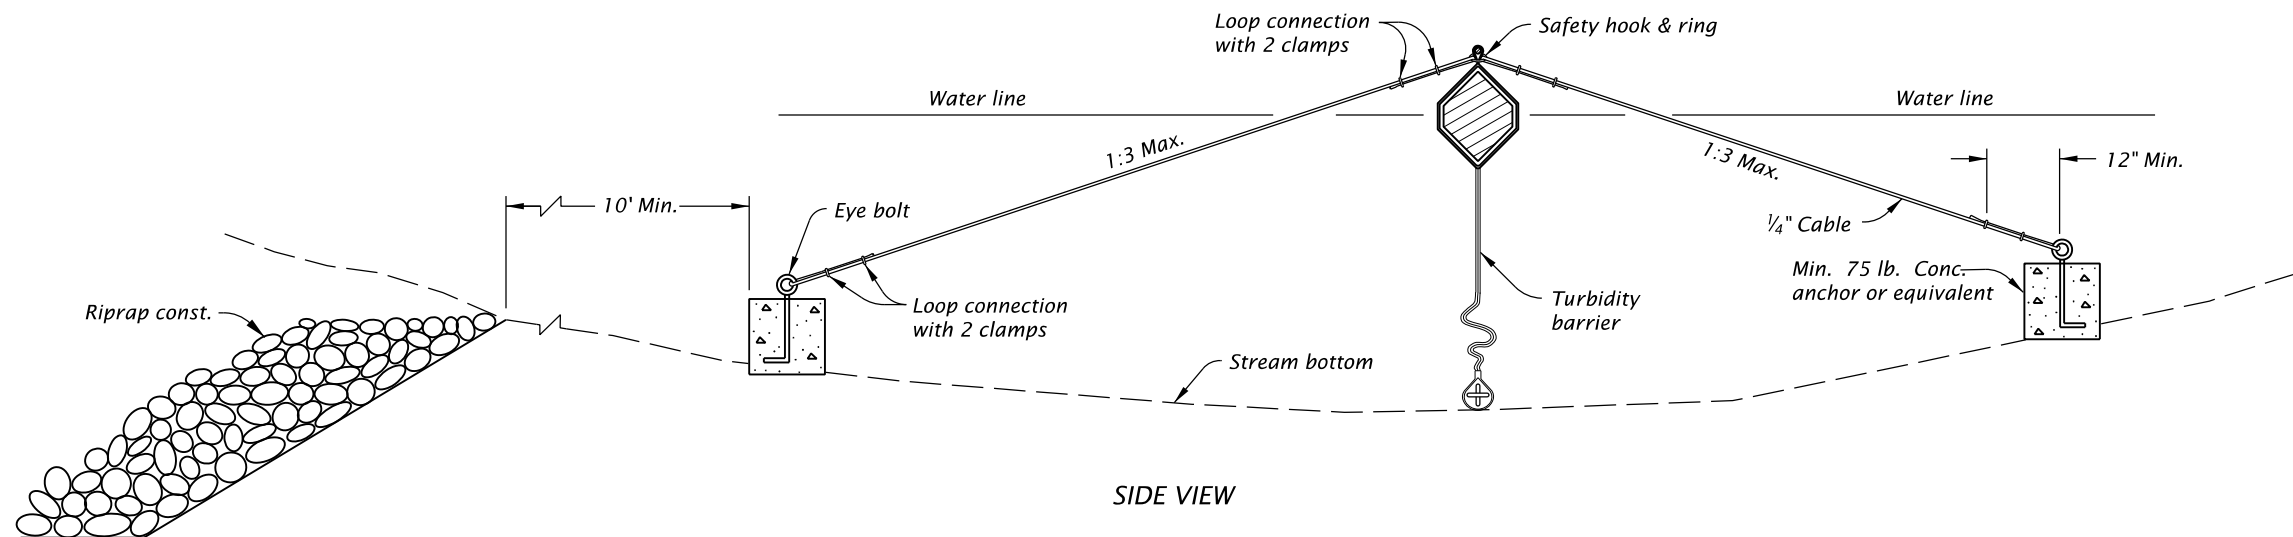
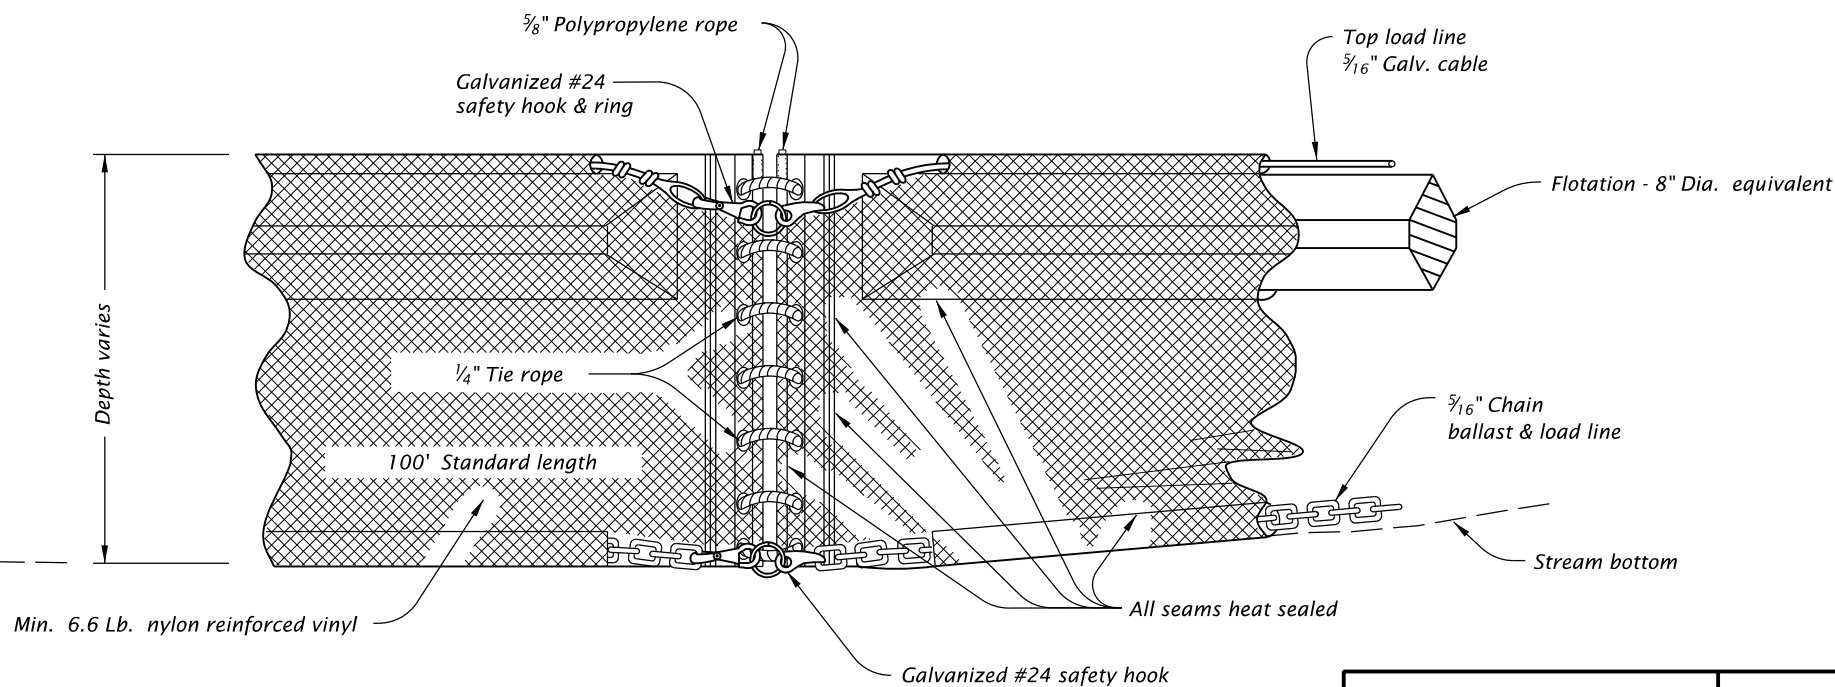
SEDIMENT BARRIER FLOATING

Components of this barrier may be similar or identical to proprietary designs. Any infringement on the proprietary rights of the designer shall be the sole responsibility of the contractor. Substitutions shall be as approved by the engineer.

ANCHOR ASSEMBLY

TURBIDITY BARRIER

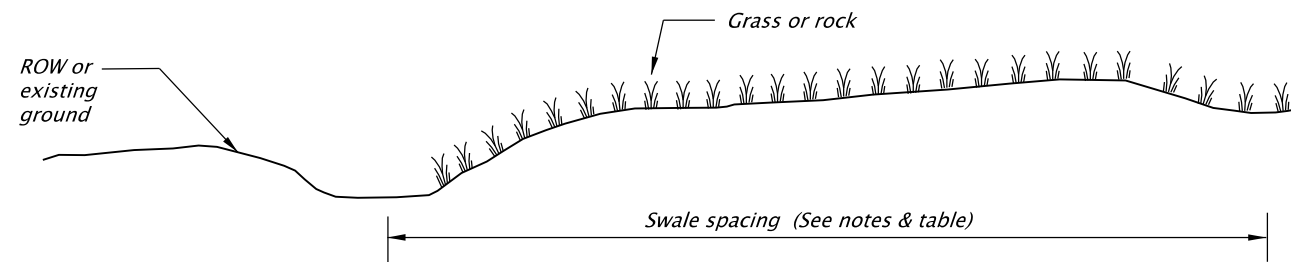
TEMPORARY INTERCEPTOR SWALE TYPE 1

SECTION

Swale Spacing	
Slope	Spacing
3-5%	300'
5-10%	200'
10-25%	100'
25-50%	50'

Side slope = 1:2 or flatter

Grade = maximum 5 percent with positive drainage to a suitable outlet (such as sedimentation pond)

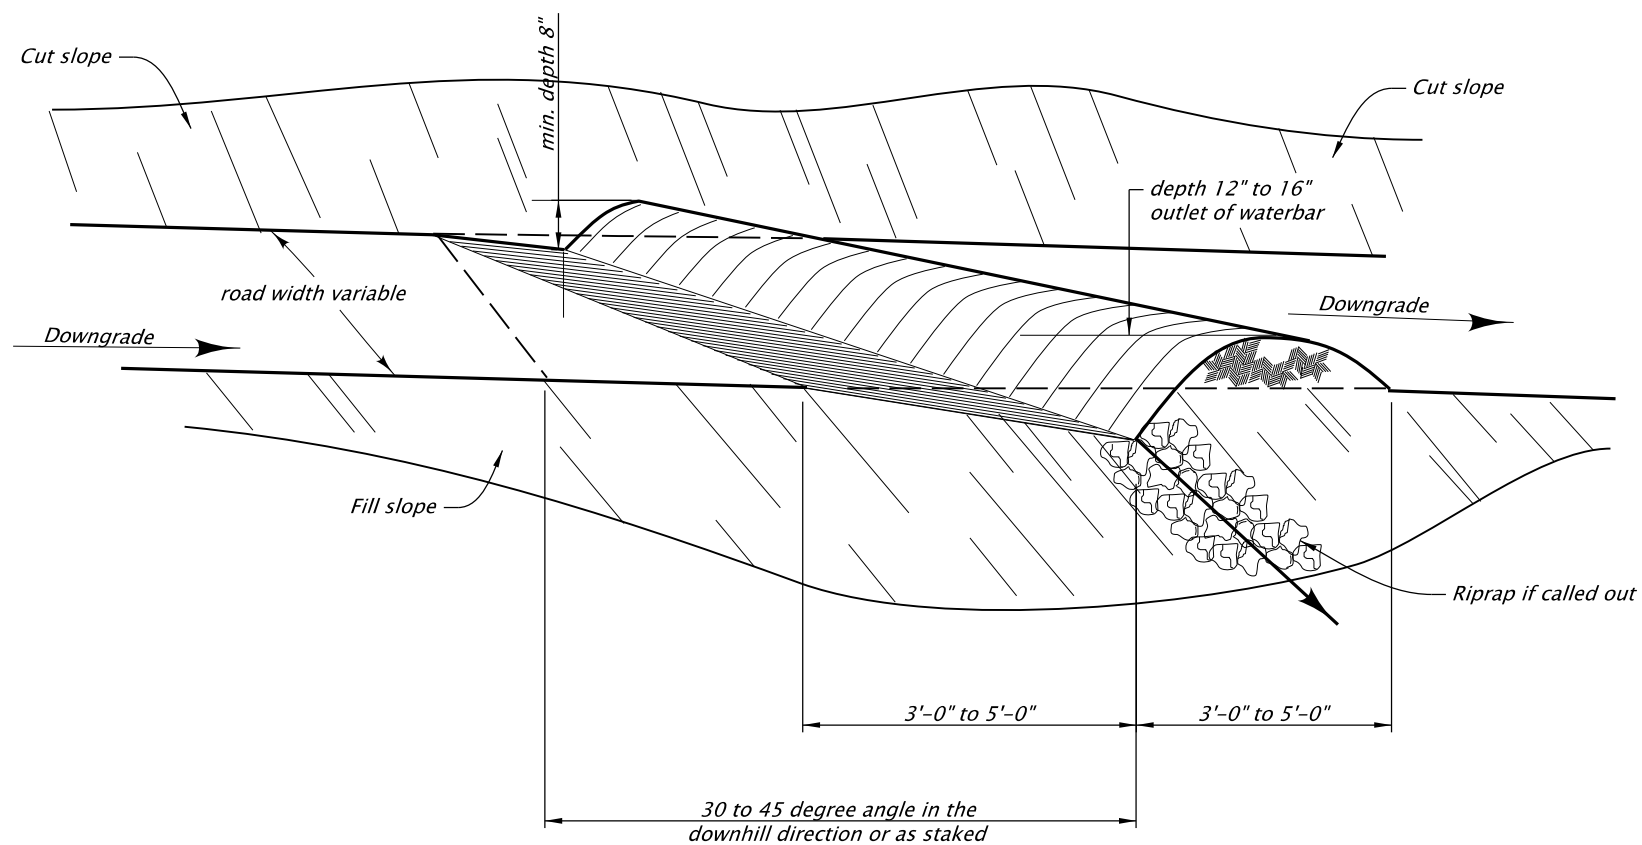
WATERBAR

1. Begin waterbars at the intersection of the roadbed and cut slope, and run across the entire width of the roadbed.
2. Ensure waterbars have a free flowing outlet for drainage.
3. Ensure that waterbars allow for passage of a construction equipment.

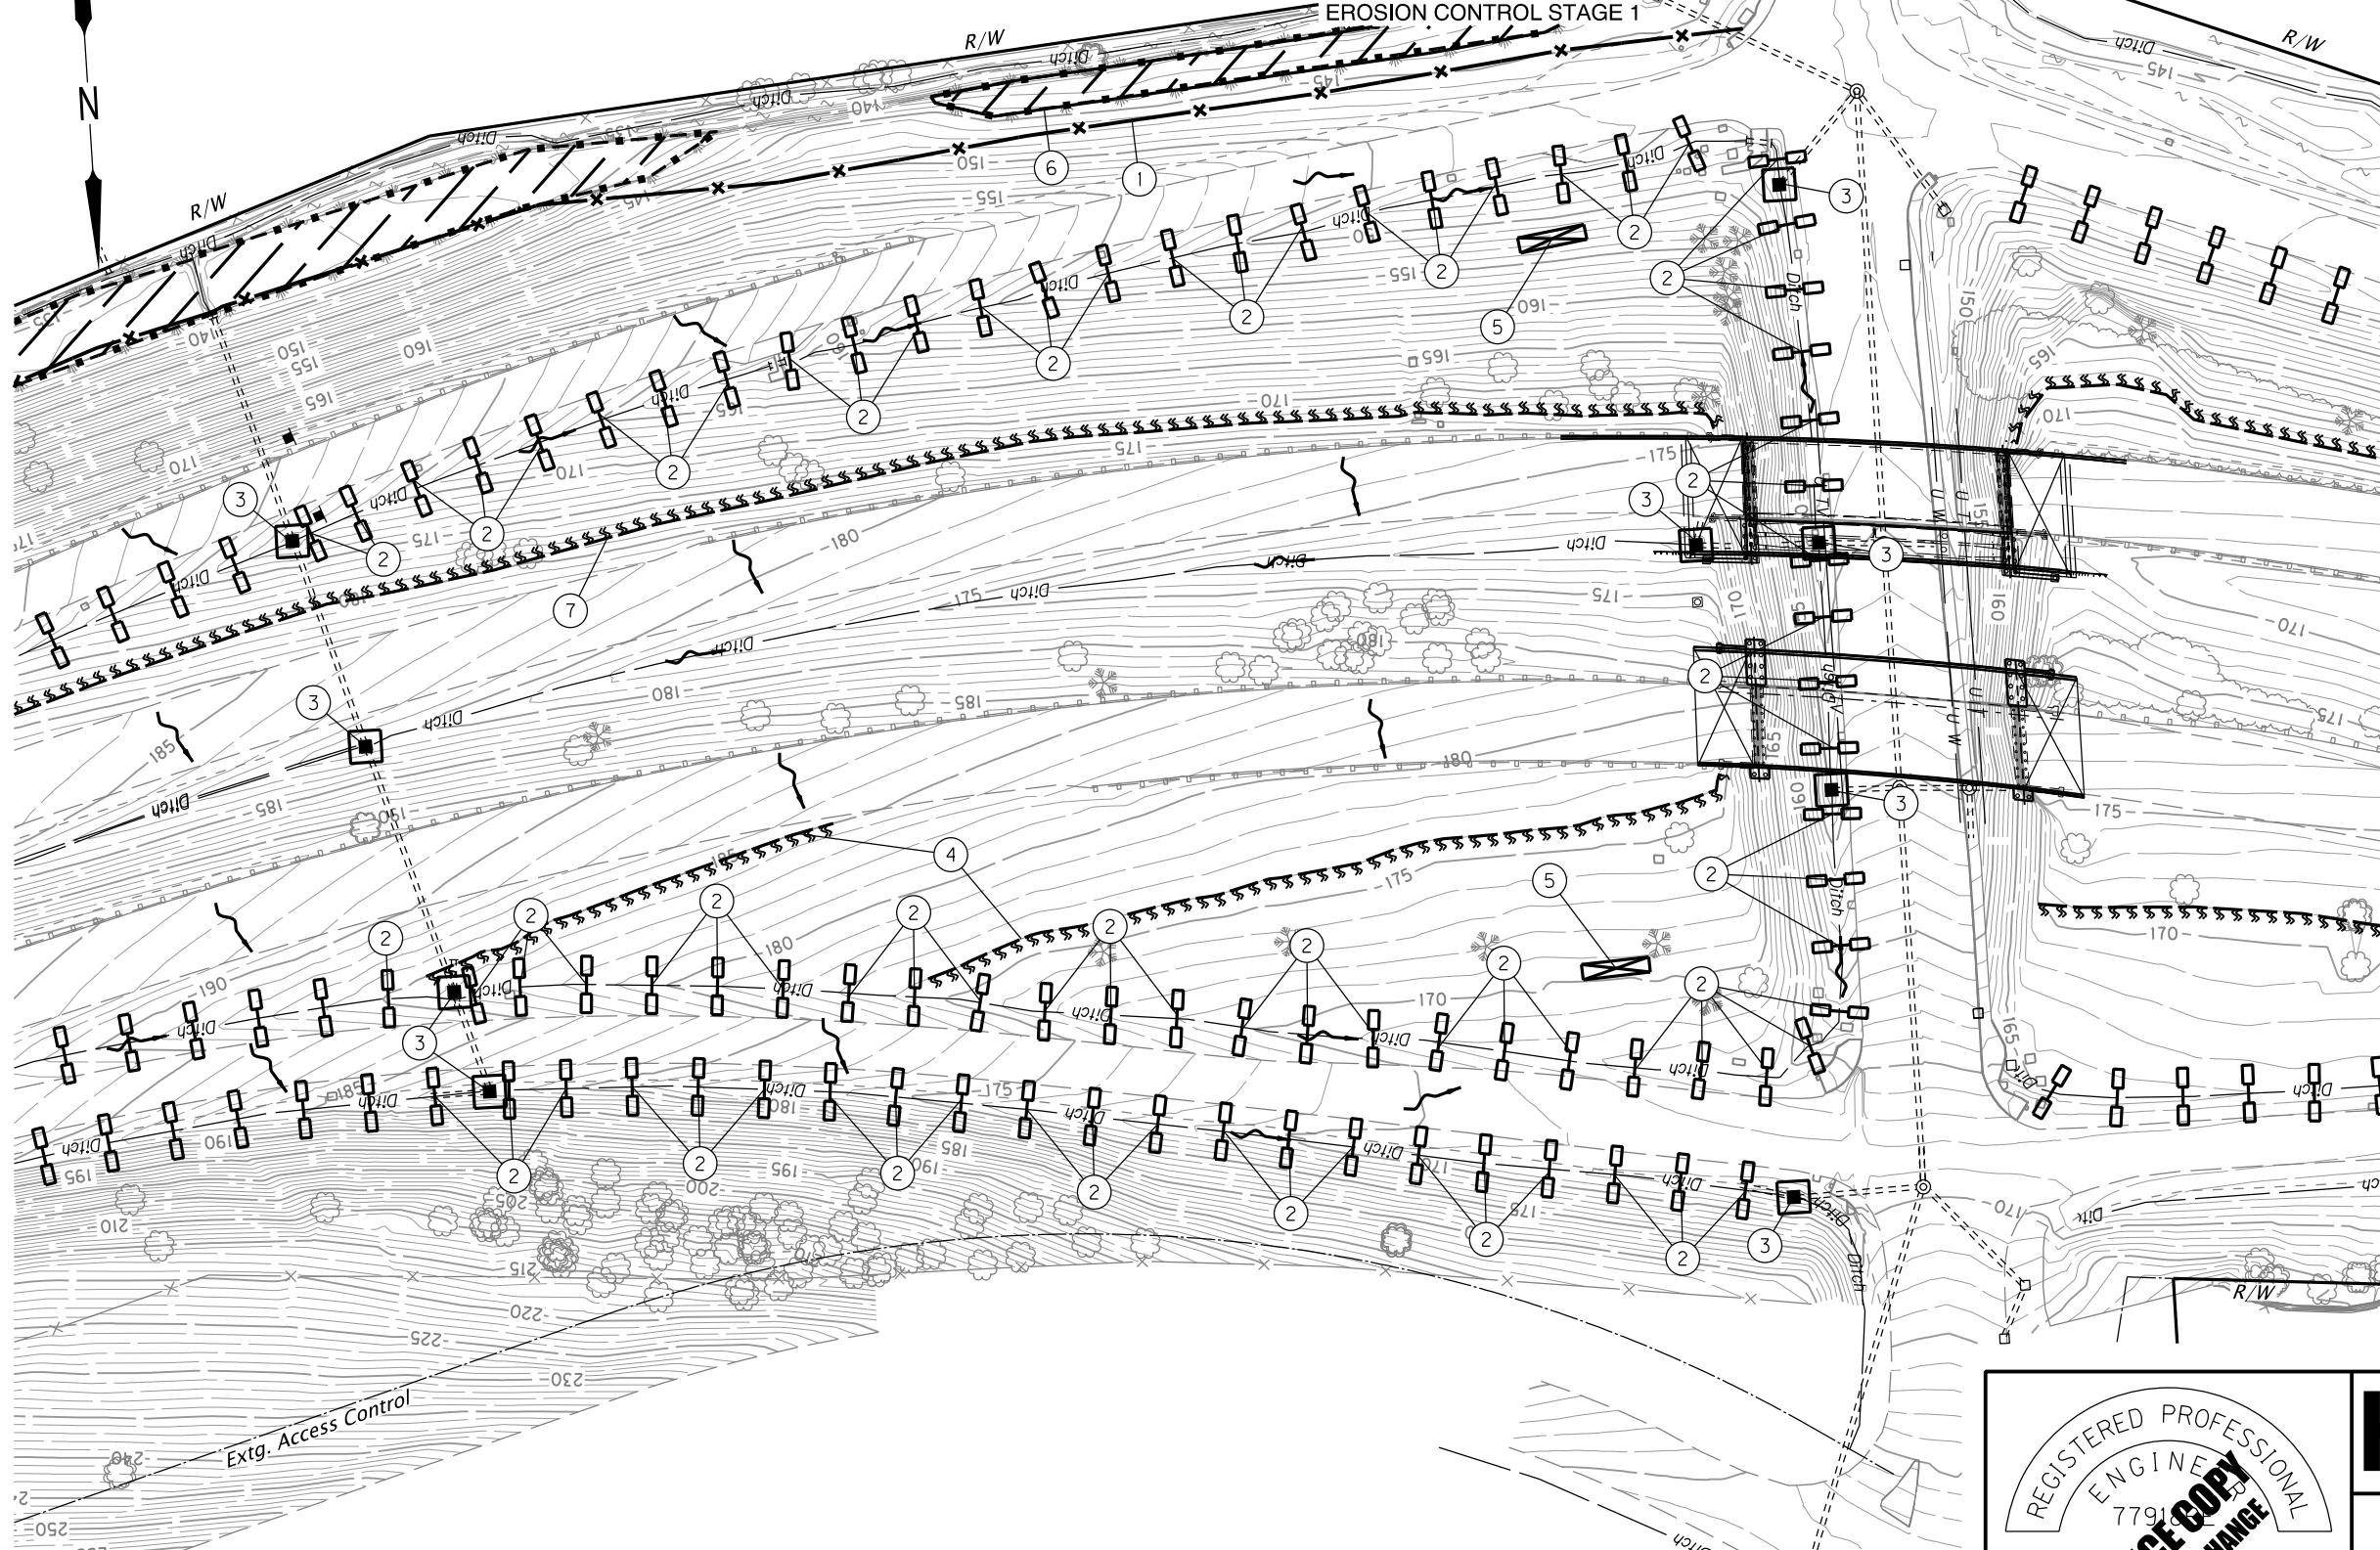
- ① Const. temp. CL-6 fence
- ② Const. check dam, (Type 6) - 81
(See drg. no. RD1006)
- ③ Const. inlet protection - 9
(Type 4)
(See drg. no. RD1015)
- ④ Install sediment barrier - 676'
(Type 9, Compost filter berm)
(See drg. no. RD1033)
- ⑤ Const. temp. sediment trap
(See drg. no. RD1065)
- ⑥ Install orange plastic mesh fencing - 750'
- ⑦ See sht. FB21, note 4
Install sediment barrier
(Type 9, Compost filter berm)
(See drg. no. RD1033)
- ⑧ See sht. FB21, note 5
Install orange plastic mesh fencing

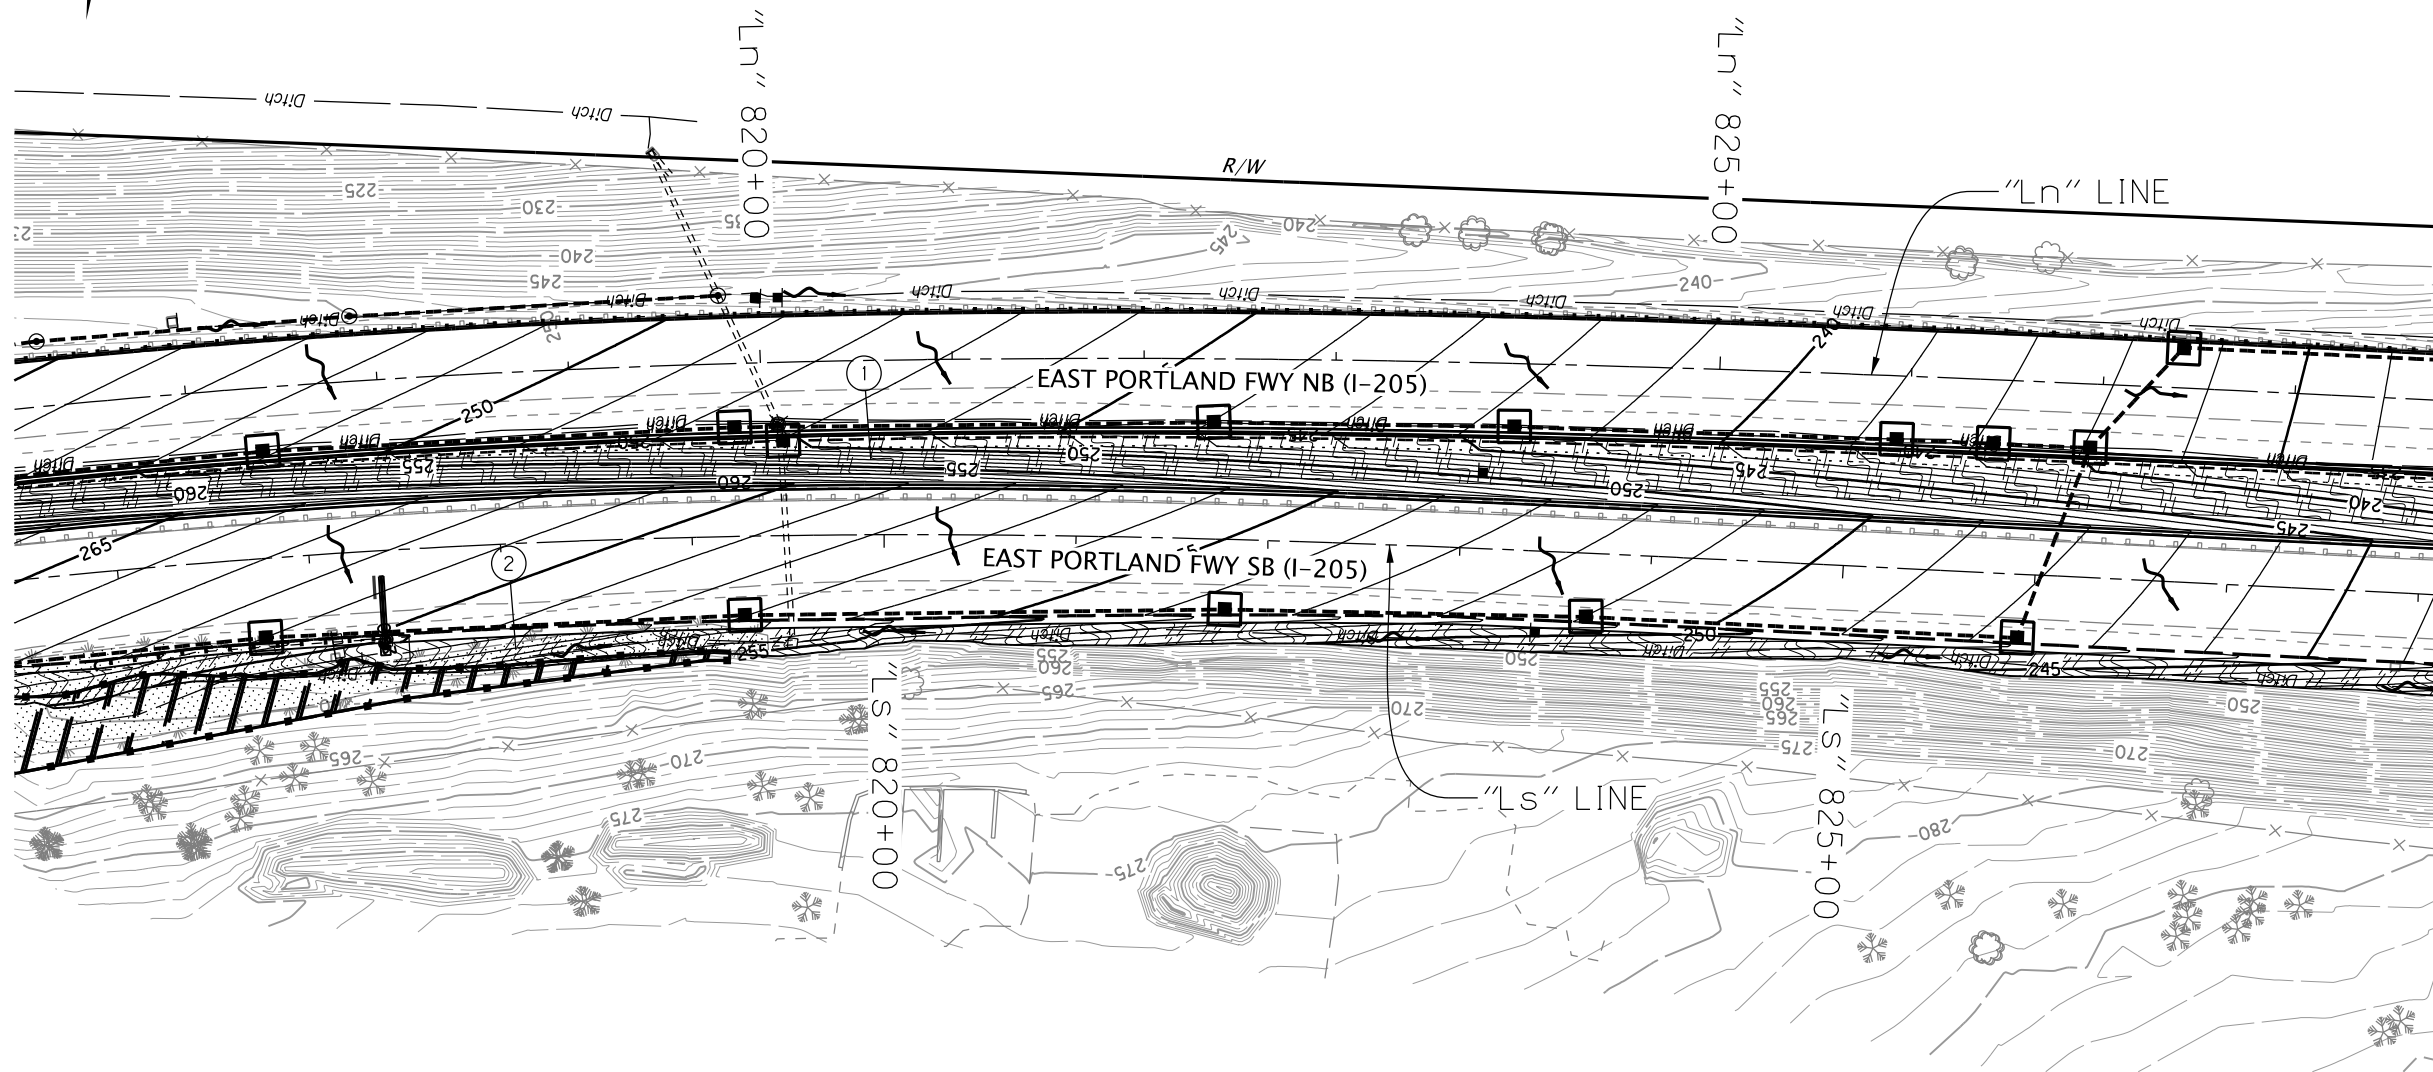
Designer: Jason Rahm Drafter: Connor Donovan	Reviewer: Matt Steigleder Checker: Brendan LeBlanc	SHEET NO. FB56
EROSION AND SEDIMENT CONTROL

- ① See sht. FB53, note 1
Install compost erosion blanket
(For details, see sht. FB01)
- ② See sht. FB55, note 1
Install compost erosion blanket
(For details, see sht. FB01)

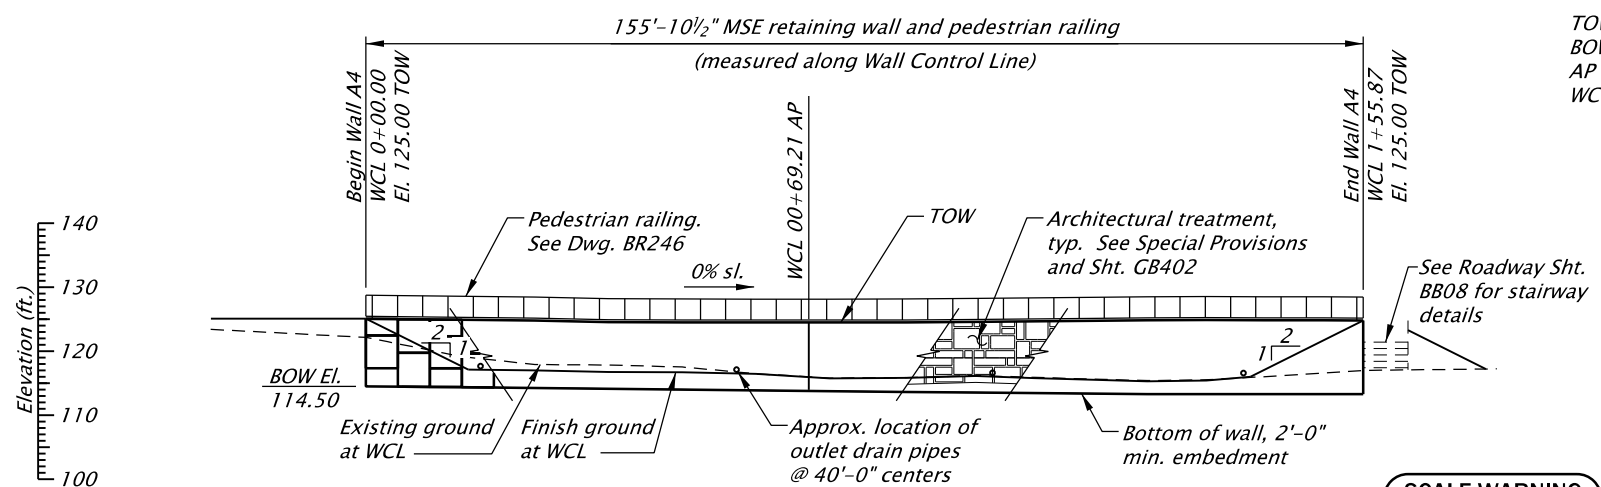
DEVELOPED ELEVATION - WALL A4
Scale: 1"=30'

Note:
Elevations shown are based on North American Vertical Datum 1988 (NAVD88).

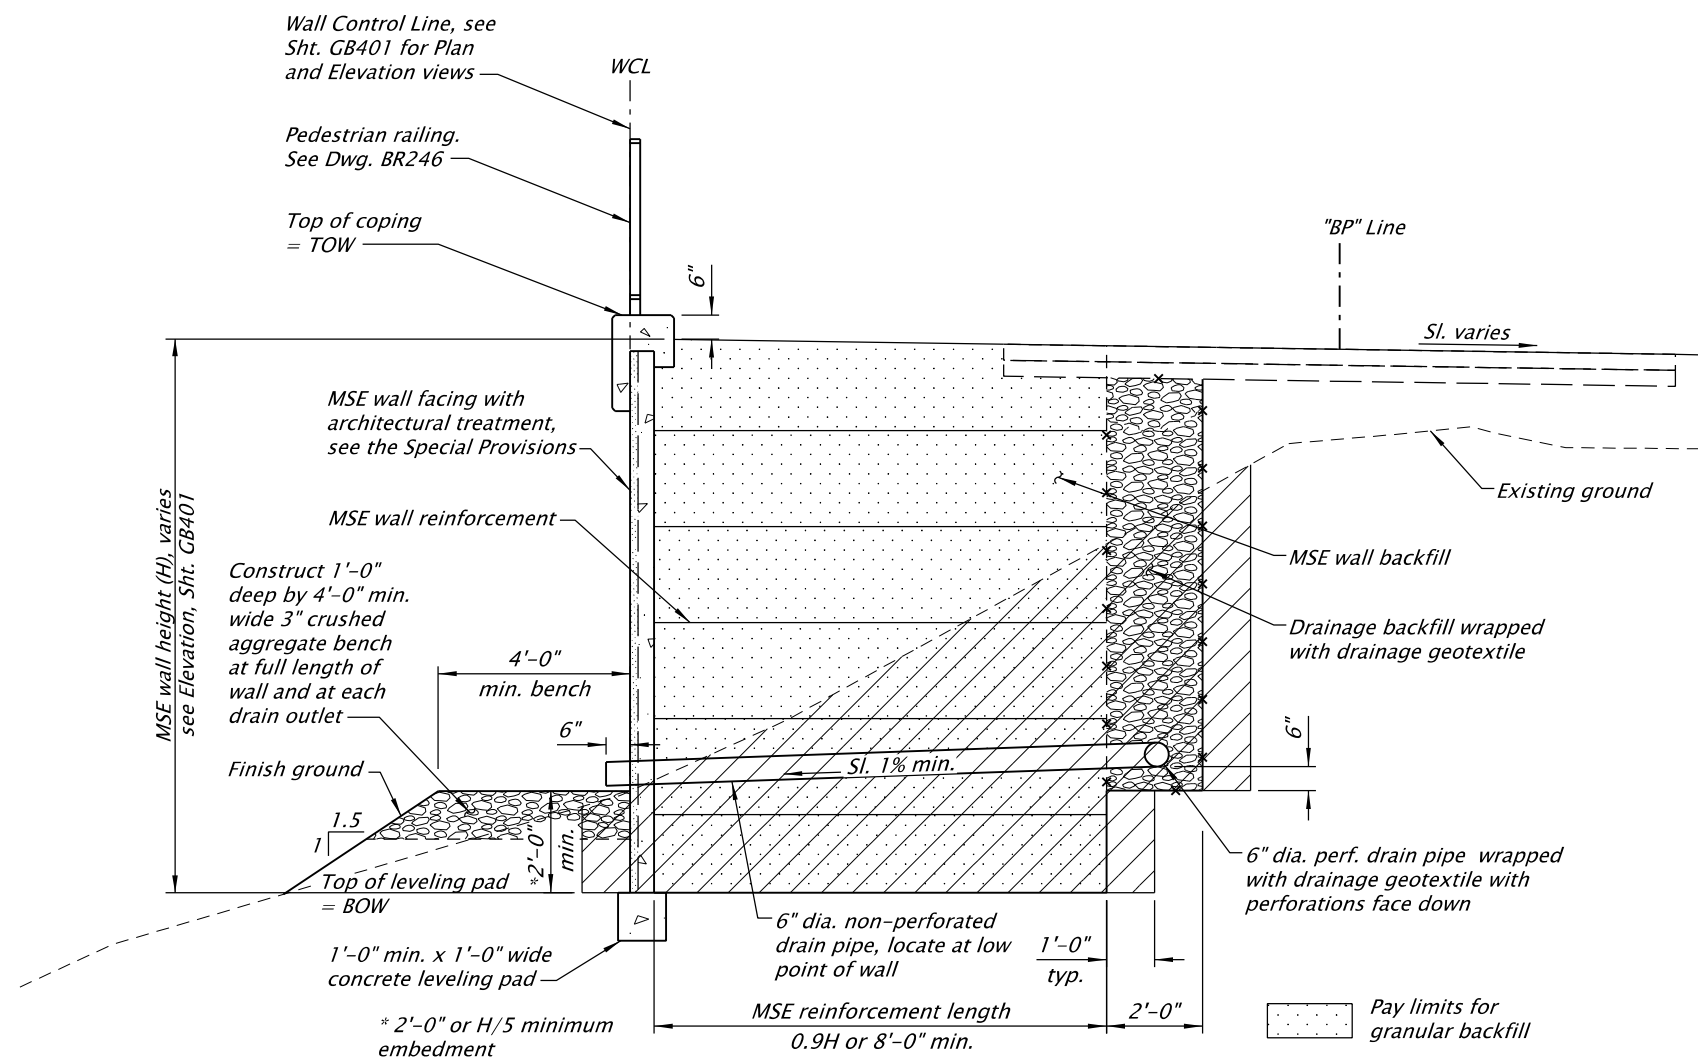
TYPICAL SECTION AND PAY LIMITS

- Pay limits for granular backfill
- Pay limits for structure excavation

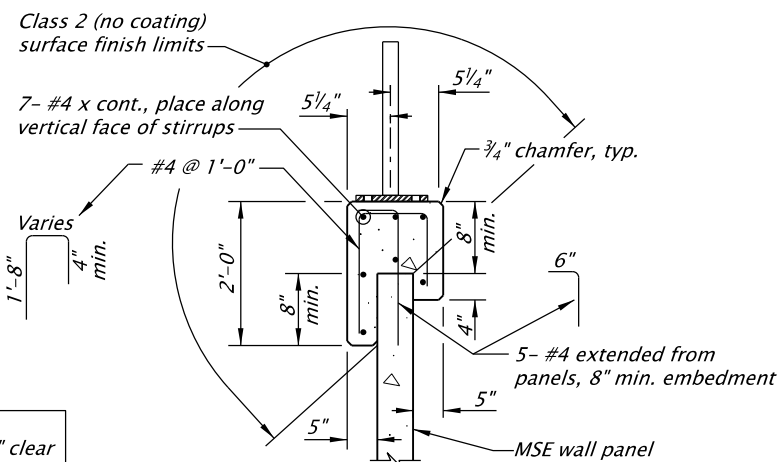
COPING DETAIL
No Scale

Coping Notes:
Stop longitudinal bars 2" clear of coping end, typ.

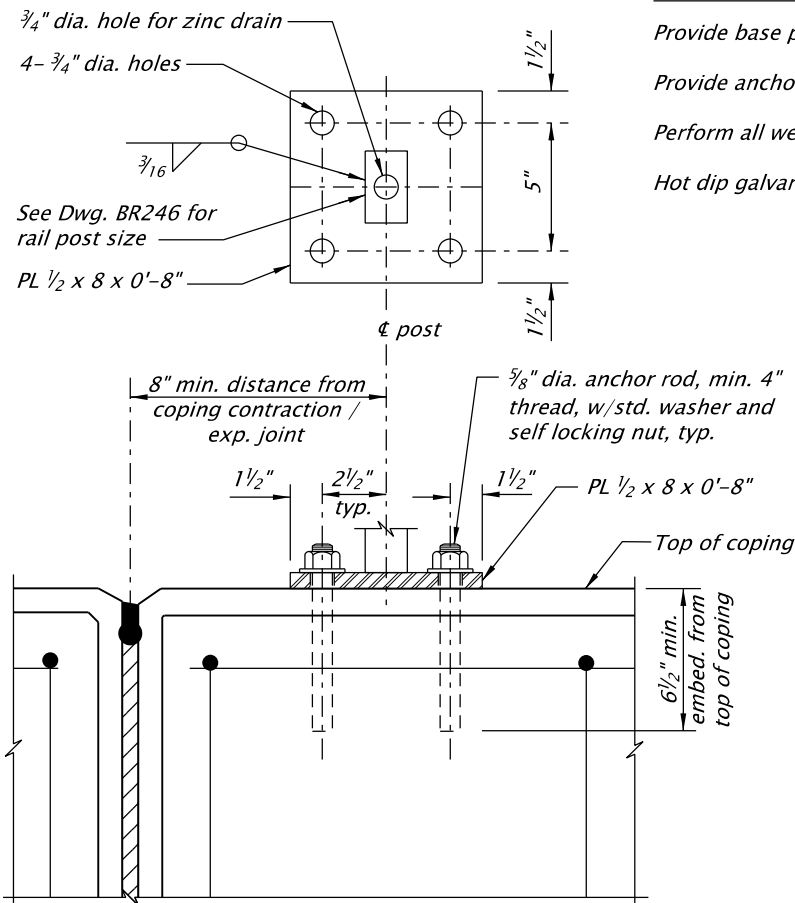
PEDESTRIAN RAIL CONNECTION DETAIL
No Scale

Note:
For details not shown of the pedestrian rail, see Dwg. BR246.

Provide threaded rods for the resin-bonded anchors according to ASTM F1554 Grade 55. Provide threaded rods threaded full length. The minimum pull-out strength is 19,600 lbs. Install resin-bonded anchors according to the manufacturer's instructions. Alternatively, provide hex head cast-in-place bolts according to ASTM F1554 Grade 55. Cast-in-place bolts shall be 3/8" diameter and embedded 6 1/2" minimum.

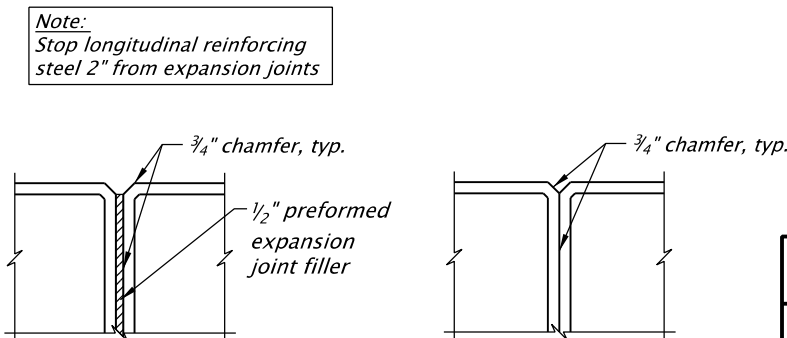
COPING EXPANSION JOINT DETAIL
No Scale

COPING CONTRACTION JOINT DETAIL
No Scale
