SUBJECT: Lake Oswego Water Treatment Plant application # CUP 12-02

The purpose of this memorandum is to supplement the record of File # CUP 12-02, the Lake Oswego Water Treatment Plant (WTP) conditional use and design review application.

LAKE OSWEGO AND TIGARD WATER TREATMENT PLANT
DESIGN REVIEW AND CONDITIONAL USE
SITE ANALYSIS

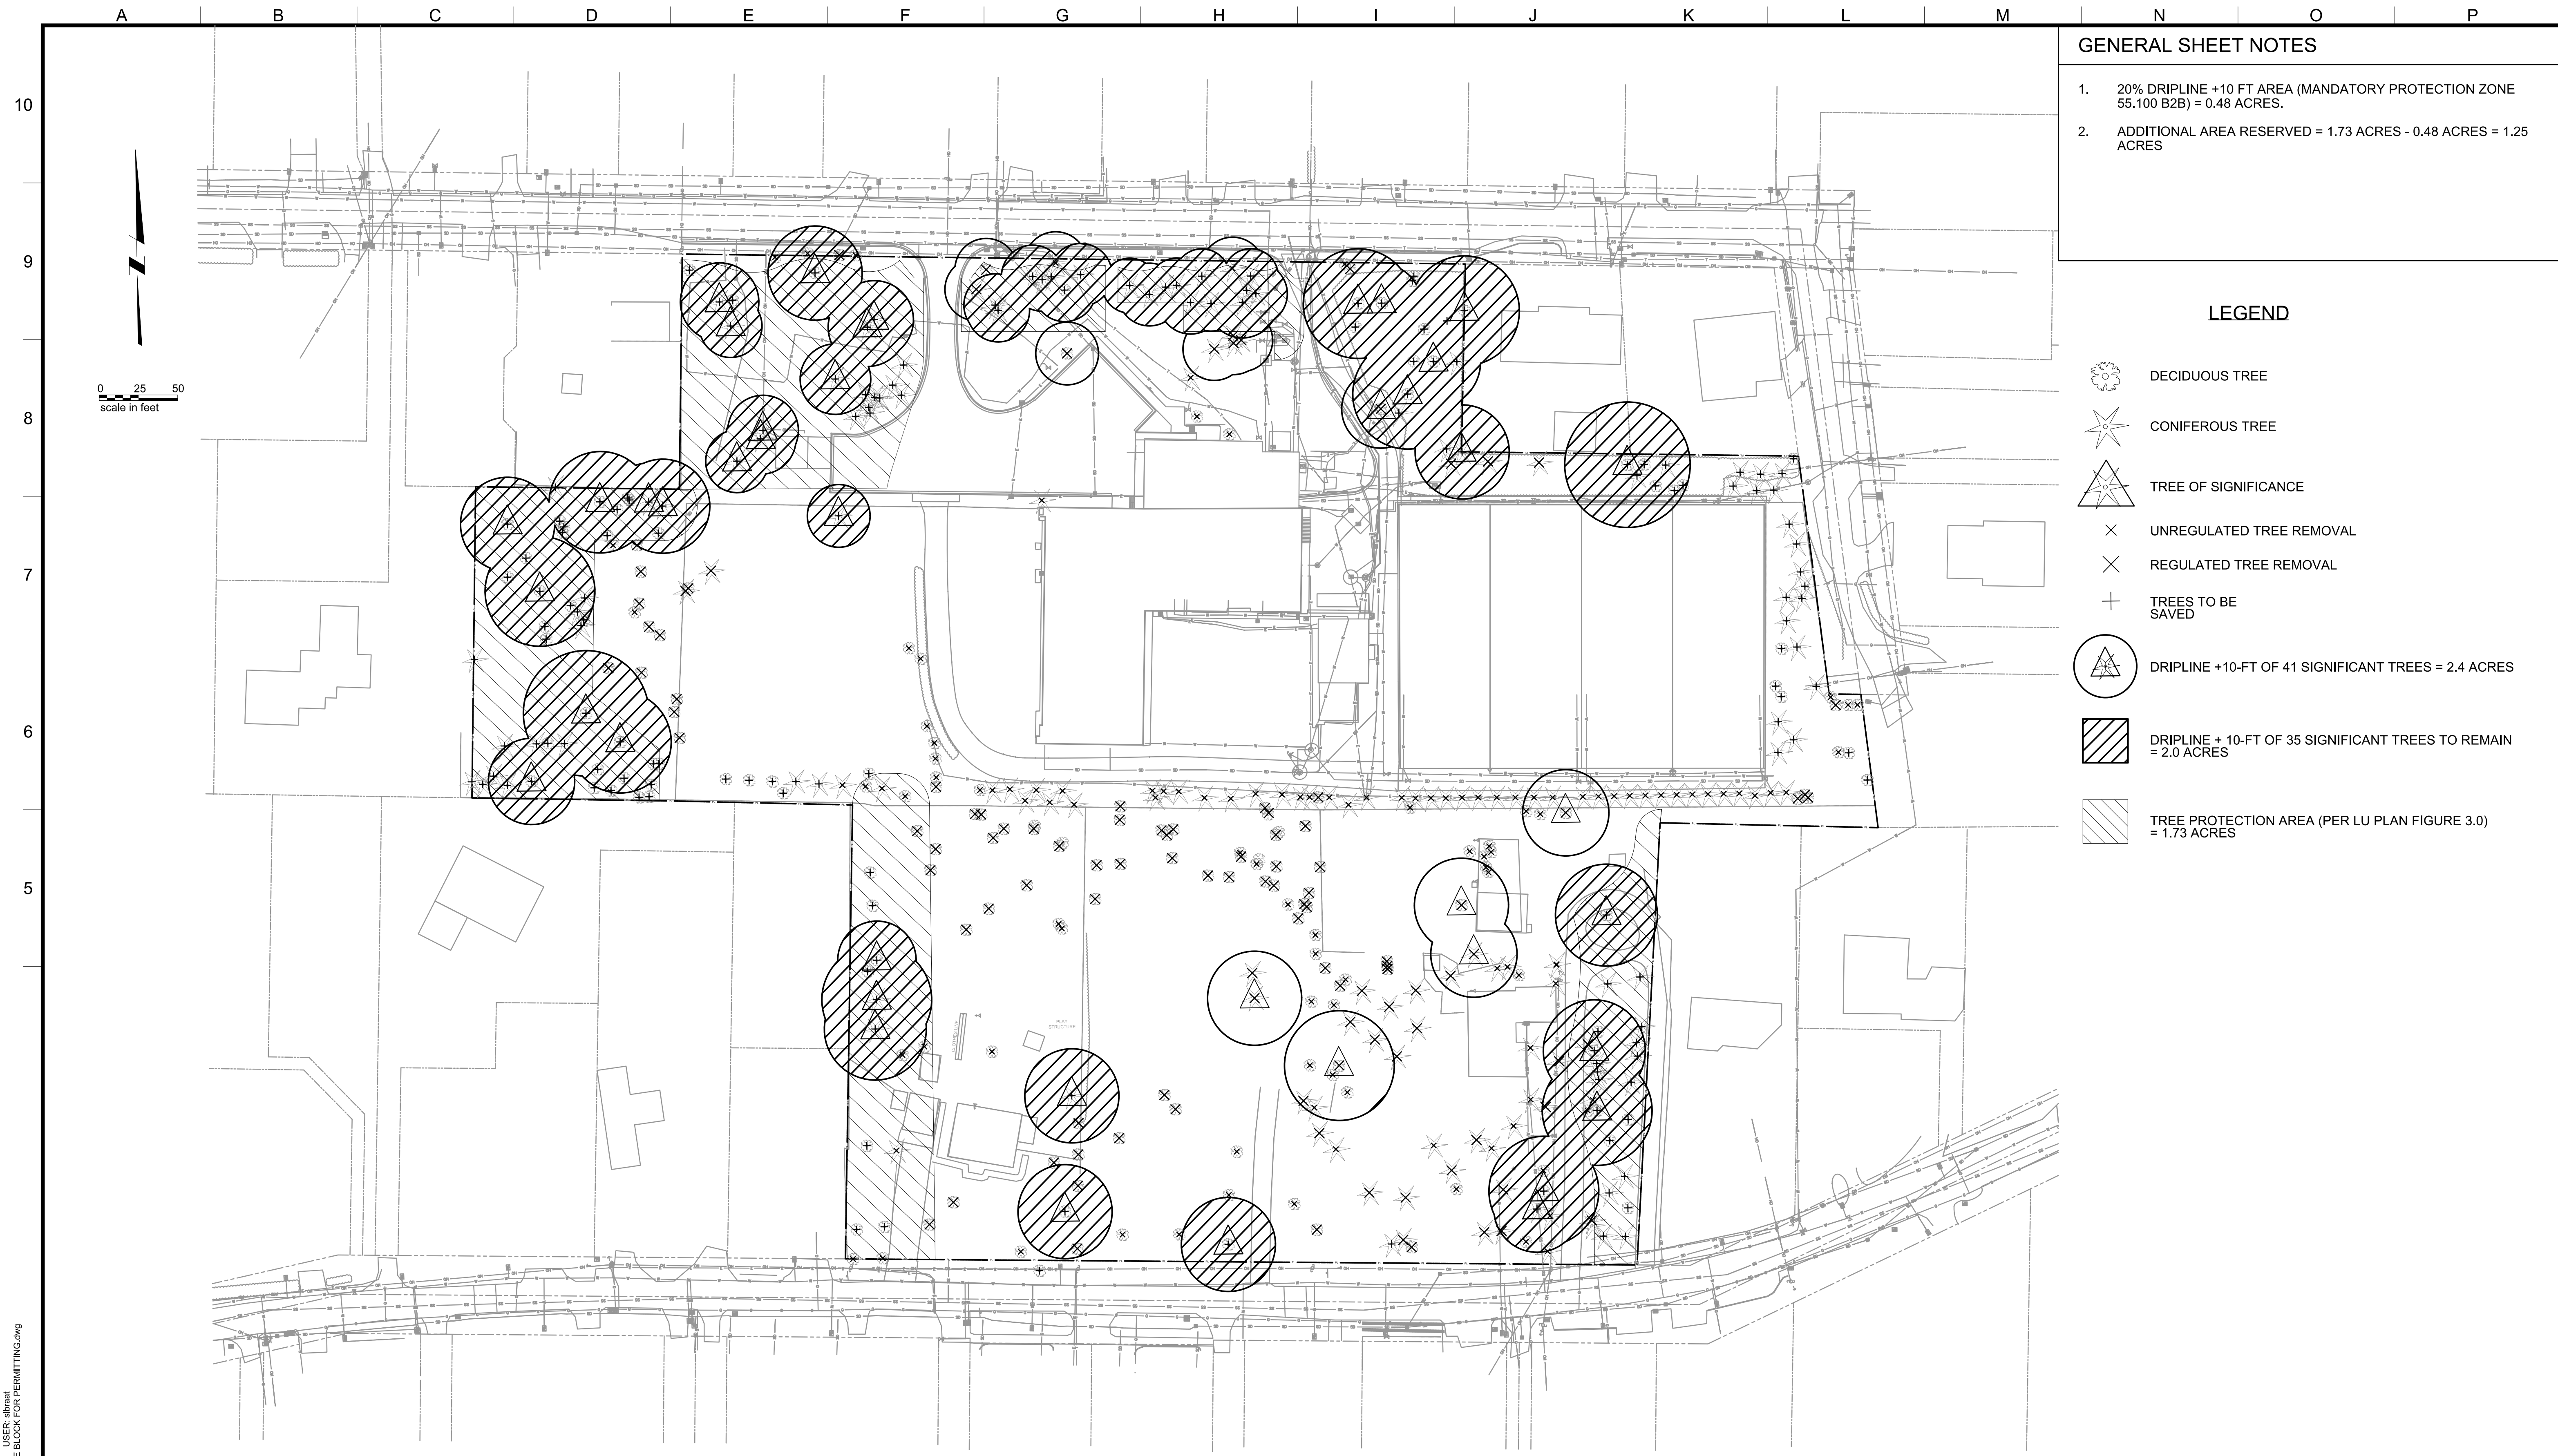
- 20% DRIPLINE +10 FT AREA (MANDATORY PROTECTION ZONE 55.100 B2B) = 0.48 ACRES.
- ADDITIONAL AREA RESERVED = 1.73 ACRES - 0.48 ACRES = 1.25 ACRES

LAKE OSWEGO AND TIGARD WATER TREATMENT PLANT
DESIGN REVIEW & CONDITIONAL USE
TREE AREAS
