**SUBJECT: HARPER'S TERRACE (SUB-13-05)**

I am writing on behalf of JT Smith Companies to request that the application for the Subdivision of Harper's Terrace property (SUB-13-05) be deemed complete upon receipt of this letter. We have prepared this correspondence as well as a revised preliminary development plan set (dated November 21, 2013) and we believe that the revised plans adequately address the comments provided by the City in the October 29, 2013 incompleteness notification letter. We believe that all issues have been satisfactorily resolved within our resubmission to allow for the initiation of the City's formal project review.

**RE:** Arborist Recommendations for Tree 3053  
Harper's Terrace Subdivision – West Linn, Oregon

**Subject:       LANDSLIDE HAZARD REVIEW  
                  THE SUMMIT SUBDIVISION - AKA ROSEMONT 2  
                  NORTHEAST CORNER OF SUMMIT STREET AND S. GLORIA DRIVE INTERSECTION  
                  WEST LINN, OREGON**

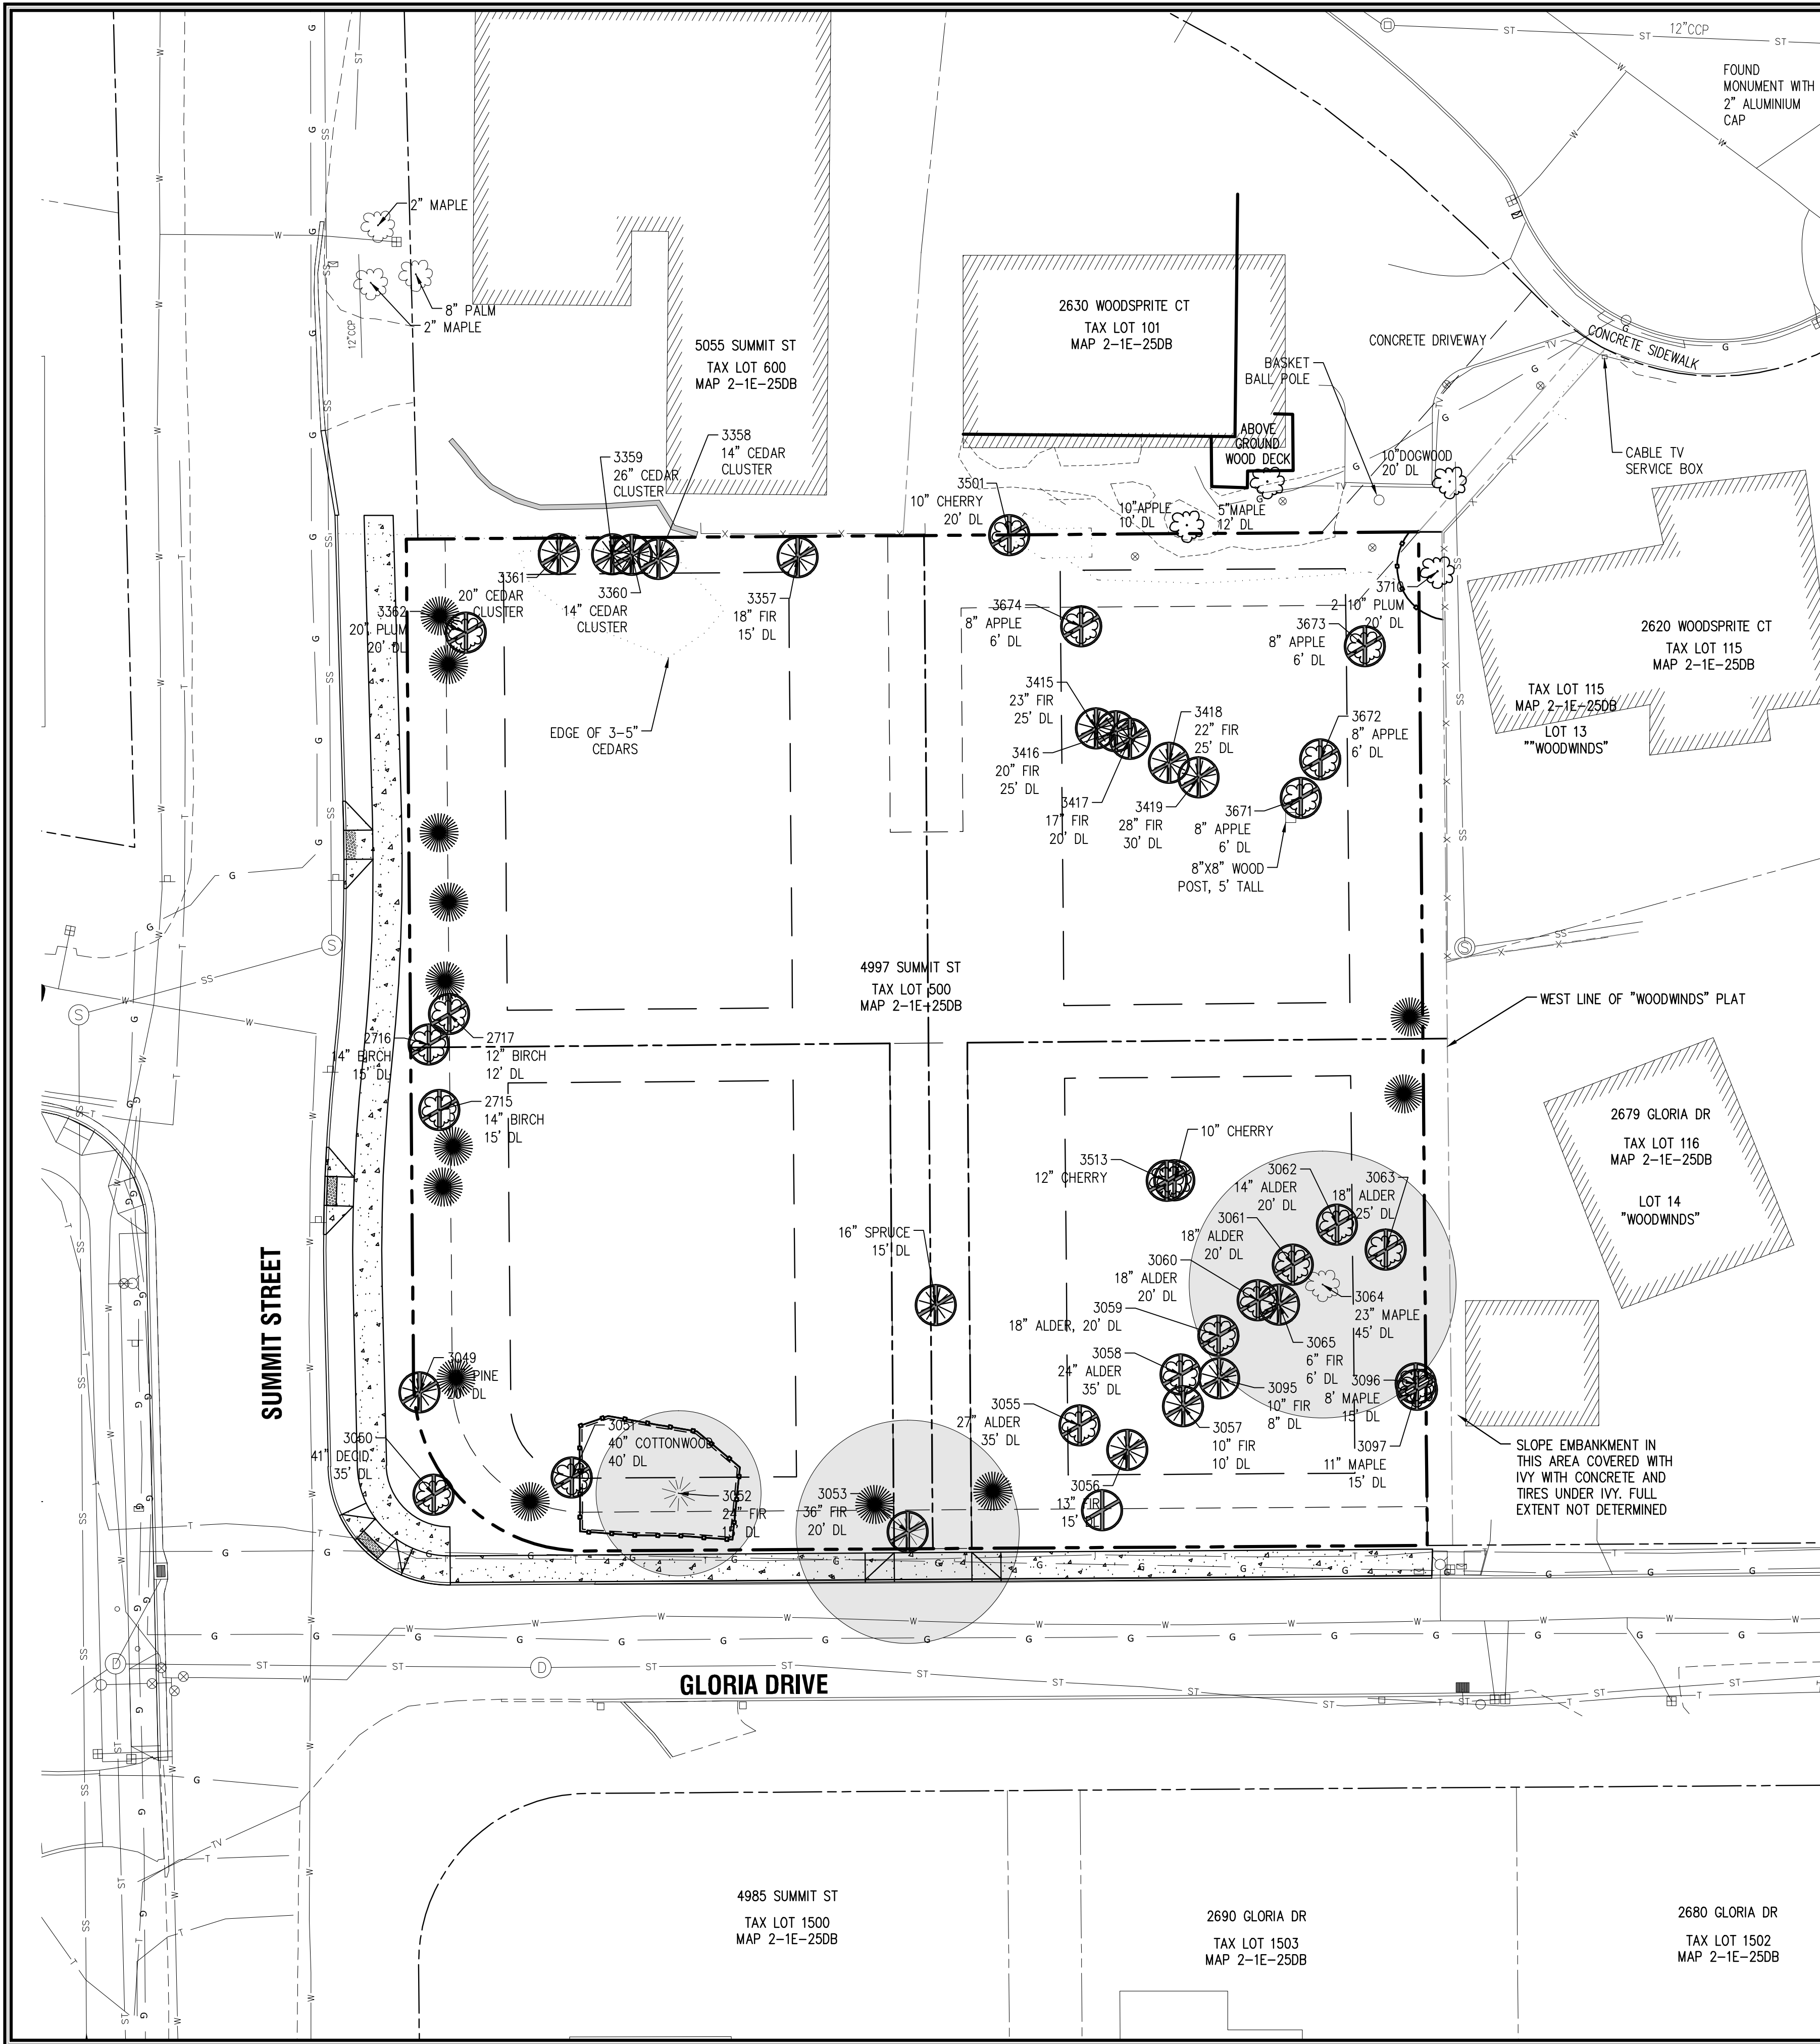
SHEET TITLE  
**TREE PLAN**  
SHEET NUMBER  
**C1.2**

**TREE INVENTORY**

**GENERAL TREE INVENTORY STATISTICS**

TOTAL TREE INVENTORY:	41 ea
TOTAL TREES RETAINED:	4 ea
TOTAL TREES REMOVED:	37 ea
TREES REMOVED DUE TO CONDITION:	34 ea
TOTAL TREE CALIPER INCHES:	738 inches
TOTAL CALIPER INCHES RETAINED:	103 inches
TOTAL CALIPER INCHES REMOVED:	635 inches

**SIGNIFICANT TREE STATISTICS**

SIGNIFICANT TREE INVENTORY:	3 ea
SIGNIFICANT TREES RETAINED:	2 ea
SIGNIFICANT TREES REMOVED:	1 ea
SIGNIFICANT TREE CALIPER INCHES:	83 inches
SIGNIFICANT CALIPER INCHES RETAINED:	47 inches
SIGNIFICANT CALIPER INCHES REMOVED:	36 inches
SIGNIFICANT TREE CANOPY COVERAGE:	3,061 Sq. Ft.
SIGNIFICANT TREE CANOPY RETAINED:	2,043 Sq. Ft.
SIGNIFICANT TREE CANOPY RETENTION:	67%
PRESERVATION EASEMENT AREA PROVIDED:	612 Sq. Ft.

Revised Slope Analysis Plan  
Revised Tree Plan  
Geotechnical Evaluation of Landslide Hazard Overlay

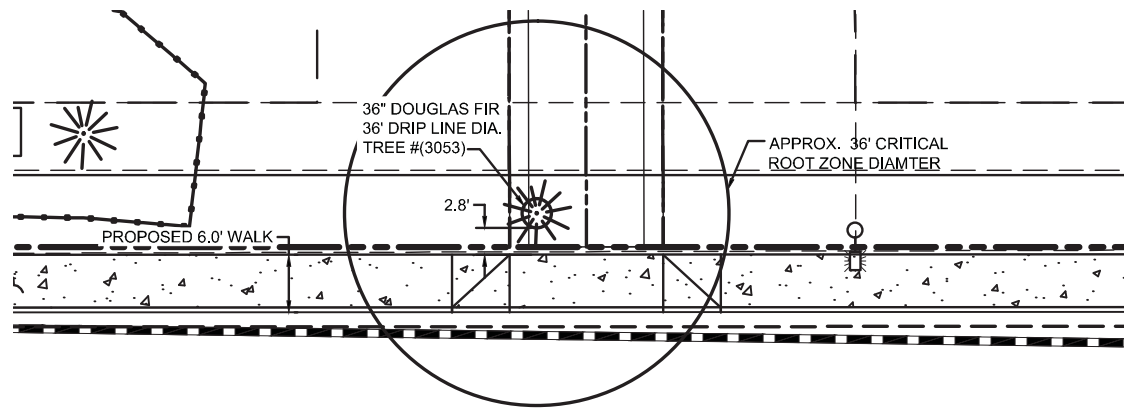
EXISTING TREE (3053) ALONG GLORIA DRIVE

**GLORIA DRIVE**

SCALE: 1"=20'

At the request of J.T. Smith Companies, we coordinated with 3J Consulting to analyze a conceptual access plan for the Harper's Terrace Subdivision project in West Linn in an effort to provide sufficient protection tree 3053. This tree is a 36-inch diameter Douglas-fir, which was classified as potentially significant but recommended for removal for the purposes of construction in the original arborist report dated October 3, 2013.

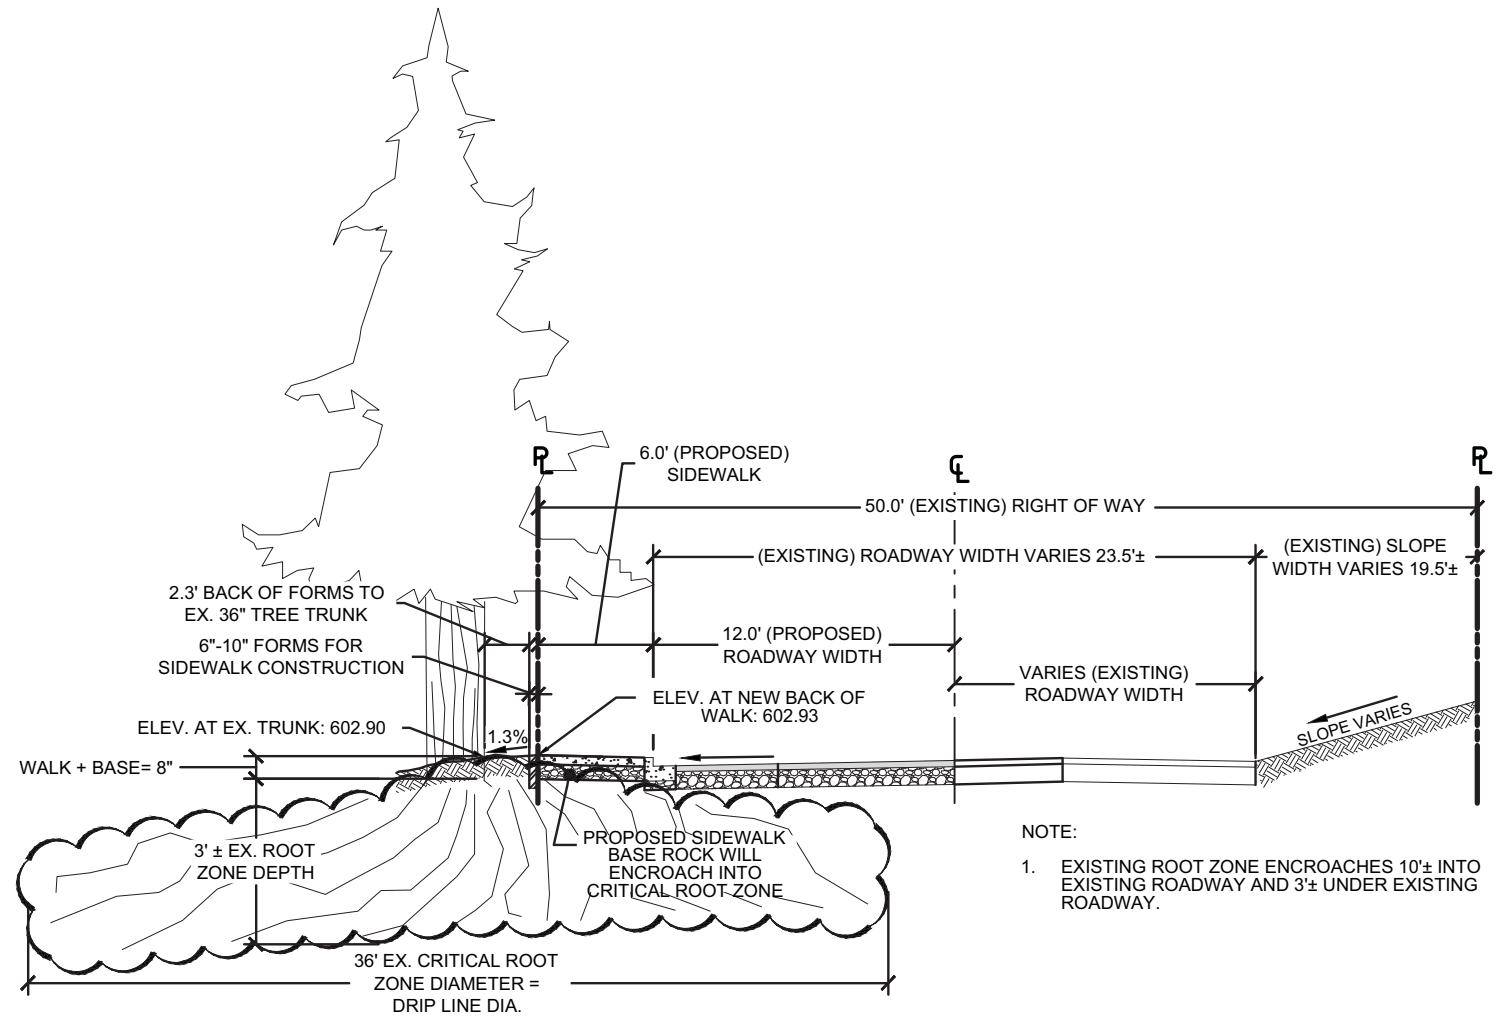
EXISTING TREE (3053) ALONG GLORIA DRIVE

SCALE: N.T.S

NOTE:

- 1. EXISTING ROOT ZONE ENCROACHES 10'± INTO EXISTING ROADWAY AND 3'± UNDER EXISTING ROADWAY.

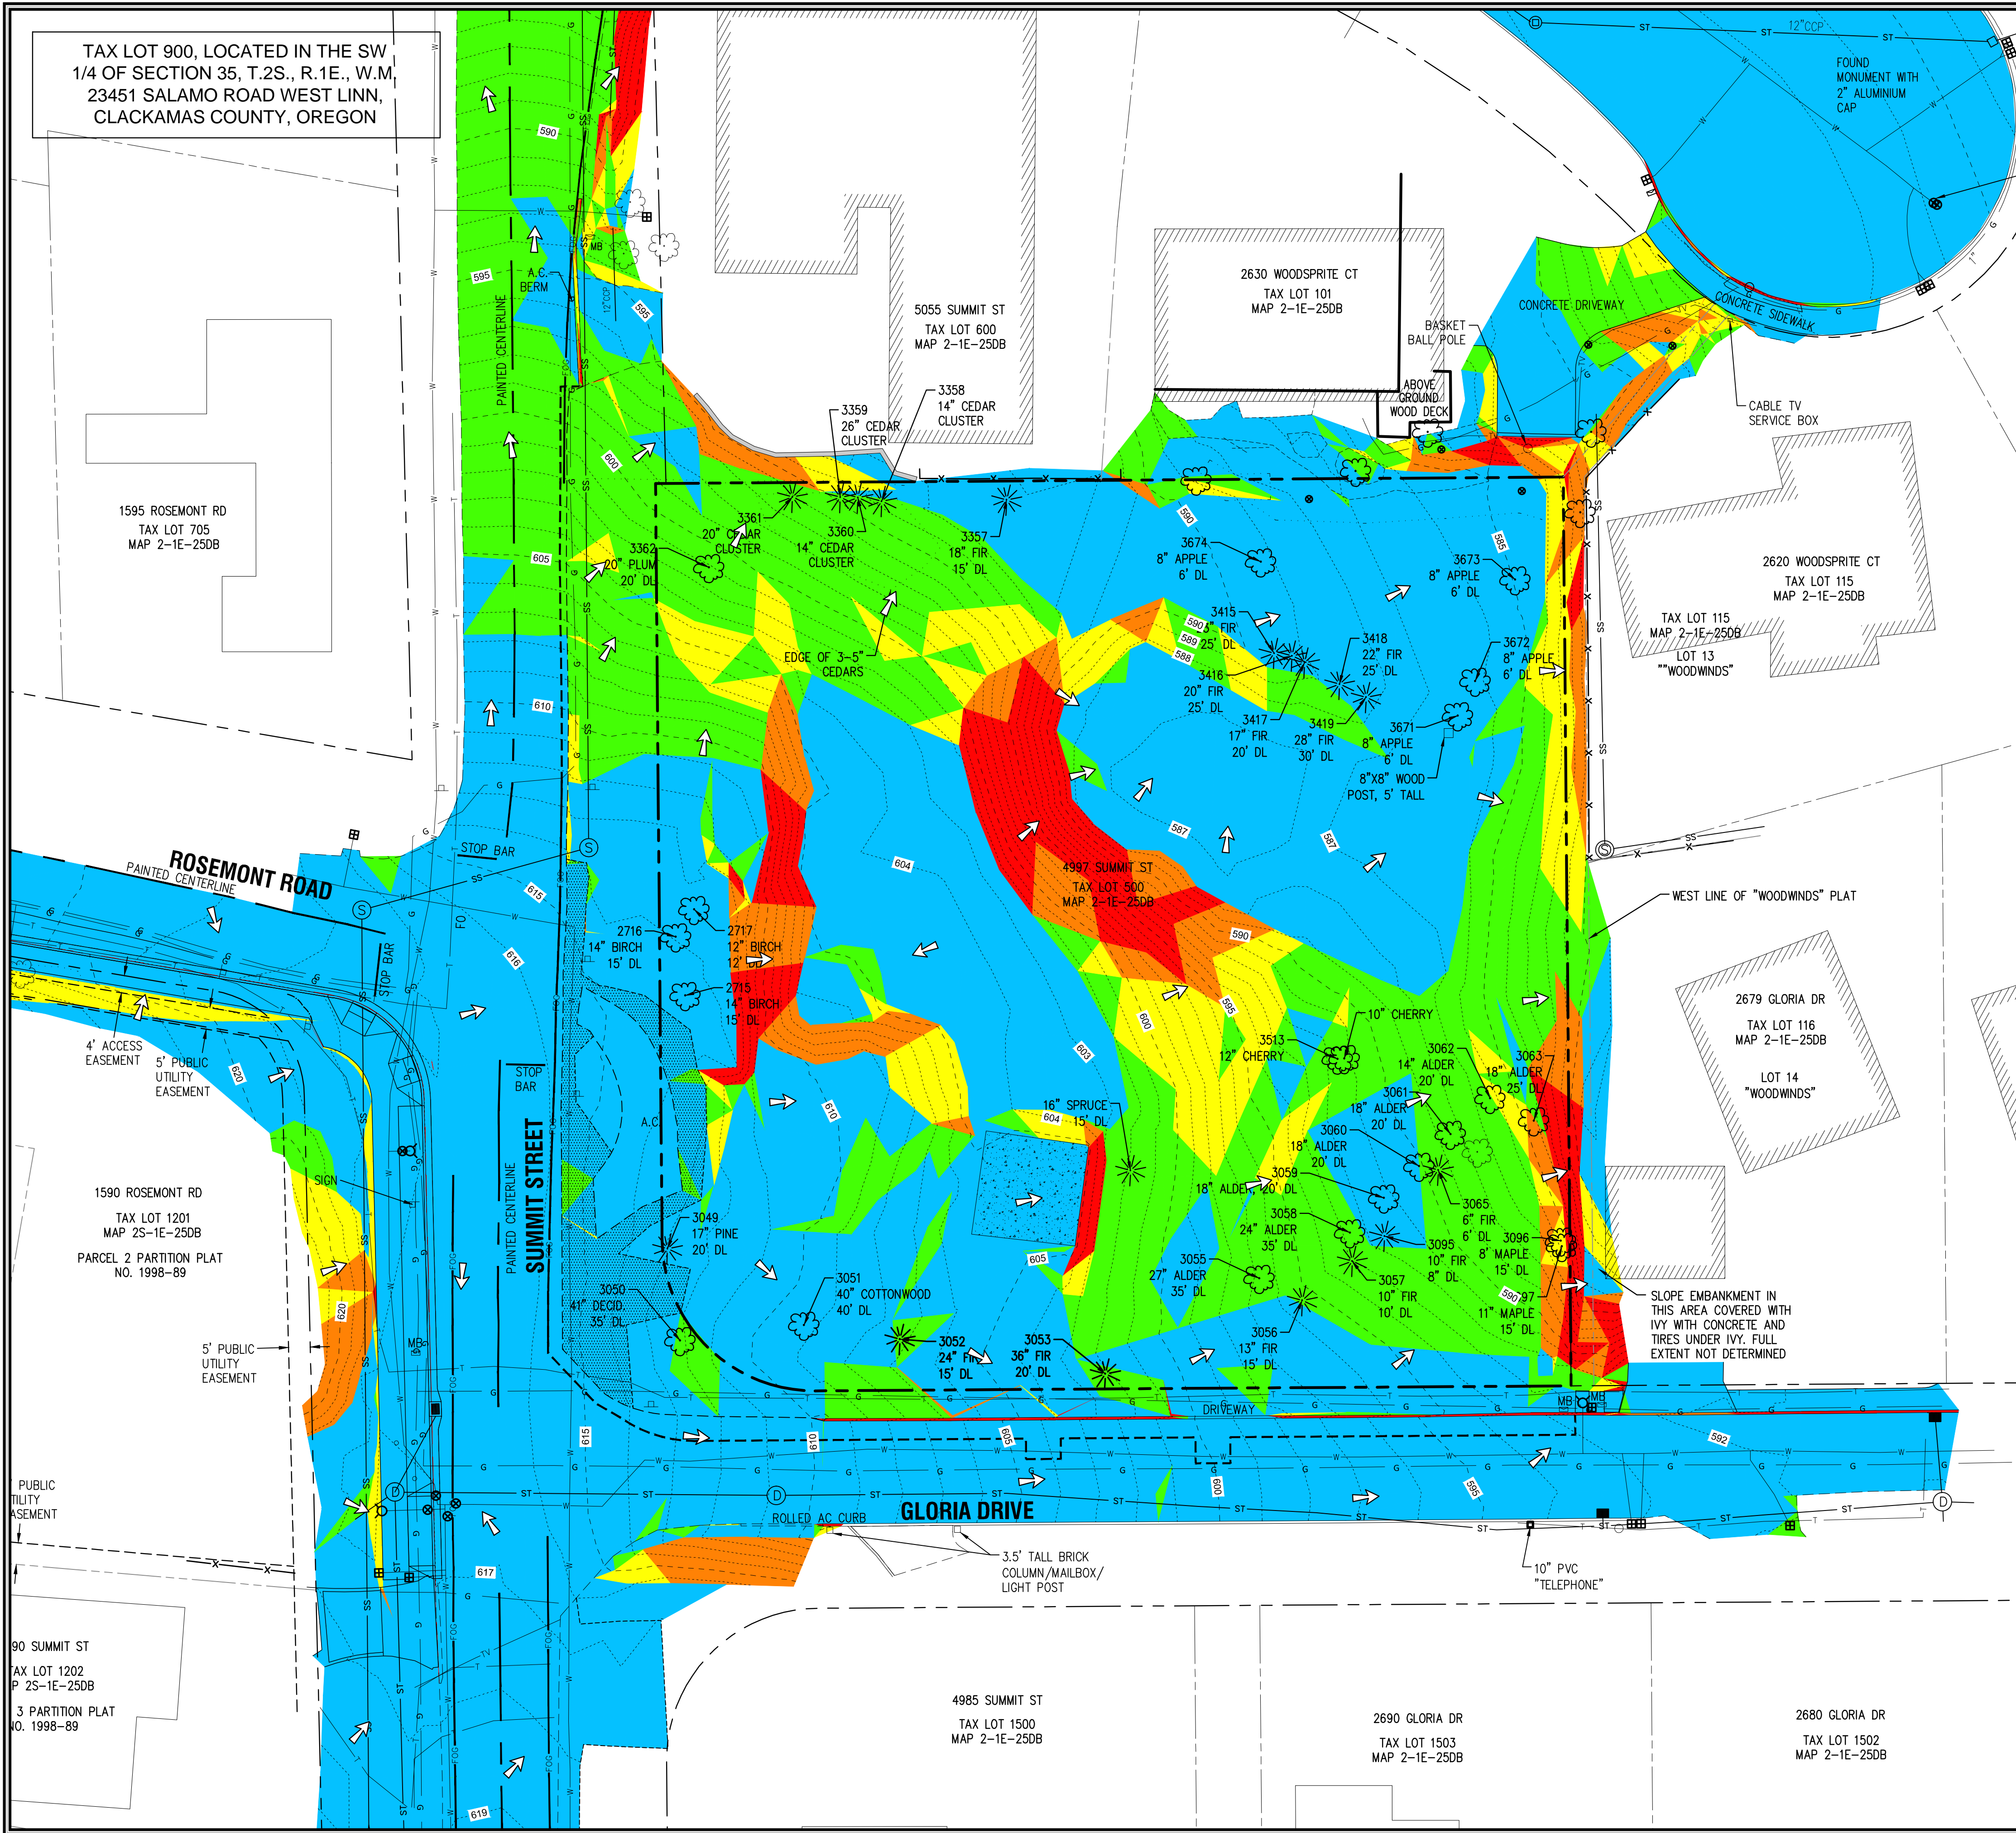
SHEET TITLE  
**SLOPE ANALYSIS**  
SHEET NUMBER

**SLOPE ANALYSIS PLAN**  
**HARPER'S TERRACE**  
**SUBDIVISION**  
LF 10, LLC  
WEST LINN, OR

85.170(A)(8)	Show all slope categories from 55.110(B)(3) including (c-e)	The Applicant has revised the Slope Analysis Plan on Sheet C1.3 to include all slope categories from 55.110(B)(3)(c-e)
