BOLTON RESERVOIR REPLACEMENT

Conditional Use Permit, Class I & II Design Review

Submitted by City of West Linn

Replace the existing 100-year old covered drinking water reservoir with a new partially buried prestressed concrete reservoir meeting current seismic design standards. Replace the existing pump station flat roof with a pitched roof more in character with the residential neighborhood.

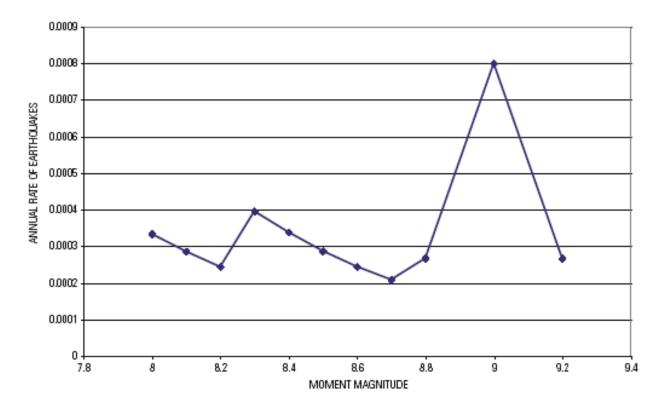
ASSUMED RUPTURE LOCATIONS (CASCADIA SUBDUCTION ZONE)

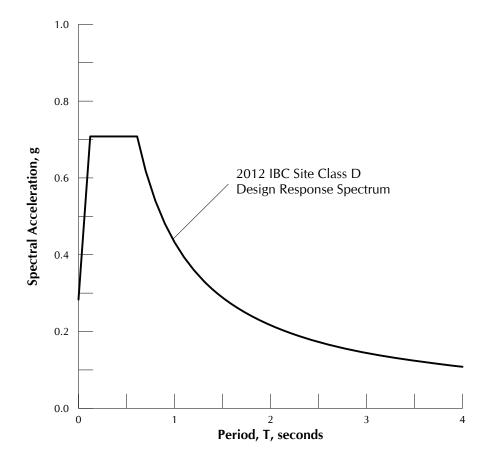
PROBABILISTIC AND DETERMINISTIC MCER RESPONSE SPECTRA COMPARISON (5% DAMPING)
