MEMORANDUM

SUBJECT: 23000 & 23010 SW Bland Circle Trip Generation and Safety Evaluation

This memorandum summarizes the existing conditions, trip generation, crash and sight distance evaluation for the proposed development located at 23000 and 23010 SW Bland Circle in West Linn, Oregon. The evaluation is done in support of a new 15-lot subdivision.

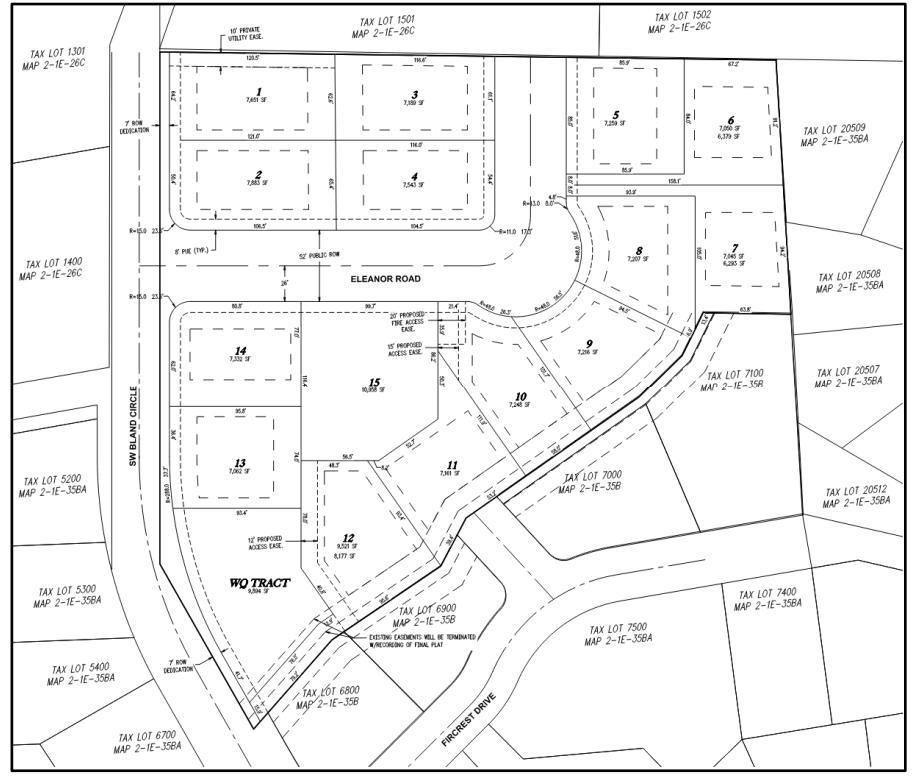
Figure 1: Site Vicinity

The proposed subdivision at 23000 and 23010 SW Bland Circle is located with an area of West Linn zoned as R-7 single family residential detach and attached housing. Figure 1 shows the proposed site plan for the development. The development is a conforming land use per the City of West Linn Municipal Code Section 12 and consists of 14 new and one existing single-family dwelling units. The new subdivision will have a single access point onto Bland Circle, north of Fircrest Drive until such time further development occurs and a future internal roadway access can be created.

Bland Circle is improved where recent development has improved roadways to meet City standards. Approximately 155 feet north of the site access, beyond the site boundaries, Bland Circle is essentially an unimproved one-lane roadway with speeds anticipated to be well below 25 mph.

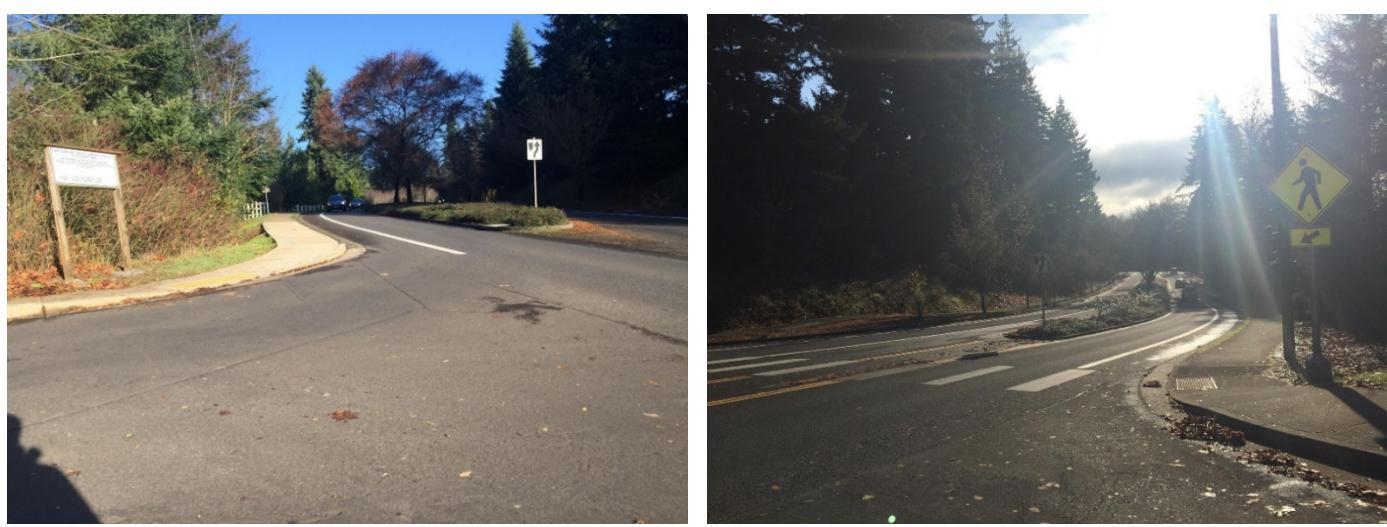
Figure 2: View North from Bland Circle Approach Figure 3: View south from Bland Circle approach

As summarized in Table 1, intersection sight distance is met for both left- and right-turning vehicles at the Bland Circle / Salamo Road intersection. Figures 2 and 3 show the existing view from the driver's eye location on the Bland Circle approach. ISD to the left was found to just meet the standard, so maintenance of vegetation around the roadway curve should be made a priority by the City to continue meeting the standard.

Sight Distance Evaluated	Available Sightline (ft)		Sight Distance Standard (ft)	Meets Standard?		
Bland Circle at Salamo Roa	ad					
Case B1: Loft turn	To the right	400	390	Yes		
	To the left	680	390	Yes		
Case B2: Right-turn	400		335	Yes		
SSD Northbound Vehicle	680		250	Yes		
SSD Southbound Vehicle	390		250	Yes		
Bland Circle at Site Access	5					
Case R1: Loft turn	To the right	260	280	No		
	To the left	240	280	No		
Case B2: Right-turn	240		240	Yes		
SSD Northbound Vehicle	>155		155	Yes		
SSD Southbound Vehicle	>155		155	Yes

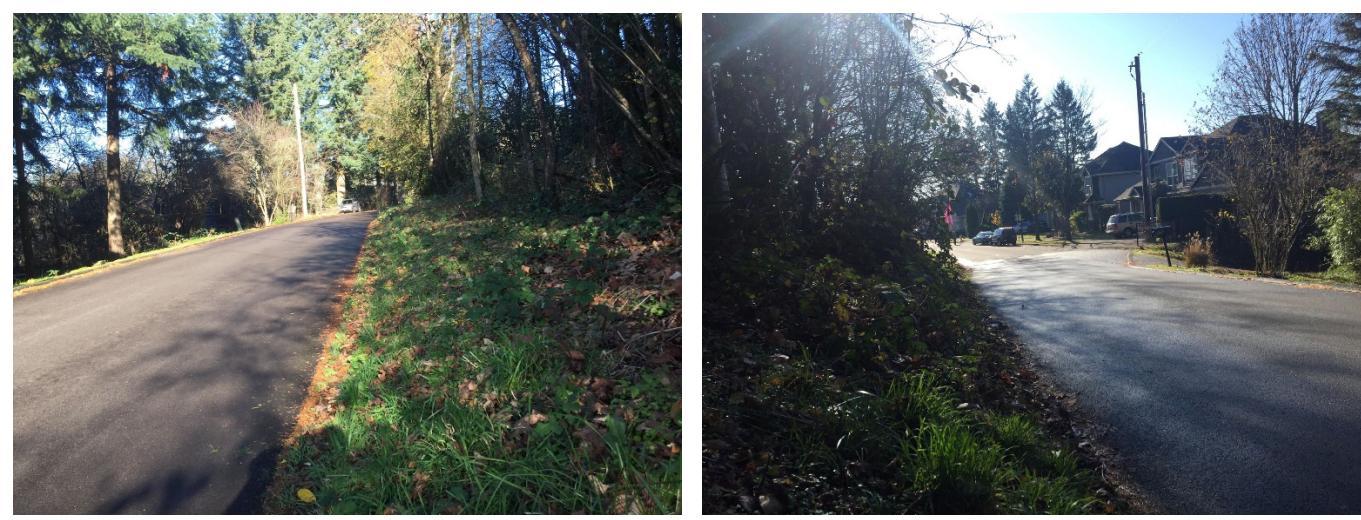
Figure 4: View North from Site Access

Figures 4 and 5 show the existing view from the driver's eye location at the proposed Site Access. The driver's eye location was estimated in the field due to embankments. Intersection sight distance at the site access is not met for Case B1 (left-turn from the minor side street). However, stopping sight distance is met for both directions based on the current plans. Although intersection sight distance is not met, it is anticipated that with further development, sight lines will be improved as roadways are constructed to meet City standards.

A safety evaluation consisting of a crash data review and a sight distance evaluation did not identify areas of concern at the Bland Circle / Salamo Road intersection. A sight distance evaluation at the Bland Circle / Site Access intersection identified that intersection sight distance for a left turning vehicle from the side street is not met but is anticipated to improve as new development occurs to the north and as Bland Circle is improved to meet City standards. All other sight distance measures were met.
