**CURB, GUTTER AND SIDEWALK DOWELING DETAIL**

phase	CONSTRUCTION
date	April 6, 2011
revisions	
ADD #1	02/23/2011
project #	09014

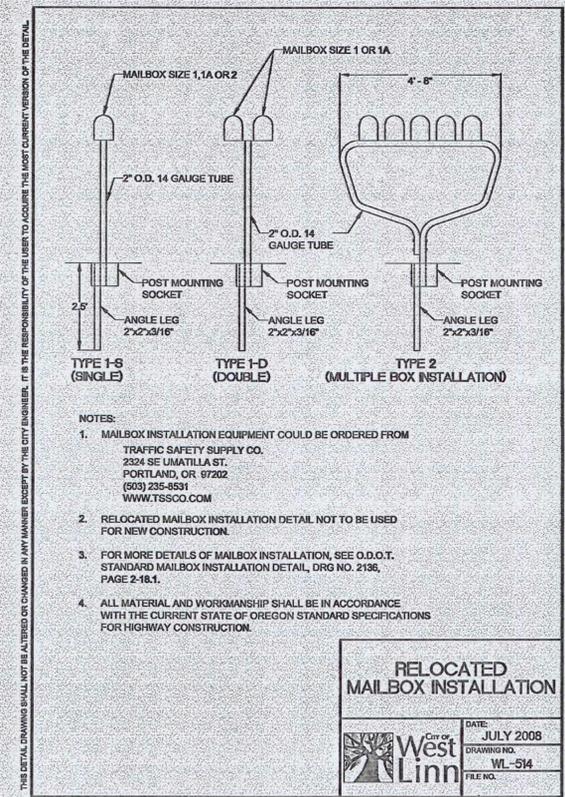
**2 RELOCATED MAILBOX WL-514**  
P13.2|P15.3 SCALE: NONE

**RELOCATED MAILBOX INSTALLATION**

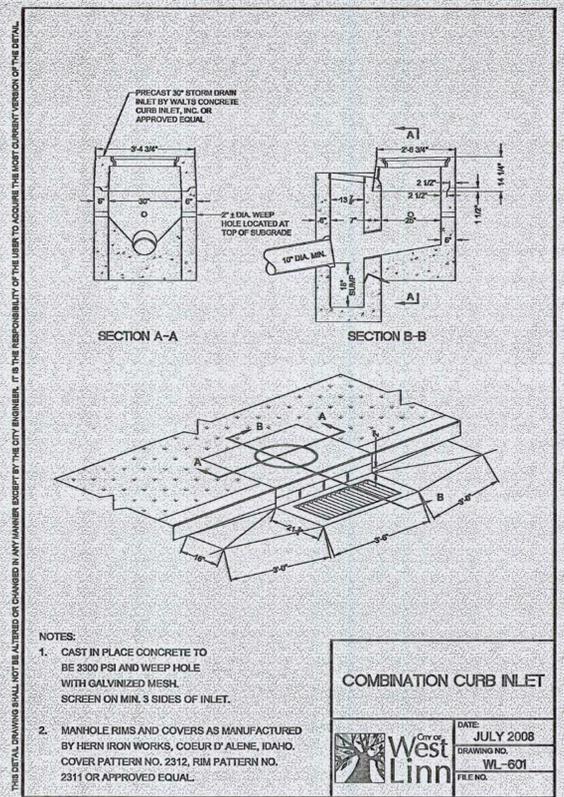
**3 CURB INLET WL-601**  
P14.1|P15.3 SCALE: NONE

**COMBINATION CURB INLET**

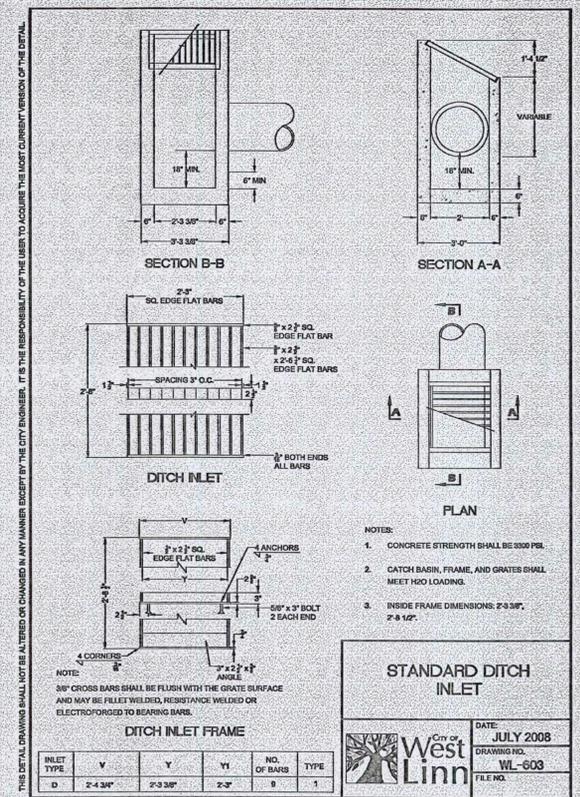
**4 DITCH INLET WL-603**  
P14.1|P15.3 SCALE: NONE

**STANDARD DITCH INLET**

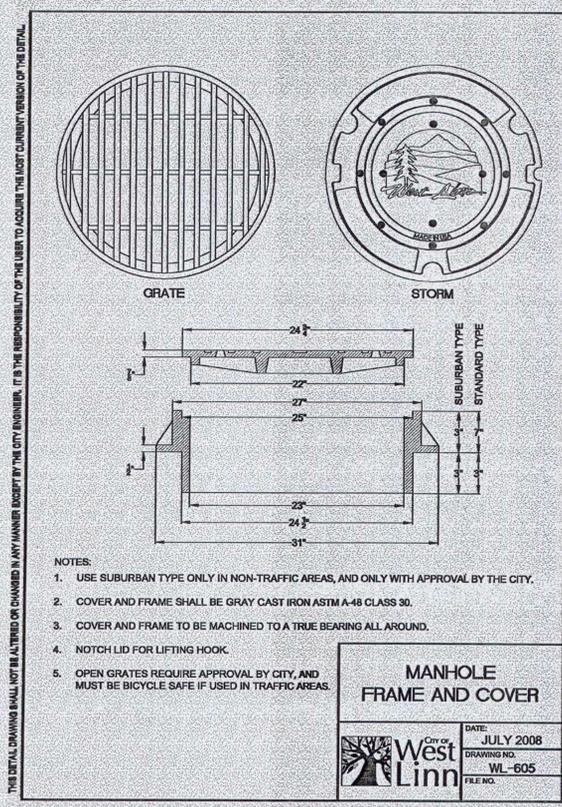
**5 MANHOLE FRAME & COVER WL-605**  
P15.1|P15.3 SCALE: NONE

**MANHOLE FRAME AND COVER**

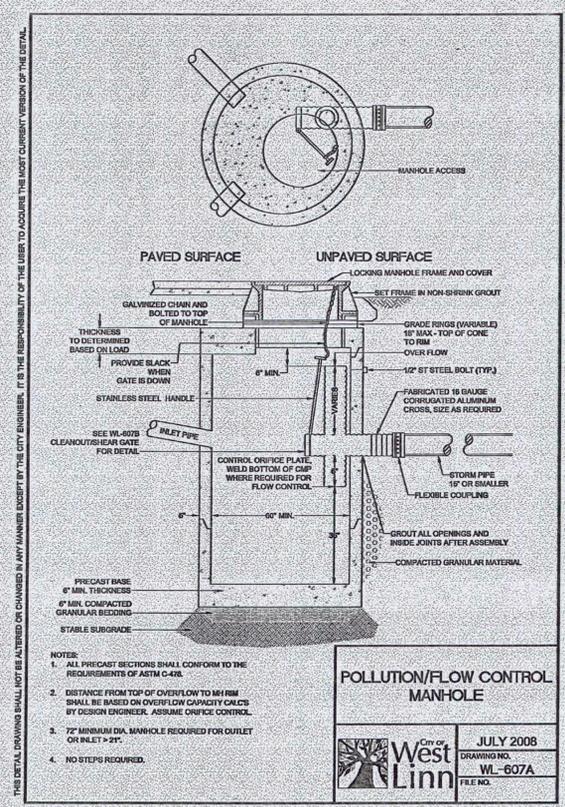
**6 POLLUTION CONTROL MANHOLE WL-607A**  
P14.1|P15.3 SCALE: NONE

**POLLUTION/FLOW CONTROL MANHOLE**

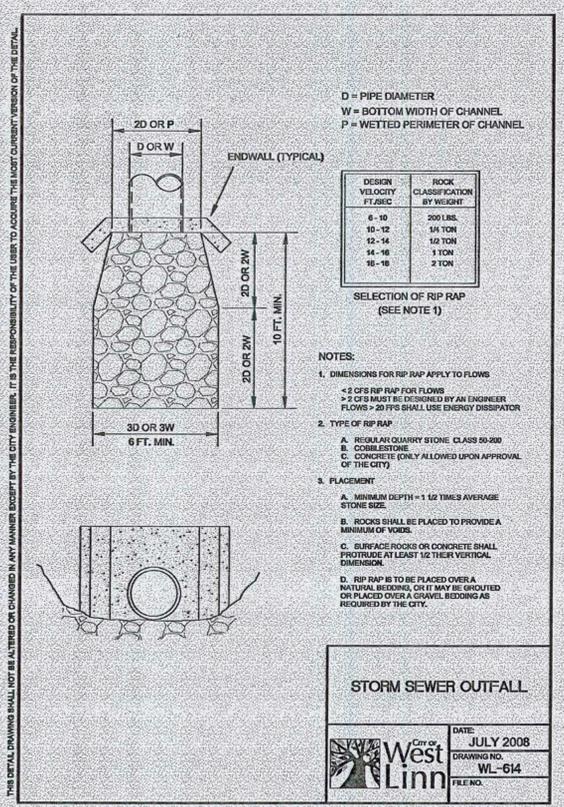
**7 STORM SEWER OUTFALL WL-614**  
P14.1|P15.3 SCALE: NONE

**STORM SEWER OUTFALL**

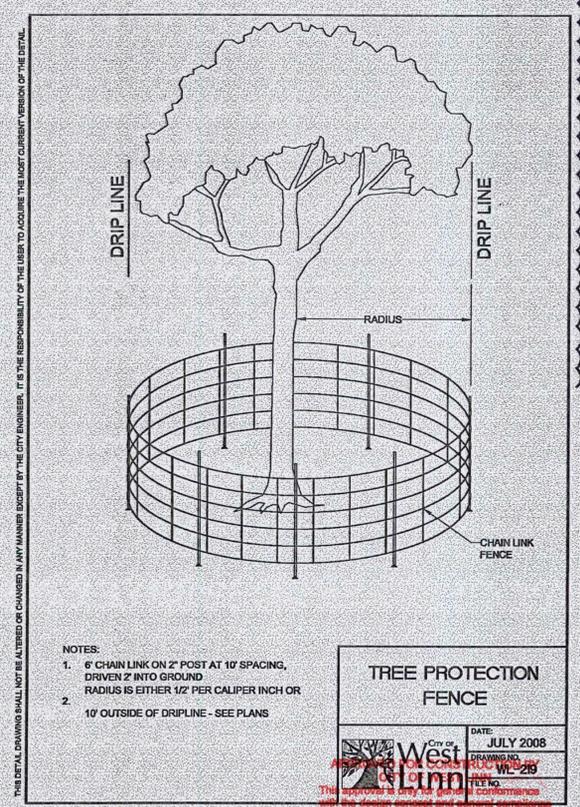
**8 TREE PROTECTION FENCE WL-619**  
P12.1|P15.3 SCALE: NONE

**TREE PROTECTION FENCE**
