# Landslide Inventory Map of the Northwest Quarter of the Oregon City Quadrangle, Clackamas County, Oregon

IMS-26

INTERPRETIVE MAP SERIES

by William J. Burns and Ian P. Madin

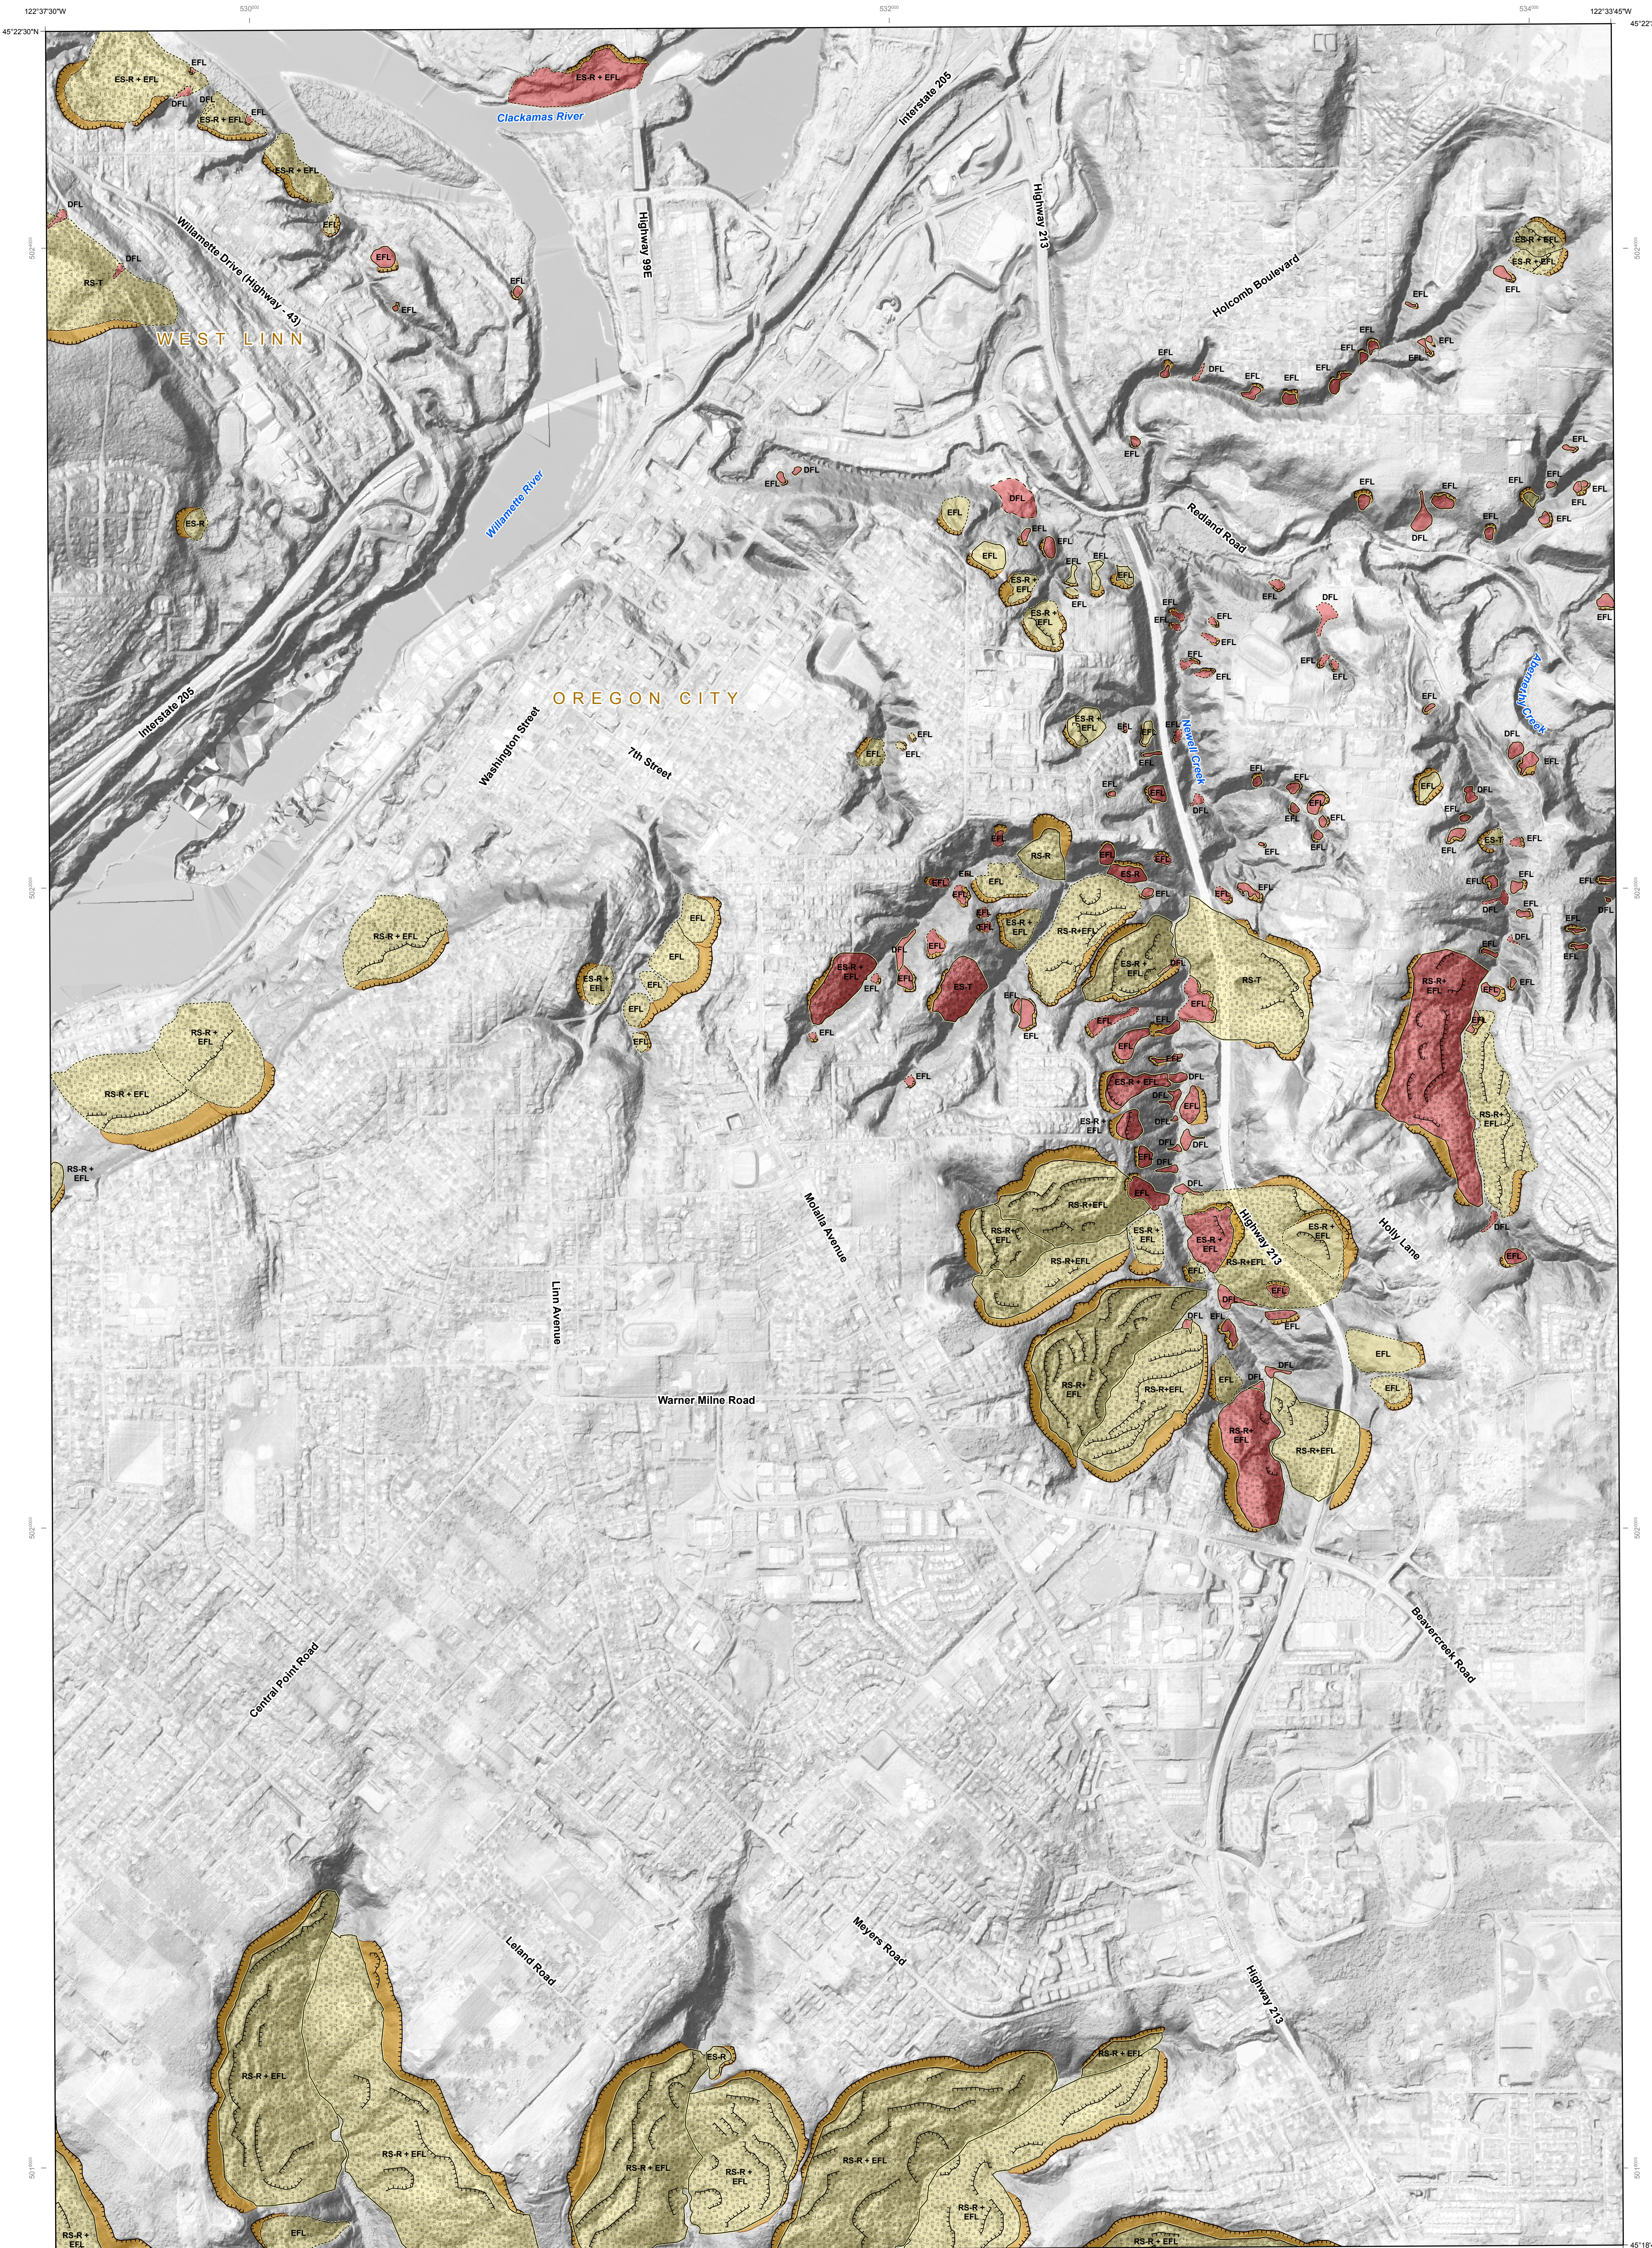
This map is an inventory of existing landslides in the quarter quadrangle. The landslide inventory is one of the essential data layers used to delineate regional landslide susceptibility. This landslide inventory is not regulatory and does not represent when new information regarding landslides is found or when future (new) landslides occur. Therefore, it is possible that landslides within the mapped area were not identified or occurred after the map was prepared.

This inventory map was prepared by following the Protocol for Inventory Mapping of Landslide Deposits from Light Detection and Ranging (Lidar) Imagery developed by Burns and Madin (2009). The three primary tasks included compilation of previously mapped landslides (including review of DOGAMI Special Paper 34 (Hofmeister, 2004) and the Statewide Landslide Information Layer for Oregon, release 1 (Burns and others, 2006)), lidar-based morphologic mapping of landslide features, and review of aerial photographs. Landslides identified by these methods were digitized and compiled into a GIS database at varying scales. The recommended map scale for these data is 1:8,000, as displayed on this map. Each landslide was also annotated with classifications for activity, depth of failure, movement type, and confidence of interpretation. The landslide data are displayed on top of a base map that consists of an aerial photograph (orthorectified) overlaid on the lidar-derived hillshade image.
