Stormwater Drainage Report

Sunset Primary School

Prepared for: West Linn Wilsonville School District

July 2016 | KPFF Project #315087

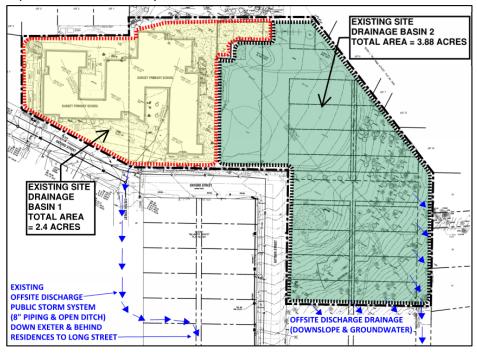
Figure 1: Existing Site Drainage Basins and Discharge

Drainage Basin 1, shown in Figure 1 below, is comprised of the west side of the site and consists of the existing school building and surrounding paved area. This basin is approximately 2.4 acres, is largely impervious and currently includes no storm treatment or detention facilities.

Drainage Basin 2 for the existing school is comprised of the east and southeast portions of the site. These areas are predominantly open field and tree areas. As Figure 1 shows, this area is approximately 3.88 acres. There are no storm collection facilities in this area and all stormwater falling in this area drains down-gradient either by overland surface flow or infiltration subdrainage to the southeast.

Due to the impervious nature of the basin (predominantly roofs and pavements), essentially all storm drainage is collected onsite and discharges in an uncontrolled manner to a relatively marginal public storm drainage system that runs down Exeter Street to the south.

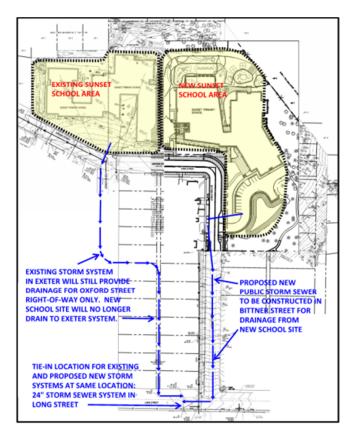
Figure 2: Sunset area offsite public storm drains

This public system is comprised of a combination of 8-inch gravity pipe segments with portions of open ditch sections. The Exeter Street system eventually is routed behind a row of residences and connects to a 24-inch main storm system in Long Street (shown in Figure 2).

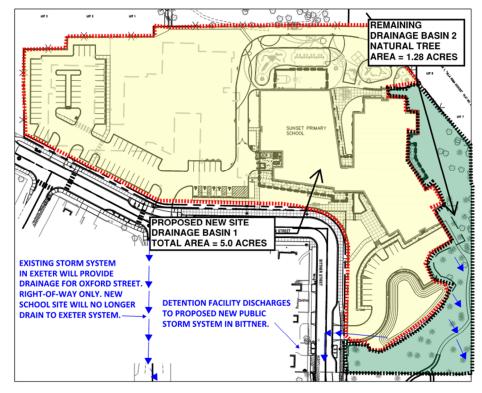
Figure 3: Sunset School new site drainage basins and discharge

As Figure 3 illustrates, the new proposed school development shifts and expands the existing Drainage Basin 1 to the east, which is largely composed of the new impervious paving and roof areas. The overall area of Drainage Basin 1 is approximately 5.0 acres (or 2.6 acres larger than the pre-development condition).

Note that with the reconfigured school layout, the proposed play field has been relocated to the west side of the site. The field is relatively flat and will be natural grass turf surface.

- A stormwater treatment and detention facility will be utilized for collection and treatment of stormwater from the enlarged Drainage Basin 1.
- A new public storm sewer will be constructed in Bittner Street to convey the Sunset stormwater discharge from the treatment and detention facility to Long Street to tie into the same discharge location as the existing Sunset school site (shown in Appendix A-3 Exhibit 3).
- The reduction of Drainage Area 2 will reduce the current level of area contributing to stormwater infiltration and migration down-gradient to the southeast. More rainwater in this area will be captured, treated, and detained for discharge to the public storm sewer system.

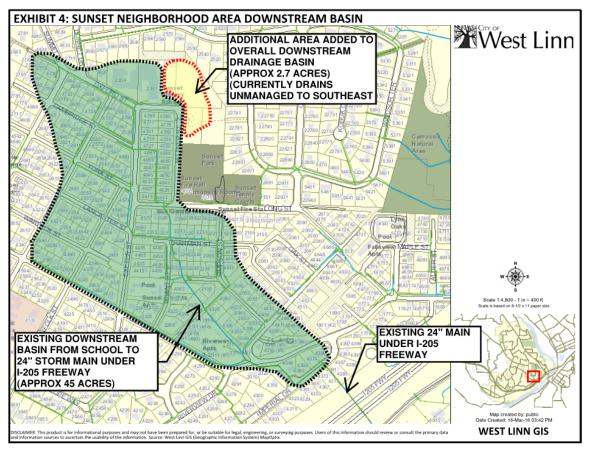
Figure 4: Sunset neighborhood area downstream basin

Figure 4 shows the estimated entire drainage basin for the Long Street system. (Note that the boundaries are approximate and have been estimated from the City of West Linn map system.) This figure illustrates the additional area of 2.6 acres added to the overall 45 acre basin.

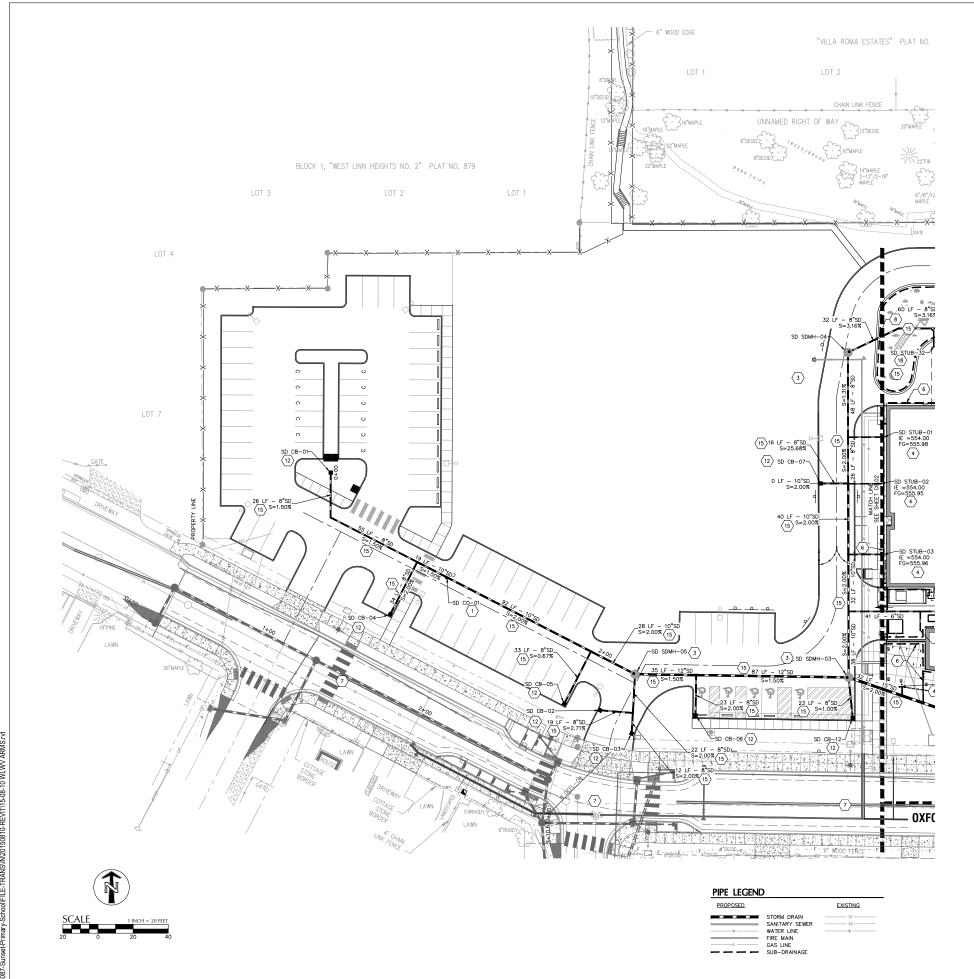
C6.01

- 1. INSTALL STANDARD CLEANOUT.
- 2. INSTALL FLOW CONTROL MANHOLE.
- 3. INSTALL STANDARD 48" DIAMETER MANHOLE. -
- 4. CONNECT TO BUILDING ROOF DRAIN STUB WITH PVC LATERAL. LATERAL TO BE 6" DIAMETER UNLESS OTHERWISE NOTEO ON PLANS. SLOPE AT A MINIMUM OF 2%. SEE PLUMBING PLANS FOR CONTINUATION. CONFIRM DOWNSPOUT LOCATION WITH ARCHITECTURAL AND PLUMBING PLANS PRIOR TO CONSTRUCTION.

STORM PLAN NORTHWEST

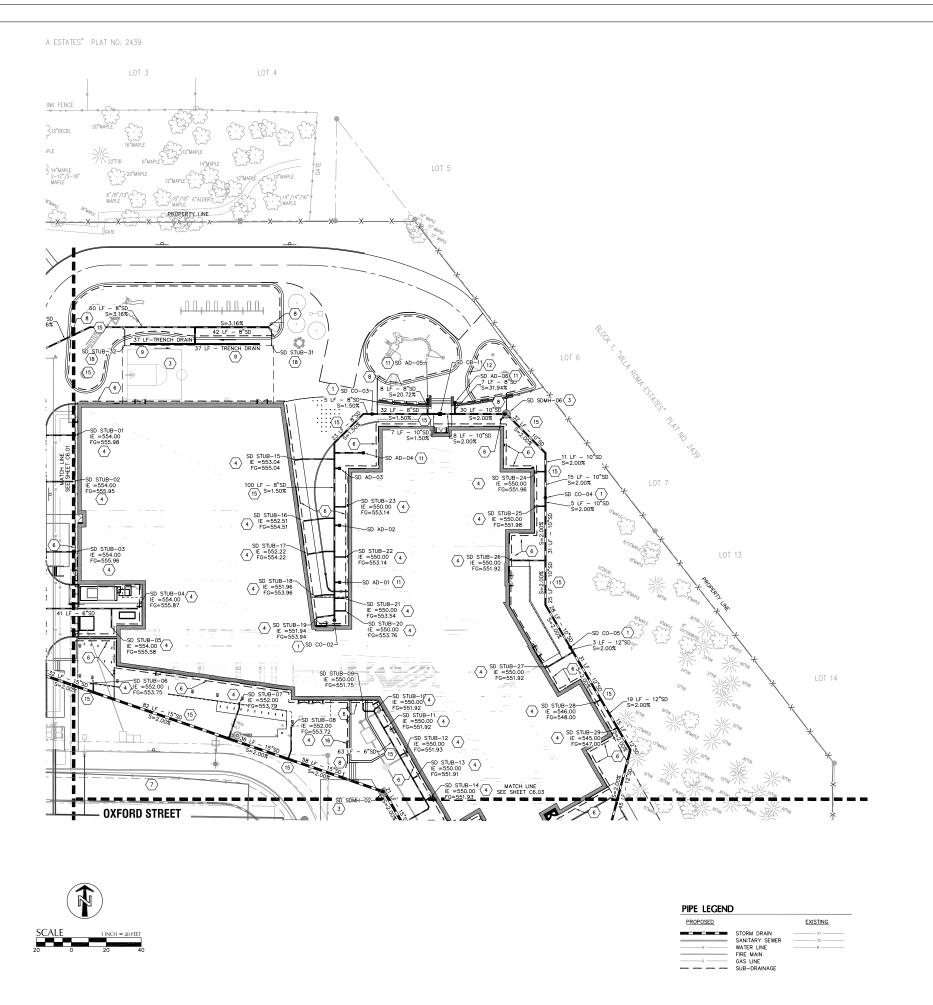
C6.02

1. INSTALL STANDARD CLEANOUT. 2 (1) 7.05 (6.05) 2. INSTALL FLOW CONTROL MANHOLE. 3. INSTALL STANDARD 48" DIAMETER MANHOLE.

CONNECT TO BUILDING ROOF DRAIN STUB WITH PVC LATERAL. LATERAL TO BE 6" DIAMETER UNLESS — OTHERWISE NOTED ON PLANS, SLOPE AT A MINIMUM OF 2%. SEE PLUMBING PLANS FOR CONTINUATION. CONFIRM DOWNSPOUT LOCATION WITH ARCHITECTURAL AND PLUMBING PLANS PRIOR TO CONSTRUCTION. 5. DAYLIGHT STORM PIPE. -

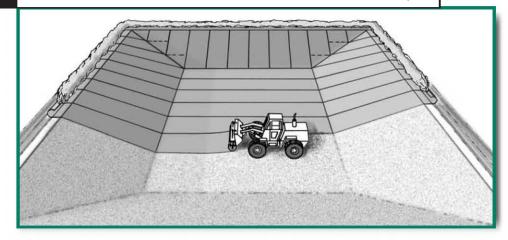
FIGURE 7 TYPICAL BENTOMAT®/CLAYMAX® INSTALLATION TECHNIQUE

5.2 Equipment which could damage the GCL should not be allowed to travel directly on it. Acceptable installation, therefore, may be accomplished such that the GCL is unrolled in front of backwards-moving equipment (Figure 7). If the installation equipment causes rutting of the subgrade, the subgrade must be restored to its originally accepted condition before placement continues.

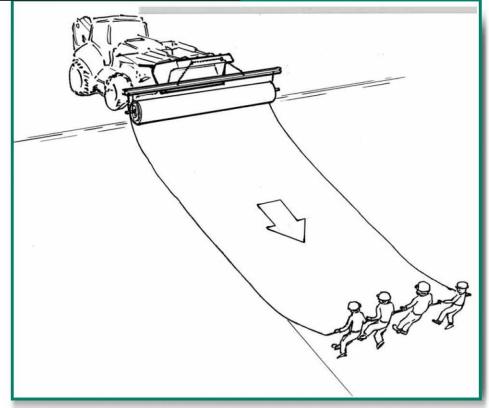
FIGURE 8 UNROLLING BENTOMAT

- 5.3 If sufficient access is available, GCL may be deployed by suspending the roll at the top of the slope with a group of laborers pulling the material off of the roll and down the slope (Figure 8).
- **5.4** GCL rolls should not be released on the slope and allowed to unroll freely by gravity.
- 5.5 Care must be taken to minimize the extent to which the GCL is dragged across the subgrade in order to avoid damage to the bottom surface of the GCL. Care must also be taken when adjusting Bentomat CLT panels to avoid damage to the geotextile surface of one panel of GCL by the textured sheet of another panel of GCL. A temporary geosynthetic subgrade covering, commonly known as a slip sheet or rub sheet, may be used to reduce friction damage during placement.

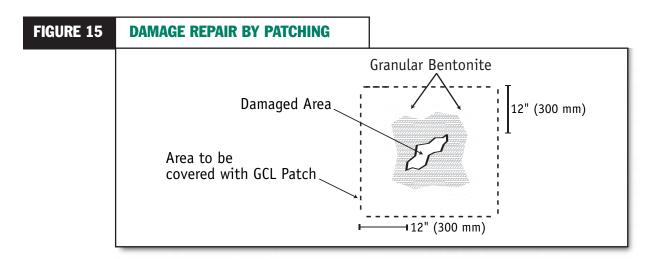
9.1 If the GCL is damaged (torn, punctured, perforated, etc.) during installation, it may be possible to repair it by cutting a patch to fit over the damaged area (Figure 15). The patch should be cut to size such that a minimum overlap of 12 inches (300 mm) is achieved around all parts of the damaged area. Granular bentonite or bentonite mastic should be applied around the damaged area prior to placement of the patch. It may be necessary to use an adhesive such as wood glue to affix the patch in place so that it is not displaced during cover placement. Smaller patches may be tucked under the damaged area to prevent patch movement.

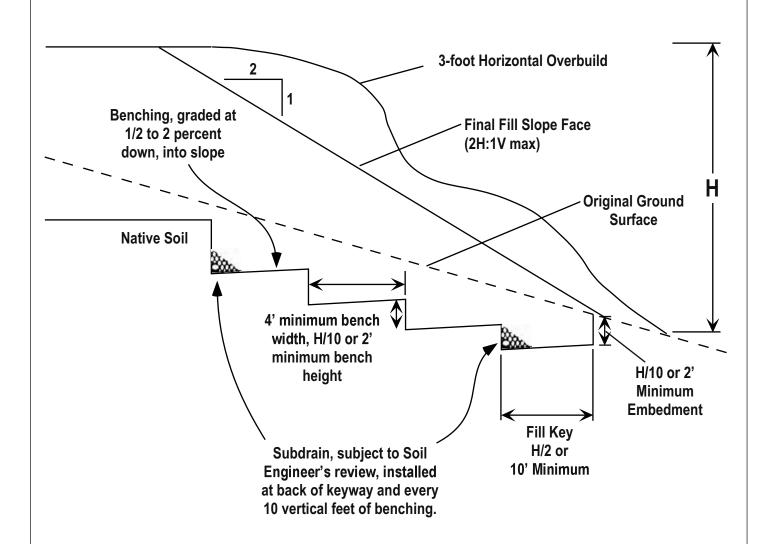
FILL SLOPE DETAIL

NOTE: Surfaces to receive fill with slopes steeper than 5H:1V (horizontal:vertical) should be benched and keyed as shown.

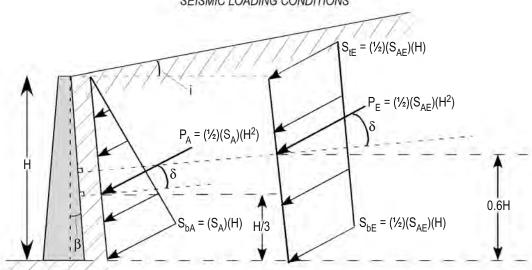
SEISMIC LOADING CONDITIONS

- P_A = Static active thrust force acting at a triangular distribution on wall (lb/ft³)
- P_E = Dynamic component of active thrust force acting at a uniform distribution on wall (lb/ft)
- i = Slope of backfill (degrees)**
- S_{Δ} = Active (static) component of equivalent fluid pressure (lb/ft³)*
- S_{tF} = Active earth pressure (dynamic) at the top of the wall (lb/ft³)
- S_{bA} = Active earth pressure (static) at the bottom of the wall (lb/ft³)

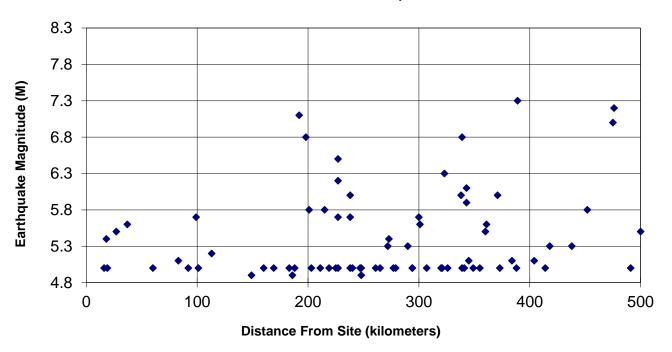
Inset 1. Historical Earthquakes

Based on the historical record and crustal faulting models of the region, the maximum earthquake for crustal sources within the Pacific Northwest is estimated to be M5.75⁵⁰ (independent of recurrence interval). Similarly, the maximum earthquake for an intra-slab source on the subducting Juan De Fuca plate is estimated to be M7.5 to M7.7.
